RE: ENVIRONMENTAL MANAGEMENT PLAN - WARNERVALE TOWN CENTRE, MANAGEMENT OF POTENTIAL CONTAMINATION DURING DEVELOPMENT

Audit Number: RS 010B-1

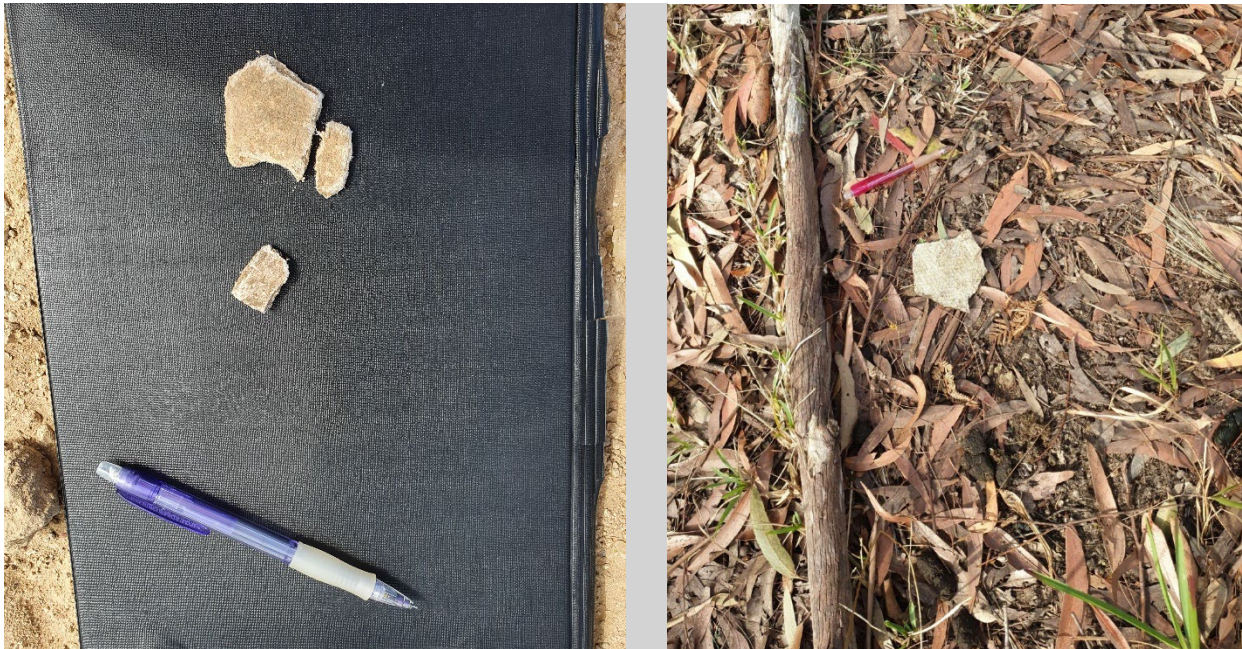
Figure 2: Example of Bonded Potential ACM Fragment Find

Based on the results of previous investigations and the remediation undertaken, contamination at the site which requires ongoing management has not been identified. However, there are risks associated with potential residual asbestos at the site, including from isolated fragments of bonded potential asbestos containing material (ACM) associated with previous illegal dumping (see Figure 2 for examples) and potential further illegal dumping of waste materials containing asbestos prior to future development (see Figure 3 for example). There is also potential for ACM to be found within mounded fill

UFP Item	Details
<i>Objectives of the UFP</i>	Objectives of the UFP should be clearly stated and should generally be to: <ul style="list-style-type: none"> • Manage potential unexpected finds of contamination (if any), • Mitigate human health and environmental risks (if any) associated with the unexpected find, • Require a suitably qualified environmental consultant to adequately assess the find to provide appropriate advice, and • Allow remediation and validation of the unexpected find.
<i>Responsibilities</i>	The UFP is to identify responsible parties including who is responsible for implementing the unexpected find procedure and who is responsible for engaging a suitably qualified environmental consultant to assess the unexpected find.
<i>Potential Unexpected Finds</i>	The UFP is to include examples of potential unexpected finds which maybe encountered at the site. These are most likely to include: <ul style="list-style-type: none"> • Visually contaminated or odourous soil and/or groundwater • Aesthetically unacceptable material (demolition waste (bricks, concrete, wood and metal) and/or ashy material) • Asbestos containing material (bonded and fibrous asbestos). Examples are shown in Section 4 above.

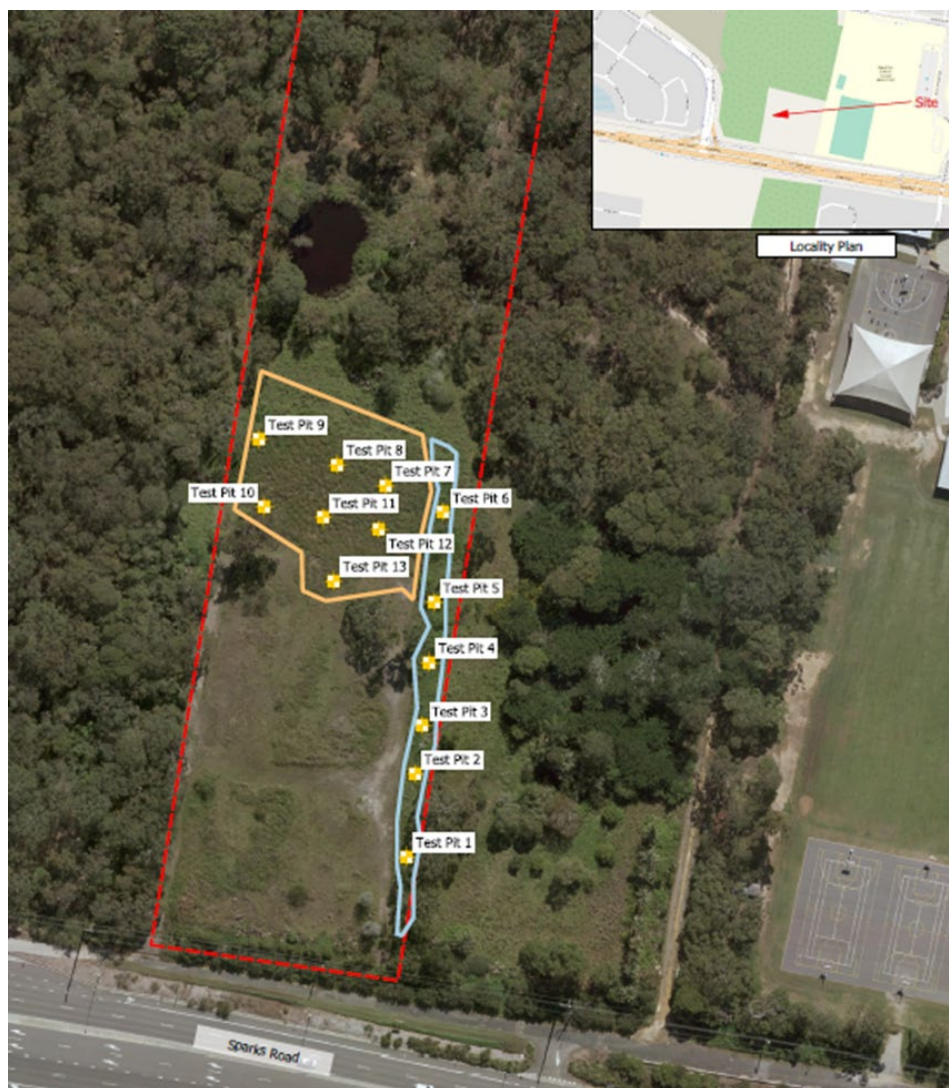
Figure 4: Location of Mounded Fill within 103 Sparks Road

within 103 Sparks Road, located as shown on Figure 4, or within the densely vegetated E2/E3 zoned areas. These risks can be appropriately managed during the development process through implementation of an UFP.
