Reference: 21322v4

Preliminary Site Investigation – 263-273 and 273A Coward Street and 76-82 Kent Road, Mascot NSW

PSI Report

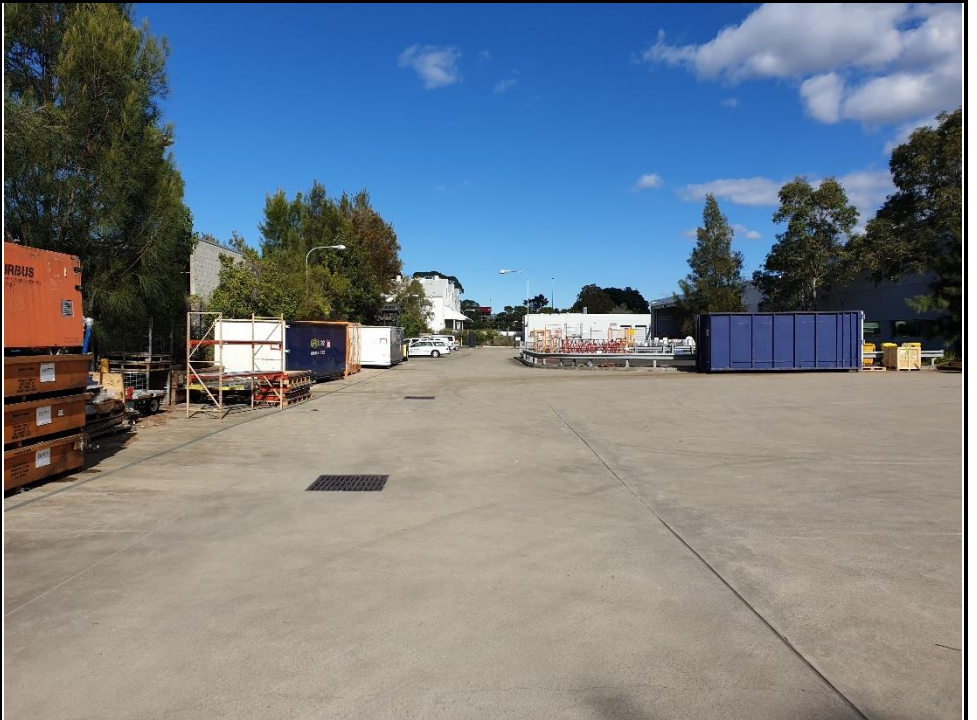
Photo No.	Date	
3	17 May 21	
Description: Looking south along the SDC loading dock and hardstand area.

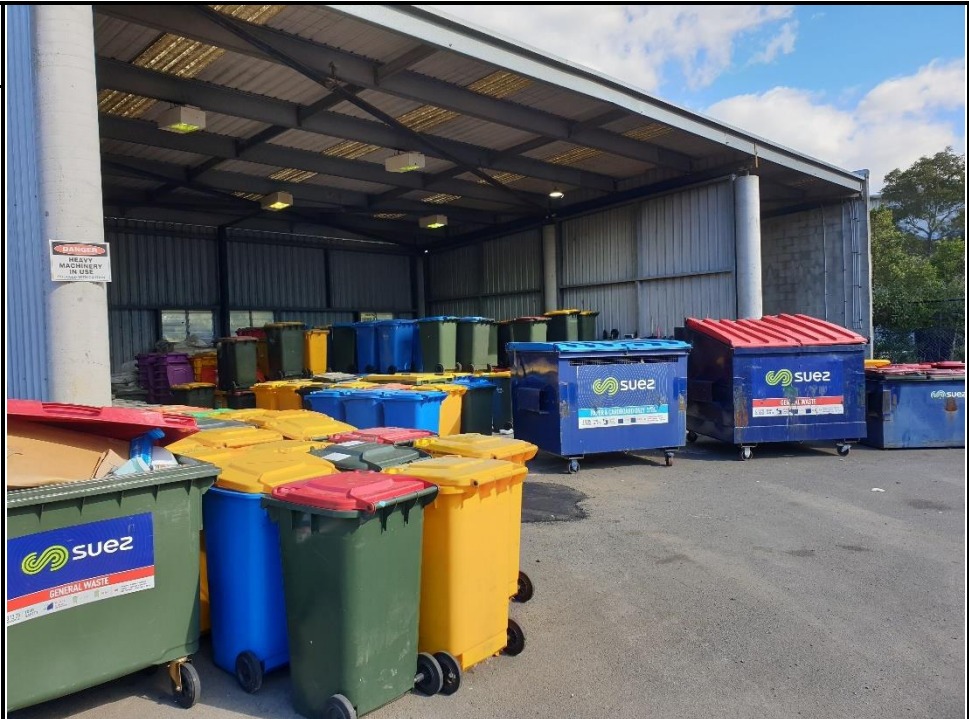
Photo No. 13	Date 17 May 21

Description: SUEZ Rubbish bin storage area within and around the unnamed shed on the Coward Street Lot.

- Waste materials (oil cans, aerosol cans, filters and oily rags) for recycling/disposal are stored in the shed. Various garbage bins were observed stored around and behind the shed. A oily water separator was observed on the western external wall of the shed. The area was overgrown and could not be accessed. It is unknown if the oily/water separator was being used/maintained.

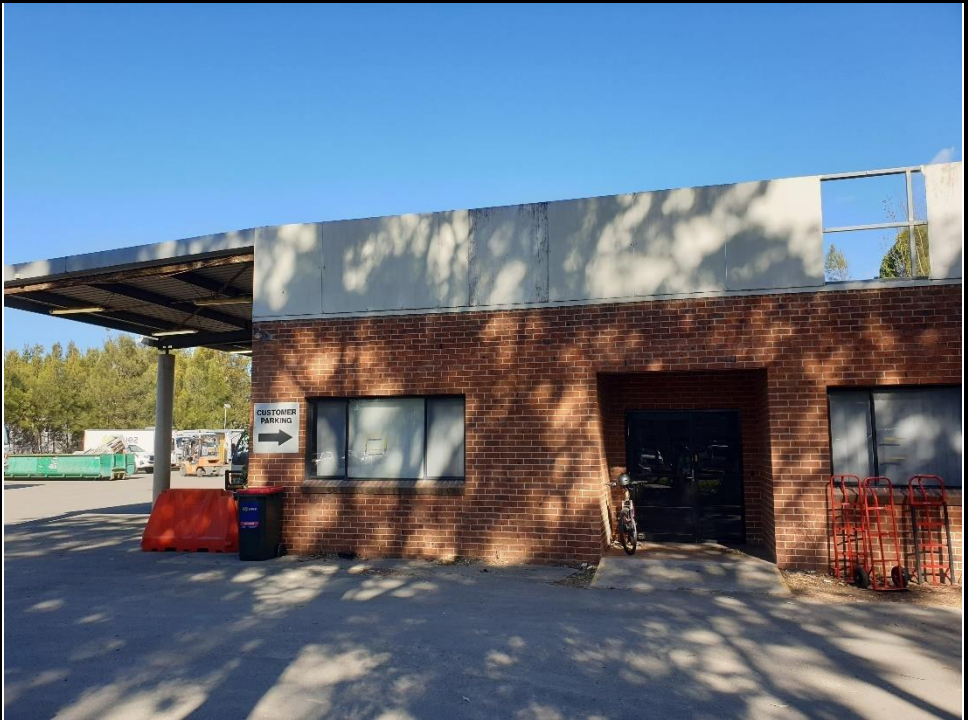
Photo No.	Date	
19	17 May 21	
Description: Looking south and the entry to the unnamed building located in the sealed portion of the Coward Street Lot. Fibro sheeting observed on elevated building façade.

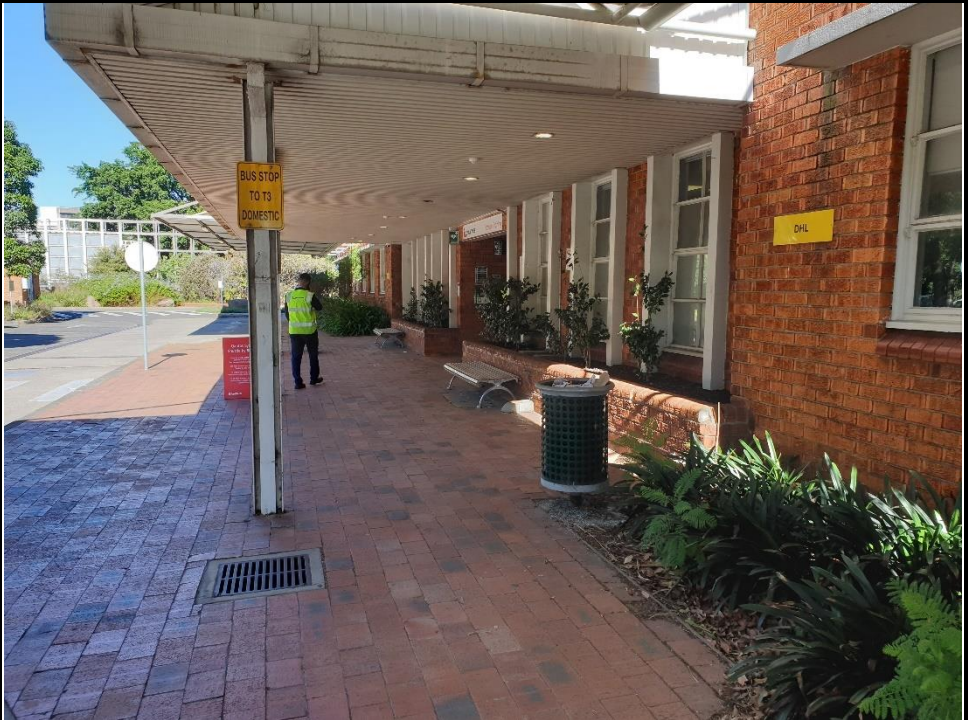
Photo No.	Date	
28	17 May 21	
Description: Looking east along the northern side of the STC building. The electrical substation in the caged area is evident. The external of the building has peeling/flaking paint and ACM eaves.

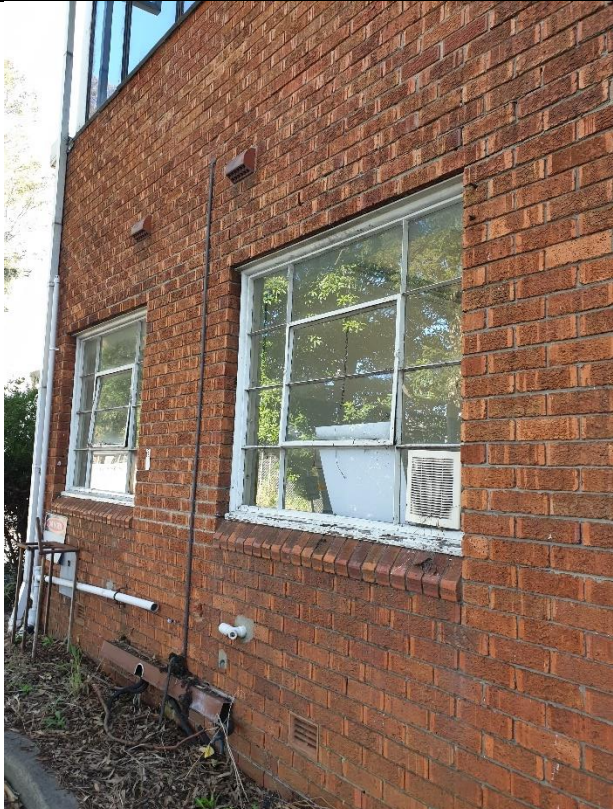
Photo No.	Date	
30	17 May 21	
Description: Southern side of the STC building. Timber windows with peeling/flaking paint and asbestos notification stickers on brickwork.

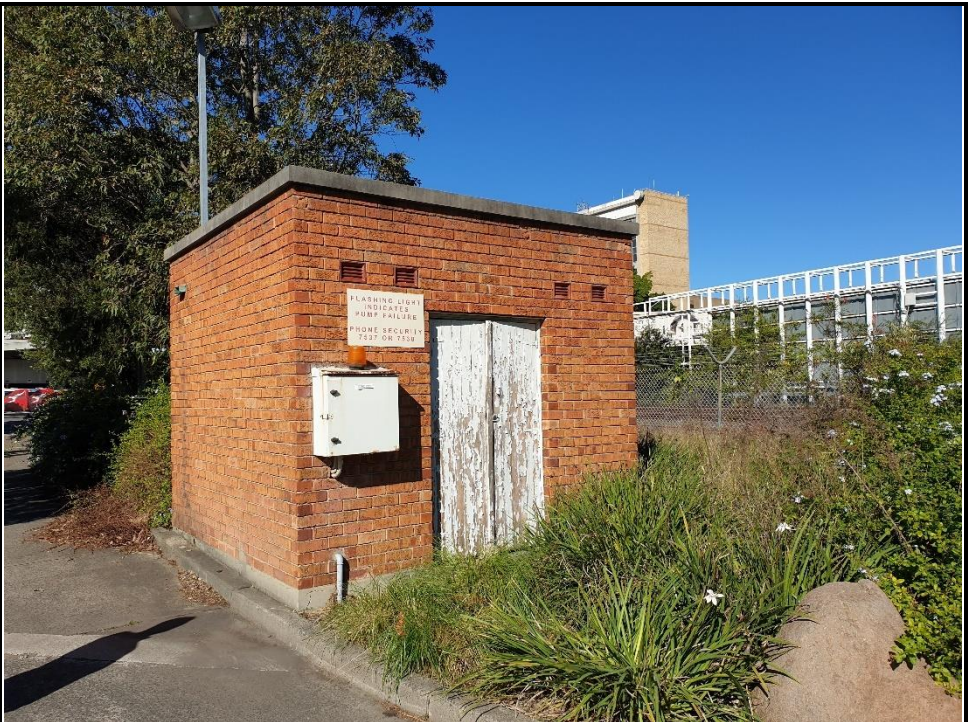
Photo No.	Date	
35	17 May 21	
Description: Small brick sewer pump structure located southeast of the STC building. The entry door has peeling/flaking potentially leaded paint.

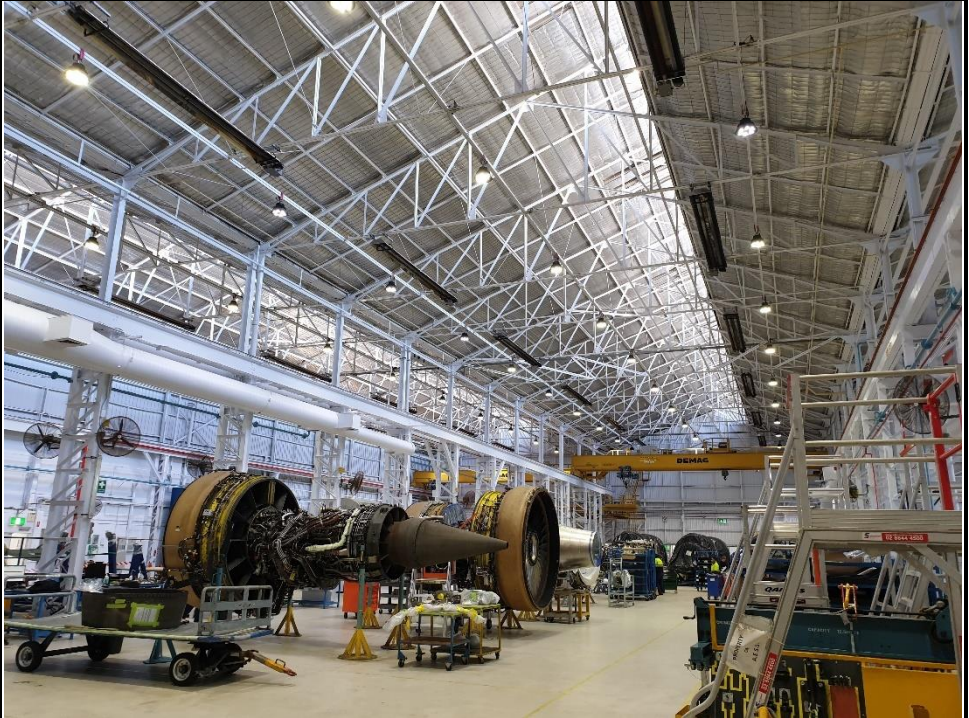
Photo No.	Date	
37	17 May 21	
Description: Example inside the LEO workshop building. Concrete floor observed to be in particularly good condition.

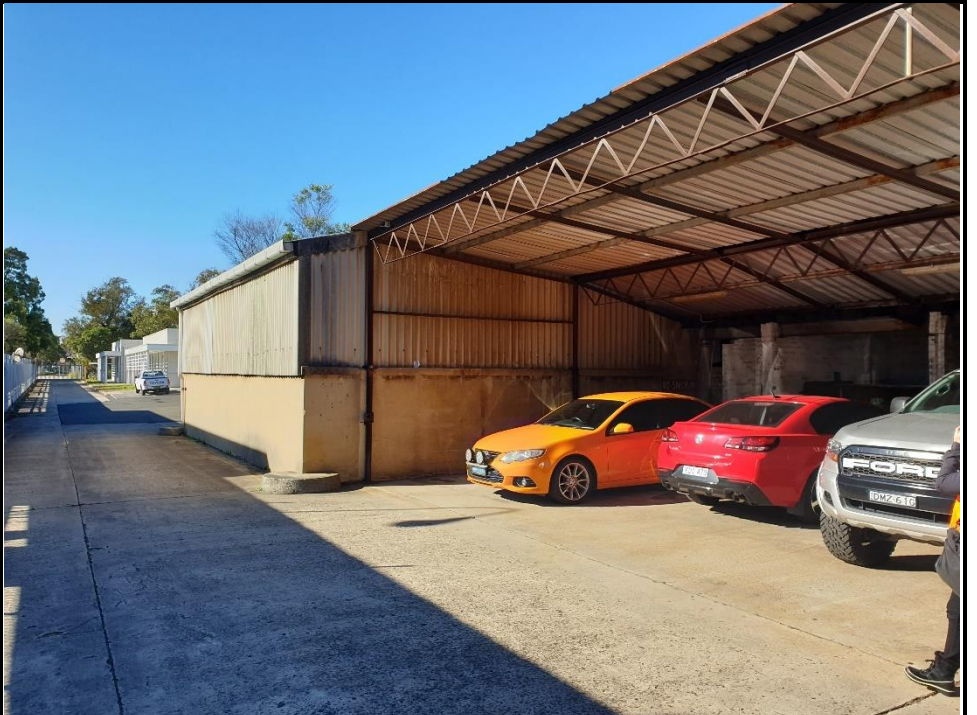
Photo No.	Date	
45	17 May 21	
Description: Looking west at the unnamed storage shed located north of the ARC building. Roof and walls constructed of corrugated fibro likely containing asbestos.

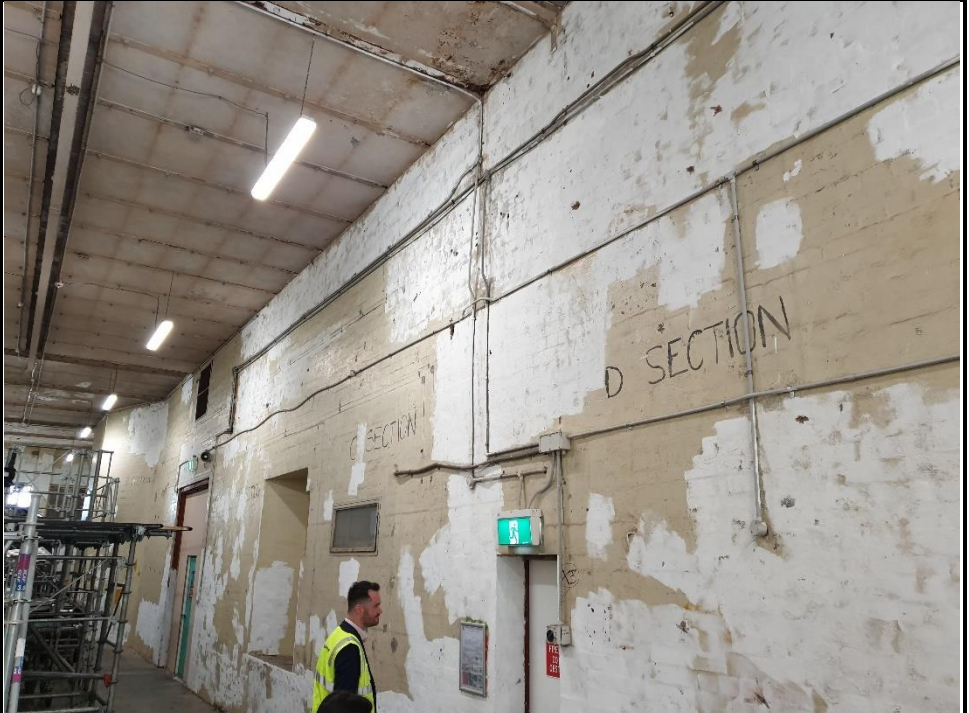
Photo No.	Date	
47	17 May 21	
Description: Internal are of the ARC building. The area being used for the storage of GSE (tug) and aircraft engines

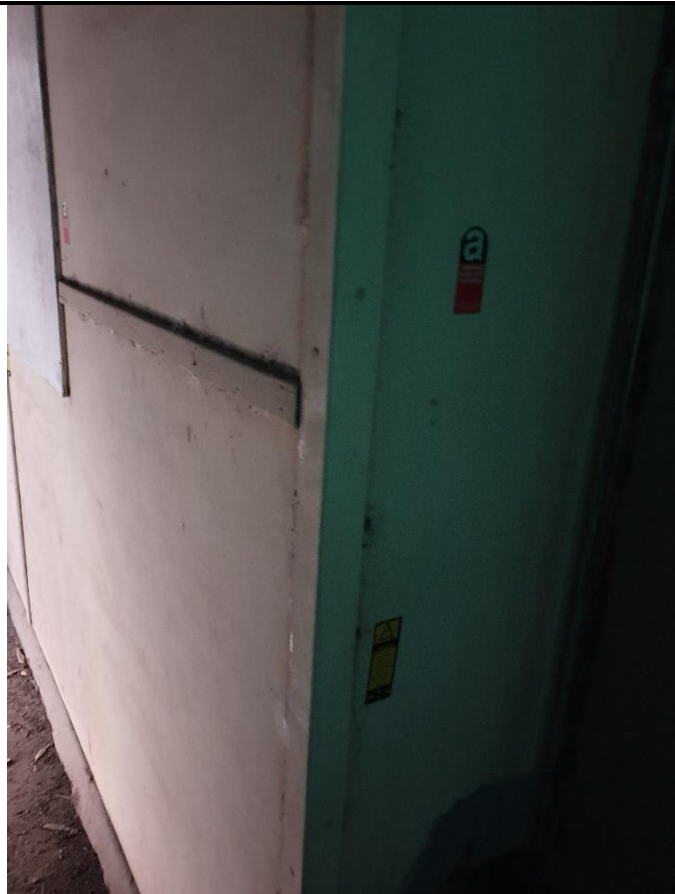
Photo No. 49	Date 17 May 21

Description: Asbestos notification stocker on fibro walls in the ARC building.

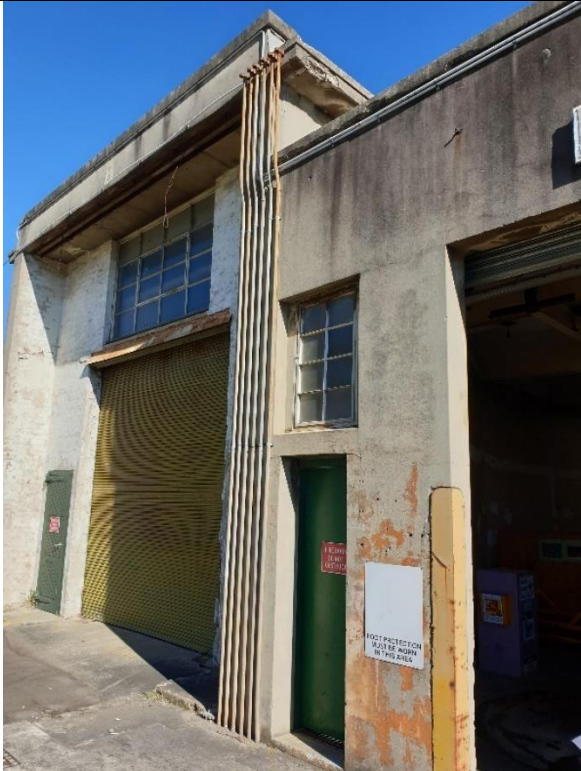
Photo No.	Date	
51	17 May 21	
Description: Six vent pipes on the eastern facade of the ARC building, indicated six USTs in the area.

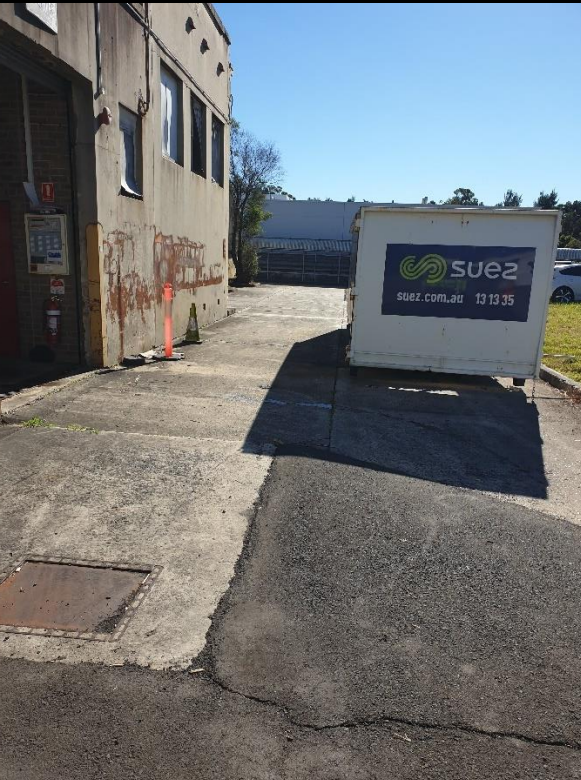
Photo No.	Date	
52	17 May 21	
Description: No fill or dip points could be located in the ground in front of the ARC building indicating the location of USTs.

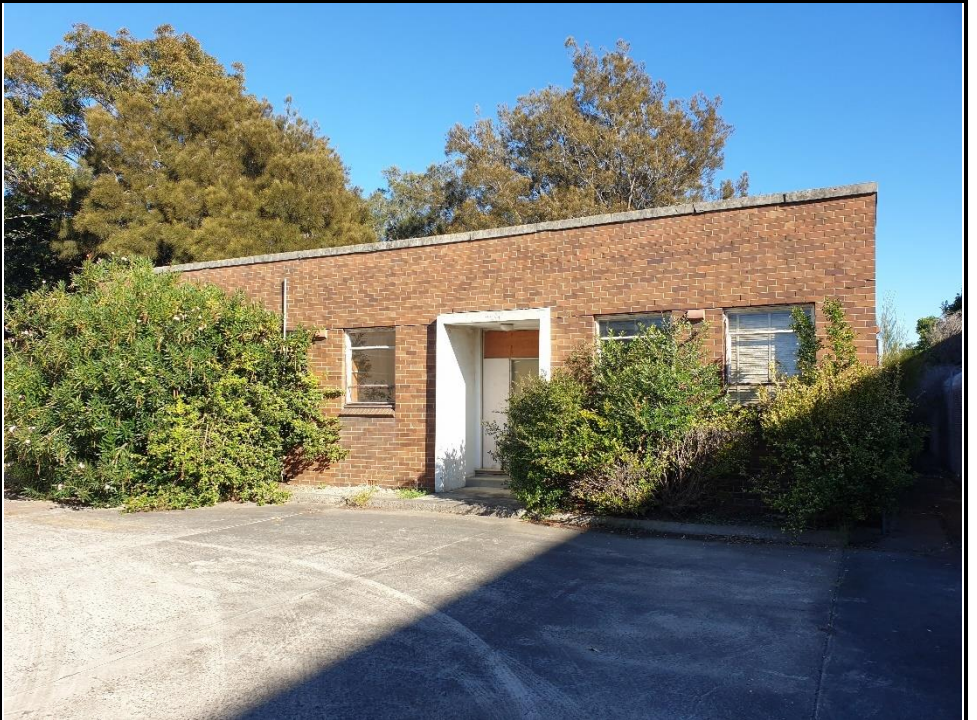
Photo No.	Date	
53	17 May 21	
Description: Looking west at the THS building entry. Landscaping areas are overgrown.

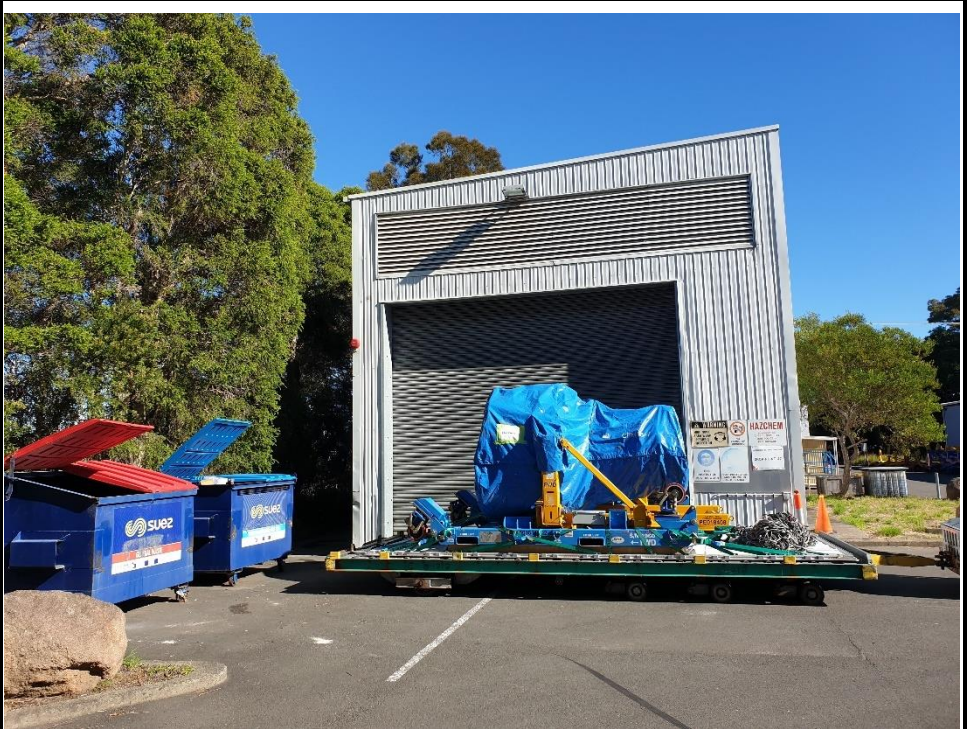
Photo No.	Date	
58	17 May 21	
Description: Entry to the spray store building located southwest of the LEO building against the southern boundary of the LOT B investigation area.

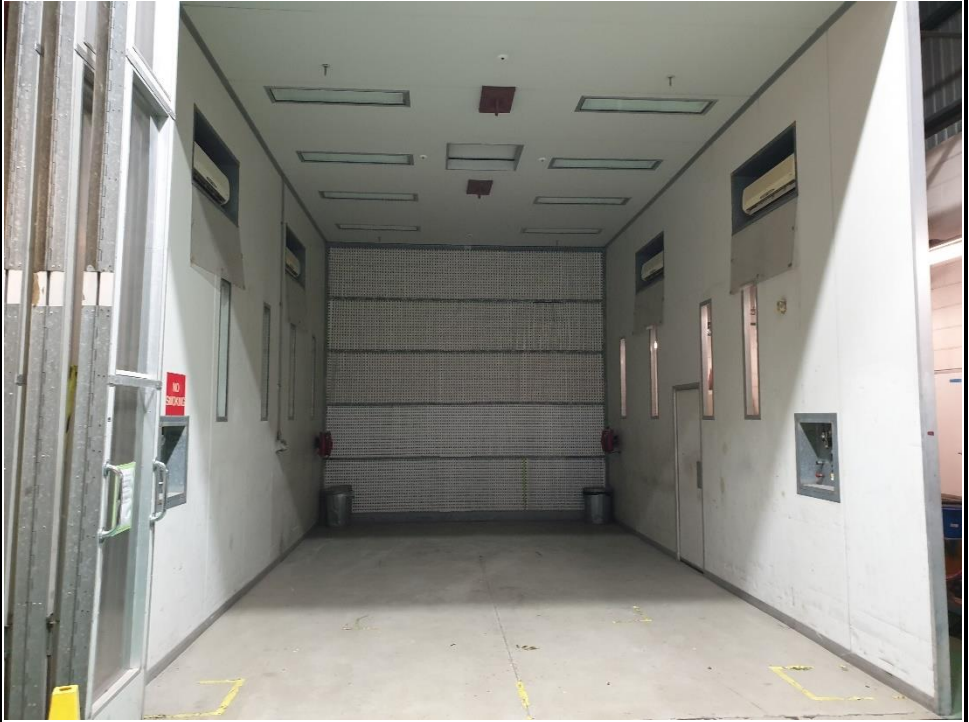
Photo No.	Date	
59	17 May 21	
Description: Spray booth inside the spray store building. The booth was in good condition and no staining was evident in or outside of the building.

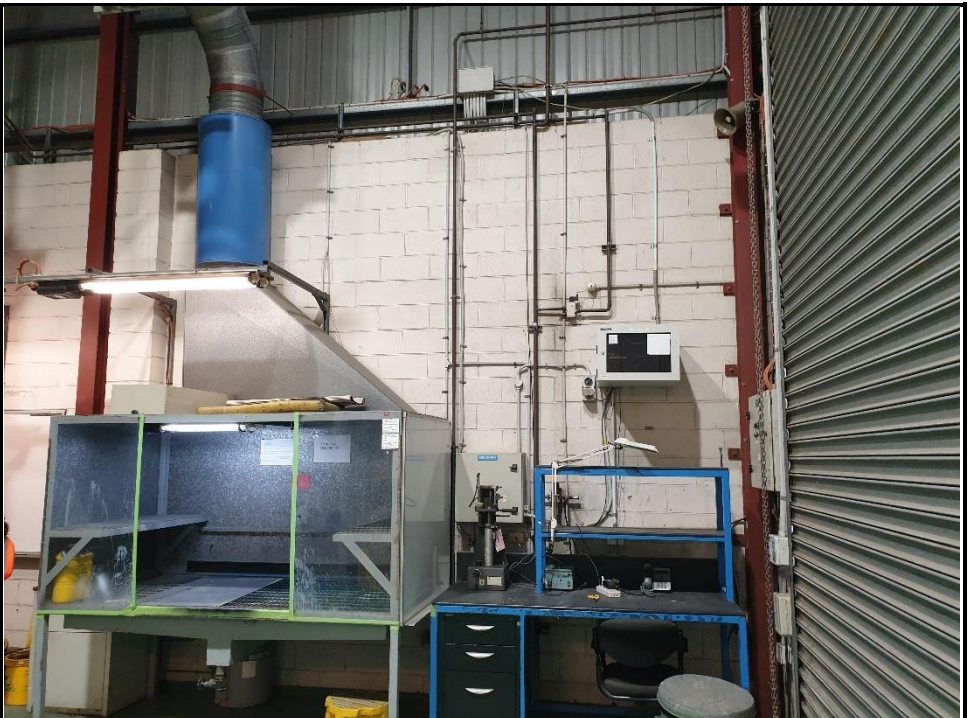
Photo No.	Date	
60	17 May 21	
Description: Paint mixing area fume hood and workbench inside the spray store building.

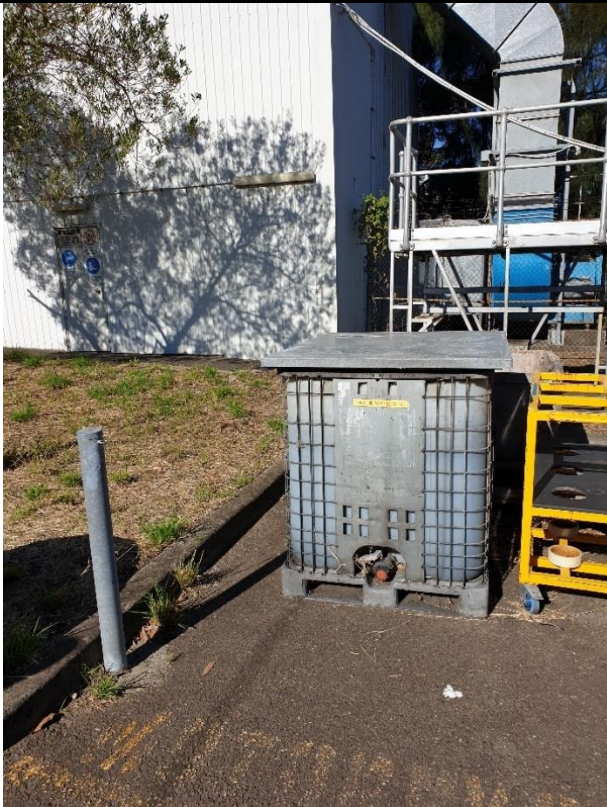
Photo No.	Date	
61	17 May 21	
Description: An IBC located at the western end of the Stray Store building containing waste engine oil. This IBC did not have secondary containment and did not appear to be located in a designated chemical storage area.

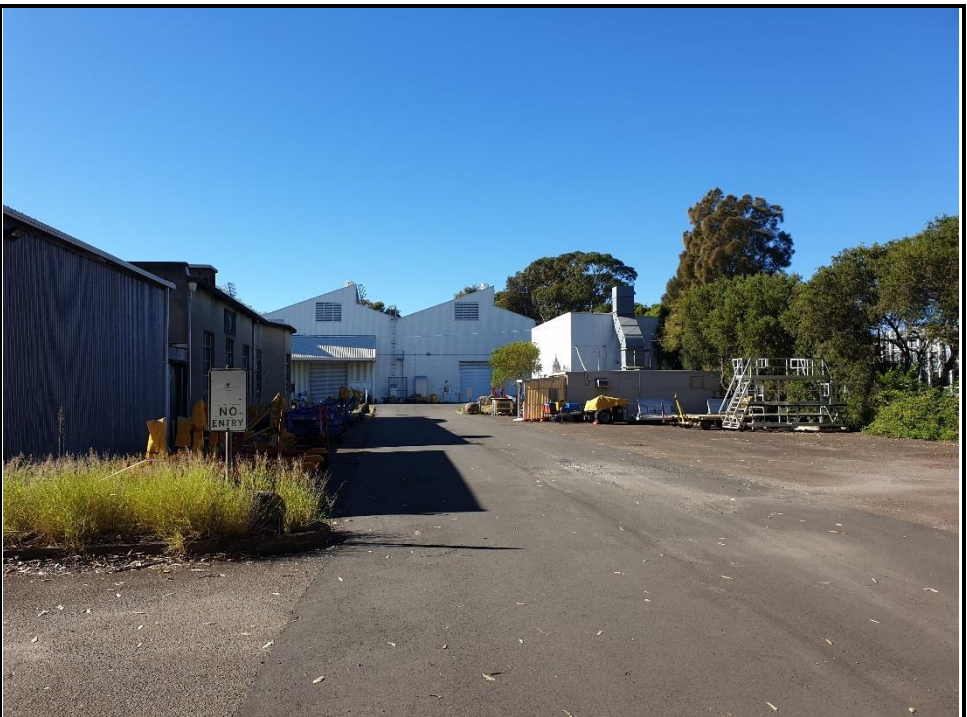
Photo No.	Date	
62	17 May 21	
Description: ARC, THS and Surrounds area looking east. The ARC building is present on the left side of the photo and an equipment set down/storage area is located on the right-hand side of the photo. The LEO building is picture in the background.

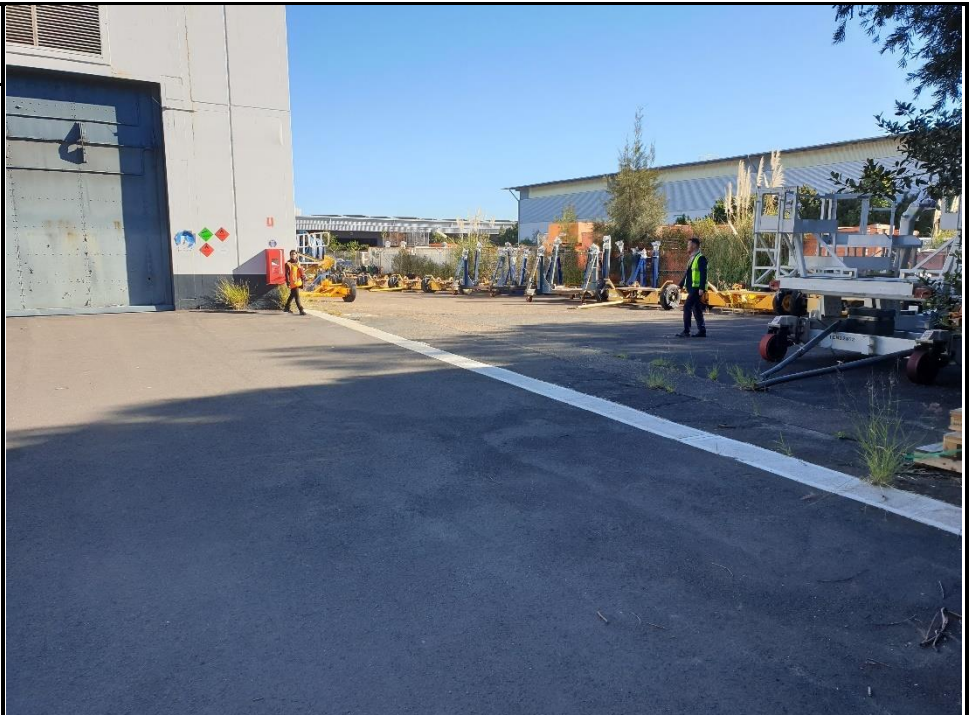
Photo No. 64	Date 17 May 21

Description: Looking northwest at the area used for the storage of engine trailers and dollies along the western fence of the JT2 area.

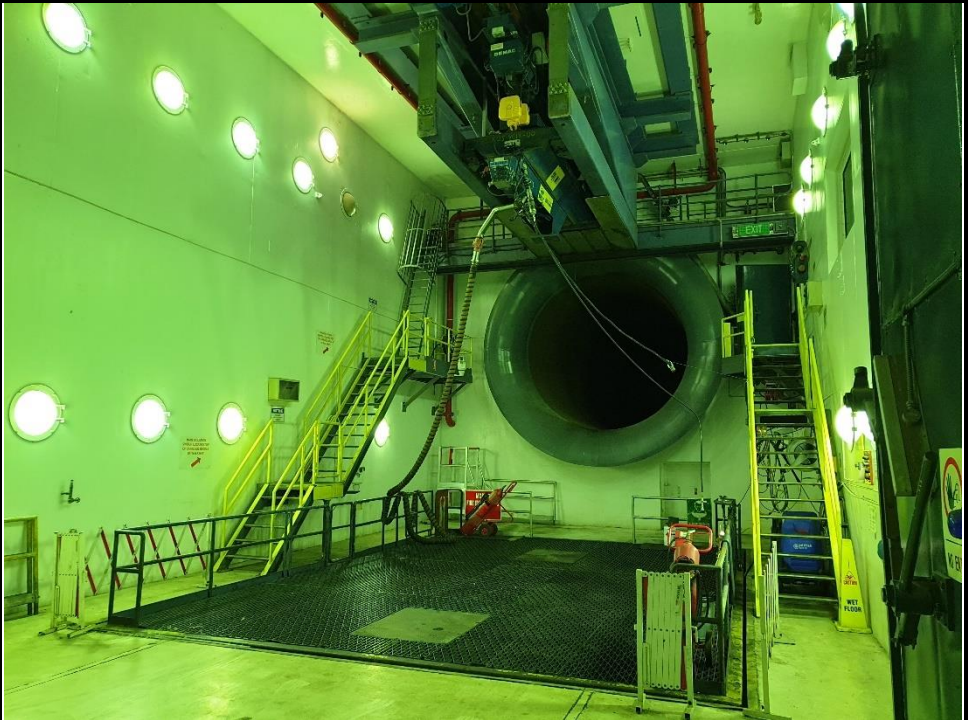
Photo No.	Date	
65	17 May 21	
Description: Engine test cell area. Exhaust funnel in background. The grated area under the engine crane is used to collect waste fuel and inhibiting oils from the engine line work. Engines are no longer tested using fuel, instead compressed air is used to spin engine blades for testing and calibration.

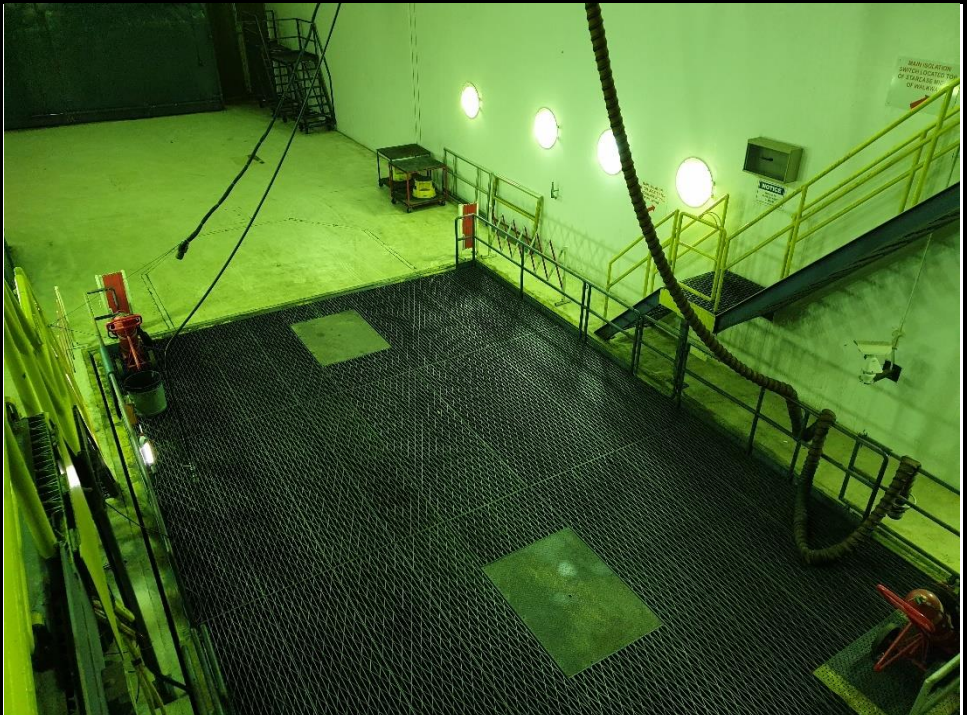
Photo No.	Date	
66	17 May 21	
Description: Looking down at grated area of the JT2 test cell used to collect waste liquids.

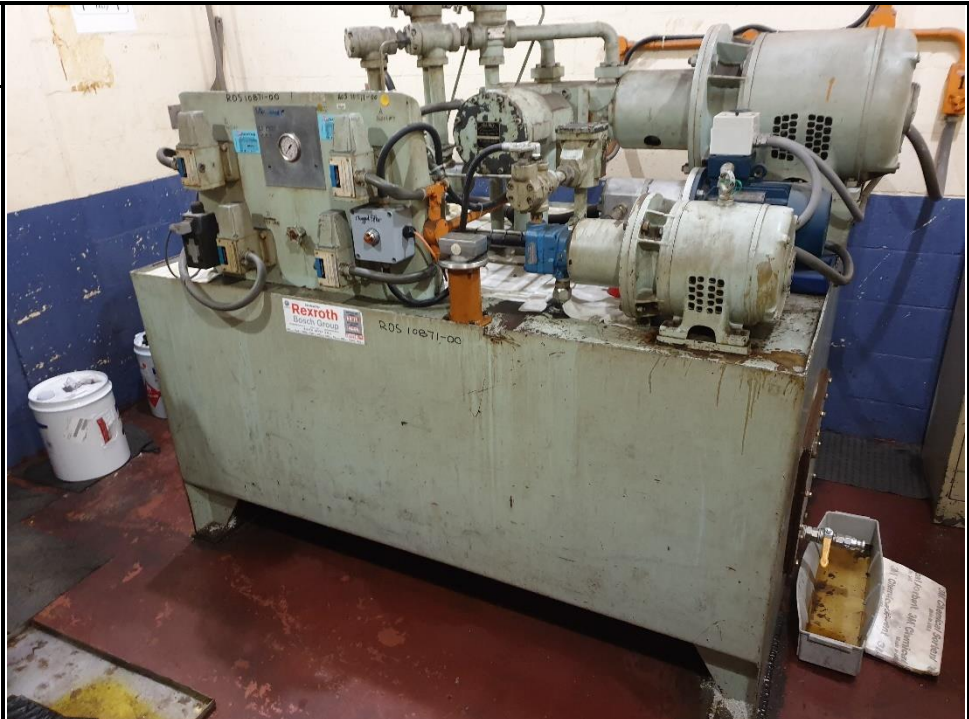
Photo No. 67	Date 17 May 21
Description: Small banded plant room inside the JT2 building. Oil spill and pooled noted oil in this area.

A photograph of a large, light-green industrial machine, identified by a label as a Rexroth Bosch Group hydraulic pump (model R05 10B71-00). The machine is mounted on a heavy metal base and features various pipes, valves, and electrical components. It is located in a small room with blue-painted walls and a red floor. A white bucket is visible on the floor to the left of the machine. The machine shows signs of wear and oil spillage on the floor around it.

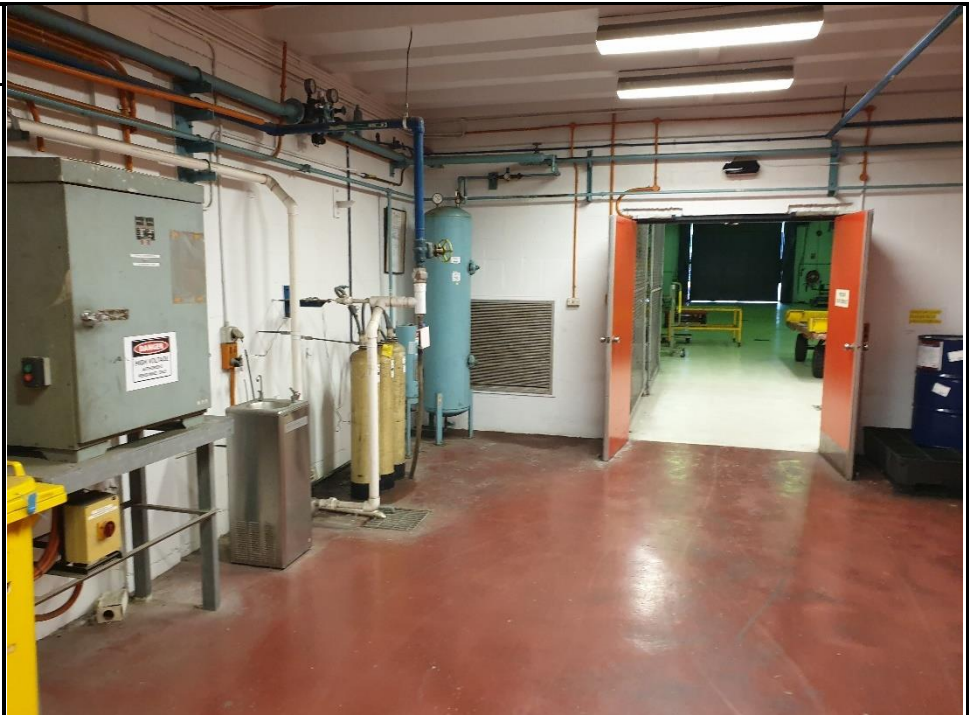
Photo No. 68	Date 17 May 21
Description: Plant and entry area to the JT2 test cell.

A photograph of a plant room with a red floor. On the left, there is a large grey electrical cabinet on a metal stand, with a yellow fire extinguisher nearby. In the center, there are yellow gas cylinders and a blue vertical tank. An open doorway in the background leads to another area with green walls and equipment.

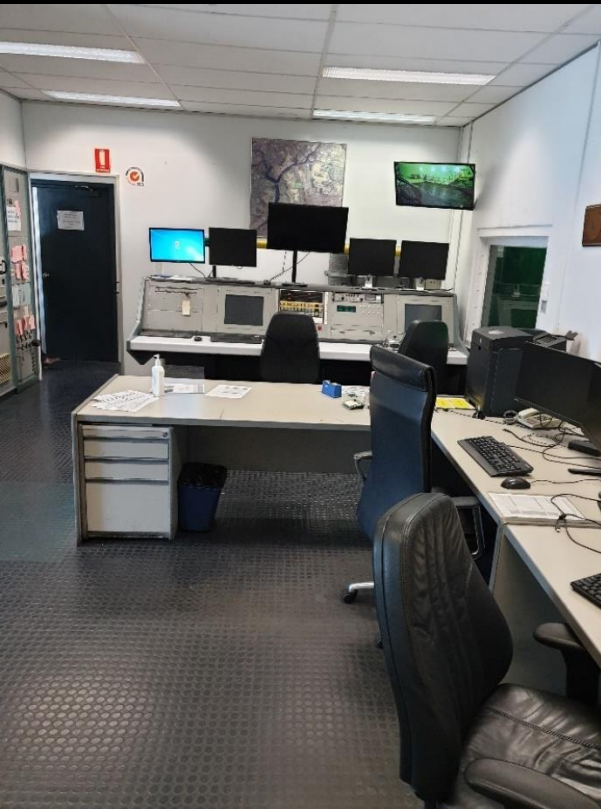
Photo No.	Date	
70	17 May 21	
Description: Control room on second level of the JT2 building.

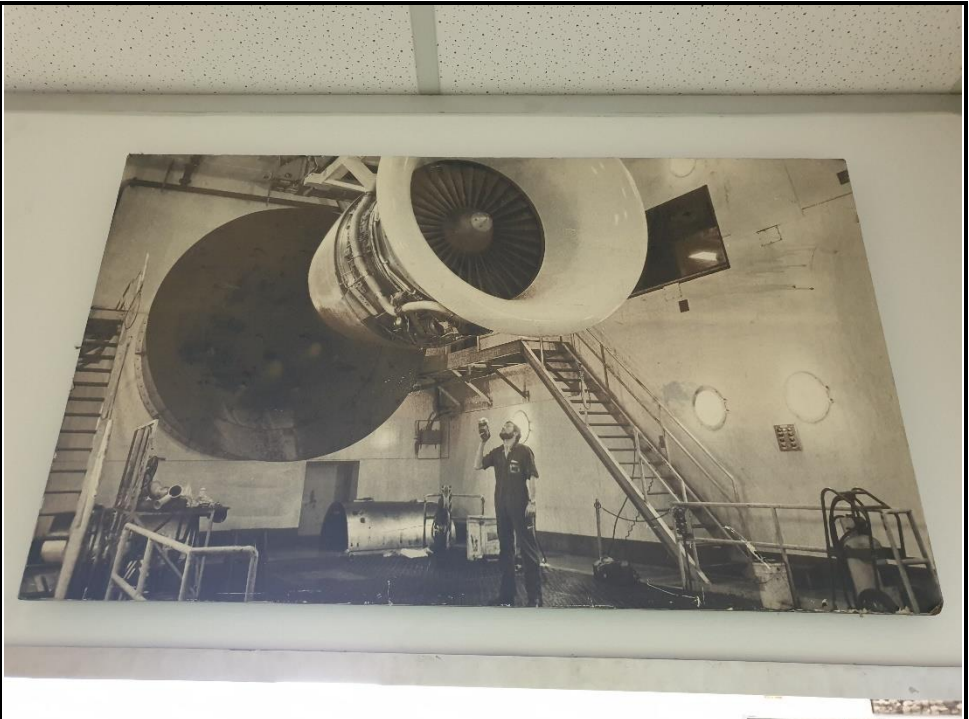
Photo No.	Date	
71	17 May 21	
Description: Photo circa 1980s showing the testing of an aircraft engine at JT2.

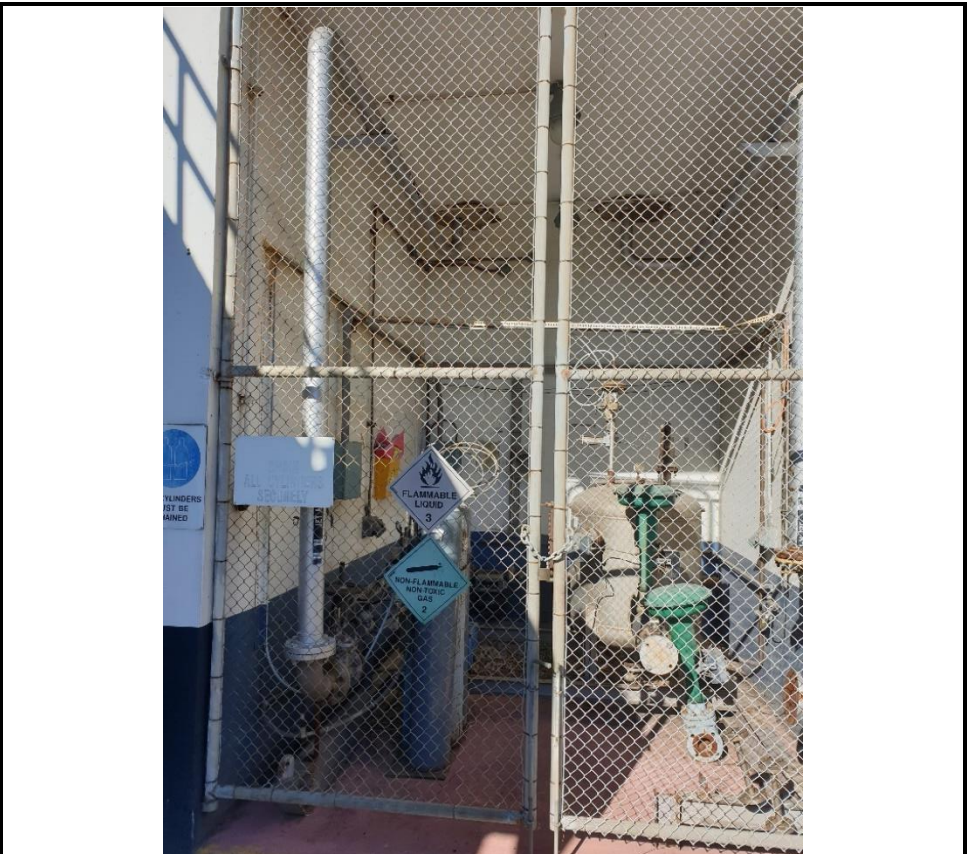
Photo No.	Date	
72	17 May 21	
Description: Decommissioned fuel room located on the northern portion outside of the JT2 building. This room contains the manifolds and Jet-A1 fuel pumps former used in testing aircraft engines at JT2.

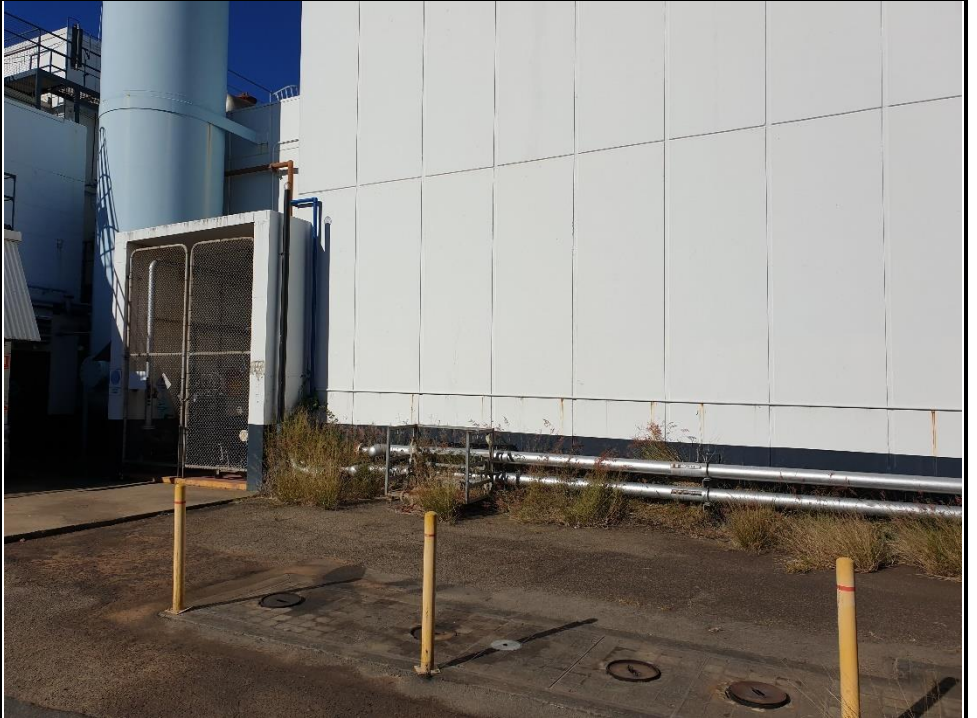
Photo No.	Date	
74	17 May 21	
Description: The waste fuel and inhibiting oils that are used in the Test cell at JT2 drain into this waste oil pit for collection by SUEZ. This pit has reportedly formerly over flown to the surrounding area.

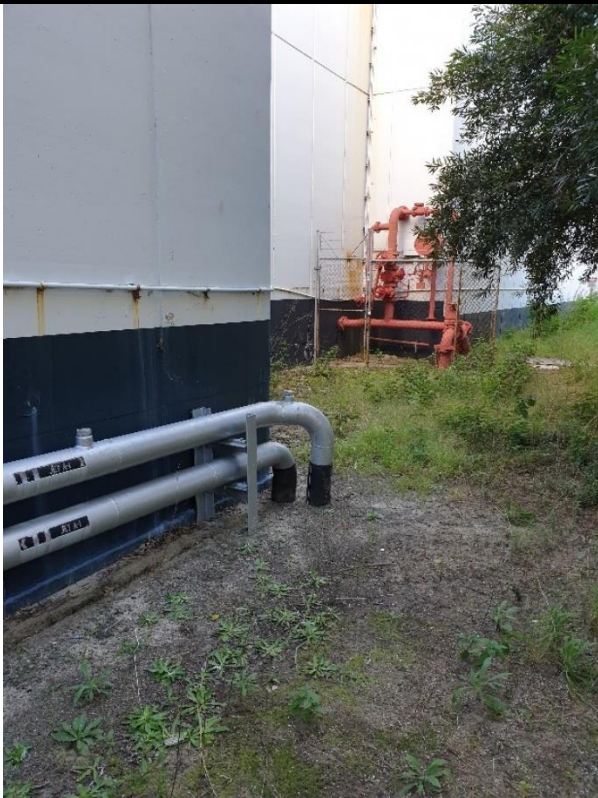
Photo No.	Date	
76	17 May 21	
Description: The decommissioned Jet A-1 lines entering the ground on the southern side of the JT2 building which head towards the Fuel Farm at the Qantas Jet Base.
