REVIEW OF 15 HERITAGE ITEMS IN HORNSBY SHIRE

Heritage Analysis and Review

FINAL REPORT

Project Director: Tim Adams
Technical Director: Brad Vale
Report No. 30522/R02
Date: March 2024

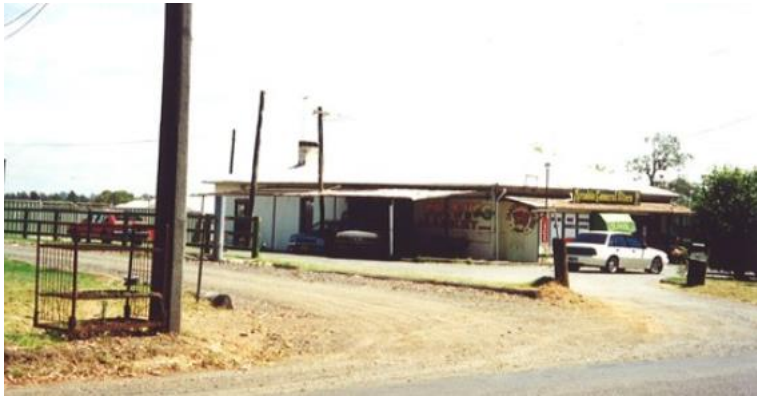
5. Description	
Category:	Rural store
Description:	The site contains a modern structure with a concrete slab, steel frame, modern brick walls and a corrugated steel roof.
Condition of fabric and/or archaeological potential:	The property is unlikely to answer questions about the development of an isolated rural store in Arcadia that cannot already be answered from the documentary record.
Integrity / intactness:	The original parts of the store have been removed. The replacement building is a substantially new structure incorporating some structure from recent decades.
Modifications Dates:	Renovation in the 1960s and following, rebuilding in the early 2020s.
Date of inspection:	December 2023
Current use:	Store.
Physical Condition:	Modified building with no original fabric.
Integrity/Intactness:	Modified building incorporates the extant structure, but no early fabric.
Recommended Management:	Remove from Schedule 5 list of items of Environmental Heritage in the Hornsby LEP 2013.

Subject of photo:	Arcadia General Store in 1997.
Date of photo:	16-Jan-1997
Photographer:	Perumal Murphy Wu
Copyright holder	Hornsby Shire Council

8. Assessment of Heritage Significance	
G. It is important in demonstrating the principal characteristics of a class of cultural places/ environments in Hornsby.	The original parts of the store have been demolished so it does not represent a type. The property does not satisfy this criterion at a local level.
Heritage Listings:	<i>Hornsby Local Environmental Plan 2013 - Schedule 5</i>
Reviewed listing recommendation:	Remove the heritage listing from Schedule 5 of the Hornsby LEP 2013.

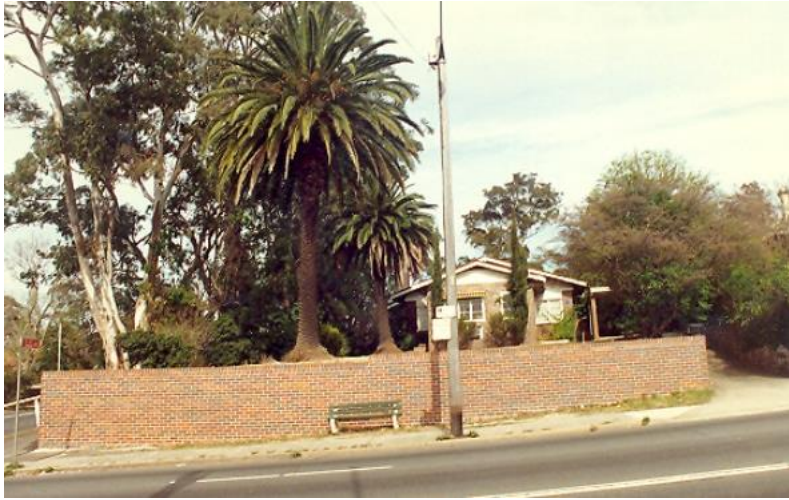
9. Image 1	
Principal image

Subject of photo:	The house at 28 Hannah Street Beecroft before extensions for dental practise.
Date of photo:	c1993
Photographer:	Perumal Murphy Wu Pty Ltd
Copyright holder	Hornsby Council

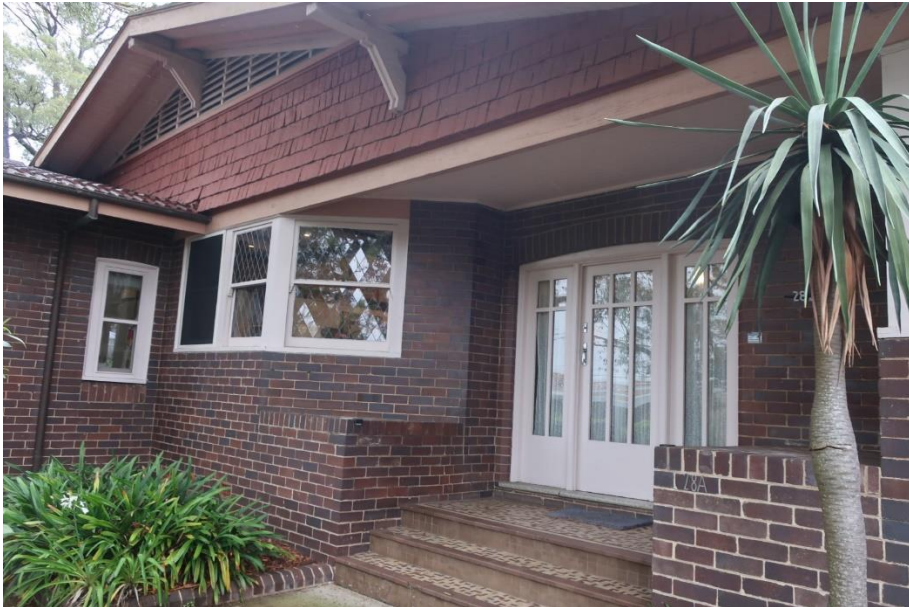
Subject of photo:	Original and intact entry to the house from Hannah Street.
Date of photo:	December 2023
Photographer:	Brad Vale
Copyright holder	Umwelt

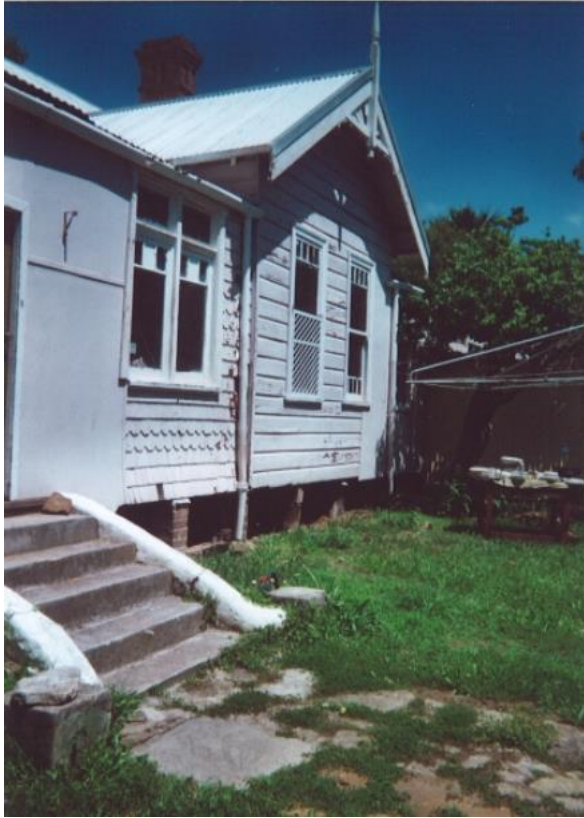
9. Image 1	
Principal image

Subject of photo:	The entry steps and part of the north-west façade of the house.
Date of photo:	1992 or 2004
Photographer:	Perumal Murphy Wu Pty Ltd
Copyright holder	Hornsby Shire Council

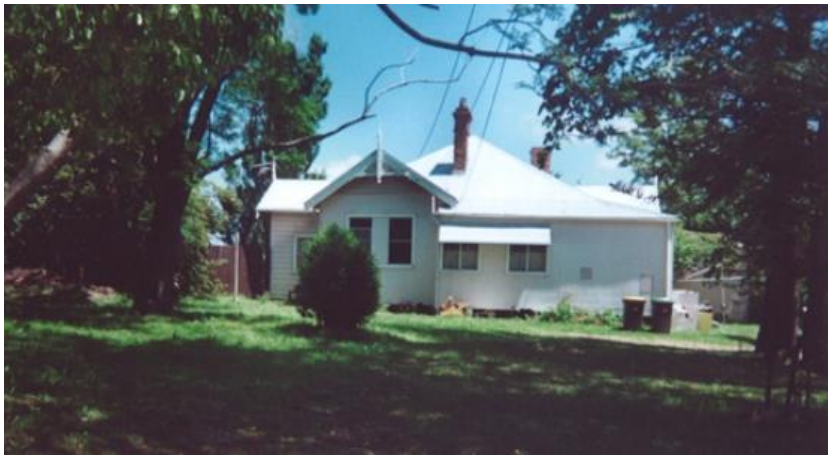
9. Image 2	
Principal image

Subject of photo:	The north-east façade of the house facing Berowra Waters Road.
Date of photo:	1992 or 2004
Photographer:	Perumal Murphy Wu Pty Ltd
Copyright holder	Hornsby Shire Council

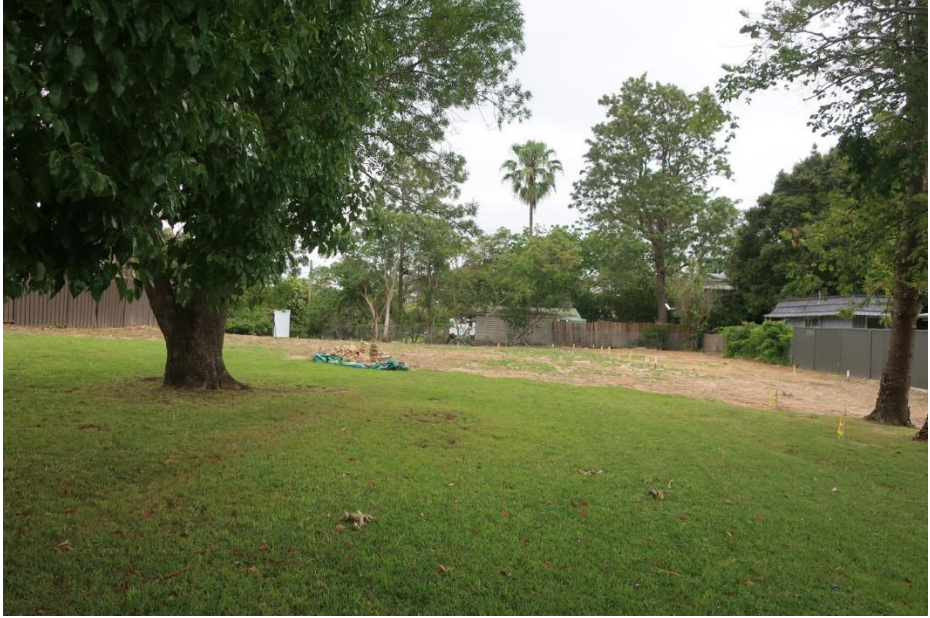
Subject of photo:	The cleared site seen from near the Berowra Waters Road frontage.
Date of photo:	December 2023
Photographer:	Brad Vale
Copyright holder	Umwelt

G. It is important in demonstrating the principal characteristics of a class of cultural places/ environments in Hornsby.	The property does not satisfy this criterion at a local or state level.
Heritage Listings:	<i>Hornsby Local Environmental Plan 2013 - Schedule 5</i>
Reviewed listing recommendation:	Remove the place from Schedule 5 Environmental Heritage Items of the Hornsby LEP 2013.

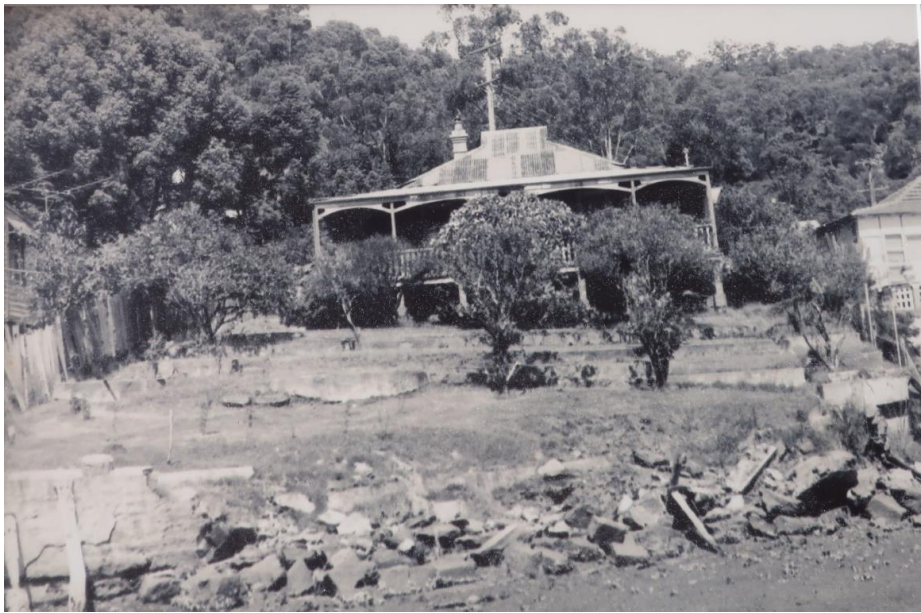
9. Image 1	
Principal image

Subject of photo:	The house at 51 Brooklyn Road in its original single-storey form, looking south.
Date of photo:	Likely mid twentieth century
Photographer:	Unknown, likely a member of the King Family.
Copyright holder	Unknown, image in ownership of Joan Wellens.

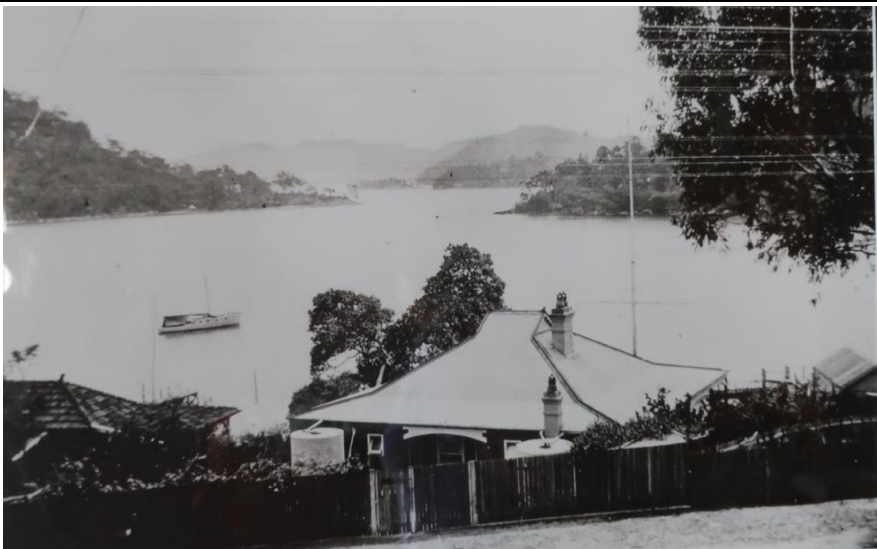
9. Image 2	
Principal image

Subject of photo:	The house at 51 Brooklyn Road in its original single-storey form, looking north.
Date of photo:	Likely early twentieth century, before provision of town water; note water tank.
Photographer:	Unknown, possibly a member of the King Family.
Copyright holder	Unknown, image in ownership of Joan Wellens.

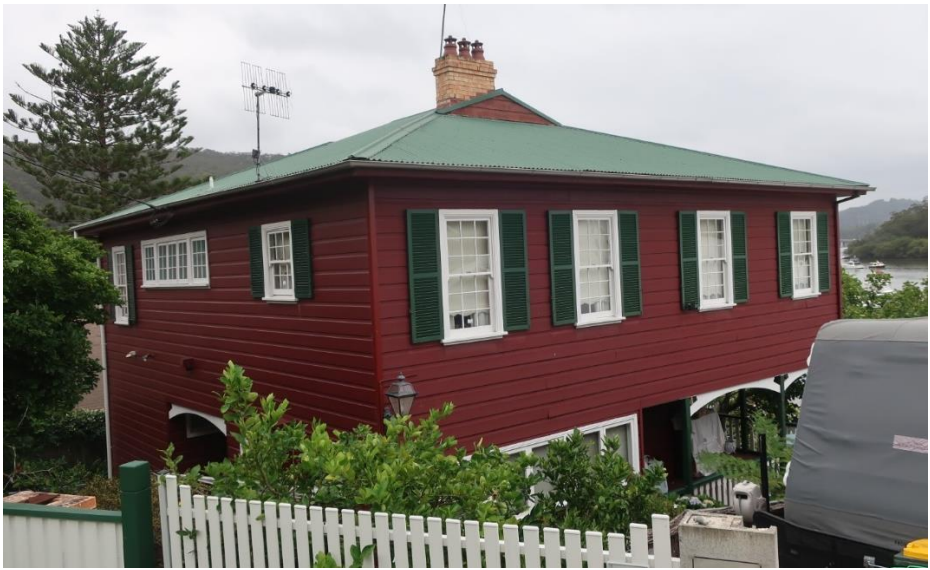
Principal image

5. Description	
Current use:	Dwelling
Physical Condition:	Good. The house is occupied and well maintained.
Significance level	Local

A two-story red house with a green roof and white picket fence. The house has white window frames with green shutters. A white picket fence is in the foreground, and a grey car is partially visible on the right. The background shows trees and a body of water.
Subject of photo:	The house at 51 Brooklyn Road, looking north-west.
Date of photo:	December 2023
Photographer:	Brad Vale
Copyright holder	Umwelt

G. It is important in demonstrating the principal characteristics of a class of cultural places/ environments in Hornsby.	The house and boatshed represent some lifestyle aspects, taste in building and decoration in the Federation period. The property satisfies this criterion at a local level.
Heritage Listings:	<i>Hornsby Local Environmental Plan 2013 - Schedule 5</i>
Reviewed listing recommendation:	The property should continue to be listed on Schedule 5 Environmental Heritage Items of the Hornsby LEP 2013.
Management:	<p>Internal alterations to the enclosed side verandahs at ground floor level and the entire first floor would not have an adverse heritage impact.</p> <p>If the garage is found to be clad with fibro asbestos, it should be re-clad with fibre cement to a similar detail. The timber-framed fenestration should be retained.</p>

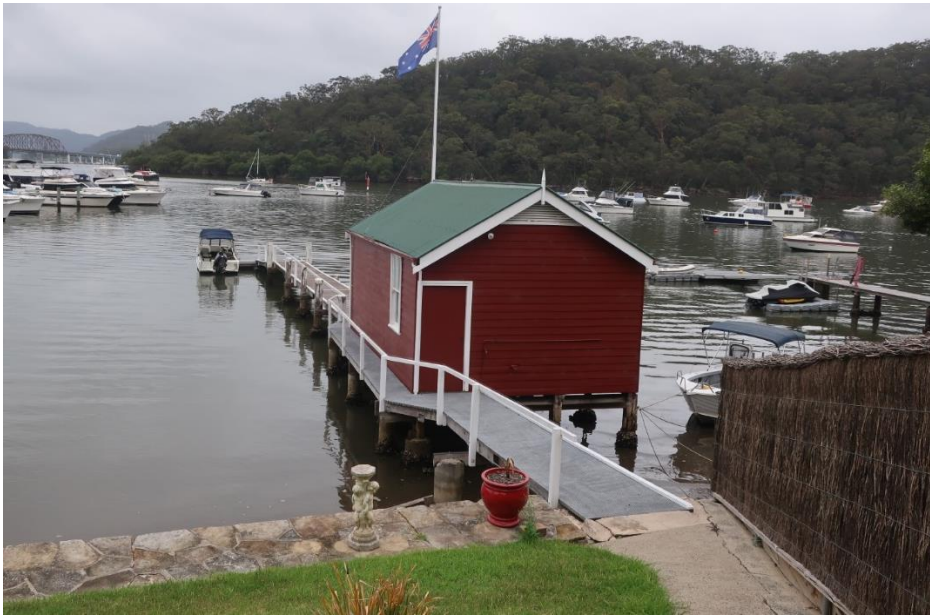
9. Image 4

A red boathouse on a pier with a flagpole. The boathouse is red with a green roof and a white picket fence. A flagpole with the Australian flag is on the roof. The pier is made of wood and has a ramp leading down to the water. The background shows a body of water with many boats and a forested hill.
Subject of photo:	The boathouse of 51 Brooklyn Road
Date of photo:	December 2023
Photographer:	Brad Vale
Copyright holder	Umwelt

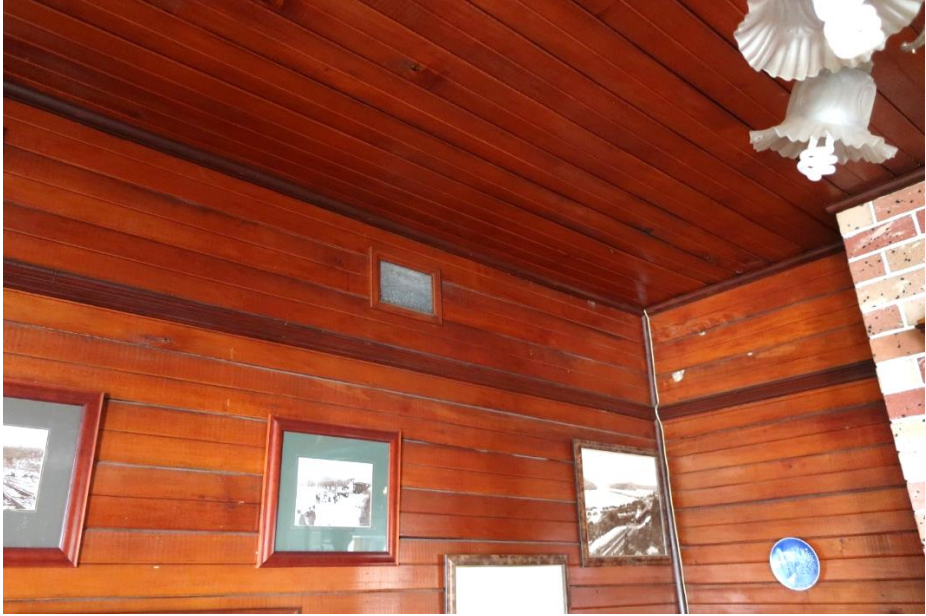
Subject of photo:	Original lining boards and profiled trims with continuing varnish at 51 Brooklyn Road.
Date of photo:	December 2023
Photographer:	Brad Vale
Copyright holder	Umwelt

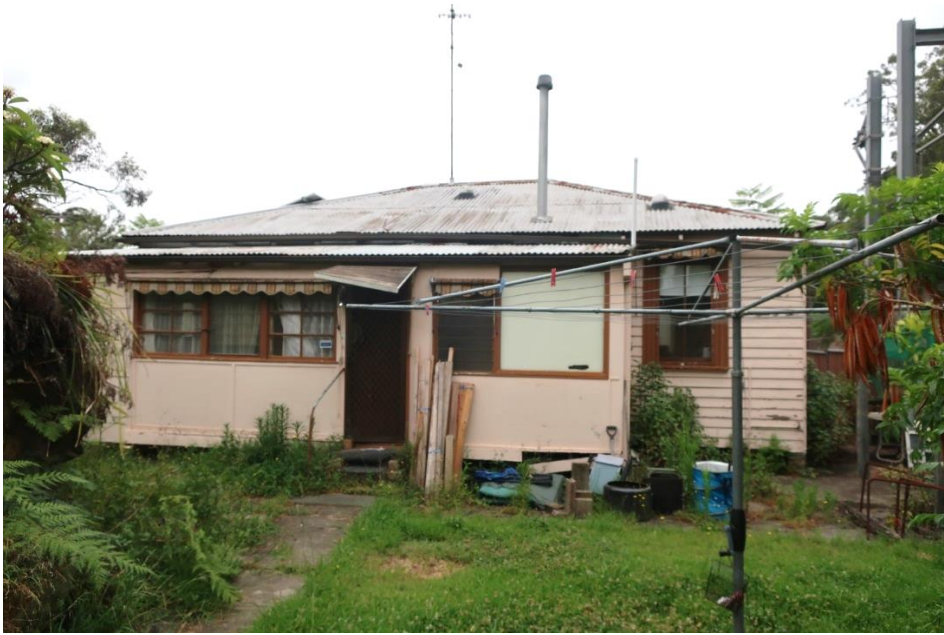
Date of inspection:	December 2023
Current use:	Dwelling (occupied by squatters)
Physical Condition:	Fair
Recommended Management:	The cottage has sufficient heritage significance to continue to be listed on Schedule 5 of the Hornsby LEP.
Significance level	Local

Subject of photo:	The cottage at 176 Brooklyn Road, looking east
Date of photo:	December 2023
Photographer:	Brad Vale
Copyright holder	Umwelt

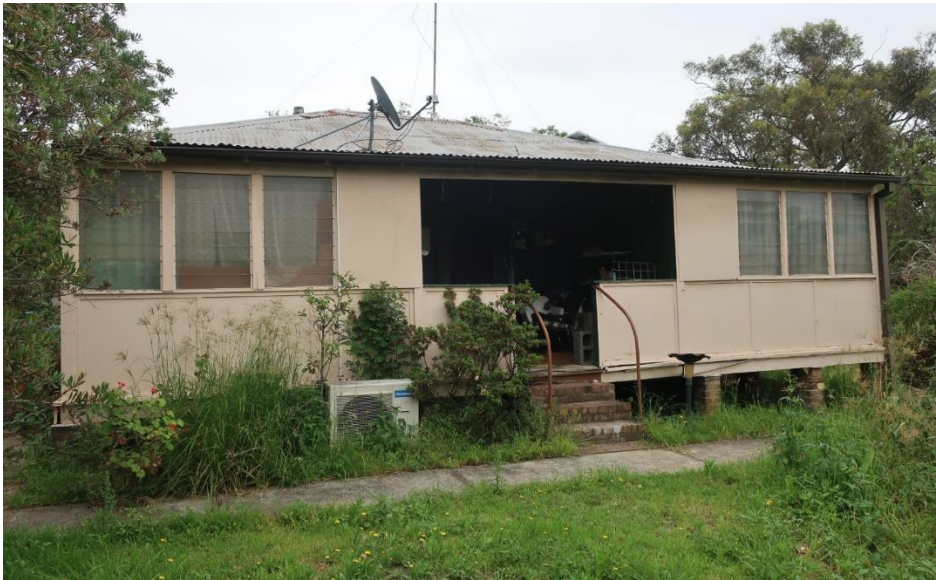
9. Image 2	
Principal image

Subject of photo:	The cottage at 176 Brooklyn Road, looking west
Date of photo:	December 2023
Photographer:	Brad Vale
Copyright holder	Umwelt

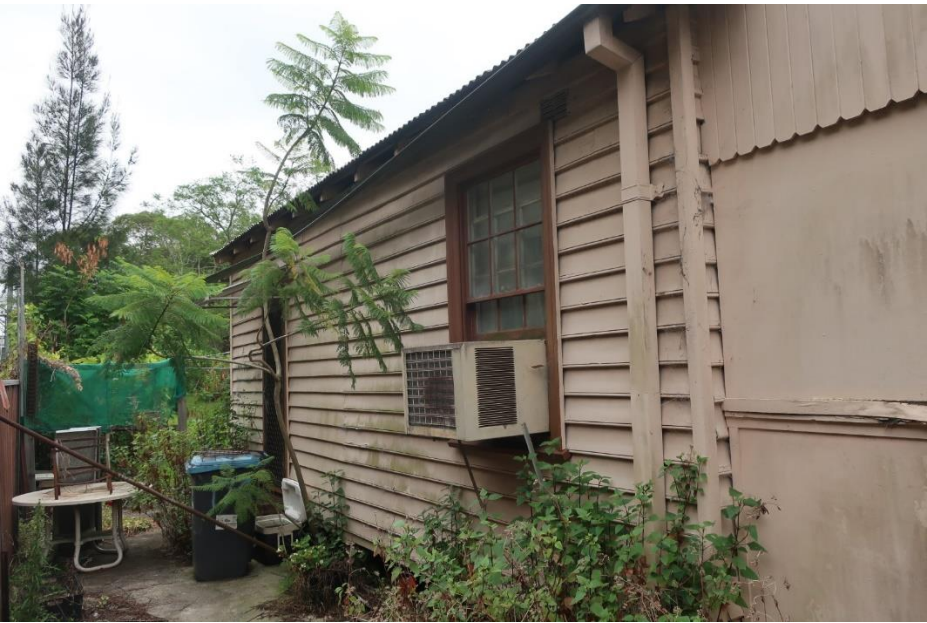
Subject of photo:	Northern elevation of the cottage at 176 Brooklyn Road, showing detail of weatherboard and sash window.
Date of photo:	December 2023
Photographer:	Brad Vale
Copyright holder	Umwelt

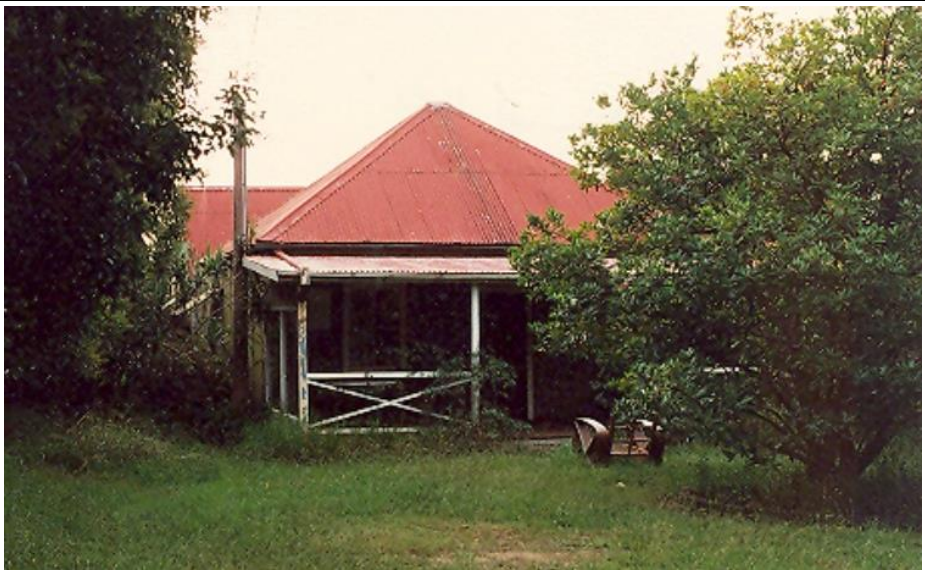
9. Image 1	
Principal image

Subject of photo:	The original house at 432 Galston Road, Dural, looking north-west.
Date of photo:	1992
Photographer:	Perumal Murphy Wu Pty Ltd
Copyright holder	Hornsby Shire Council

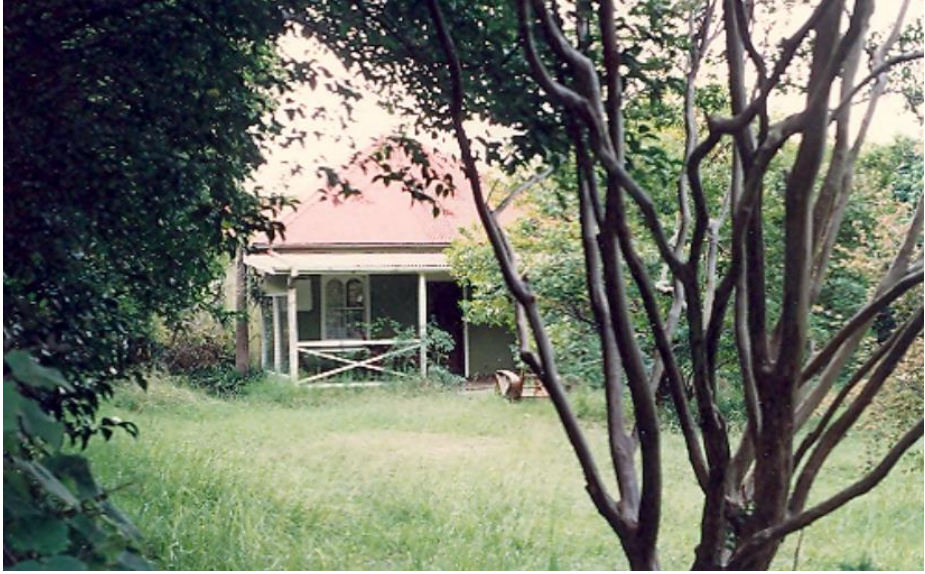
9. Image 2	
Principal image

Subject of photo:	The original house at 432 Galston Road, Dural showing original window with arched decoration.
Date of photo:	1992
Photographer:	Perumal Murphy Wu Pty Ltd
Copyright holder	Hornsby Shire Council

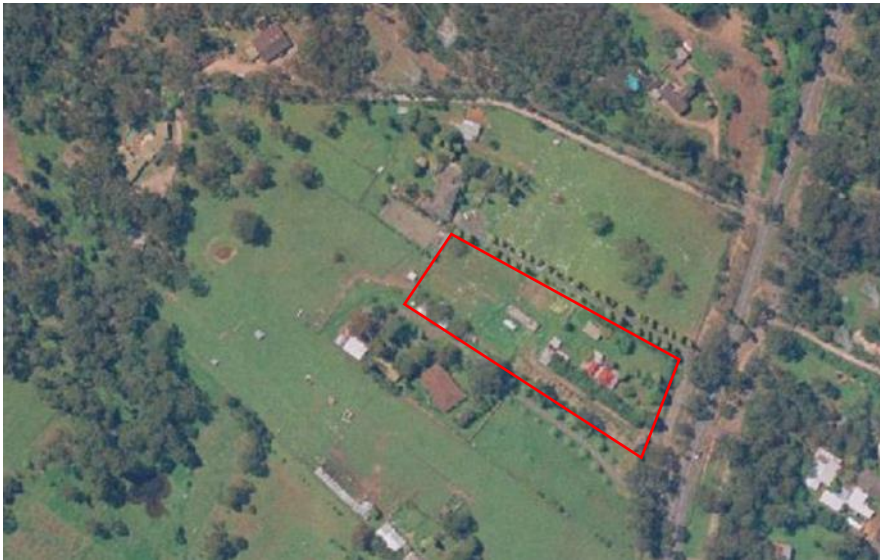
9. Image 3	
Principal image

Subject of photo:	Aerial photograph showing the original house at 432 Galston Road. The property boundary is outlined in red by Umwelt.
Date of photo:	1998
Photographer:	Services for the New South Wales Government
Copyright holder	New South Wales Government

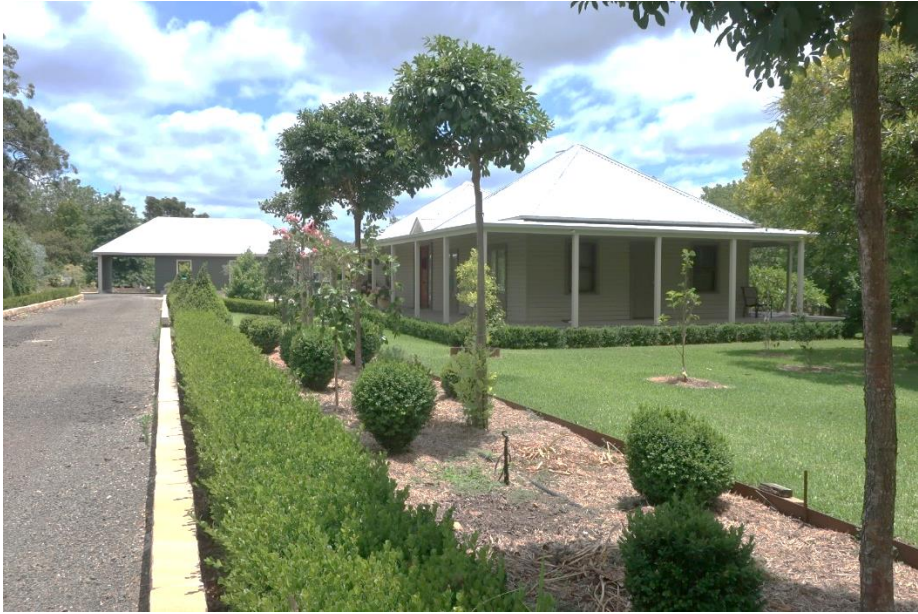
Archaeological potential:	Any archaeological resources at the property are unlikely to answer questions about the suburban development of Dural that cannot already be answered from the documentary record.
Integrity / intactness:	Two brick fire breasts remain as the only fabric from the Victorian timber farmhouse. Of these, one is intact with a full chimney.
Modifications Dates:	c2000 when the house was rebuilt, removing previous layers of change.
Date of inspection:	December 2023
Current use:	Dwelling
Physical Condition:	The house is in good condition from a contemporary construction point of view.
Integrity/Intactness:	The original fabric of the farmhouse is a small minority of the built fabric here.
Recommended Management:	Remove the heritage listing from Schedule 5 of the Hornsby LEP 2013.
Significance level	Local

Subject of photo:	North-westerly view towards the c2000 period house at 432 Galston Road.
Date of photo:	December 2023
Photographer:	Brad Vale
Copyright holder	Umwelt

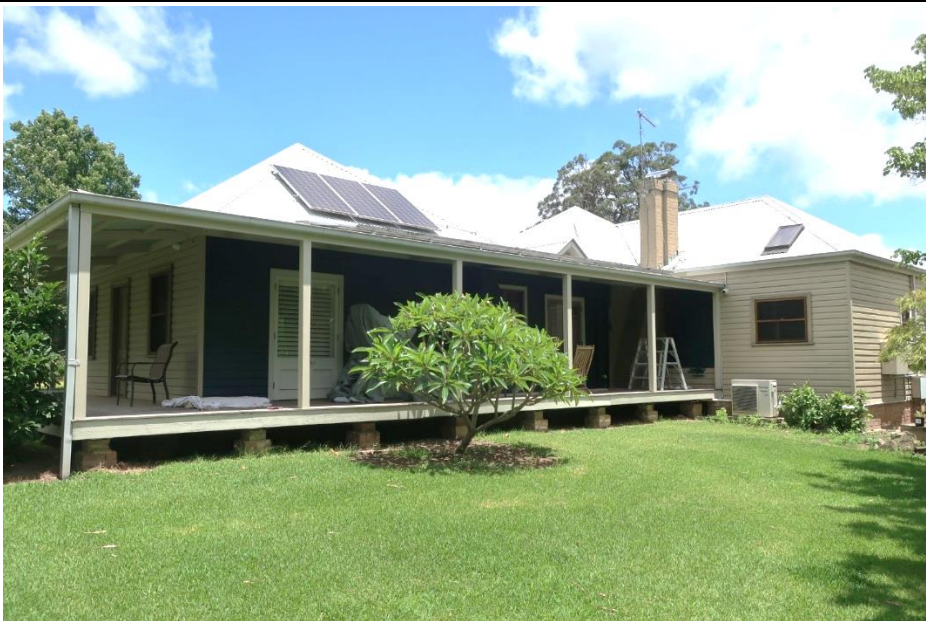
Subject of photo:	Westerly view of the house showing the remaining chimney. A further chimney breast is under the verandah to the left.
Date of photo:	December 2023
Photographer:	Brad Vale
Copyright holder	Umwelt

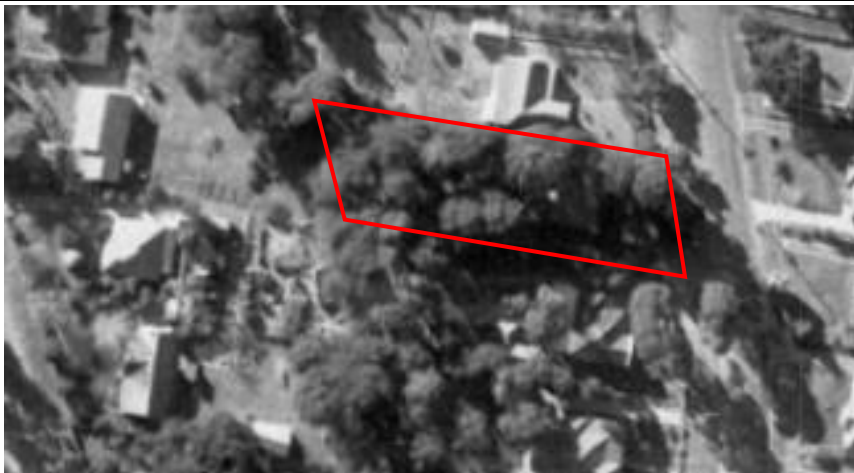
9. Image 1	
Principal image

Subject of photo:	Aerial photograph showing 29 Old Berowra Road soon after the cottage was moved. The site is outlined in red by Umwelt. The house may be discernible in the shade of the trees.
Date of photo:	1970
Photographer:	Commonwealth Government
Copyright holder	SIX Maps (NSW Spatial Information Exchange)

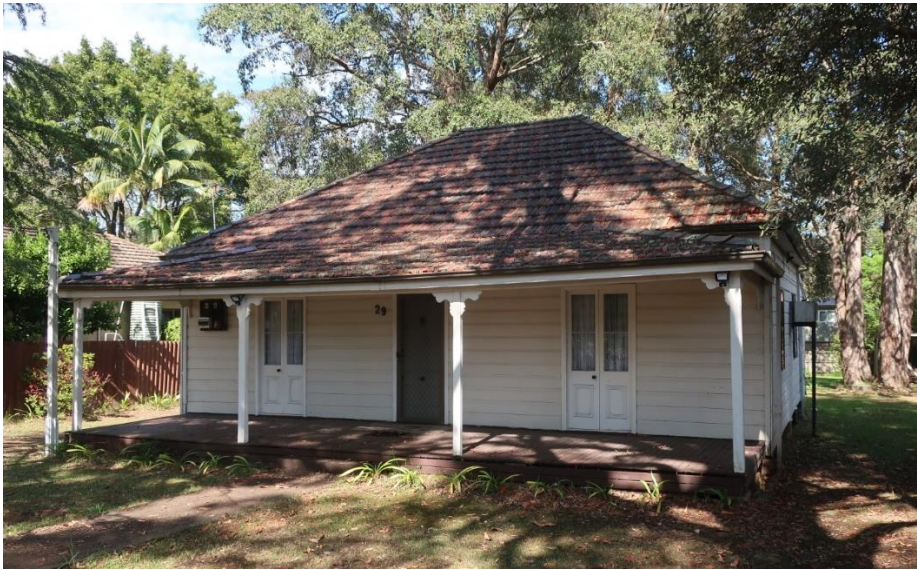
Archaeological potential:	The site has no identifiable archaeological potential.
Integrity / intactness:	The house is in habitable condition, but the settlement of the house on inadequate footings has caused visible imperfections. The massing of the house and the front elevation are intact. The side and rear elevations are less intact. The interior contains intact joinery in many internal doors and the skirtings.
Modifications Dates:	<p>c1960 the house was moved, understood to have been moved from St Ives. The likely original corrugated steel roof was replaced with new glazed tiles.</p> <p>A 900mm high wall lined with fibro was built along the sides of the front verandah; it has since been removed.</p>
Date of inspection:	December 2023

Subject of photo:	The house at 29 Old Berowra Road, seen from the street looking west.
Date of photo:	December 2023
Photographer:	Brad Vale
Copyright holder	Umwelt

G. It is important in demonstrating the principal characteristics of a class of cultural places/ environments in Hornsby.	The house is representative of modest timber houses constructed in the Federation period in the outer northern agricultural areas of Sydney. Despite the fact that the house was relocated, the property represents this housing type and satisfies this criterion.
Heritage Listings:	<i>Hornsby Local Environmental Plan 2013 - Schedule 5</i>
Reviewed listing recommendation:	The property should be retained on Schedule 5 of the Hornsby LEP, given that nothing has significantly changed since the last heritage study.
Recommended Management:	<p>The front of the house should be retained, including the roof form and front elevation. Original internal joinery should be retained. Other parts of the house may be altered subject to retaining the original form visible from the street. The house may be re-stumped with new footings, with the approval of Council.</p> <p>Sympathetic alterations and additions at the rear may be considered by Council at Development Assessment stage.</p>

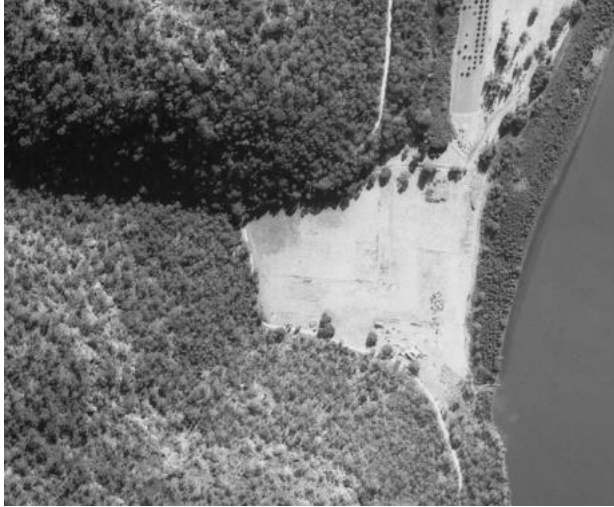
9. Image 1	
Principal image

Subject of photo:	Aerial view of Ford's Farm at the time of purchase showing the cleared land grassed with no orchard.
Date of photo:	1961
Photographer:	Commonwealth Government – flight 1056 - 5188
Copyright holder	NSW Spatial Information Exchange (SIX Maps)

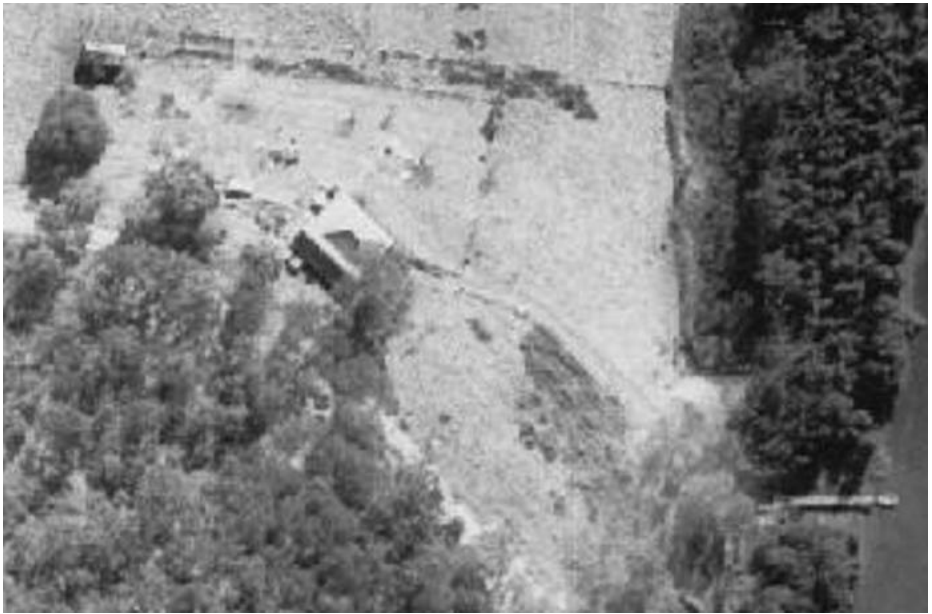
9. Image 2	
Principal image

Subject of photo:	Detailed aerial view of Ford's farmhouse with the likely original hip roof, several sheds that do not remain, and the former jetty.
Date of photo:	1961
Photographer:	Commonwealth Government – flight 1056 - 5188
Copyright holder	NSW Spatial Information Exchange (SIX Maps)

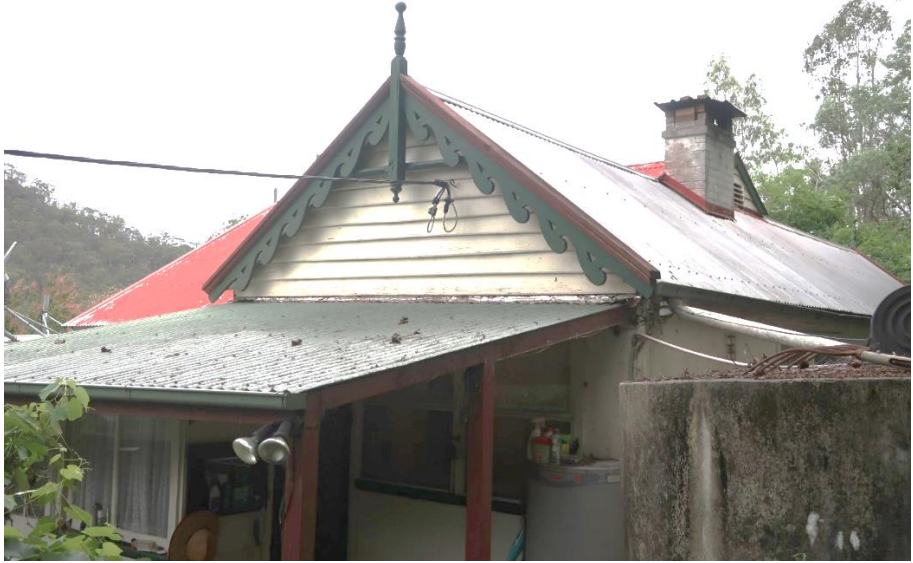
Integrity / intactness:	The c1910 house is highly altered and in a compromised structural condition. Only the south-western gable section with the fretted bargeboards, front door, one internal door and some non-styled structure appear to be early fabric.
Modifications Dates:	Through the 1960s to 1970s, the house was altered by replacing almost all the cladding materials, all the windows, and changing the form of the major part of the roof from a hip to two gables with extensions and new verandahs.
Date of inspection:	December 2023
Current use:	Dwelling and agricultural production

Subject of photo:	East view of the farmhouse at Ford's Farm showing the fretted bargeboards.
Date of photo:	December 2023
Photographer:	Brad Vale
Copyright holder	Umwelt

Heritage Listings:	<i>Hornsby Local Environmental Plan 2013 - Schedule 5</i>
Recommended Management:	<p>Remove the heritage listing from Schedule 5 list of items of Environmental Heritage in the Hornsby LEP 2013 in terms of its built and cultural landscape.</p> <p>The Narrow-leaved Apple Slopes Forest Vegetation Community may be managed using the E3 Environmental Management zoning, unless Council has specific evidence that this is of significant environmental heritage.</p>
Significance level	Local

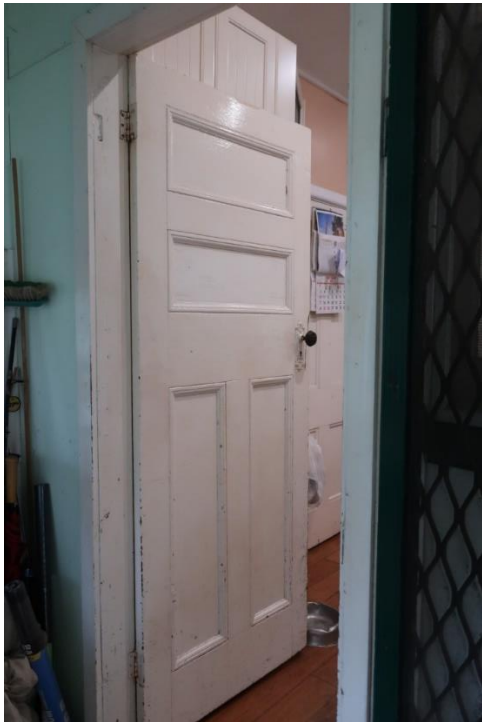
Subject of photo:	The front door to the house is an original Federation period element.
Date of photo:	December 2023
Photographer:	Brad Vale
Copyright	Umwelt

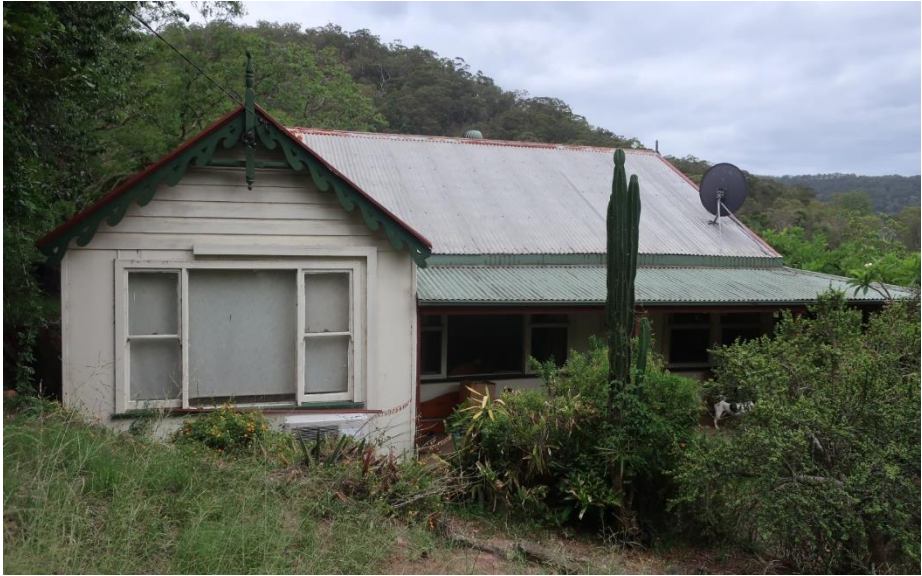
Subject of photo:	The rear of the farmhouse, which faces south-east
Date of photo:	December 2023
Photographer:	Brad Vale
Copyright holder	Umwelt

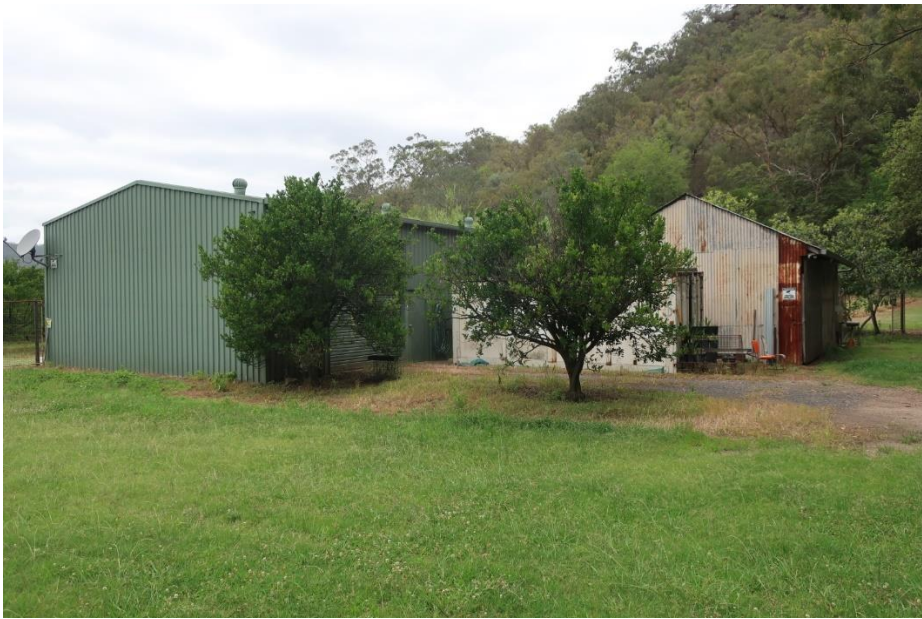
9. Image 6	
Principal image

Subject of photo:	The sheds and several citrus trees in the north-west section of the orchard.
Date of photo:	December 2023
Photographer:	Brad Vale
Copyright holder	Umwelt

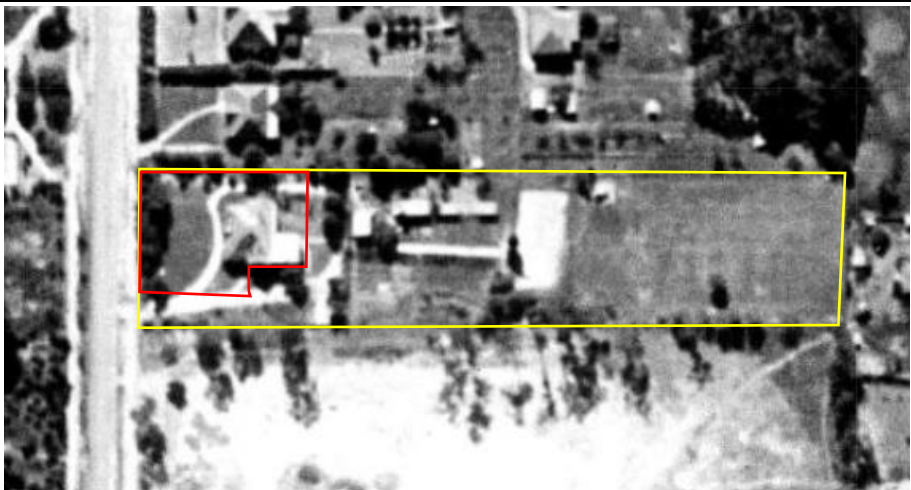
9. Image 1	
Principal image

Subject of photo:	Aerial photograph showing the house on its original allotment (outlined in yellow by Umwelt, also showing the current property boundary in red).
Date of photo:	1943
Photographer:	Commonwealth Government
Copyright holder	NSW Spatial Information Exchange (SIX Maps)

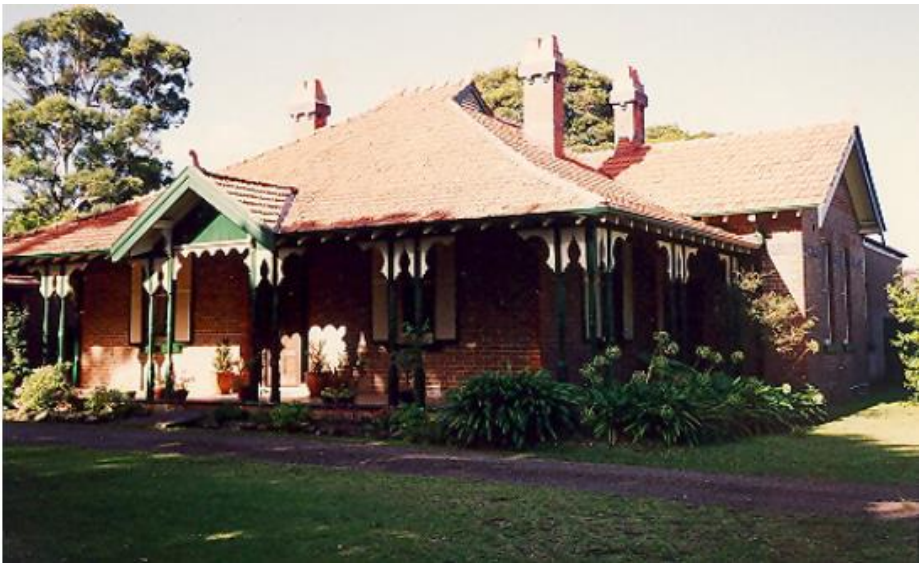
9. Image 2

Subject of photo:	The house in 1992, looking north-east.
Date of photo:	1992
Photographer:	Perumal Murphy Wu Pty Ltd
Copyright holder	Hornsby Shire Council

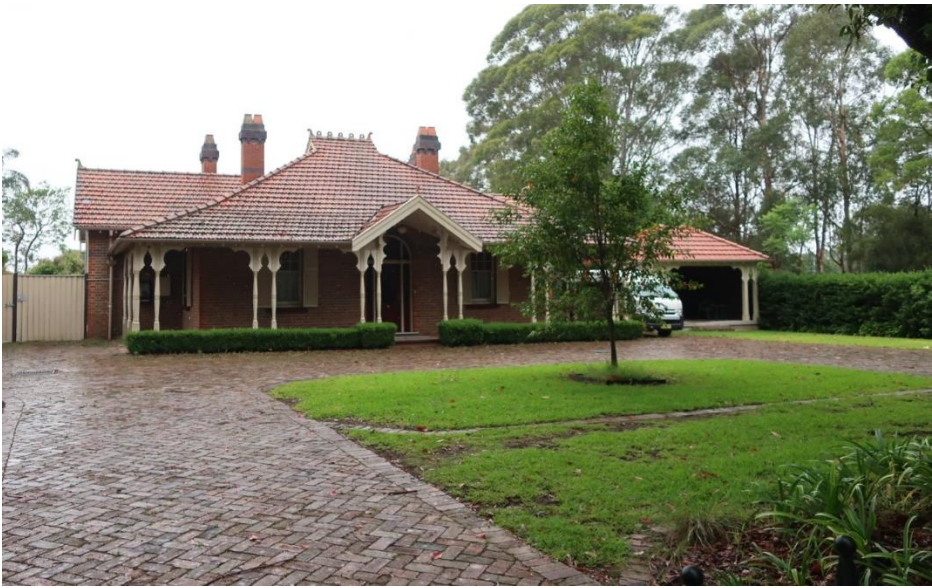
Integrity / intactness:	The massing of the house and its period detail in the external building envelope are intact, though the original allotment has been reduced.
Modifications Dates:	<p>The original timber front fence had been removed by 1992, and new front fence set in place.</p> <p>Several subdivisions occurred in the 1960s.</p> <p>The garage near the northern boundary was built by 1986.</p>
Date of inspection:	December 2023
Current use:	Dwelling
Physical Condition:	Good
Integrity/Intactness:	The house is largely intact externally.
Significance level	Local

Subject of photo:	West front of the house at 70 Norfolk Road
Date of photo:	December 2023
Photographer:	Brad Vale
Copyright holder	Umwelt

G. It is important in demonstrating the principal characteristics of a class of cultural places/ environments in Hornsby.	The house is representative of fine Federation Queen Anne houses across the state. The property satisfies this criterion at a local level.
Heritage Listings:	<i>Hornsby Local Environmental Plan 2013 - Schedule 5</i>
Reviewed listing recommendation:	Retain the property on Schedule 5 of the Hornsby LEP.

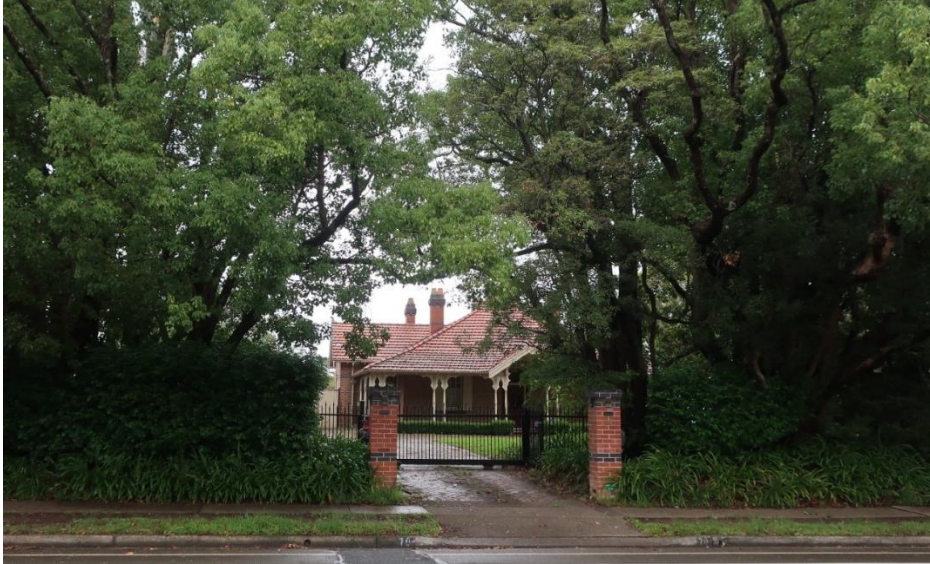
9. Image 4	
Principal image

Subject of photo:	The house seen from Norfolk Road through its screen of camphor laurel trees.
Date of photo:	December 2023
Photographer:	Brad Vale
Copyright holder	Umwelt

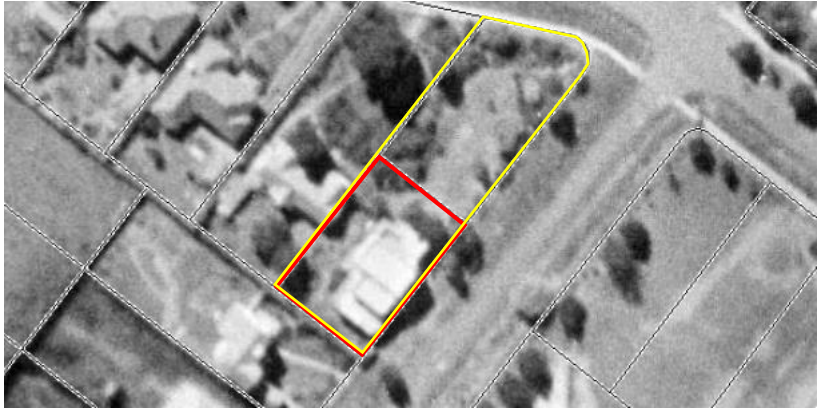
9. Image 1	
Principal image

Subject of photo:	Aerial photograph showing the original house, with its boundary outlined in yellow, and the existing property boundary superimposed in red by Umwelt.
Date of photo:	1943
Photographer:	Commonwealth Government
Copyright holder	NSW Spatial Information Exchange (SIX Maps)

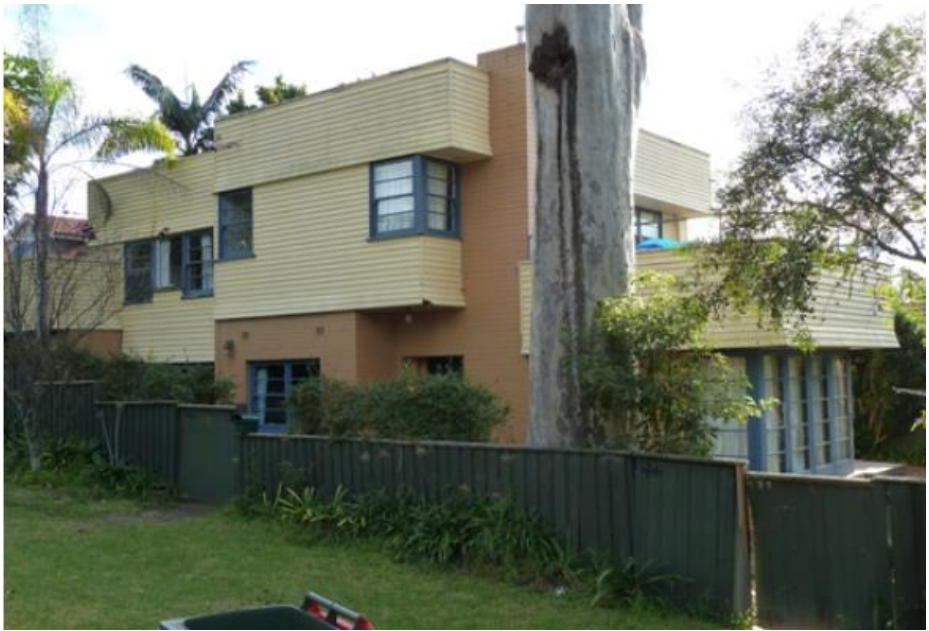
9. Image 2	
Principal image

Subject of photo:	The house at 6 Greycliffe Avenue, seen looking west.
Date of photo:	2012
Photographer:	Godden Mackay Logan
Copyright holder	Hornsby Council

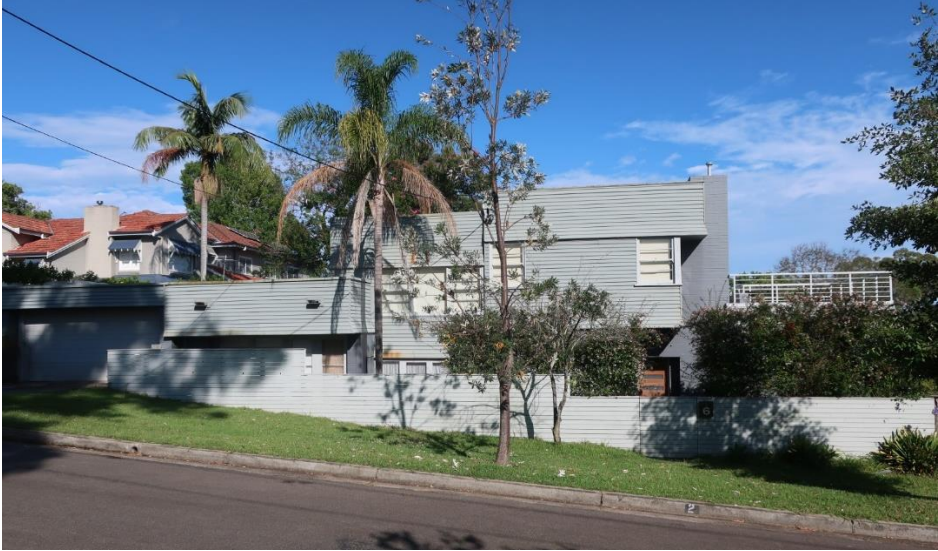
Physical Condition:	Fair
Integrity/Intactness:	<p>The north-eastern half of the original allotment has been subdivided for another housing allotment. The form of the house is largely intact, and many construction details are also intact, recognising the following alterations and extensions that have no heritage significance:</p> <ul style="list-style-type: none"> • The garage is a 1960s construction. • The following elements and materials are not original: <ul style="list-style-type: none"> ○ all metal roofing

Subject of photo:	The south-east façade of the house facing Greycliffe Avenue.
Date of photo:	December 2023
Photographer:	Brad Vale
Copyright holder	Umwelt

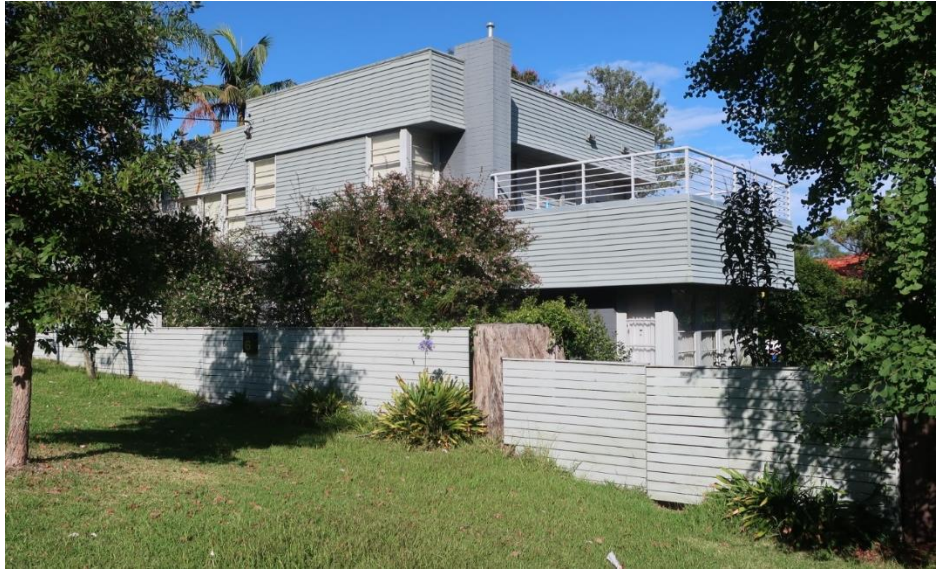
9. Image 4	
Principal image

Subject of photo:	The house at 6 Greycliffe Avenue, seen looking west.
Date of photo:	December 2023
Photographer:	Brad Vale
Copyright holder	Umwelt

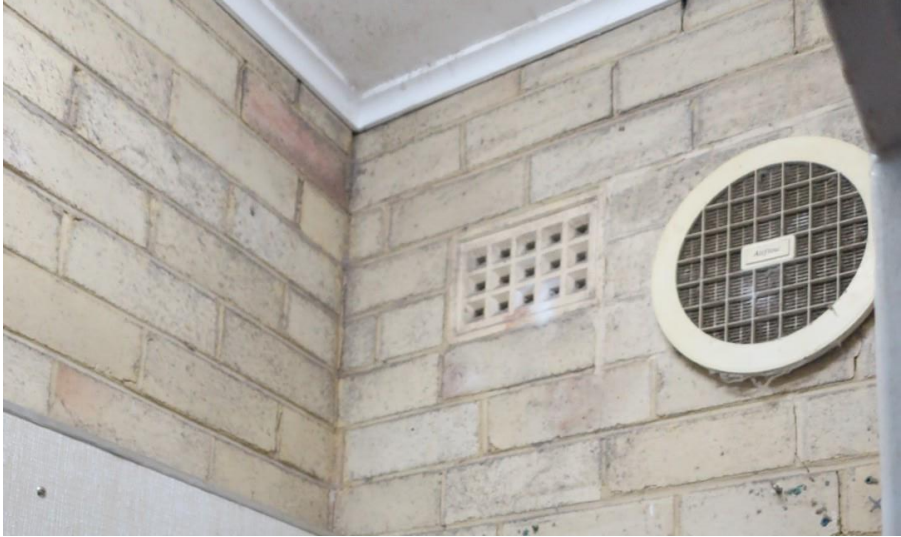
Subject of photo:	Original unpainted brickwork inside the laundry, that likely provided airflow from the original breezeway between the dwelling and home office next to the garage.
Date of photo:	December 2023
Photographer:	Brad Vale
Copyright holder	Umwelt
