REVIEW OF 15 HERITAGE ITEMS IN HORNSBY SHIRE

Heritage Analysis and Review

FINAL REPORT

Project Director: Tim Adams
Technical Director: Brad Vale
Report No. 30522/R02
Date: March 2024

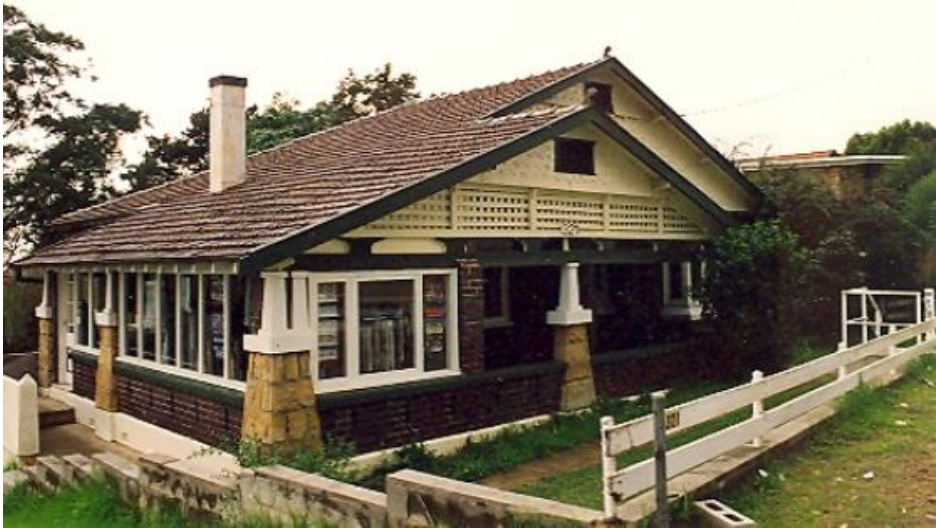
9. Image 2	
Principal image

Subject of photo:	The California Bungalow at 2A Paling Street
Date of photo:	1992
Photographer:	Perumal Murphy Wu Pty Ltd
Copyright holder	Hornsby Council

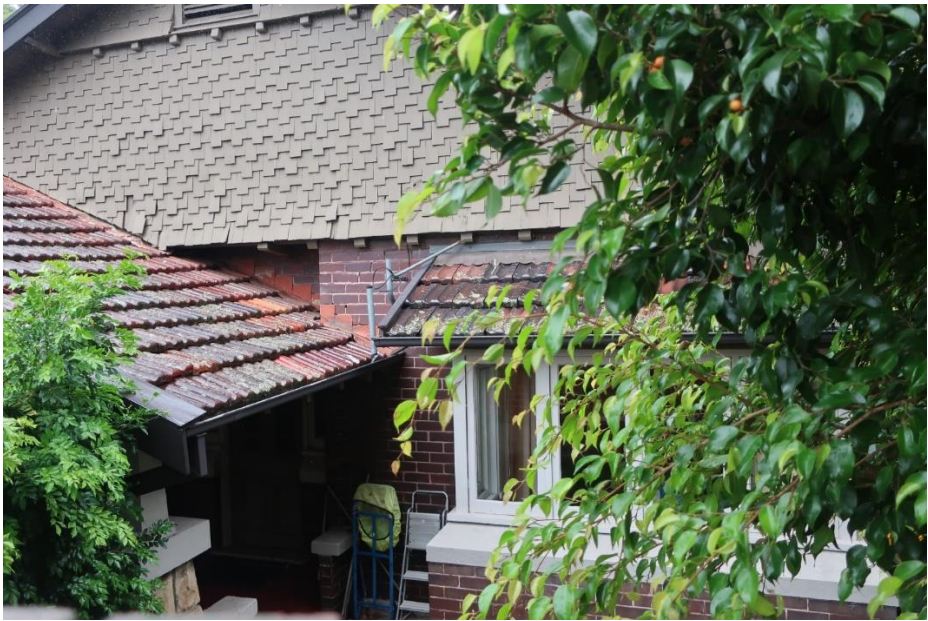
Subject of photo:	Detail of the front facade
Date of photo:	December 2023
Photographer:	Brad Vale
Copyright holder	Umwelt

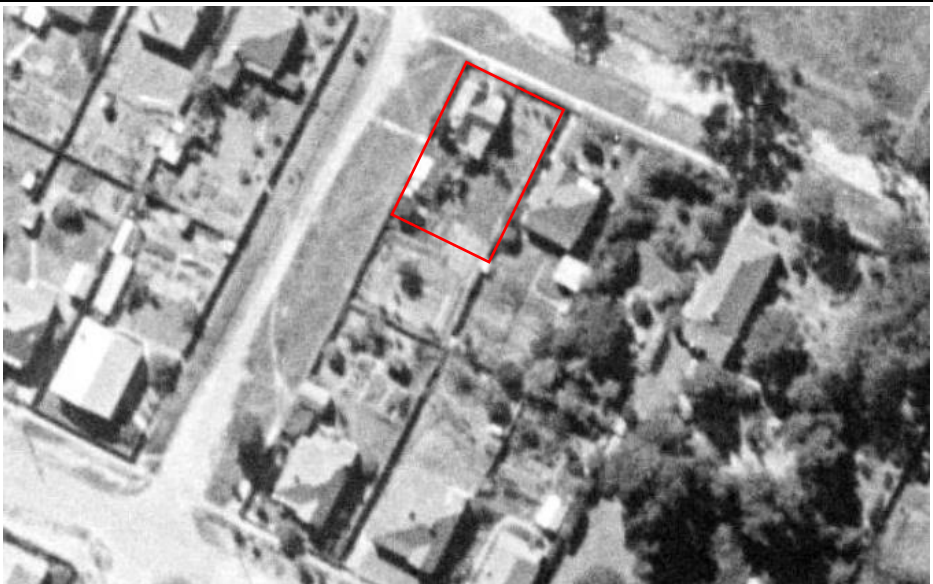
9. Image 1	
Principal image

Subject of photo:	Aerial photograph of the site with the current boundary outlined in red by Umwelt. The original extent of the larger backyard is discernible.
Date of photo:	1943
Photographer:	Commonwealth Government
Copyright holder	NSW Spatial Information Exchange (SIX Maps)

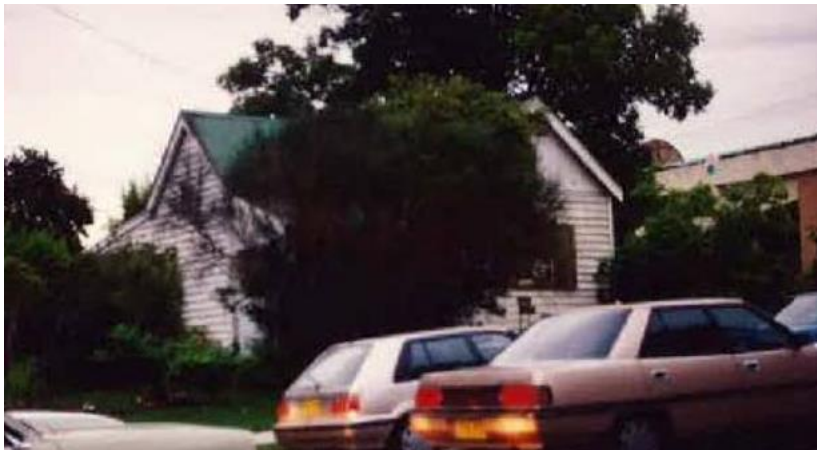
9. Image 2	
Principal image

Subject of photo:	The cottage in 1993, looking west from The Comenarra Parkway.
Date of photo:	1993
Photographer:	Perumal Murphy Wu Pty Ltd
Copyright holder	Hornsby Shire Council

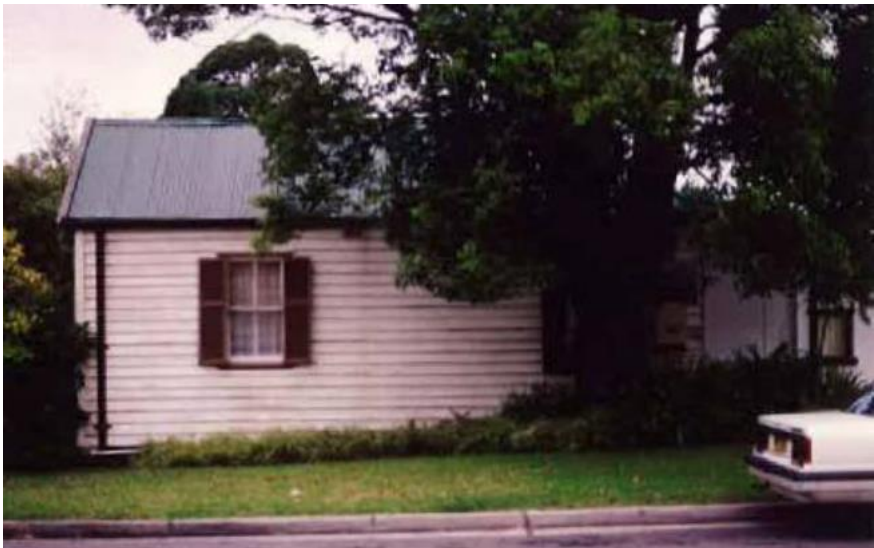
9. Image 3	
Principal image

Subject of photo:	The cottage in 1993, looking south-east from Wood Street.
Date of photo:	1993
Photographer:	Perumal Murphy Wu Pty Ltd
Copyright holder	Hornsby Shire Council

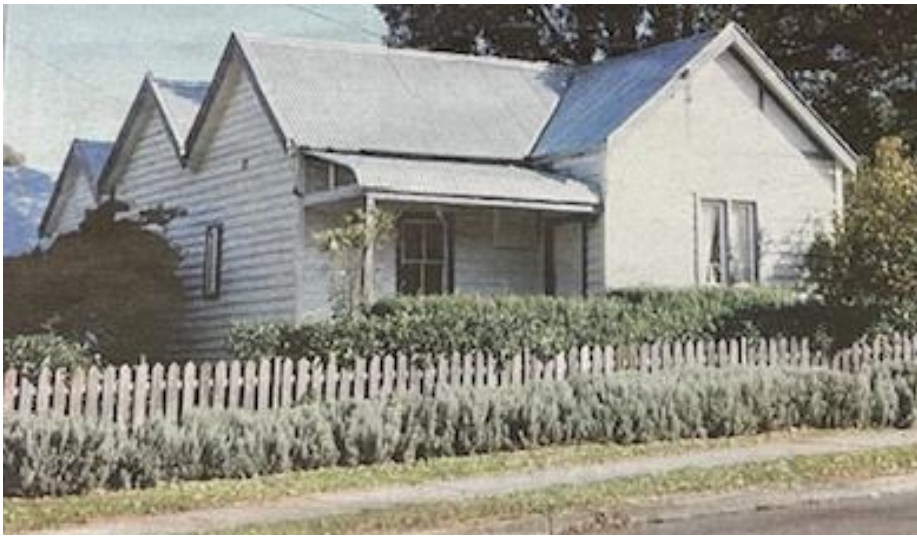
9. Image 4	
Principal image

Subject of photo:	The cottage seen from The Comenarra Parkway.
Date of photo:	June 2002
Photographer:	Not known
Copyright holder	Hornsby Advocate

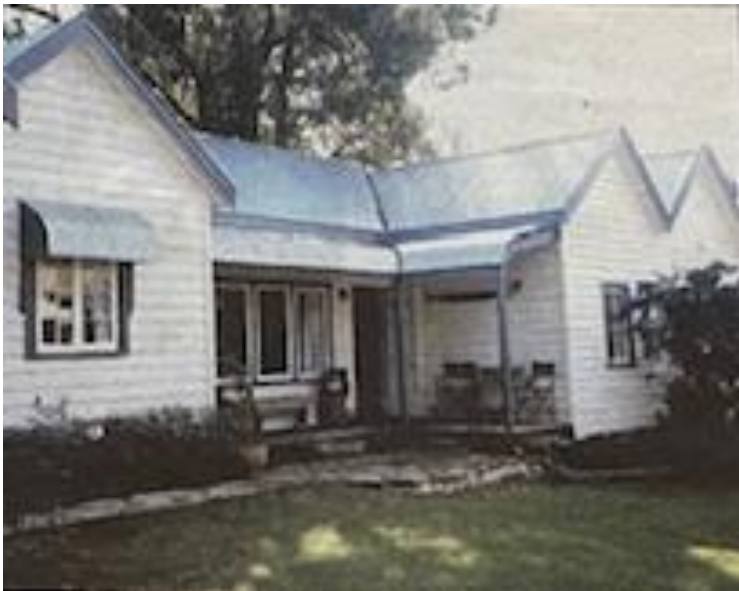
9. Image 5	
Principal image

Subject of photo:	The extended cottage facing the courtyard, looking north-west.
Date of photo:	June 2002
Photographer:	Not known
Copyright holder	Hornsby Advocate

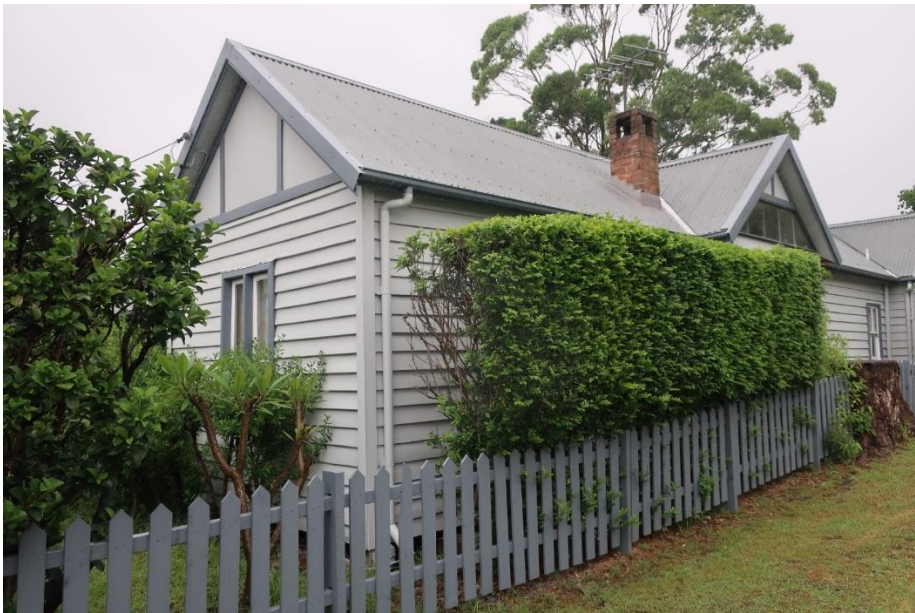
Subject of photo:	The northern corner of the cottage, by The Comenarra Parkway and Wood Street
Date of photo:	December 2023
Photographer:	Brad Vale
Copyright holder	Umwelt

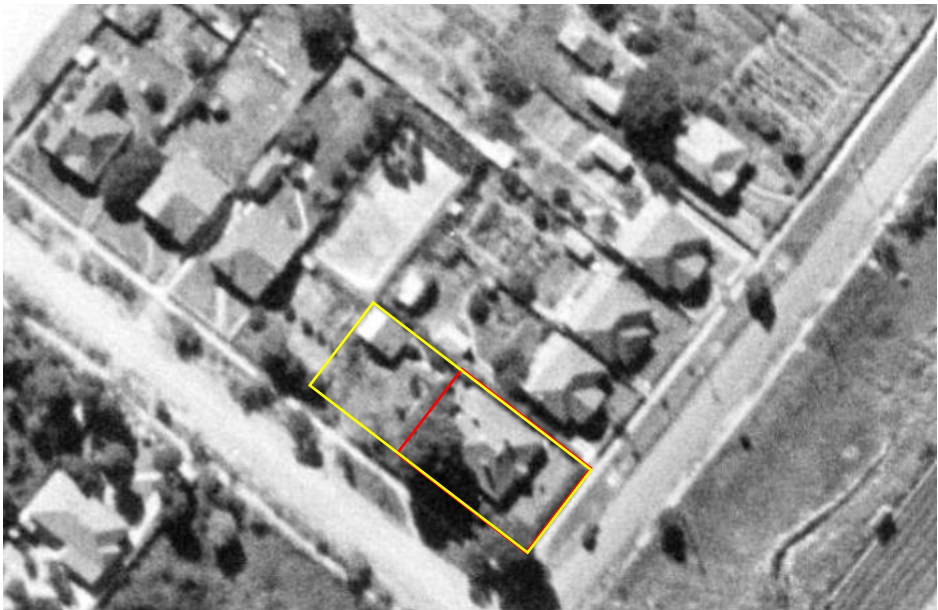
9. Image 1	
Principal image

Subject of photo:	Aerial photograph of the site with the current boundary outlined in red by Umwelt. The original boundary outlined in yellow by Umwelt.
Date of photo:	1943
Photographer:	Commonwealth Government
Copyright holder	NSW Spatial Information Exchange (SIX Maps)

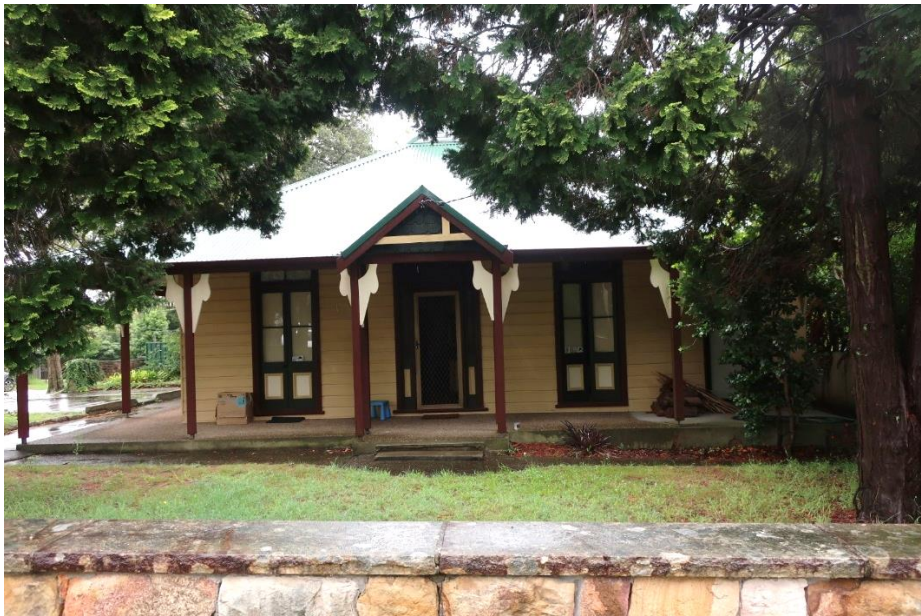
Subject of photo:	East elevation of 80 The Esplanade, facing towards the railway line.
Date of photo:	December 2023
Photographer:	Brad Vale
Copyright holder	Umwelt

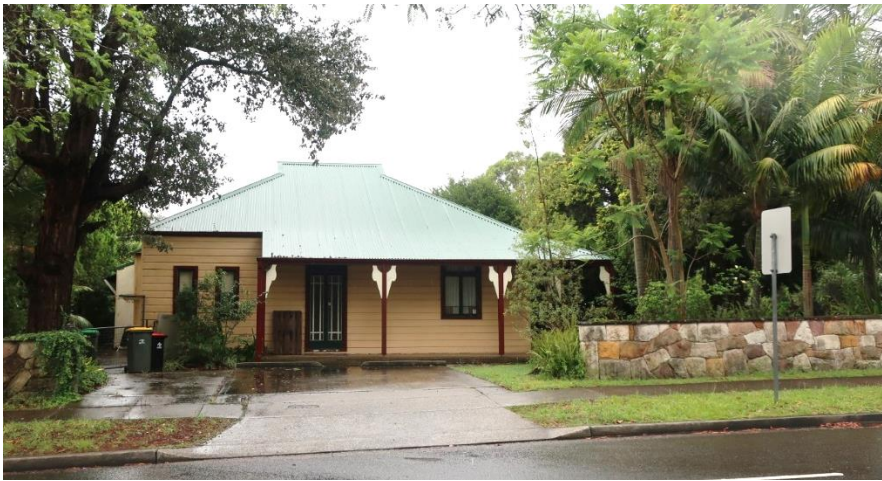
Subject of photo:	South elevation of 80 The Esplanade
Date of photo:	December 2023
Photographer:	Brad Vale
Copyright holder	Umwelt

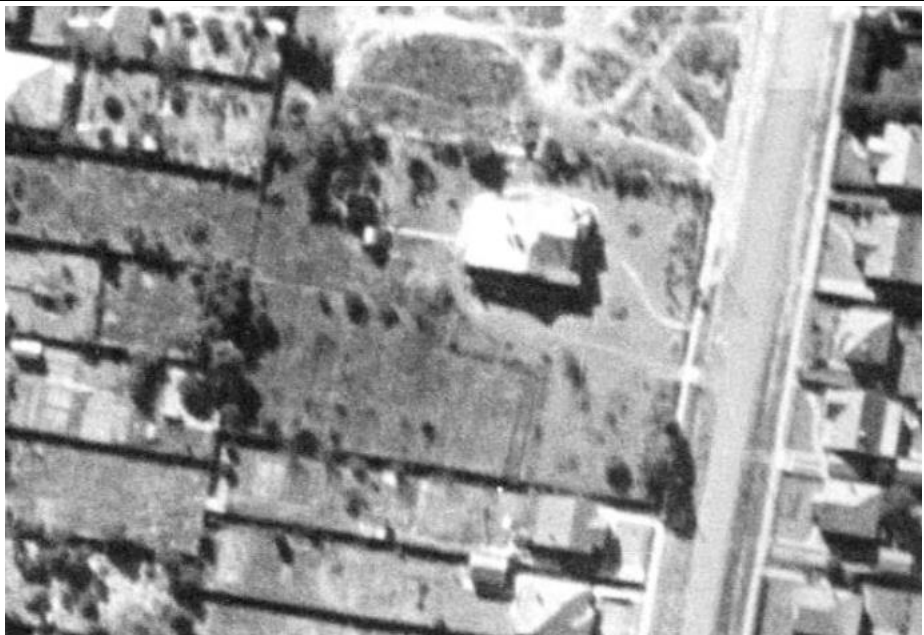
9. Image 1	
Principal image

Subject of photo:	Aerial photograph of the house and its original garden at 75 Balmoral Street (centre).
Date of photo:	1943
Photographer:	Commonwealth Government
Copyright holder	NSW Spatial Information Exchange (SIX Maps)

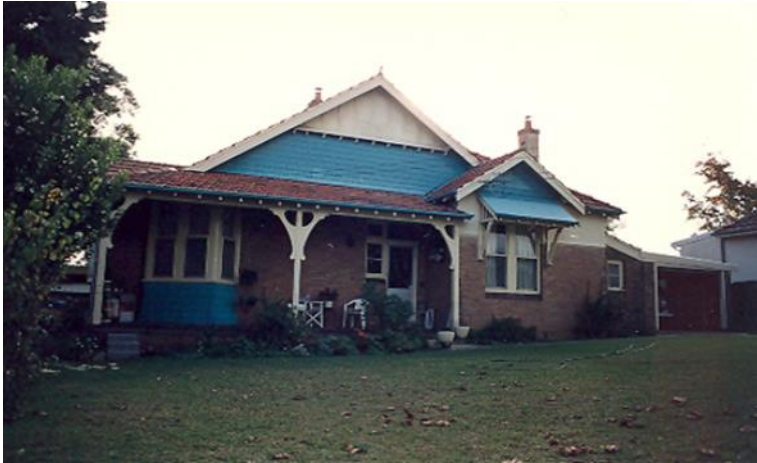
9. Image 2	
Principal image

Subject of photo:	The house seen from 75 Balmoral Street
Date of photo:	1992
Photographer:	Perumal Murphy Wu Pty Ltd
Copyright holder	Hornsby Shire Council / Perumal Murphy Wu Pty Ltd

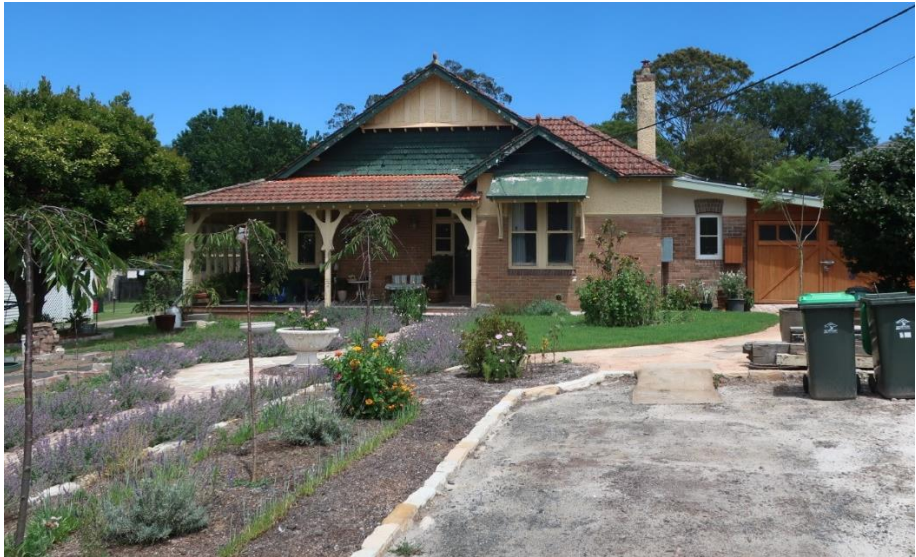
Subject of photo:	The house at 75 Balmoral Street, seen looking west over the garden.
Date of photo:	December 2023
Photographer:	Brad Vale
Copyright holder	Umwelt

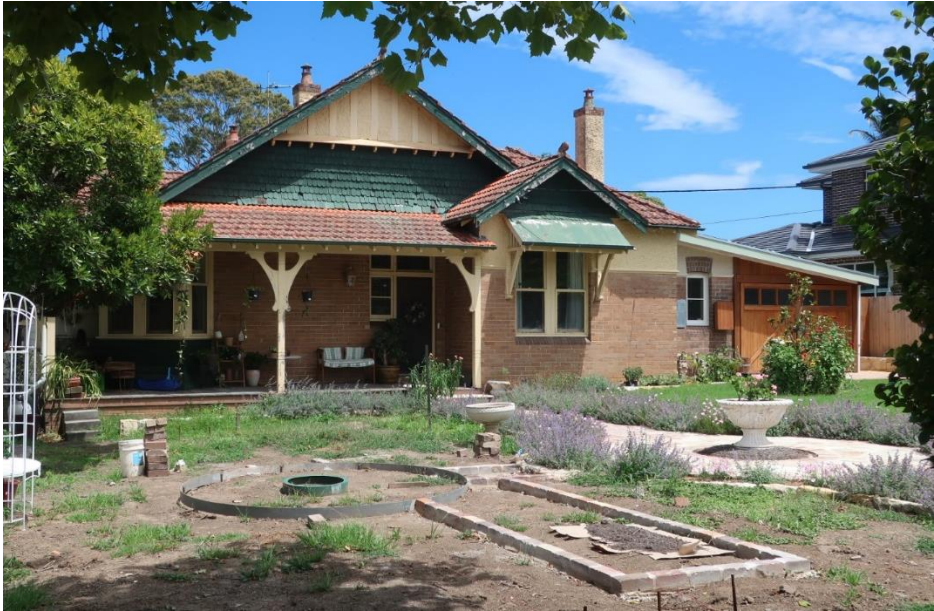
9. Image 4	
Principal image

Subject of photo:	Detailed view of the house at 75 Balmoral Street, seen looking west over the garden.
Date of photo:	December 2023
Photographer:	Brad Vale
Copyright holder	Umwelt

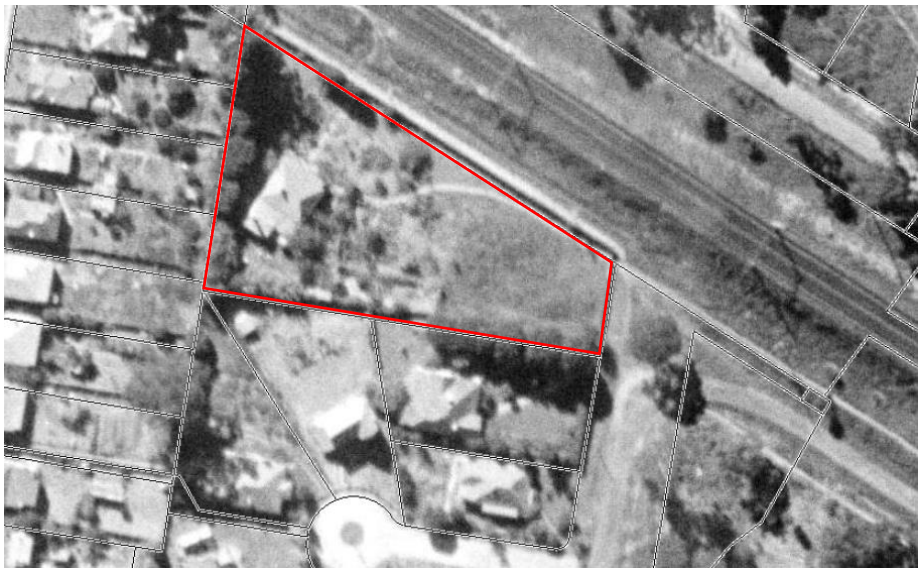
9. Image 1	
Principal image

An aerial photograph showing a residential area. A specific property is outlined with a red line, indicating its original boundary. The surrounding area includes other houses, trees, and a road.
Subject of photo:	Aerial view of the site showing the extent of the original house. The property boundary is outlined in red by Umwelt.
Date of photo:	1943
Photographer:	Commonwealth Government
Copyright holder	NSW Spatial Information Exchange (SIX Maps)

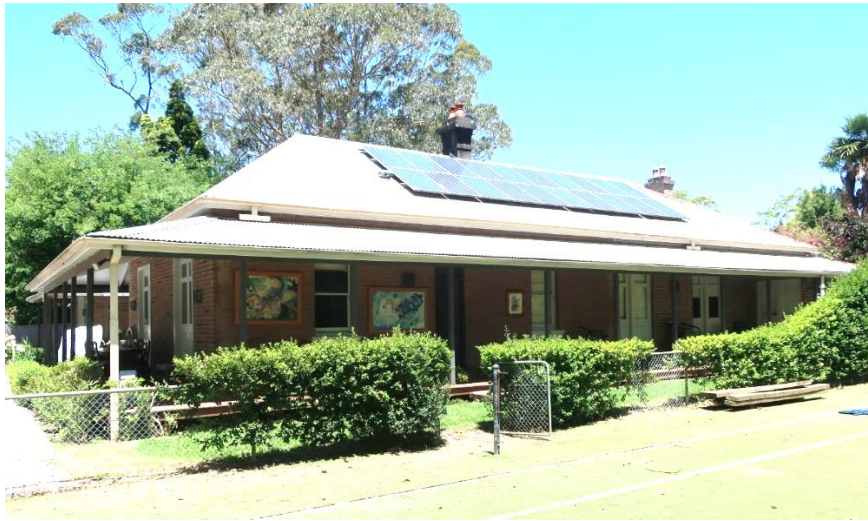
9. Image 3	
Principal image

Subject of photo:	The northern façade of the house. The left half is original.
Date of photo:	December 2023
Photographer:	Brad Vale
Copyright holder	Umwelt

Current use:	Dwelling. Subdivision for two additional housing lots have been approved.
Physical Condition:	Good, while noting that most of the house is a relatively recent construction.
Integrity/Intactness:	The heritage integrity of the house is low, limited to the eastern half of the north elevation, and the adjacent two adjacent rooms.
Recommended Management:	Due to the low historical integrity of the house, the property should be removed from Schedule 5 of the LEP 2013. The heritage values of the property should continue to be managed under Conservation Area C7.
Significance level	Local

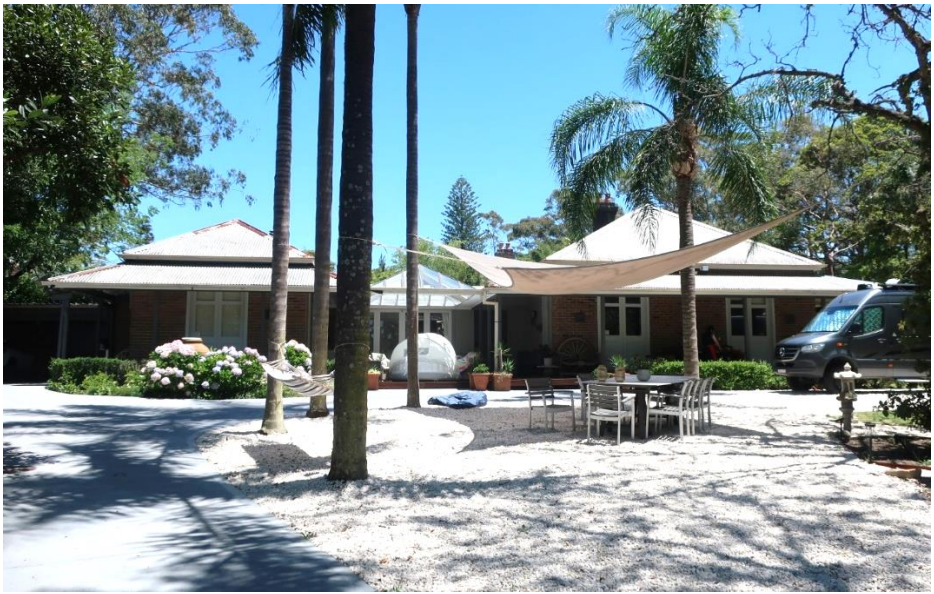
9. Image 5	
Principal image

Subject of photo:	The east side of the subject house showing 1980s work in Federation style.
Date of photo:	December 2023
Photographer:	Brad Vale
Copyright holder	Umwelt
