PRELIMINARY SITE INVESTIGATION

PROPOSED REZONING

**Lot 15 DP 1236885
40 The Tunnell Road
Billinudgel NSW**

HMC2024.667

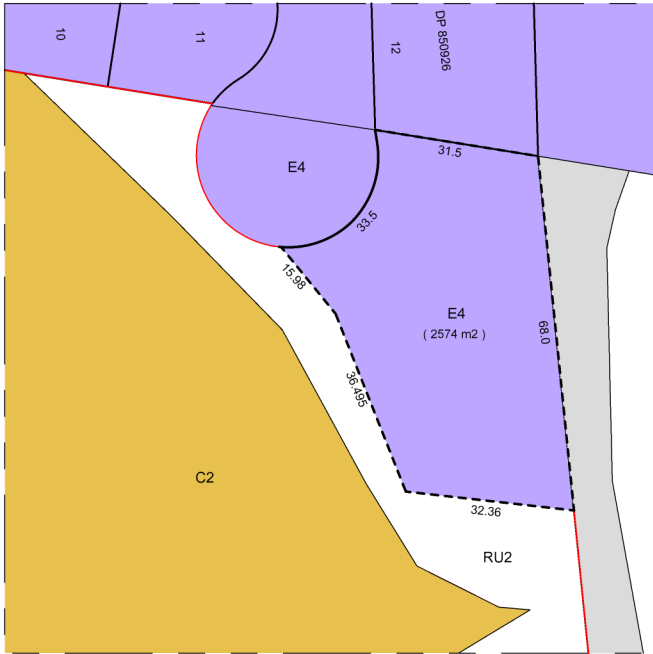
B				DRAWING DETAILS	Existing and Proposing Zoning		DRAWING NUMBER	PP - 01		
		C										
				D					APPROVED

Existing Zoning
Scale A

Larger Proposed Rezoning Detail

Proposed Zoning
Scale A

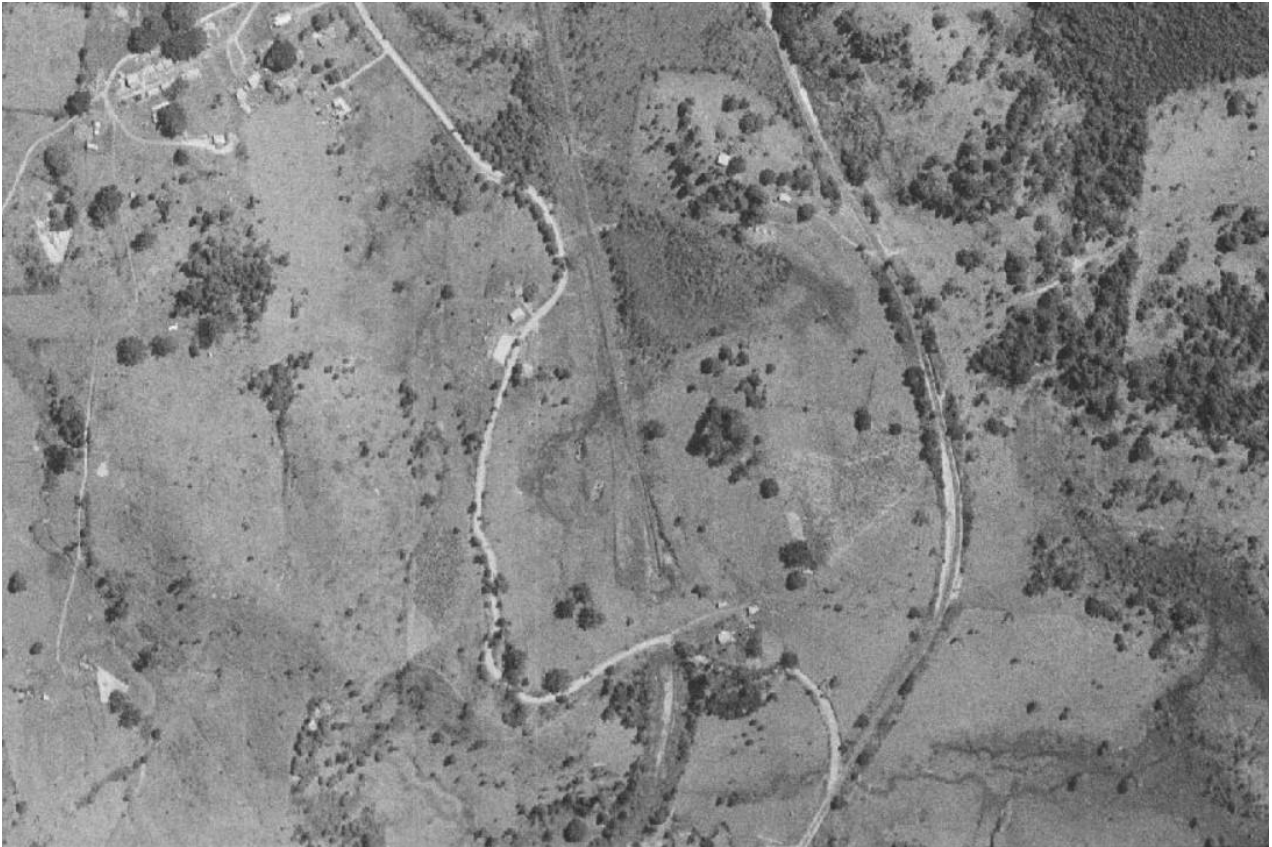
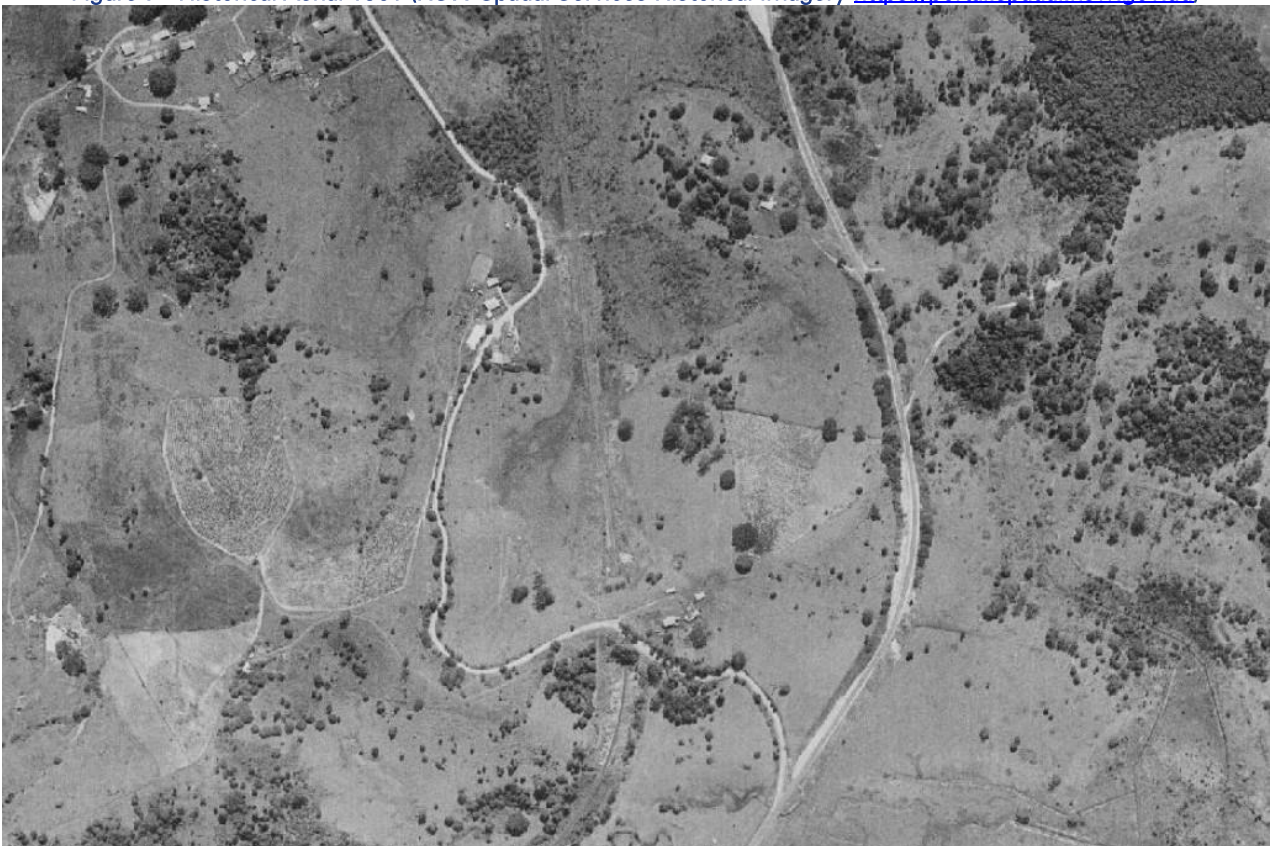
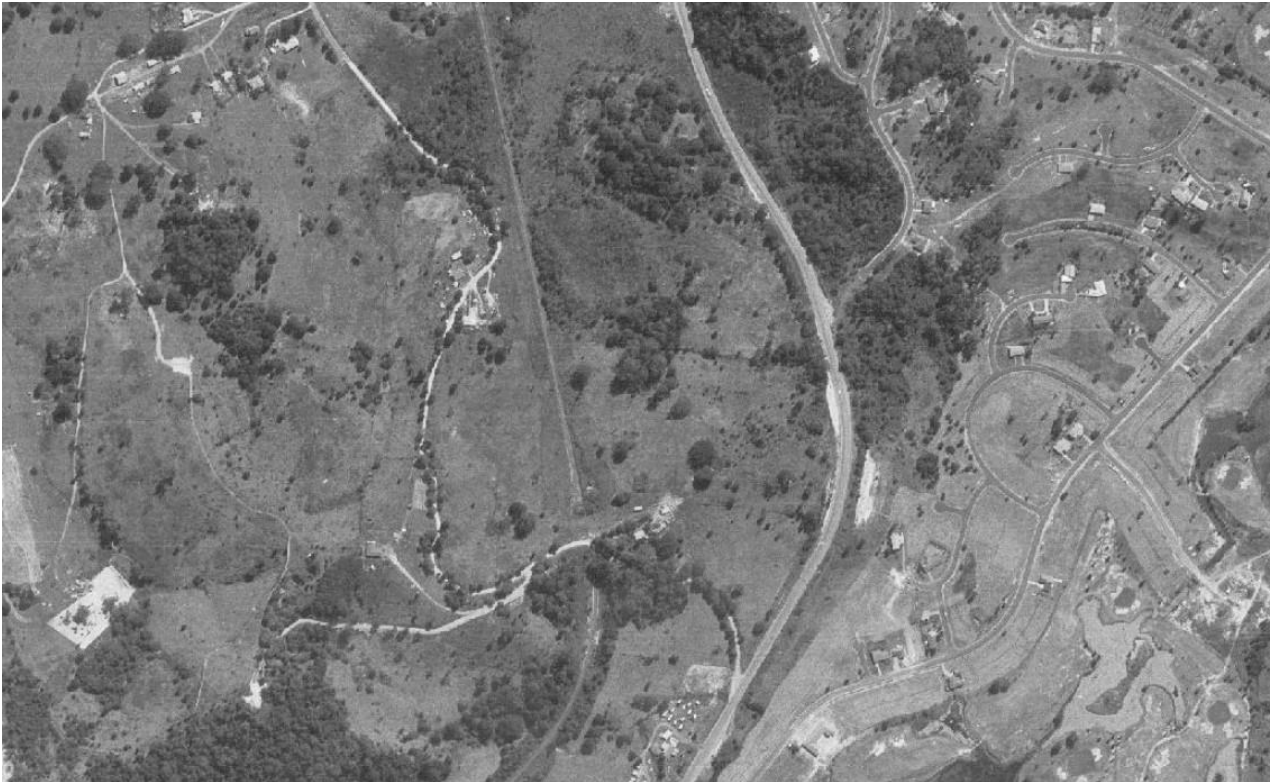
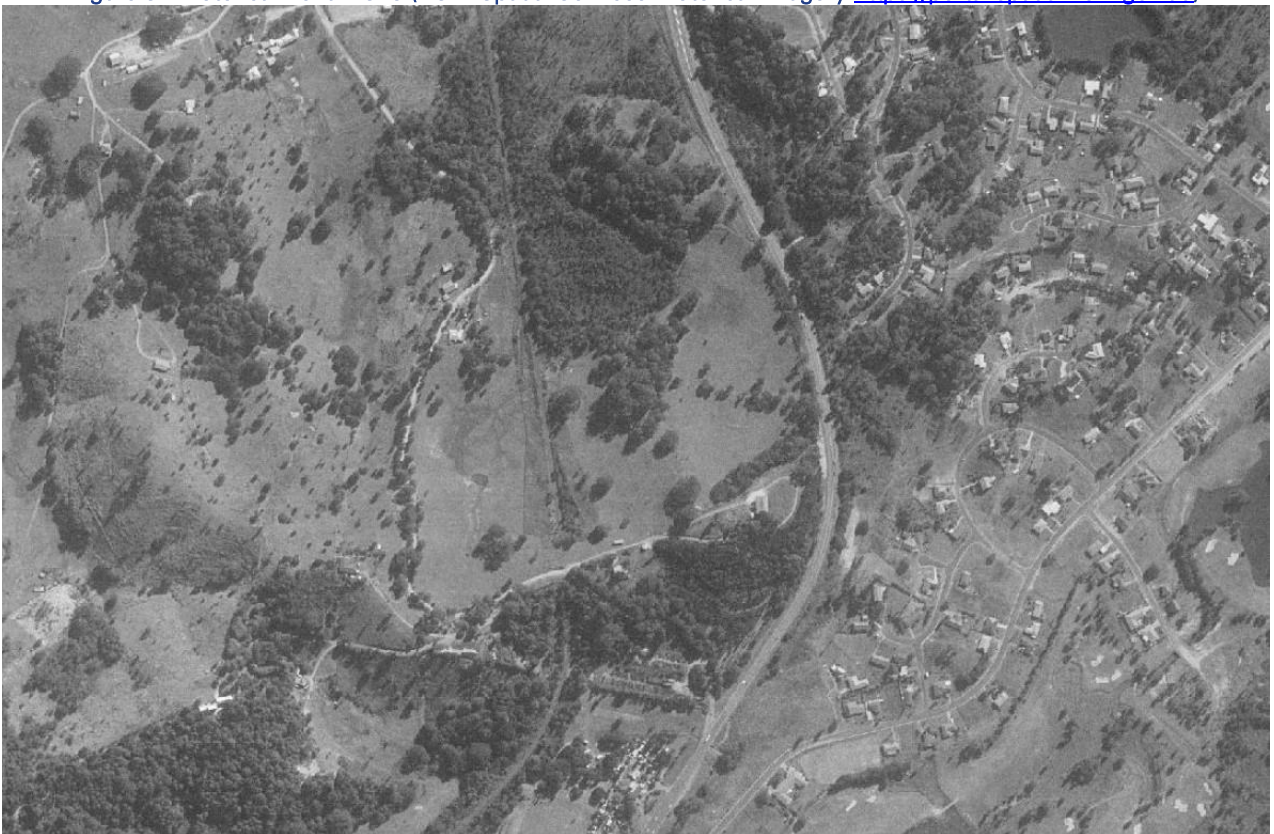
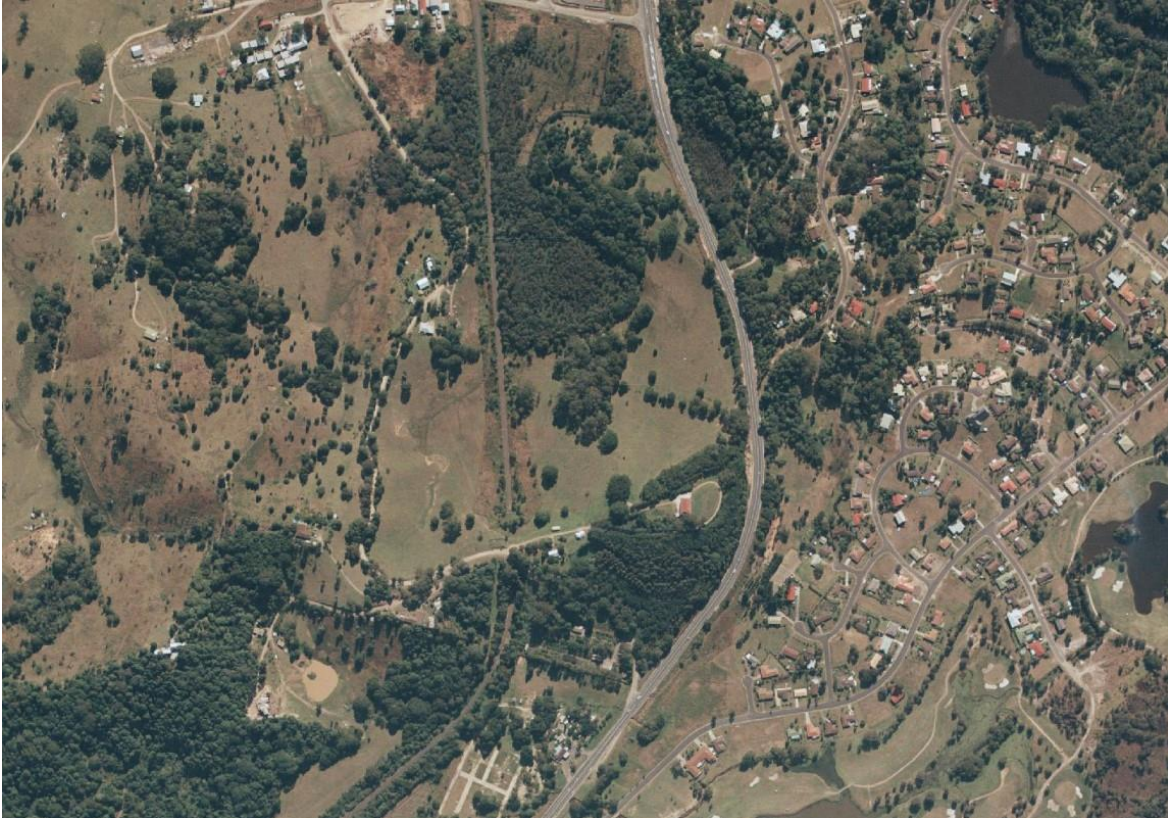
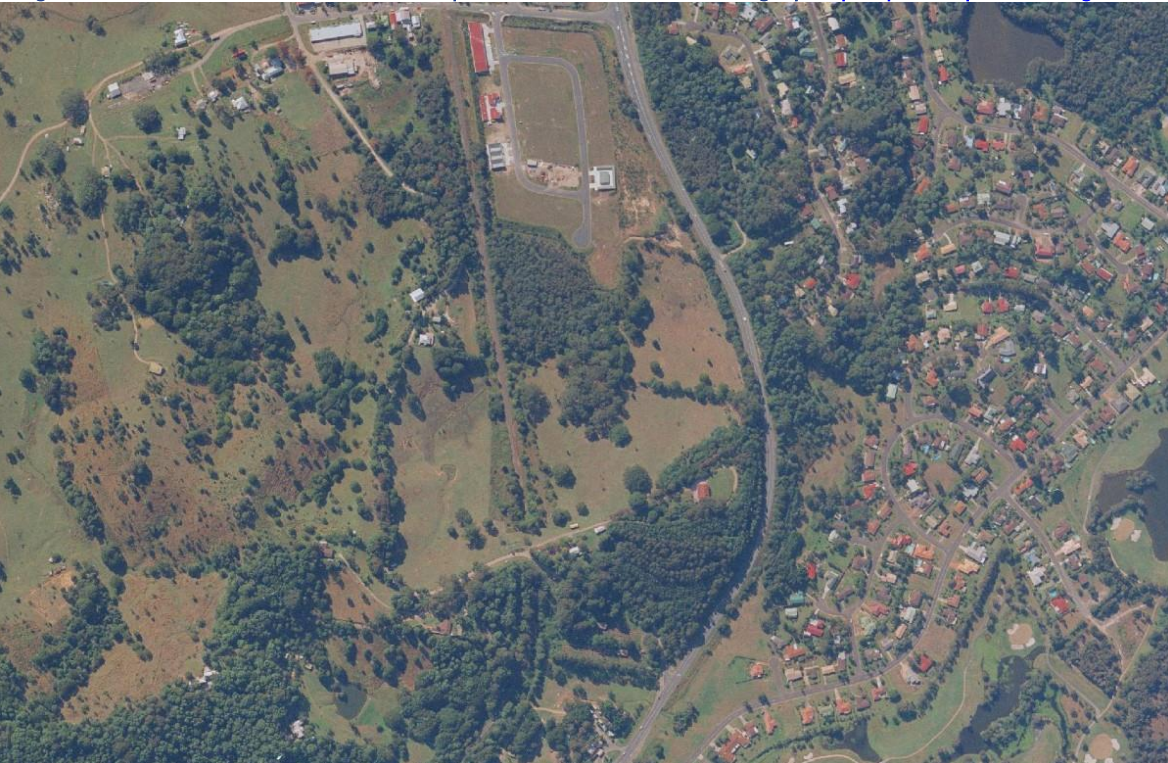
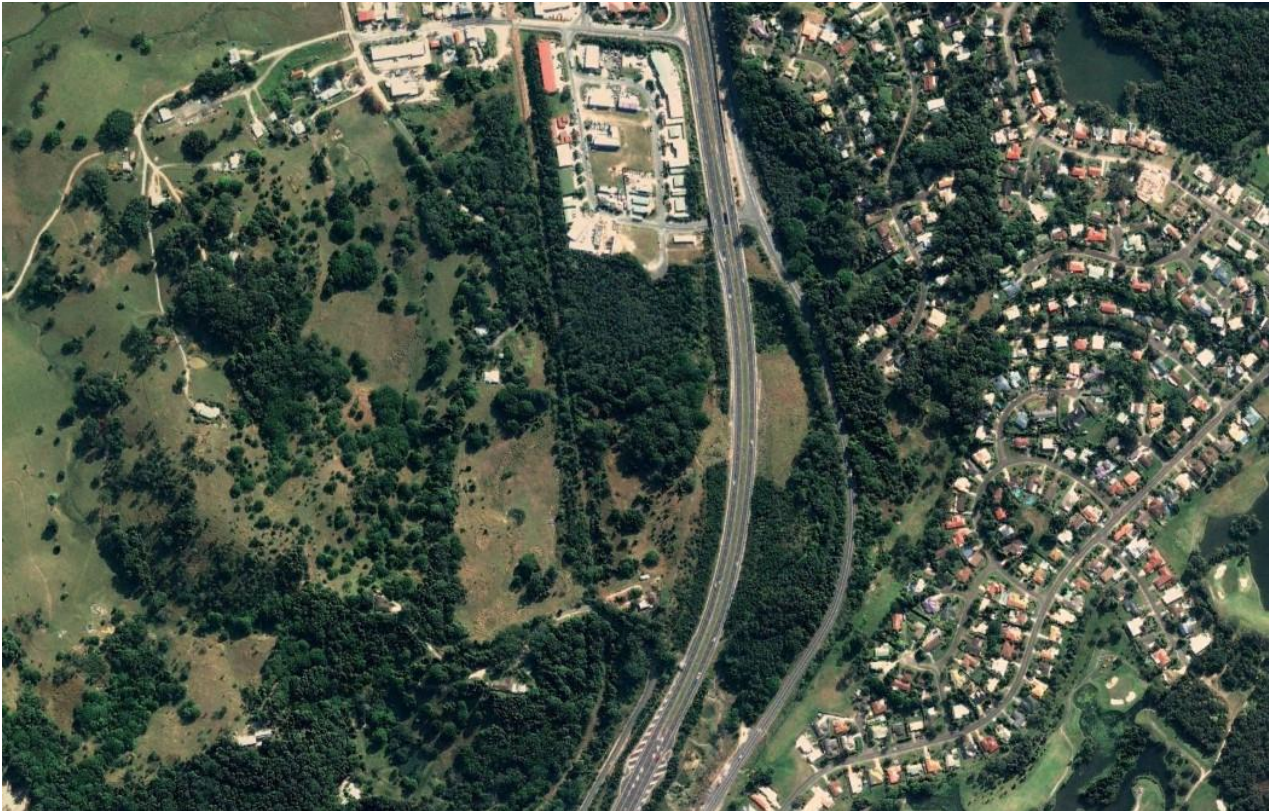
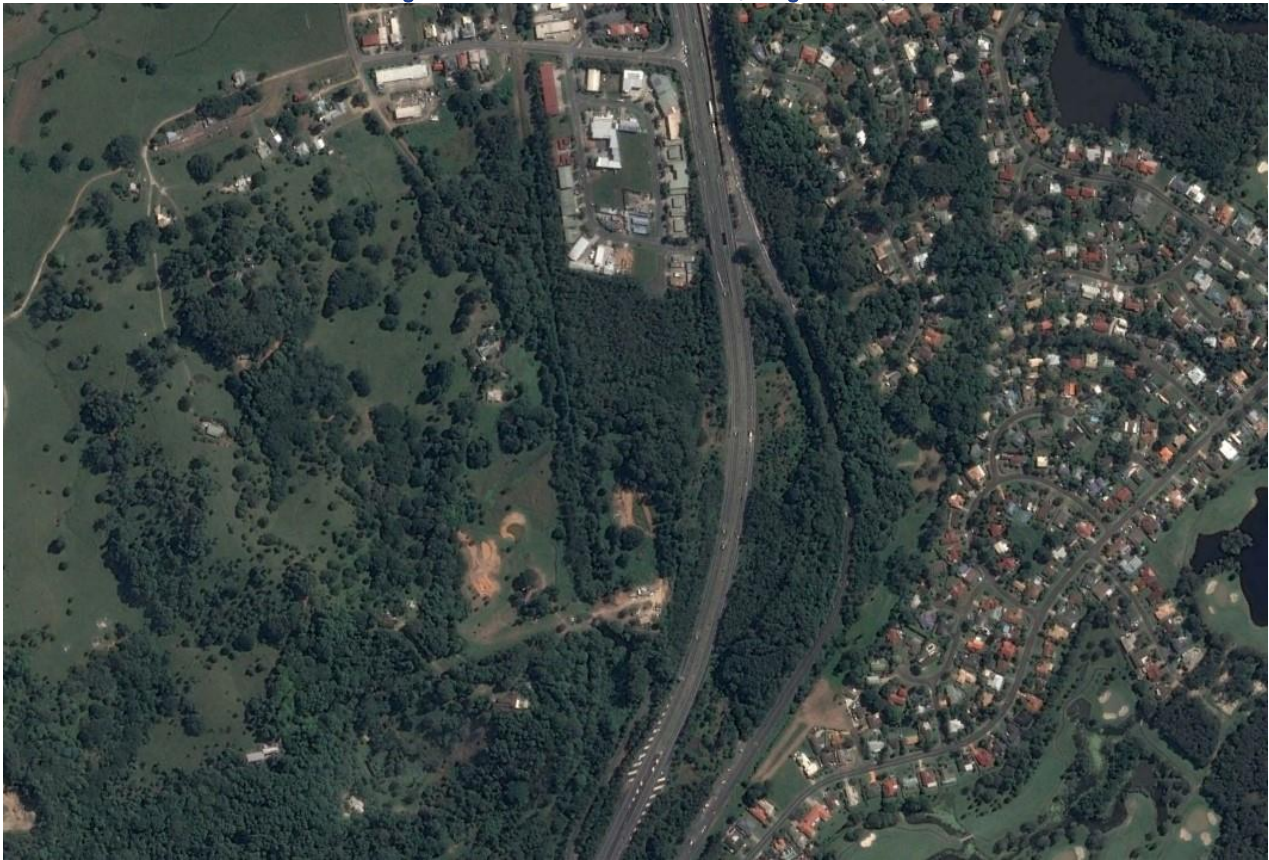
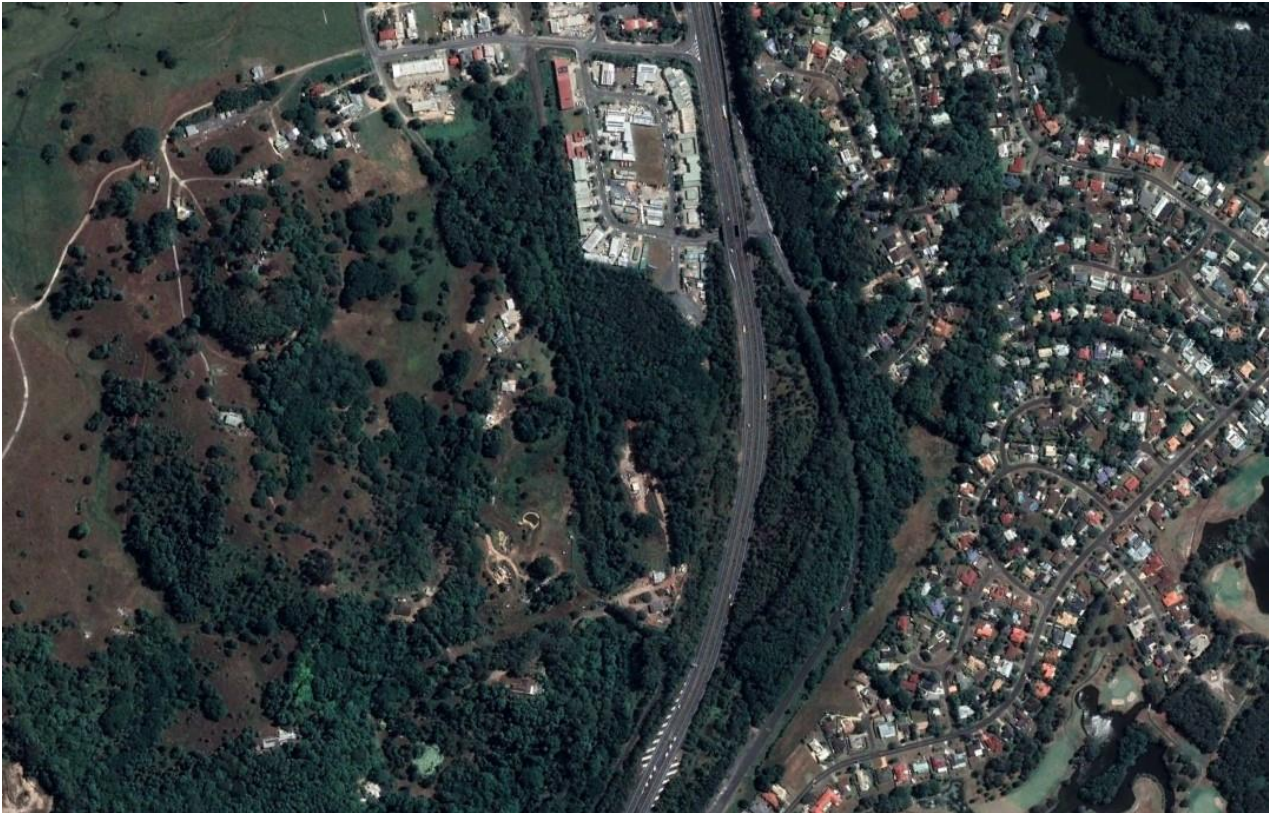
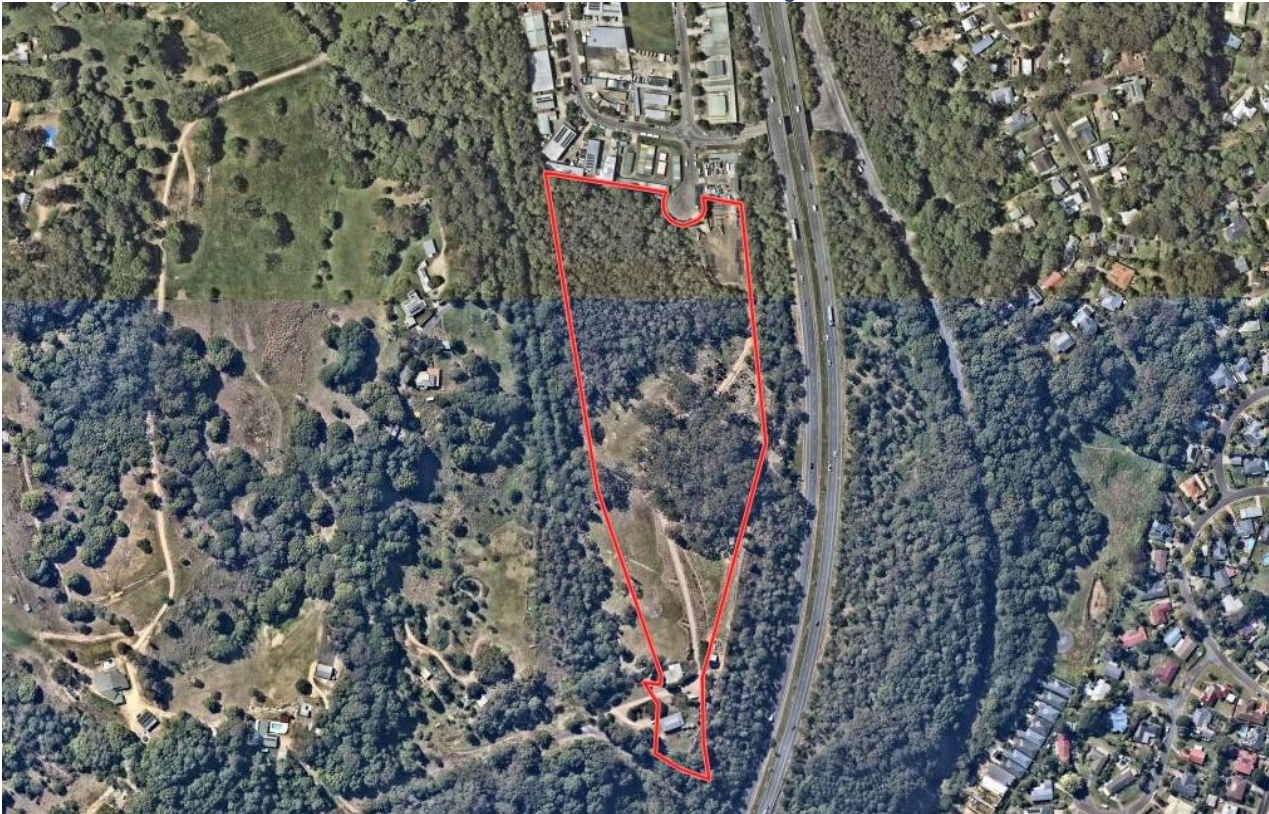
Year	Source	Comments	Areas of Potential Concern Yes/No
1961	NSW Government (Historical Imagery) ⁽¹⁾	The site appears to be generally clear of native vegetation, along with the surrounding area, with scattered patches of vegetation in the area. There are no visible intensive land uses or structures located on the site. There are two structures visible to the north of the site. The railway is visible to the west and Brunswick Valley Way to the east.	NO Investigation area (proposed development area and immediate surrounds) clear of any intensive land uses from
1965		Similar to 1961. No significant changes to the investigation area or the surrounding area noted.	
1978		Increased vegetation cover over the site and surrounding area to the north. The existing structures to the north of the site are no longer visible, however they may now be obscured by the

vegetation. Significant residential development is under structure to the east of Brunswick Valley Way.	1961 to present. Appears to have remained vacant with periods of vegetation cover.
1987		Significant increase in vegetation over the investigation area and surrounding areas.	
1990		Similar to 1987. No changes noted to the densely vegetated investigation area. Increased residential development is noted east of Brunswick Valley Way.	
1996		The investigation area, and the adjacent land to the north has been cleared of all vegetation. The industrial area has begun to be developed, with the existing roadways, including Lucky Lane, now existing. Scattered structures are noted in the industrial area.	
2009 - 2019	Google Earth	Vegetation re-growth has occurred over the site, with it now generally covered by mature vegetation. The Pacific Motorway has now been constructed adjacent east of the investigation area. The adjacent industrial area has now generally been developed with a number of structures existing along Lucky Lane.

2019 - 2022		The site has now been cleared of vegetation. It appears that the site has also been filled and levelled. No permanent structures or land uses are noted for the site.

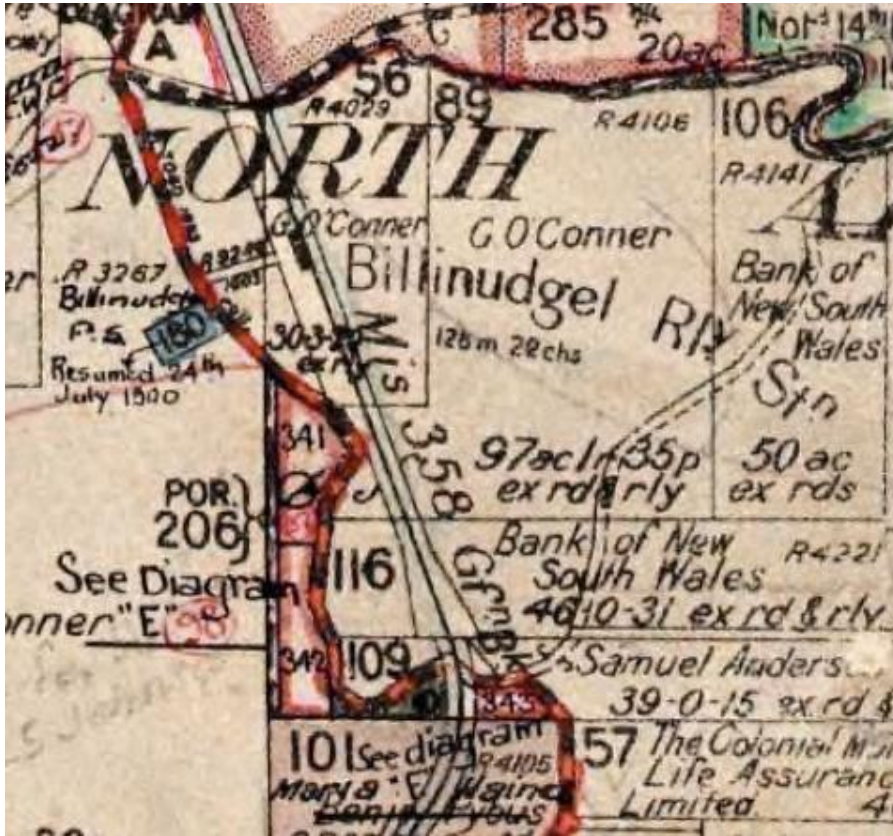
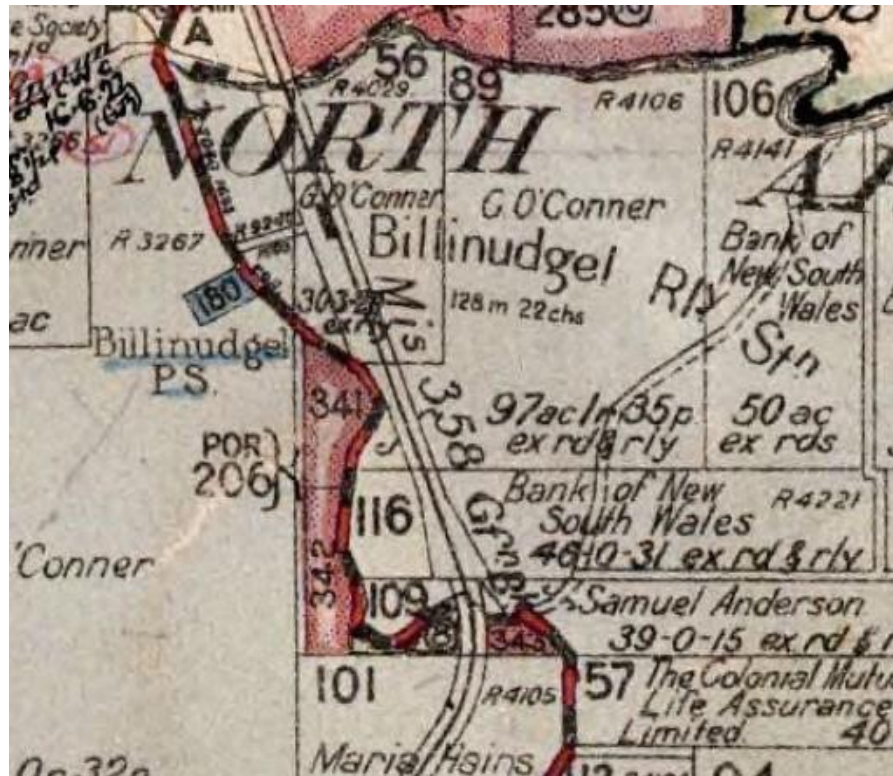
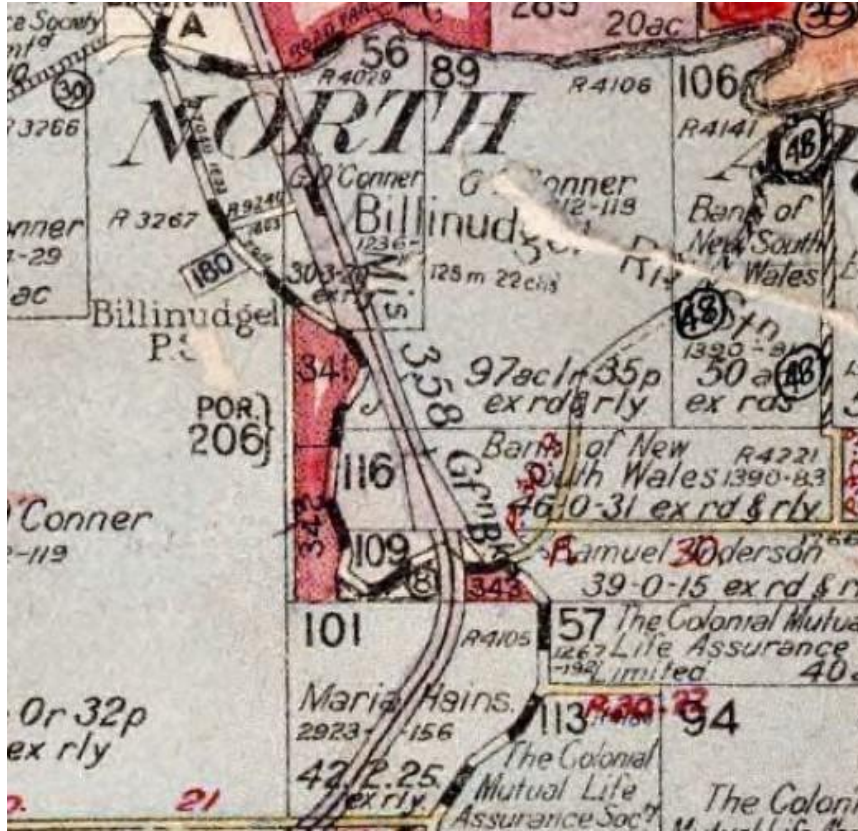
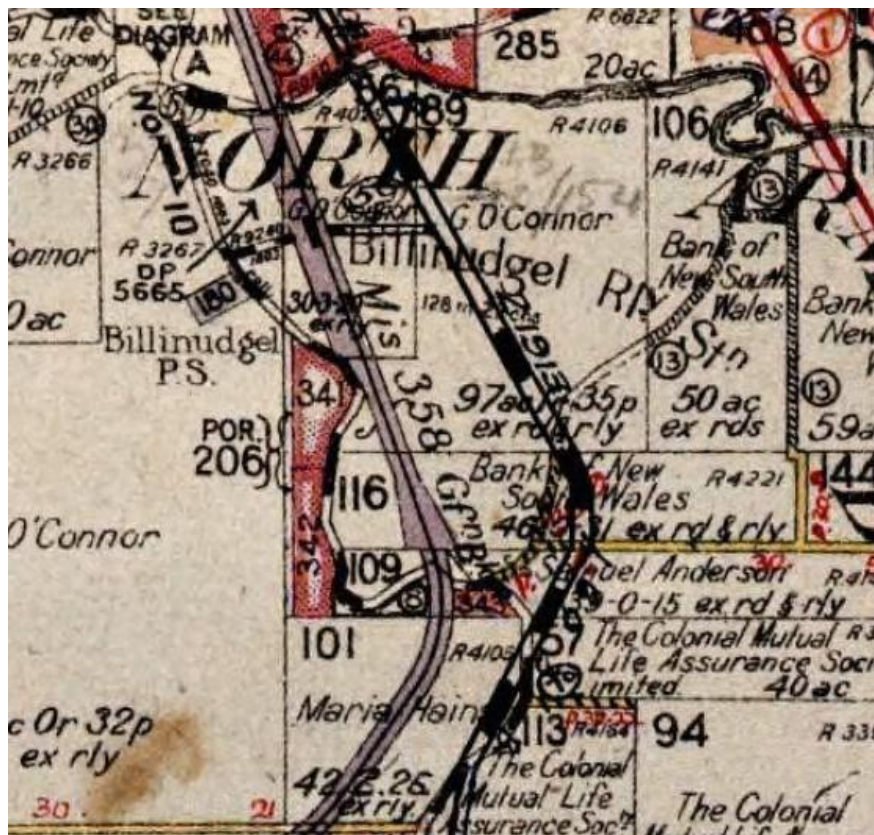
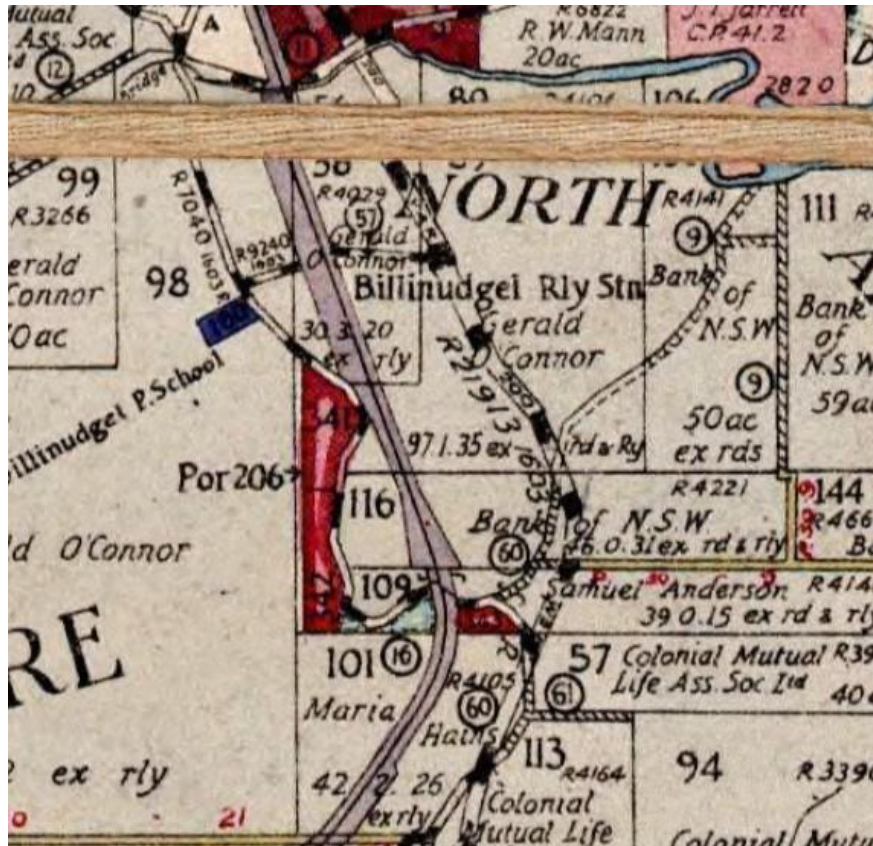
Search	Comment
Historic Billinudgel Parish Maps 1914, 1922, 1929, 1937, 1946 https://hlrv.nswlrs.com.au/	Maps do not record land use. Billinudgel parish maps 1914 to 1946 show the subject site as part of the larger historic portion 89 (97 acres). No changes were noted during the 1914-1946 period.
Topographic Maps ● Central Mapping Authority of NSW (1984), 1:25000 9640-4-N Brunswick Heads, Topographic Map	The property is mapped as a larger historic Lot 604 DP 240398. There are no structures or land uses mapped for the investigation area. The area is mapped as scattered timber.

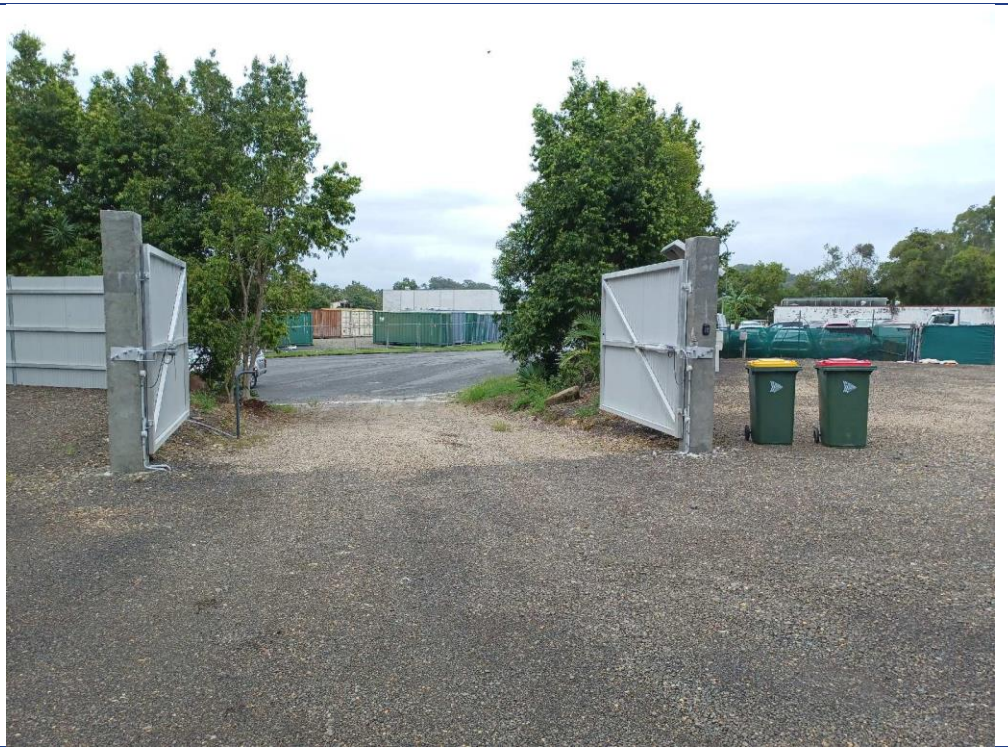
Photo No. 4	Date
	30.01.2024
Description: View of the existing driveway access to the remainder of the property to the south of the investigation area.
