Sunnyside Cultural Heritage Construction Management Plan

Prepared for Stockland Development Pty Ltd

June 2022

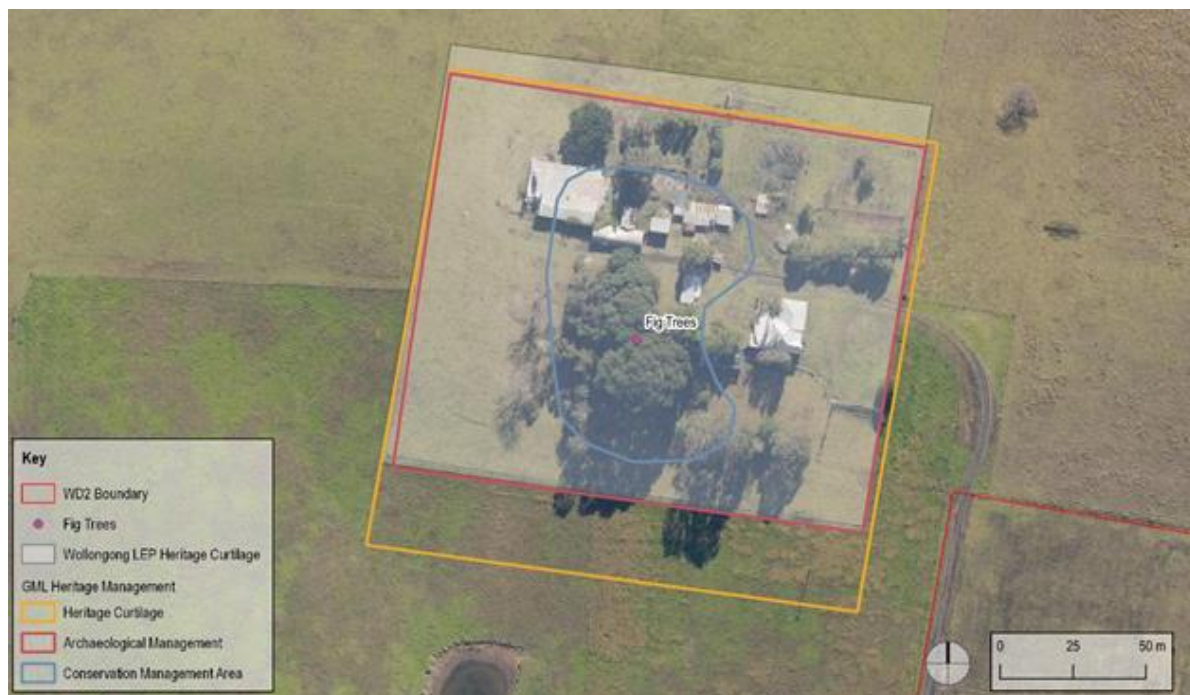
Figure 1.1 Sunnyside, showing the Wollongong LEP heritage curtilage (the white zone). (Source: Nearmap, with GML overlay 2021)

The site of the 'former Sunnyside homestead' is a locally listed item on the Wollongong Local Environmental Plan (LEP) 2009. It is identified under Schedule 5, Environmental heritage. The LEP listing boundary is shown in Figure 1.1. The original CMA boundary (Figure 1.1) identified by GML was updated and revised following the archaeological test excavation (Sunnyside Archaeological Test Excavations Report, GML 2021). The revised boundary is shown in Figure 1.2.

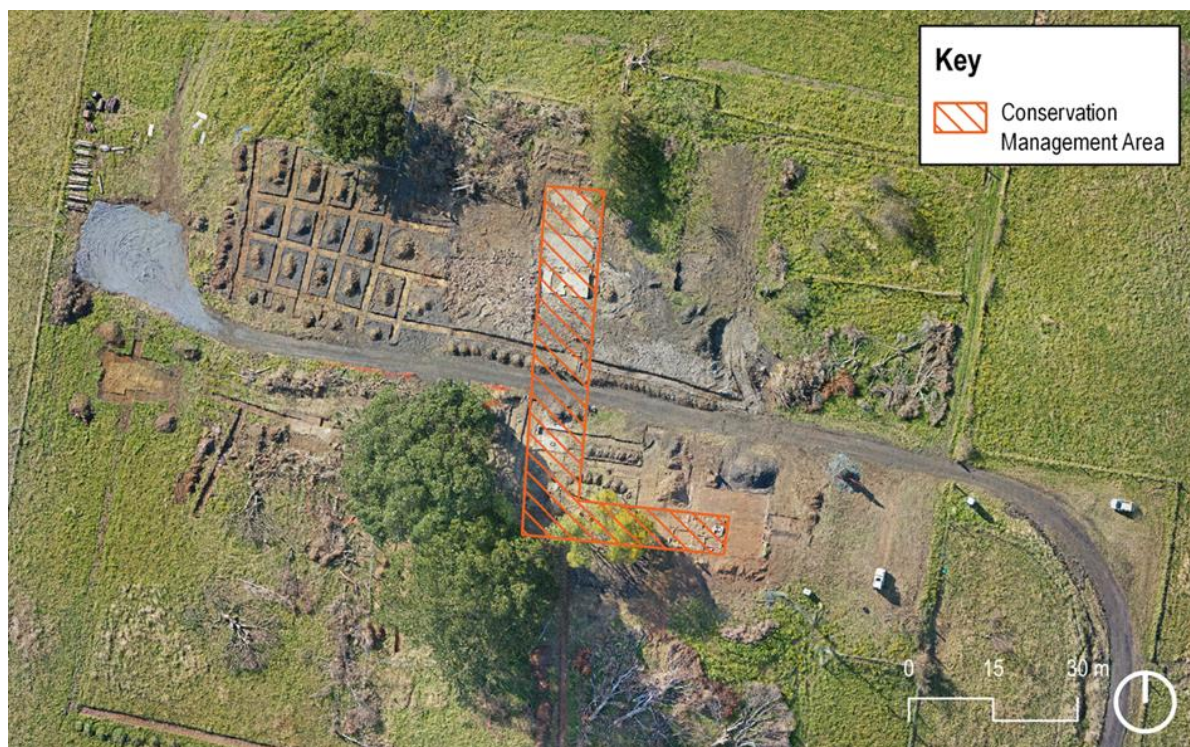
Figure 1.2 The Conservation Management Area boundary (orange), which includes all Phase 1 archaeological fabric. (Source: Guy Hazel 2021, GML Heritage 2021, over Nearmap aerial photography)

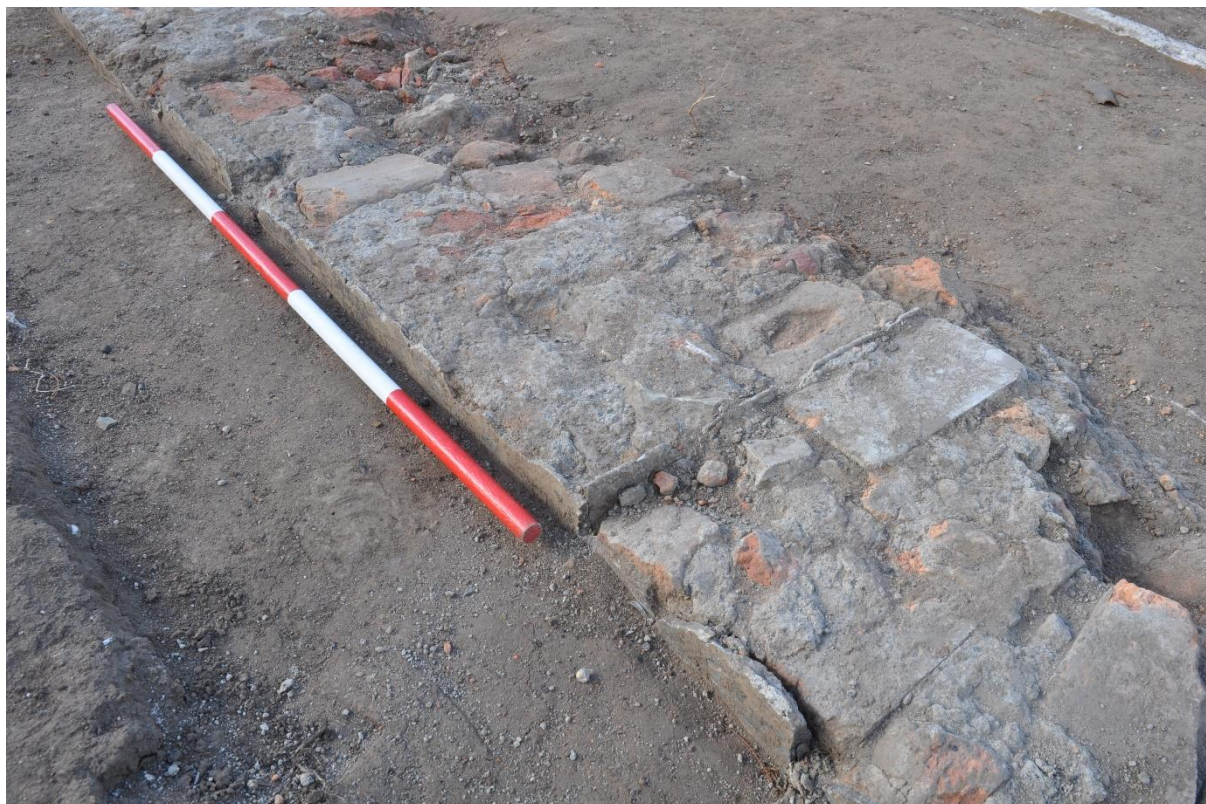
Figure 2.1 Showing sheets of asbestos within the Phase 2 remains of Sunnyside house.

- Any surface asbestos inside the CMA should be handpicked without the use of heavy machinery.
- The archaeological remains associated with a specific part of the former Phase 2 Sunnyside house contains sheets of embedded bonded asbestos. These are shown in Figure 2.1. Some of this asbestos is located inside the CMA. If the removal of this material from within the CMA is required, a location specific plan will need to be developed, in consultation with a suitably qualified heritage consultant, prior to any works. Further details associated with this removal action are described in Section 3.2.5 below.

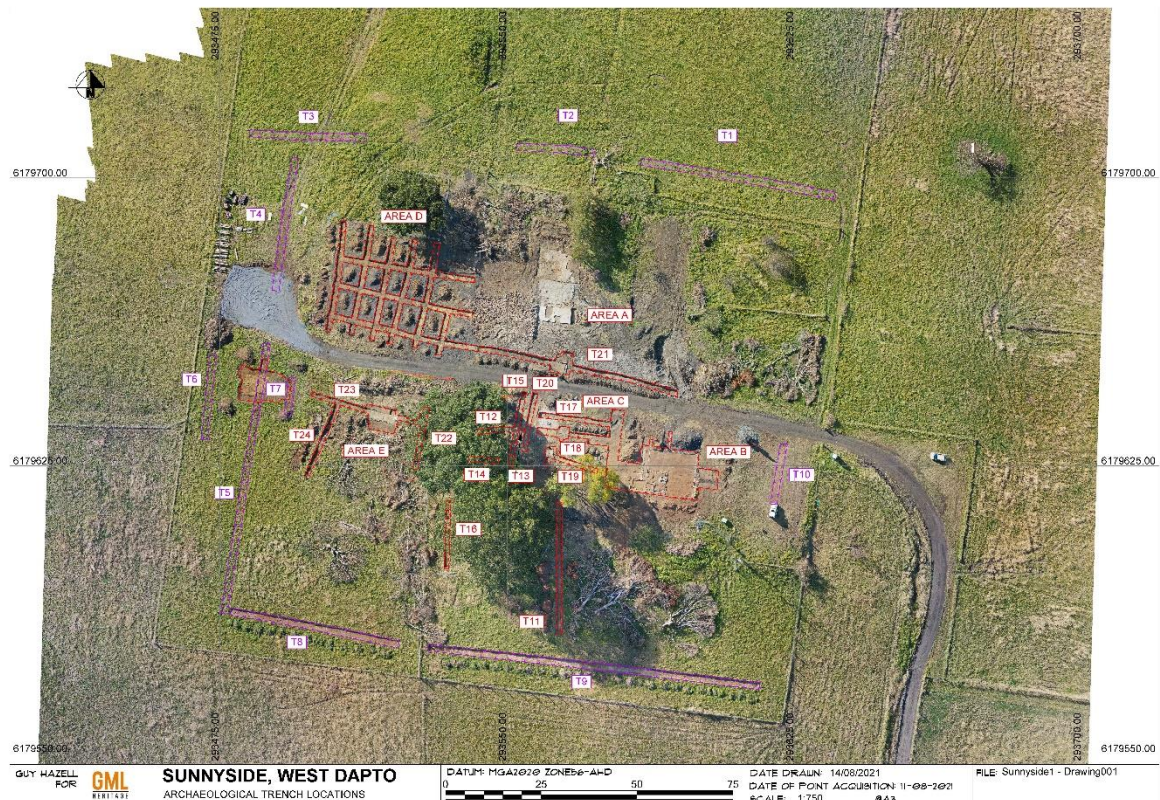
Figure 3.1 Location of 24 trenches and excavation Areas A to E. Phase 1 trenches (T1 to T10) are shown in pink, phase 2 trenches (T11-T24) and areas (A to E) are outlined in red. (Source: GML Heritage and Guy Hazell, 2021)

The archaeological work was conducted in two phases (Figure 3.1). The first phase investigated areas around the periphery of a core zone with the highest archaeological potential. This phase aimed to identify whether archaeological materials or evidence of landform modifications were located outside the proposed Sunnyside Park boundary, albeit inside the LEP Sunnyside curtilage. The second phase was undertaken following the

demolition of the extant non-heritage items and removal of vegetation. The work involved the excavation of 24 trenches and work in five further areas (called A to E), which resulted in the identification of material evidence attributed with two historical phases of Sunnyside's development, occupation, and use.

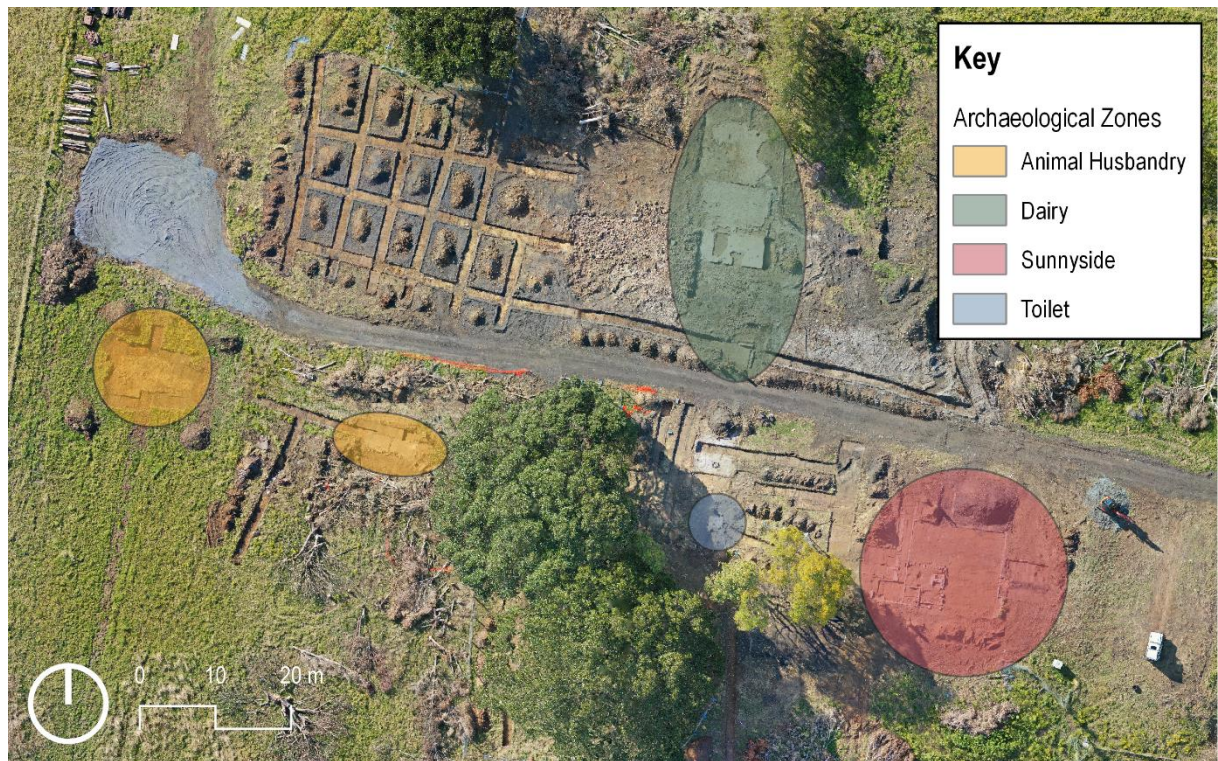
Figure 3.2 Archaeological zones within the study area. (Source: GML Heritage 2021, aerial image by Guy Hazell)

We note that the occupants of Sunnyside re-used locations when redeveloping eg the house site, toilet and dairy were all reused between Phases 1 and 2. The archaeological remains can be grouped into four zones of activity (Figure 3.2).

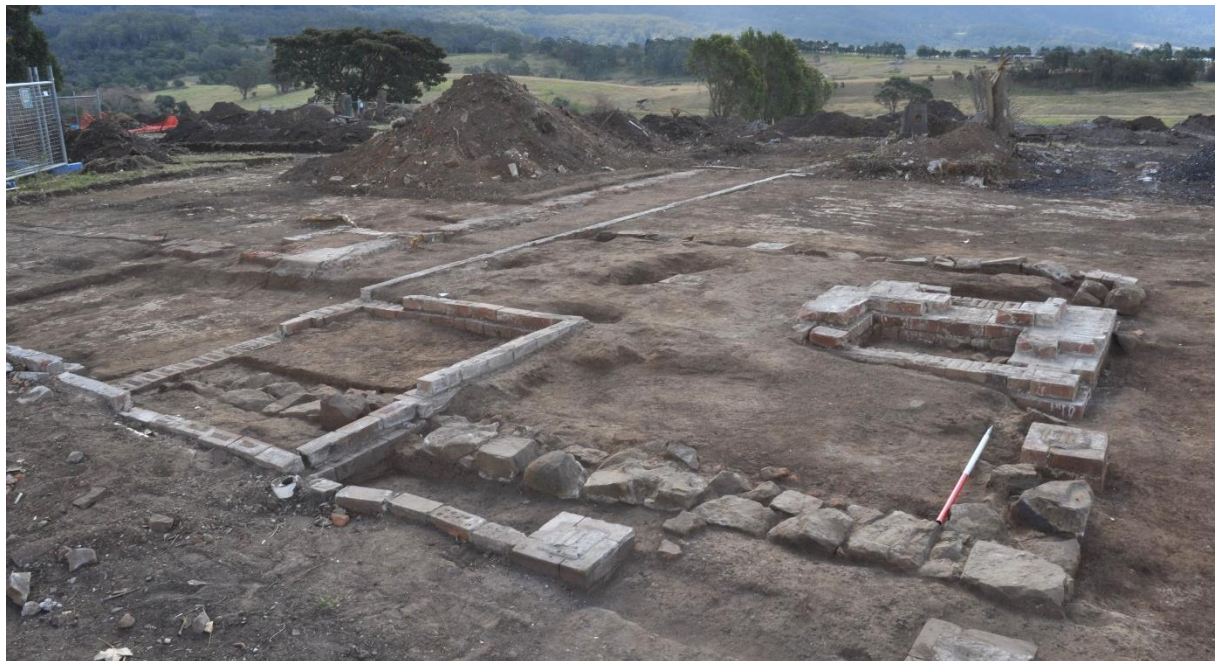
Figure 3.3 Showing the remains of Sunnyside Phase 1 (sandstone), overbuilt by Sunnyside Phase 2 (machine cut bricks). (AR #177, facing NW).

The footings of the first Sunnyside house were identified below the second house which had been built above the remains (Figure 3.3). The first house was square, relatively small, and may have had an earthen floor and thatched roof. It represents the foundation remains of a rare example of a house built in the Irish vernacular architectural tradition. The rear of the house (facing west) had a double to single row of sandstock bricks, which *could* have formed the base of a lean-to.

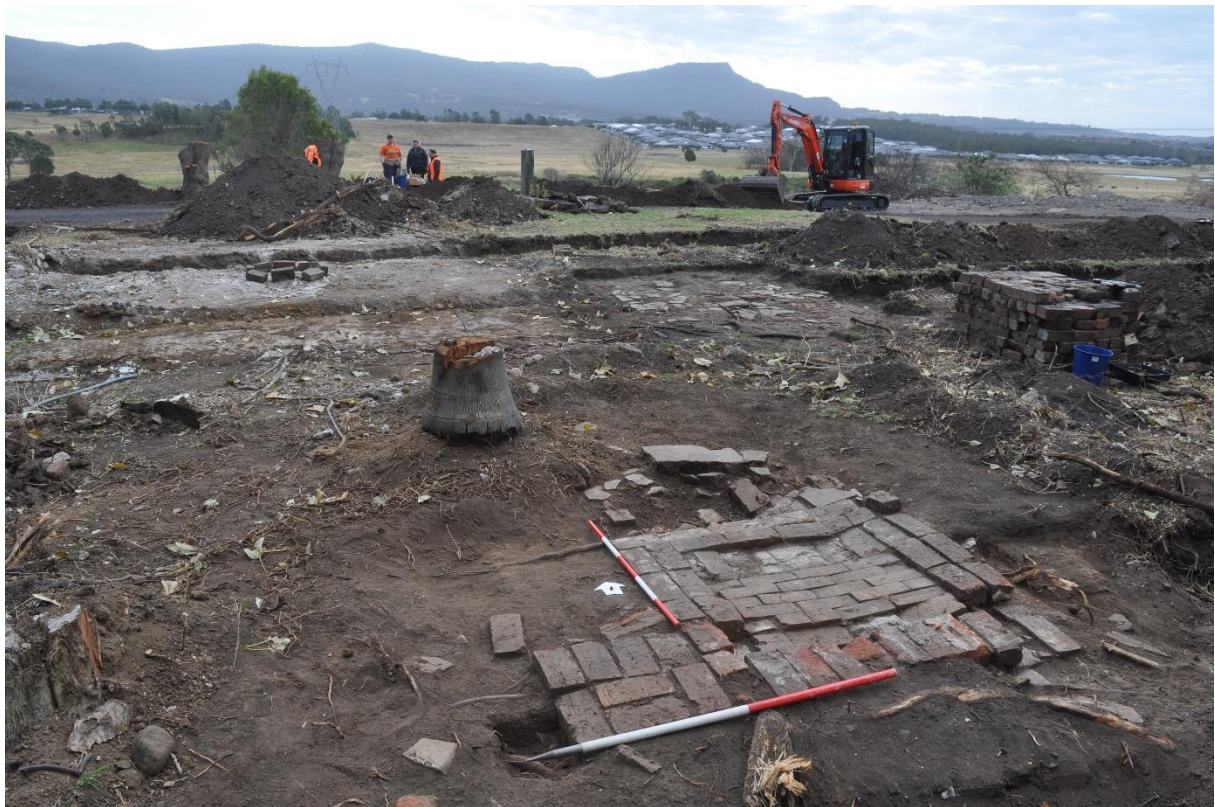
Figure 3.5 Showing the remains of Pail Closet, with a view to Mount Kiera. (AR #137, facing NNE)

The pail closet base was found to the west of the house. It was built of sandstock bricks and had later been resurfaced with a concrete slab (Figure 3.5). It likely that it remained in use into the second half of the twentieth century. The pail closet was located to the rear of the Sunnyside House, approximately 20m from the rear of the lean-to.

Interestingly the pail closet was orientated to the north (based on the brick pattern), with a door likely facing in the direction of Mount Kiera. Whilst the late nineteenth century ablutions at Sunnyside may not have been salubrious, the view certainly would have been appreciated on a daily basis.

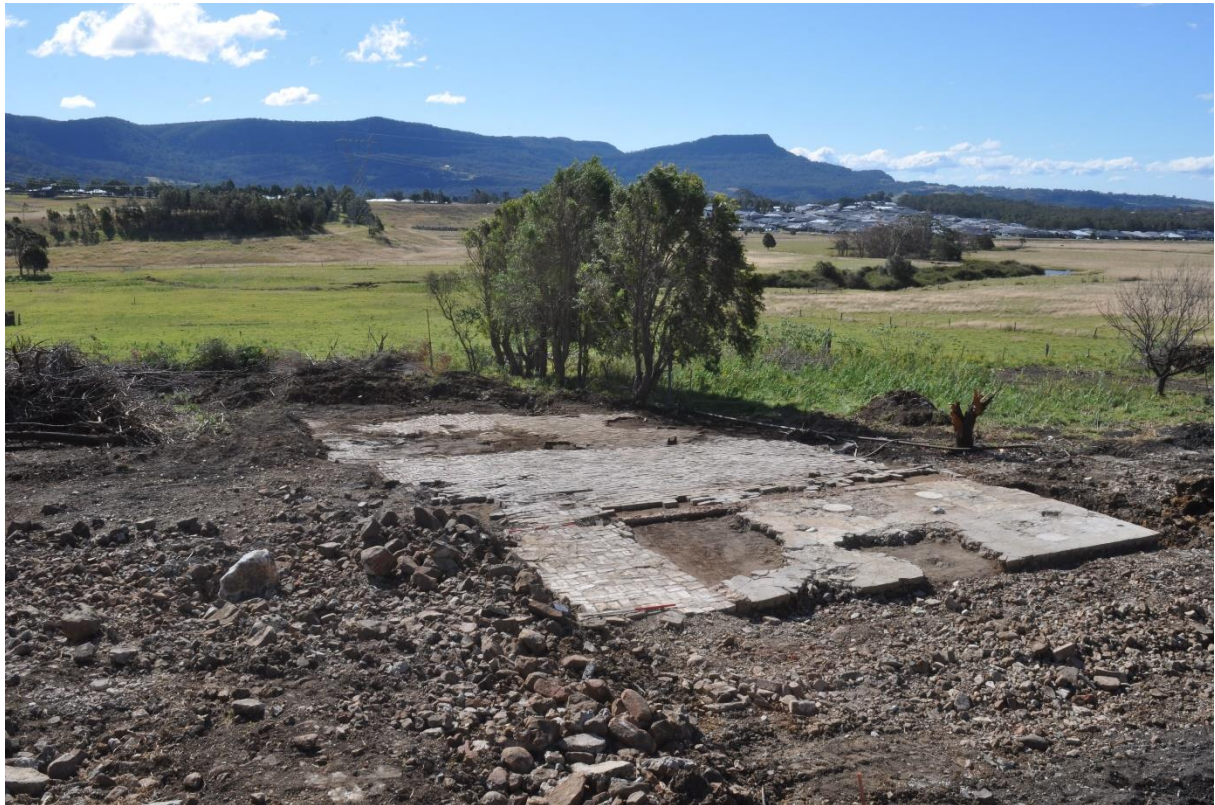
Figure 3.6 Showing the remains of the dairy, with three different surfaces relating to different functional areas (concrete, leading to two separate dry pressed brick pavements). The north facing pasture in the background. (AR #14, facing NW).

The remains of the dairy included three zones (Figure 3.6), which led to an ancillary building abutting the entrance driveway. The dairy's first zone, located upslope and constructed on a flat surface was a concrete surface with concrete footings. The abutted two separate dry pressed brick pavements, which were lined by timber posts. On the basis of the materials present (the bricks and concrete), it is likely that the dairy was

built in the early twentieth century during the Sunnyside Phase 1. The dairy remains provide evidence for the daily movement of cows for milking, the process of milking, and subsequent 'cream-on' separation of butter milk from the whey. The two brick walls found to the south of the dairy surfaces may represent an ancillary building for the storage of milk prior to collection.

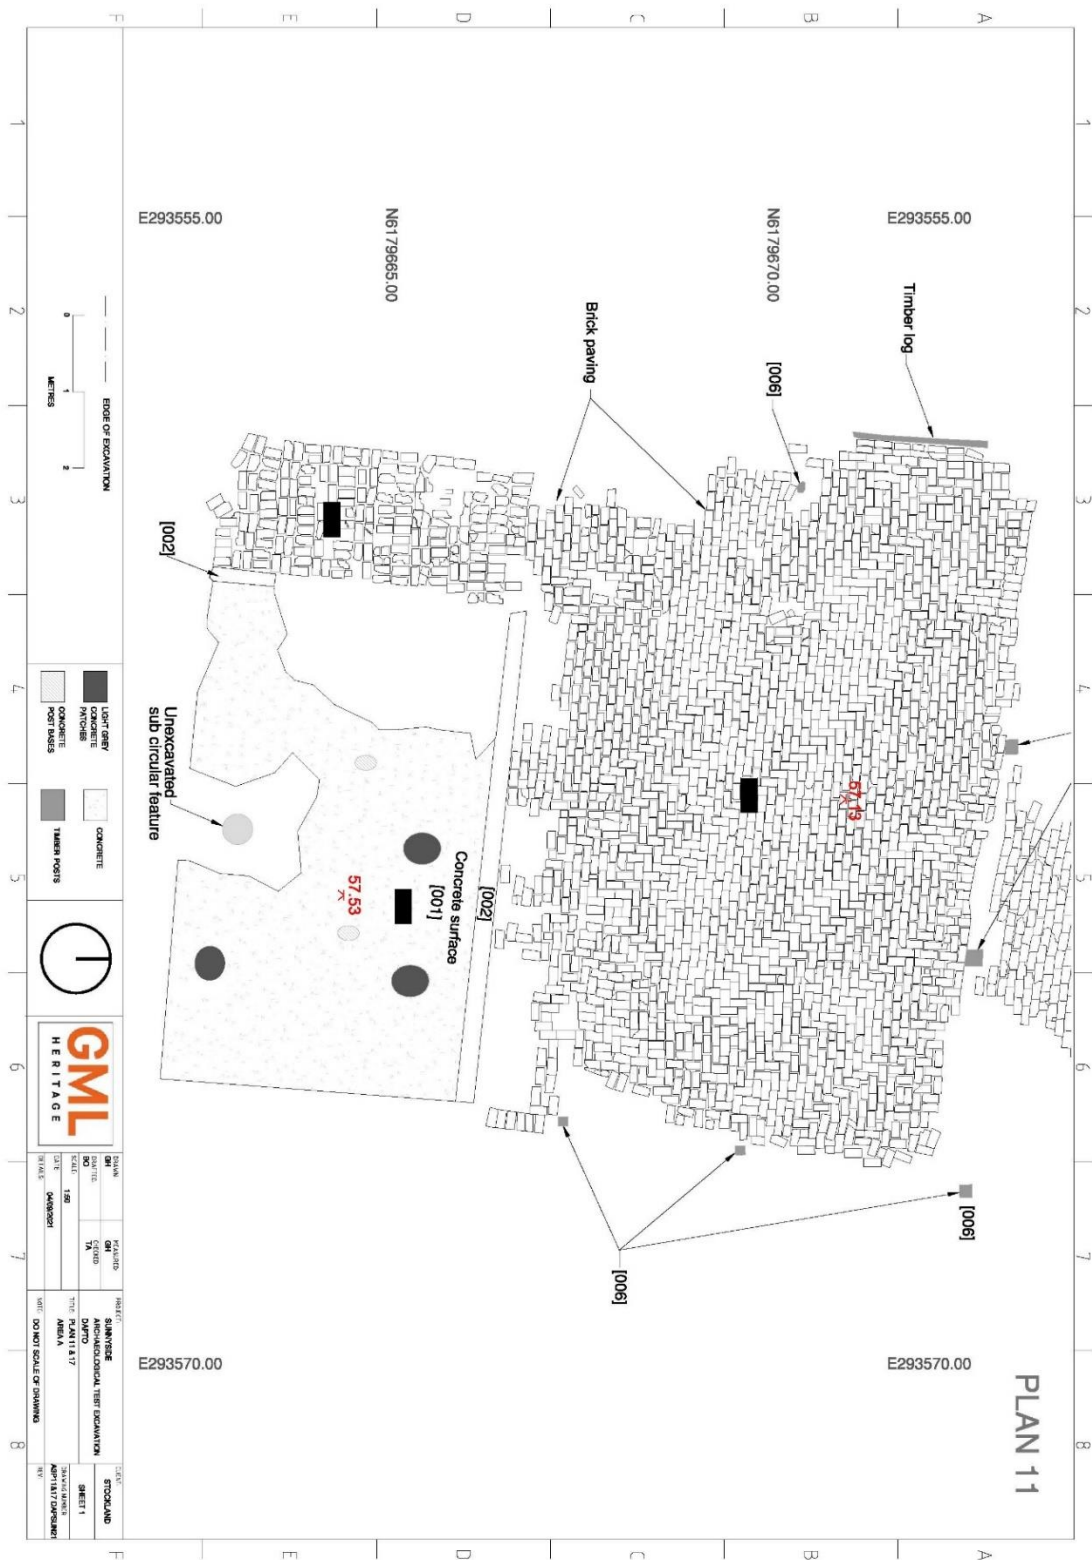
Figure 3.7 Showing the southern portion of the dairy paving and concrete surface.

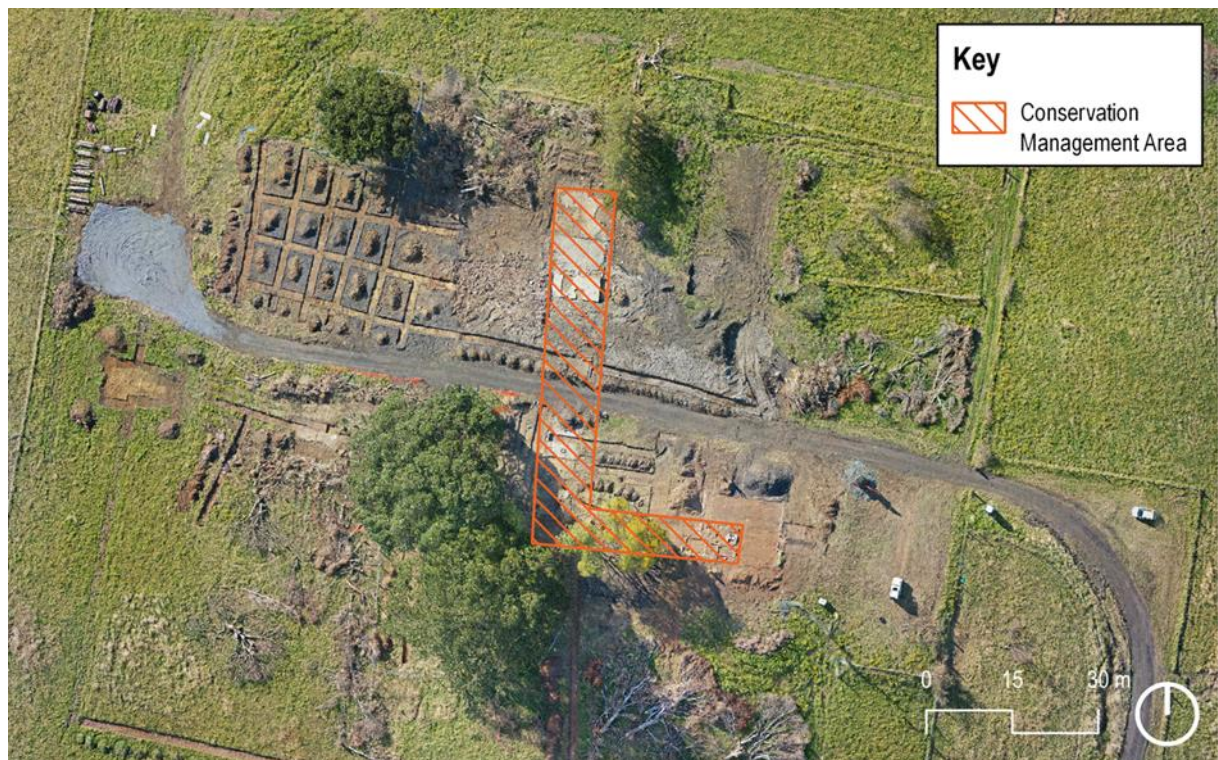
Figure 3.8 The redefined Conservation Management Area, which includes all Phase 1 archaeological fabric. (GML Heritage 2021, aerial image by Guy Hazell)

Based on the archaeological findings, GML recommended an updated Conservation Management Area (CMA) that includes the archaeological remains of the first Sunnyside house, the pail closet base, and the dairy and ancillary building. The extent of this zone is shown in Figure 1.2 (and repeated as Figure 3.8 for convenience). These features tell the story of the living conditions in this rural setting during its first historical phase connected with the regional dairying industry.
