Brou Landfill Post Bushfire Expansion

Geotechnical Investigation Report

Public Works | Department of Regional NSW

Reference: 754-CBRGE301356-R01

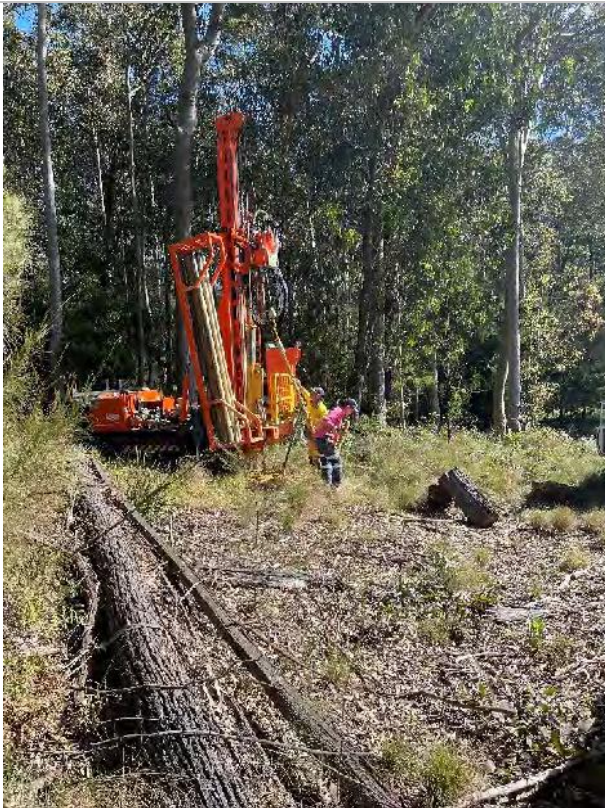
Photo 3: Hanjin D&B 8D drilling rig setup in the Phase 1 development area at BH11.

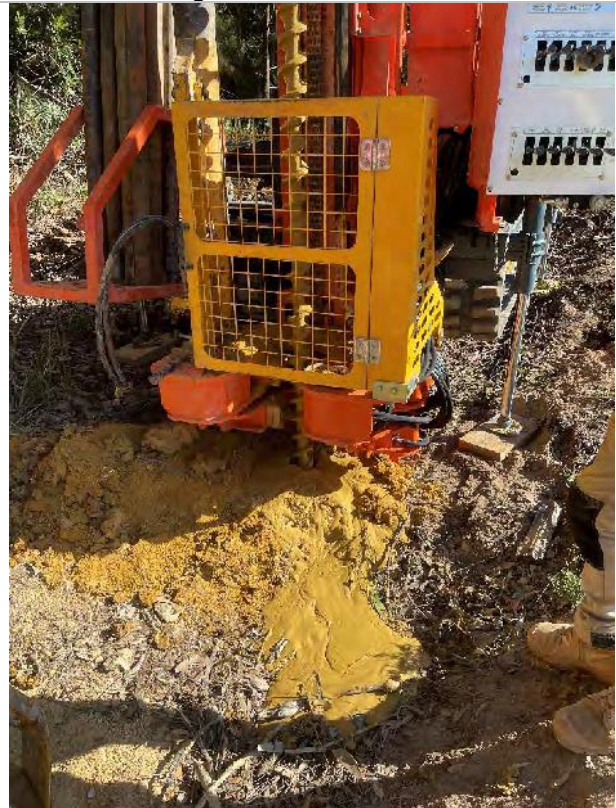
Photo 4: Groundwater encountered in the Phase 1 development area at BH12.

¹ Boreholes BH08-BH12 were terminated upon encountering groundwater to reduce the potential for cross-contamination of groundwater. It is noted that boreholes BH08-BH12 were positioned downgradient from the existing landfill cell. This precautionary approach was agreed with ESC and NSW Public Works during fieldworks.

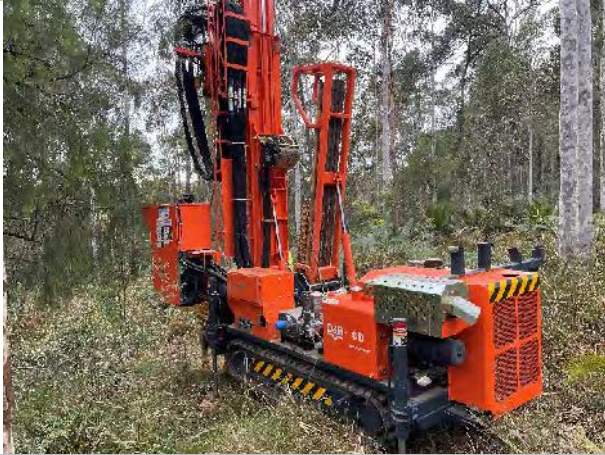
Photo 5: Hanjin D&B 8D drilling rig used for borehole drilling in the Phase 1 development area.

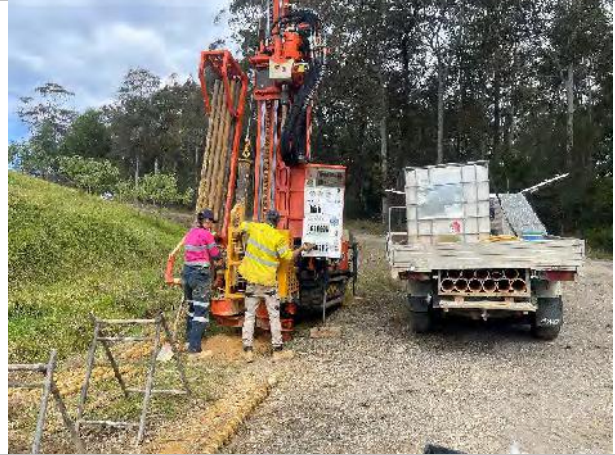
Photo 6: Drilling rig setup at BH10.

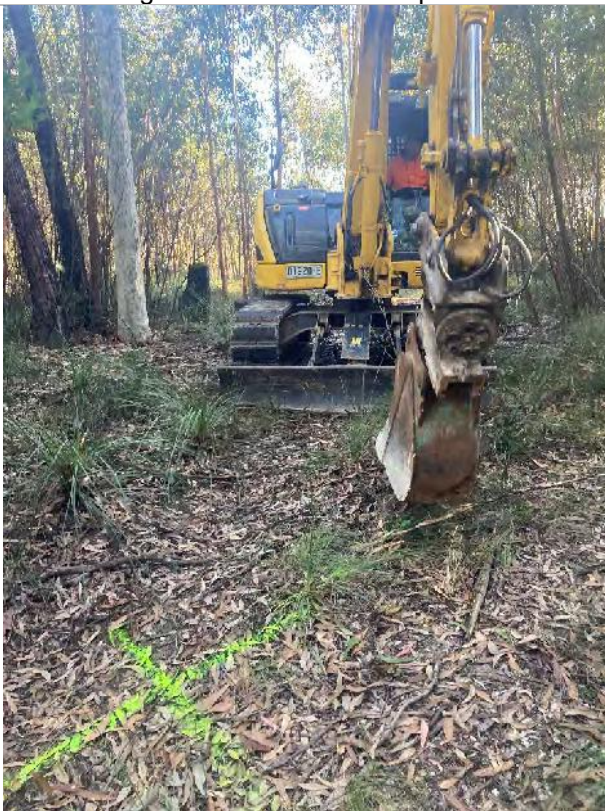
Photo 7: Sumitomo 8-tonne excavator used for test pit excavation in the Phase 2 development area.

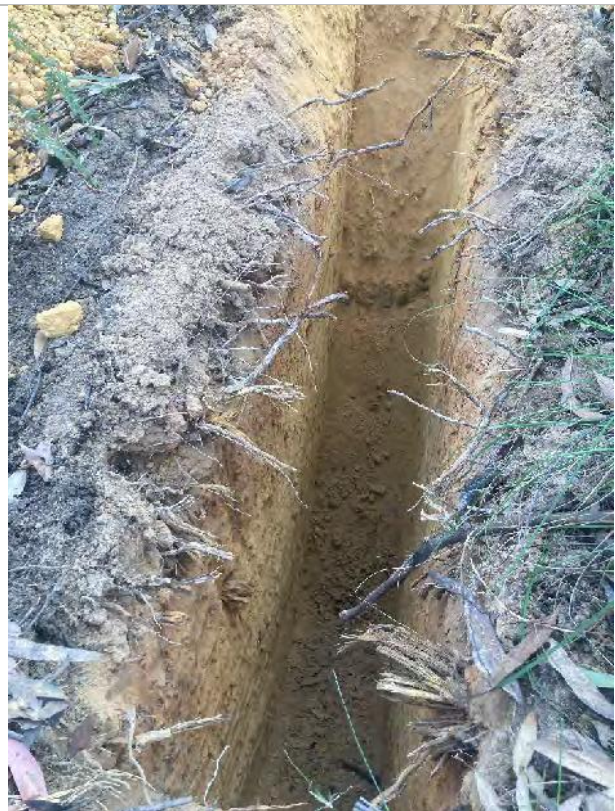
Photo 8: Test pit TP02 following excavation.

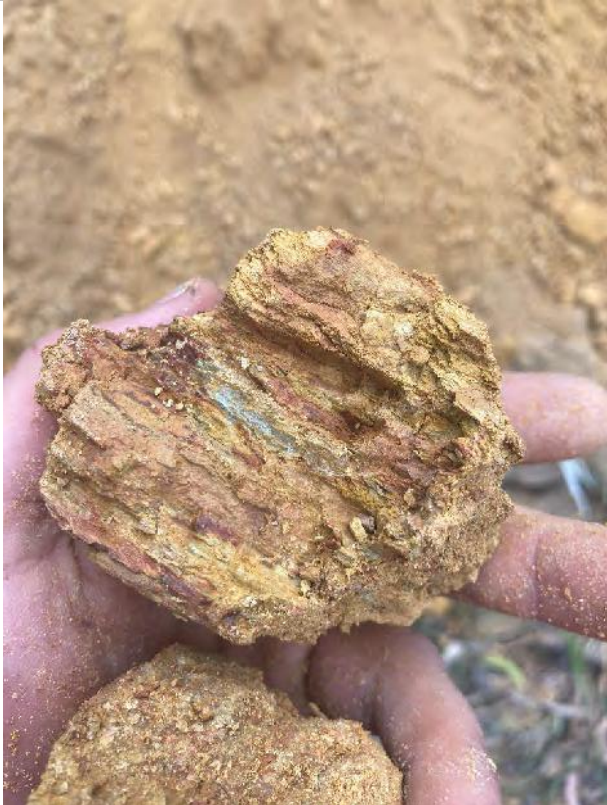
Photo 9: Extremely weathered siltstone recovered from test pit TP02.

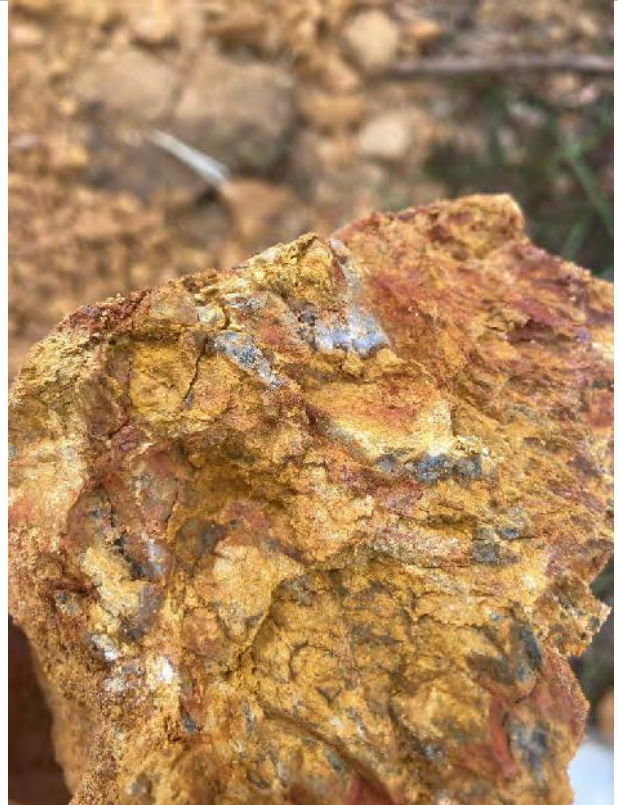
Photo 10: Extremely weathered sandstone recovered from test pit TP06.
