## **REDBANK COMMUNITIES**

### **REDBANK EXPANSION AREA (KEMSLEY PARK) GROSE VALE ROAD, NORTH RICHMOND PRELIMINARY GEOTECHNICAL ASSESSMENT**

**REPORT 12261/44-AA-R1  
16 JULY 2024**

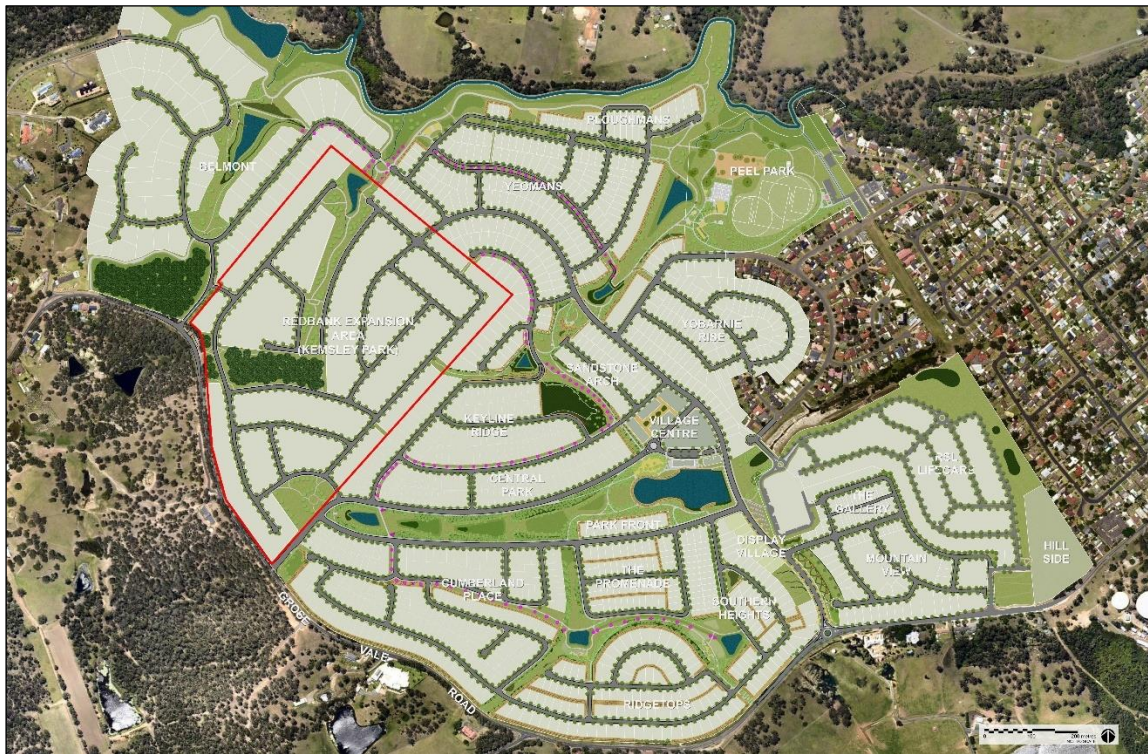
Figure 1: Redbank Expansion Area (Kemsley Park) within Greater Redbank Development

We understand that the site forms part of the overall Redbank master plan. Figure 1 shows the locality of the proposed site within the greater Redbank Development area. The site requires rezoning, and as a precursor a Gateway Planning Proposal is required to be prepared and lodged by Redbank to Hawkesbury City Council. In this regard, a preliminary geotechnical assessment is required for rezoning purposes of the site.

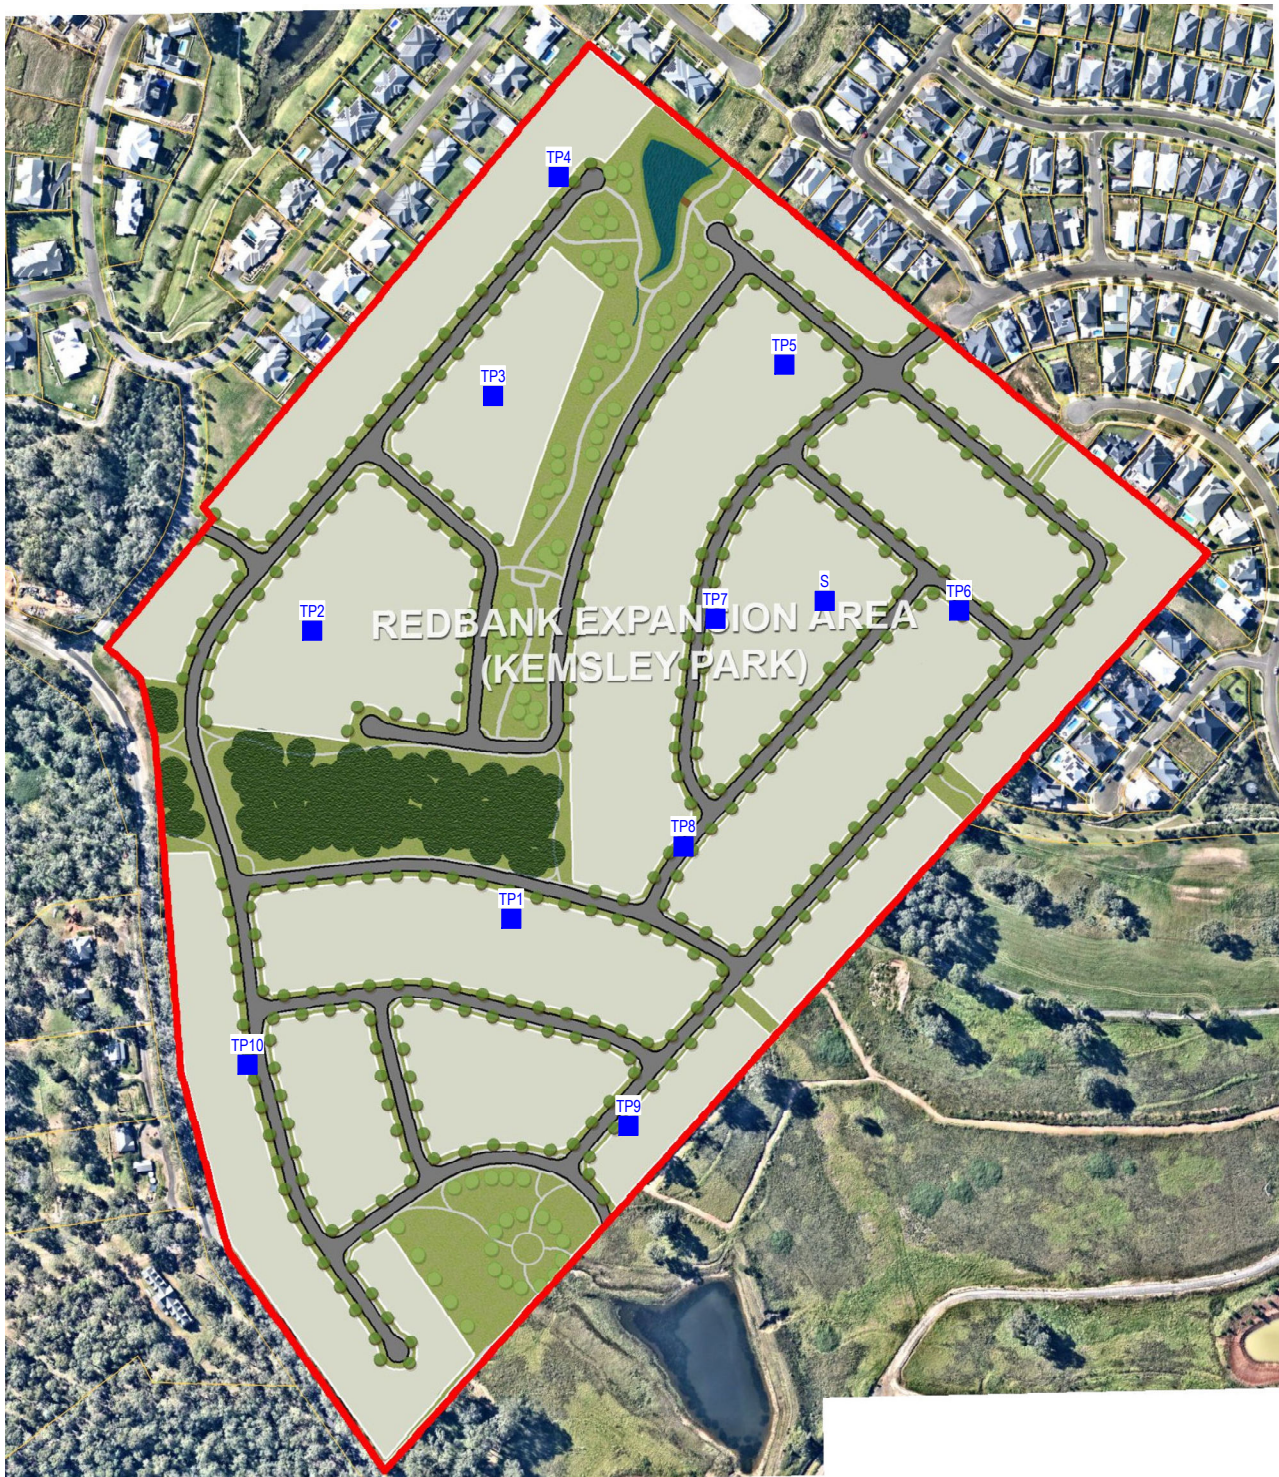
**DRAWING NO 12261/44-AA1**  
**(Test Pit Location Plan)**

■ Test Pit

Appendix A	Drawing No 12261/44-AA1 (Test Pit Location Plan)
Appendix B	Engineering Excavation Logs, Legends & Explanatory Notes
