PRELIMINARY SITE INVESTIGATION

PROPOSED SUBDIVISION

**Lot 8 DP 755685, Lot 1 DP 364474, Lot 1 DP 410859,
Lot 1 DP 376131, Lot 1 DP 328107 & Lot A DP 174886
133-193 Dulguigan Road
Dulguigan NSW**

HMC2023.616.02

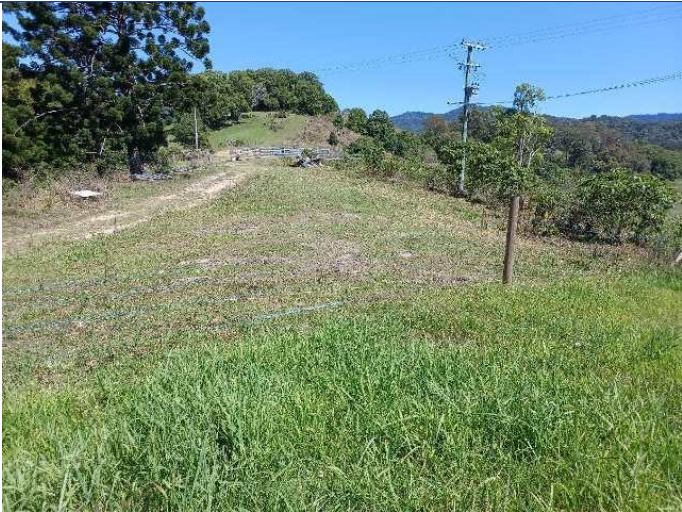
| Photo No. 1 | Date 6.12.2023 | Description: View NW from Proposed lot dwelling site across historic structure location towards Proposed Lot 6 dwelling site near cattle yards | |

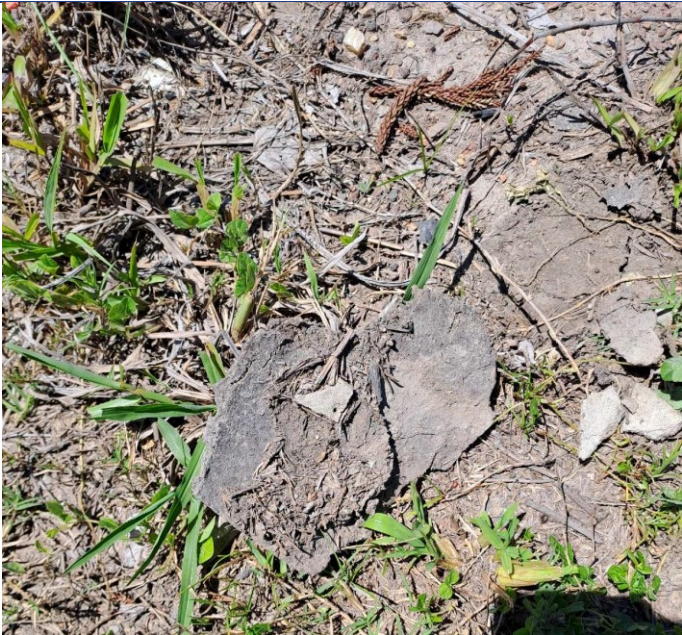
| <div>Photo No. 5</div> <div>Description: DR15A ACM (Near DRL15A)</div> | <div>Date 6.12.2023</div> <div></div> |

| Primary Sample | Location | Depth (mm) | ID | Soil Description | Laboratory Program |
|---|--|---|---|--|---|
| DRL15A-ACM | ACM found at sampling location L2DR5A | | | | |

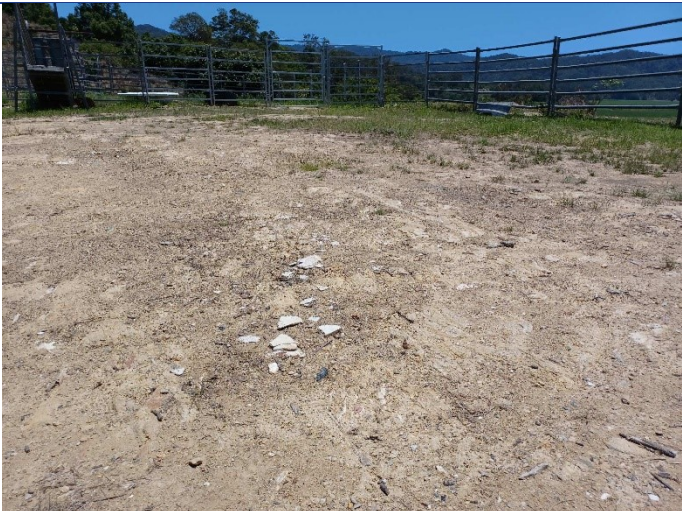
| <div>Photo No. 6</div> <div>Description: DRL2 ACM1</div> | <div>Date 06.12.2023</div> <div></div> |

| Primary Sample | Location | Depth (mm) | ID | Soil Description | Laboratory Program |
|---|--|---|---|--|---|
| DRL2-ACM1 – DRL2-ACM3 | ACM found on or near Potential Lot 2 dwelling site | | | | |
