Appendix 5: Preliminary Contamination Investigation, Envirowest 2024

Preliminary contamination investigation

34L Pinedale Road, Lot 103 DP 1143590, Dubbo NSW 2830

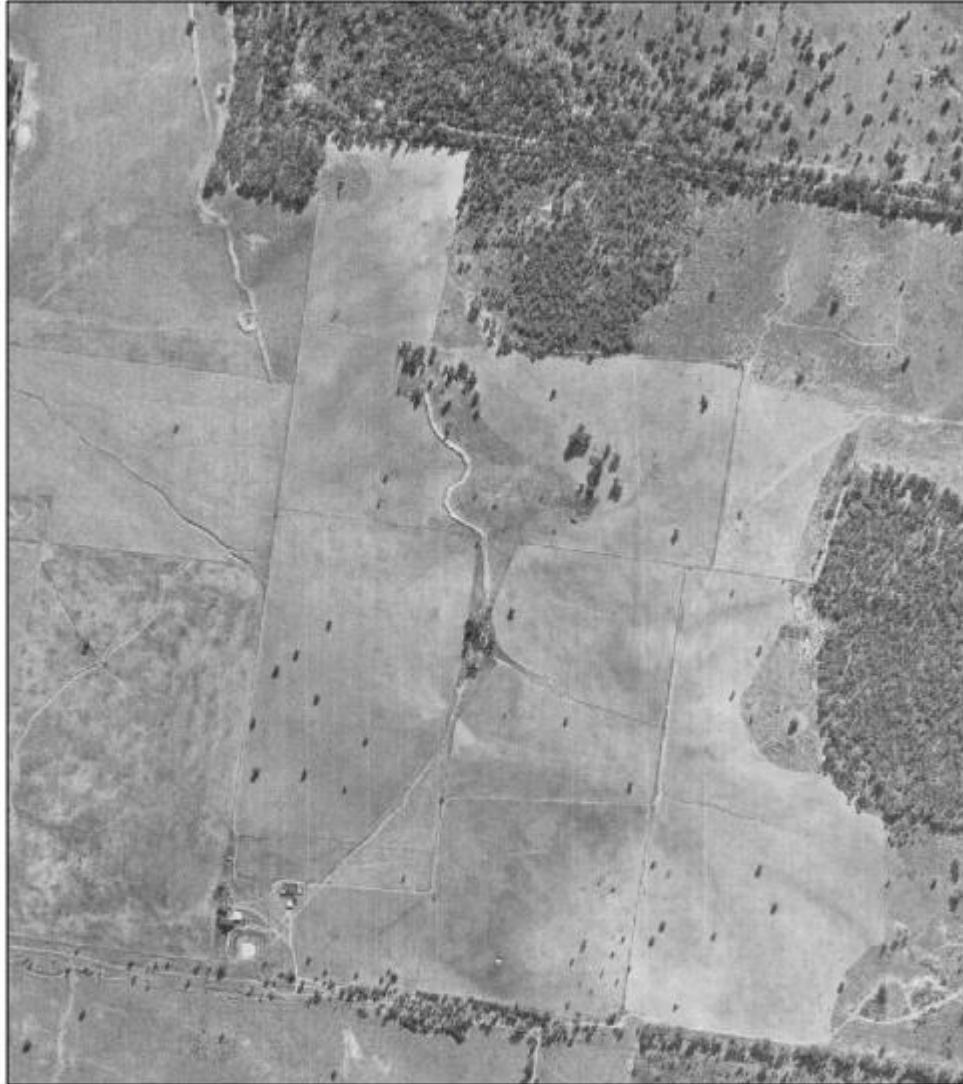
Appendix 1. Historic Aerial Photograph of the site in 1964

Year	Visual observations on site	Surrounding area
1964	The site is in a rural locality and primarily cleared agricultural land. A cluster of trees is seen near the north site boundary and further trees are scattered throughout the site. Land-use appears to be grazing. Access road via Pinedale Road veers southwest onto adjacent property. Vehicle track on site visible halfway into site (Appendix 1).	Land-use on all surrounding areas appears to be agricultural comprising grazing. Pinedale Road to the south is identifiable as a tree corridor. A dirt track and tree corridor are identifiable as part of the north site boundary. Beni State Conservation Area to the East of the site.
1971	Tree cluster near north site boundary appears to have been removed. Small dam constructed towards the Southeast corner of the site.	Tree and shrubbery cluster on properties to the north and east appear to have also been removed.

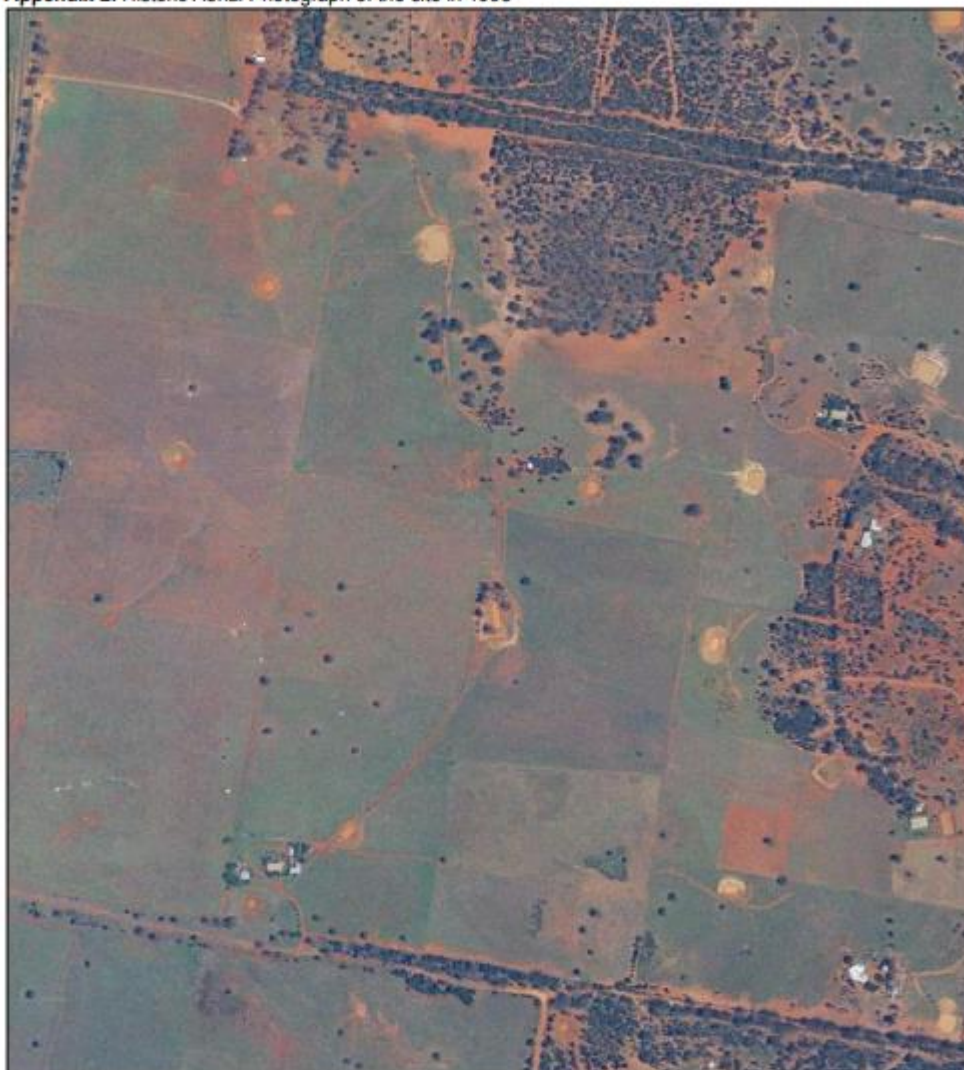
Appendix 2. Historic Aerial Photograph of the site in 1995

1980	Previously removed woodland tree cluster appears to have regrown minimally or been replanted.	Small number of rural-residential dwellings constructed on the surrounding properties to the east.
1995	Dam constructed in the Northwest corner of the site. Vehicle track within the site extended northwest towards the site boundary (Appendix 2).	Multiple additional rural-residential dwellings constructed on the surrounding properties.
2009	Existing vehicle tracks on site are more pronounced and additional supporting vehicle tracks have been developed throughout the site.	Subdivision of surrounding sites and further rural-residential dwellings appear in the immediate surrounds.
2023	New bitumen access road created from Pinedale Road to main site. Four dwellings constructed in the Northwest corner of the site (Figure 2).	Additional tree corridors, tree clusters and subdivision of plots emerge in the area. Rural-residential dwellings and infrastructure increase further in the surrounding area.
