REPORT TO
WINTEN PROPERTY GROUP

ON
GEOTECHNICAL DESKTOP ASSESSMENT

FOR
PROPOSED RESIDENTIAL DEVELOPMENT

AT
177-183 GREENWICH ROAD, GREENWICH, NSW

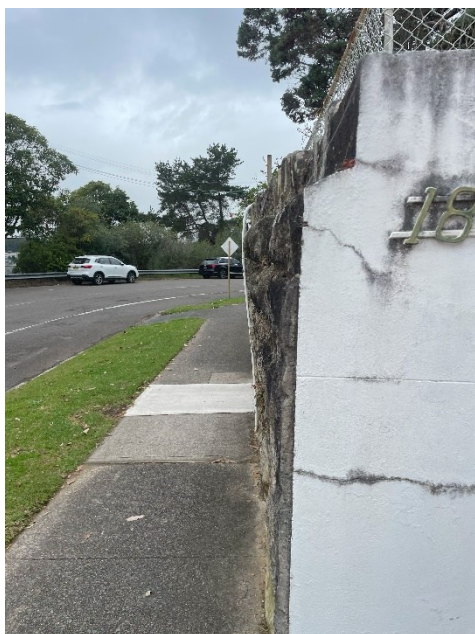
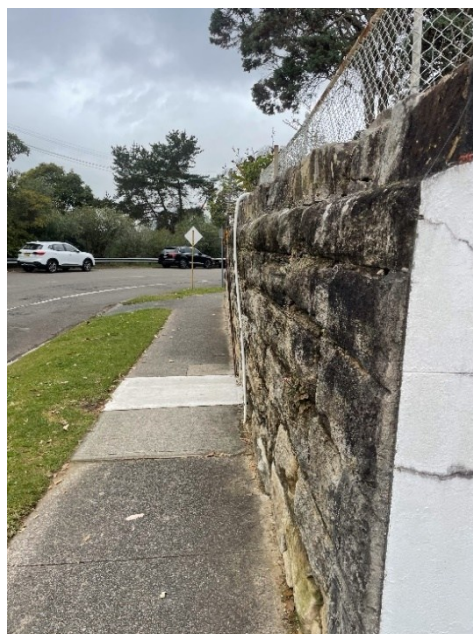
- **No. 183 Greenwich Road** – This is the most southern property within the site and it contains a two-storey brick rendered house with a sandstone block subfloor level, no visible signs of distress were observed based on our external inspection. This property has a sandstone block retaining wall along the eastern (or Greenwich Road) boundary that has an approximate retention height of 2m and is showing significant bulging within the upper section of the wall, see Plates 1 and 2 below. The front of the property gently slopes west at less than 1°, whereas the rear garden of the property slopes west at approximately 2° to 3°. The boundary between the rear garden and bushland to the west is separated by a set of concrete steps and a sandstone block retaining wall which has a retention height of approximately 1m. The steps appear to be in poor condition with significant cracking up to 30mm. No visible signs of distress were noted in the retaining wall. There is a sandstone outcrop at the base of the retaining wall and the exposed sandstone was assessed to be moderately weathered and low to medium strength.

Plates 1 and 2 - View looking south showing bulge within No. 183 Greenwich Road front boundary retaining wall.

3. There are a number of retaining walls within the site and along site boundaries that are in poor condition. To reduce the risk of retaining wall failure these walls will need to be replaced or stabilised as part of the early works.

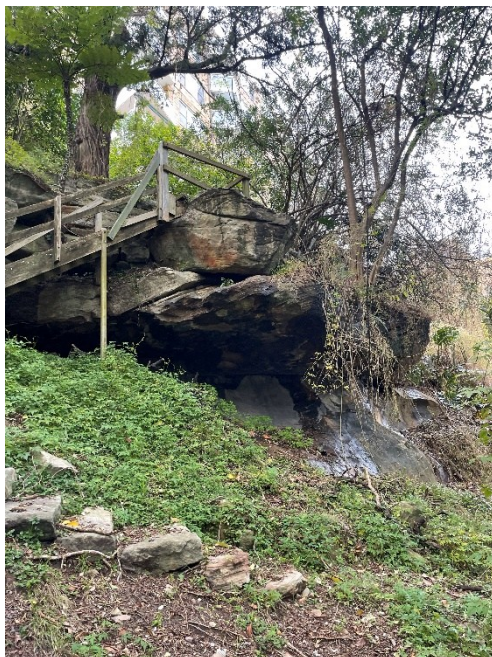
- **Cliff face overhangs/undercuts** – A low to medium strength sandstone cliff face was identified near the southern boundary of the site, immediately beyond the back garden of No 183. A photograph of the cliff face is shown in Plate 3, and its approximate location is indicated on Figure 2. The cliff face features an overhang that measures approximately 3.5 meters in height and 5 meters in width, the

bedding was observed to be oriented perpendicular to the face and dipping east at 10° to 20°. Additionally, a semi-mature tree was observed growing on the cliff face.

Plate 3 - Cliff face overhang/undercut – looking east

For rock excavation within the south western corner of the site where overhangs/undercuts are present, we do not recommend the use of percussive excavation equipment due to the risk of damage to the cliff that could affect the overhangs. Any rock excavation should be carried out using non-percussive excavation equipment, such as rock saws and grinders. In addition, excavation and other construction equipment should not traffic over the undercut portions of the cliff, with an exclusion zone enforced located at least 1m from the rear of any undercut sections.

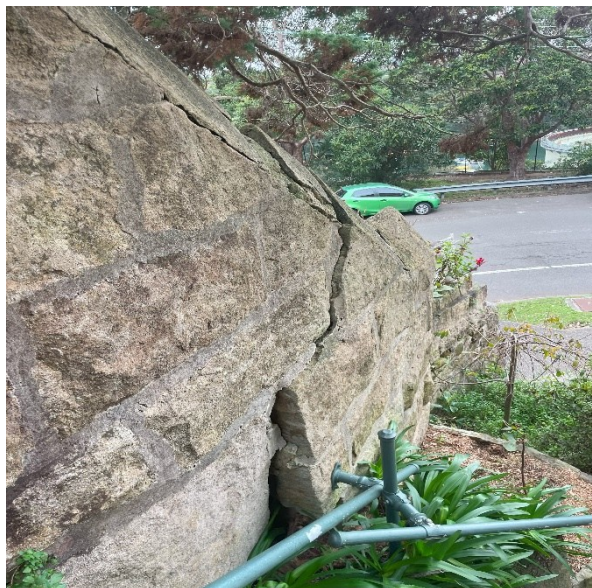
- No. 4 Landenburg Place, is to the south of the subject site, and it contains a five-storey brick apartment building. The apartment building is offset approximately 3m from the boundary with the subject site. The boundary is delineated by a sandstone block retaining wall that has a retention height of approximately 2.1m. The wall appears to be in poor condition as the lower section has moved eastward by approximately 60mm to 70mm as shown in Plate 4 below. The retaining wall was

observed, in parts, to be directly founded on sandstone bedrock, the bedrock was assessed to be moderately weathered and of low to medium strength.

Plate 4 - Photograph looking East of failed retaining wall between No. 183 Greenwich Road and No. 4 Landenburg Place.
