**47-63 GALLIPOLI STREET
TEMORA NSW 2666**

**PRELIMINARY
SITE INVESTIGATION**

**FOR THE PROPOSED
REZONING OF LAND**

REPORT NO: 9668

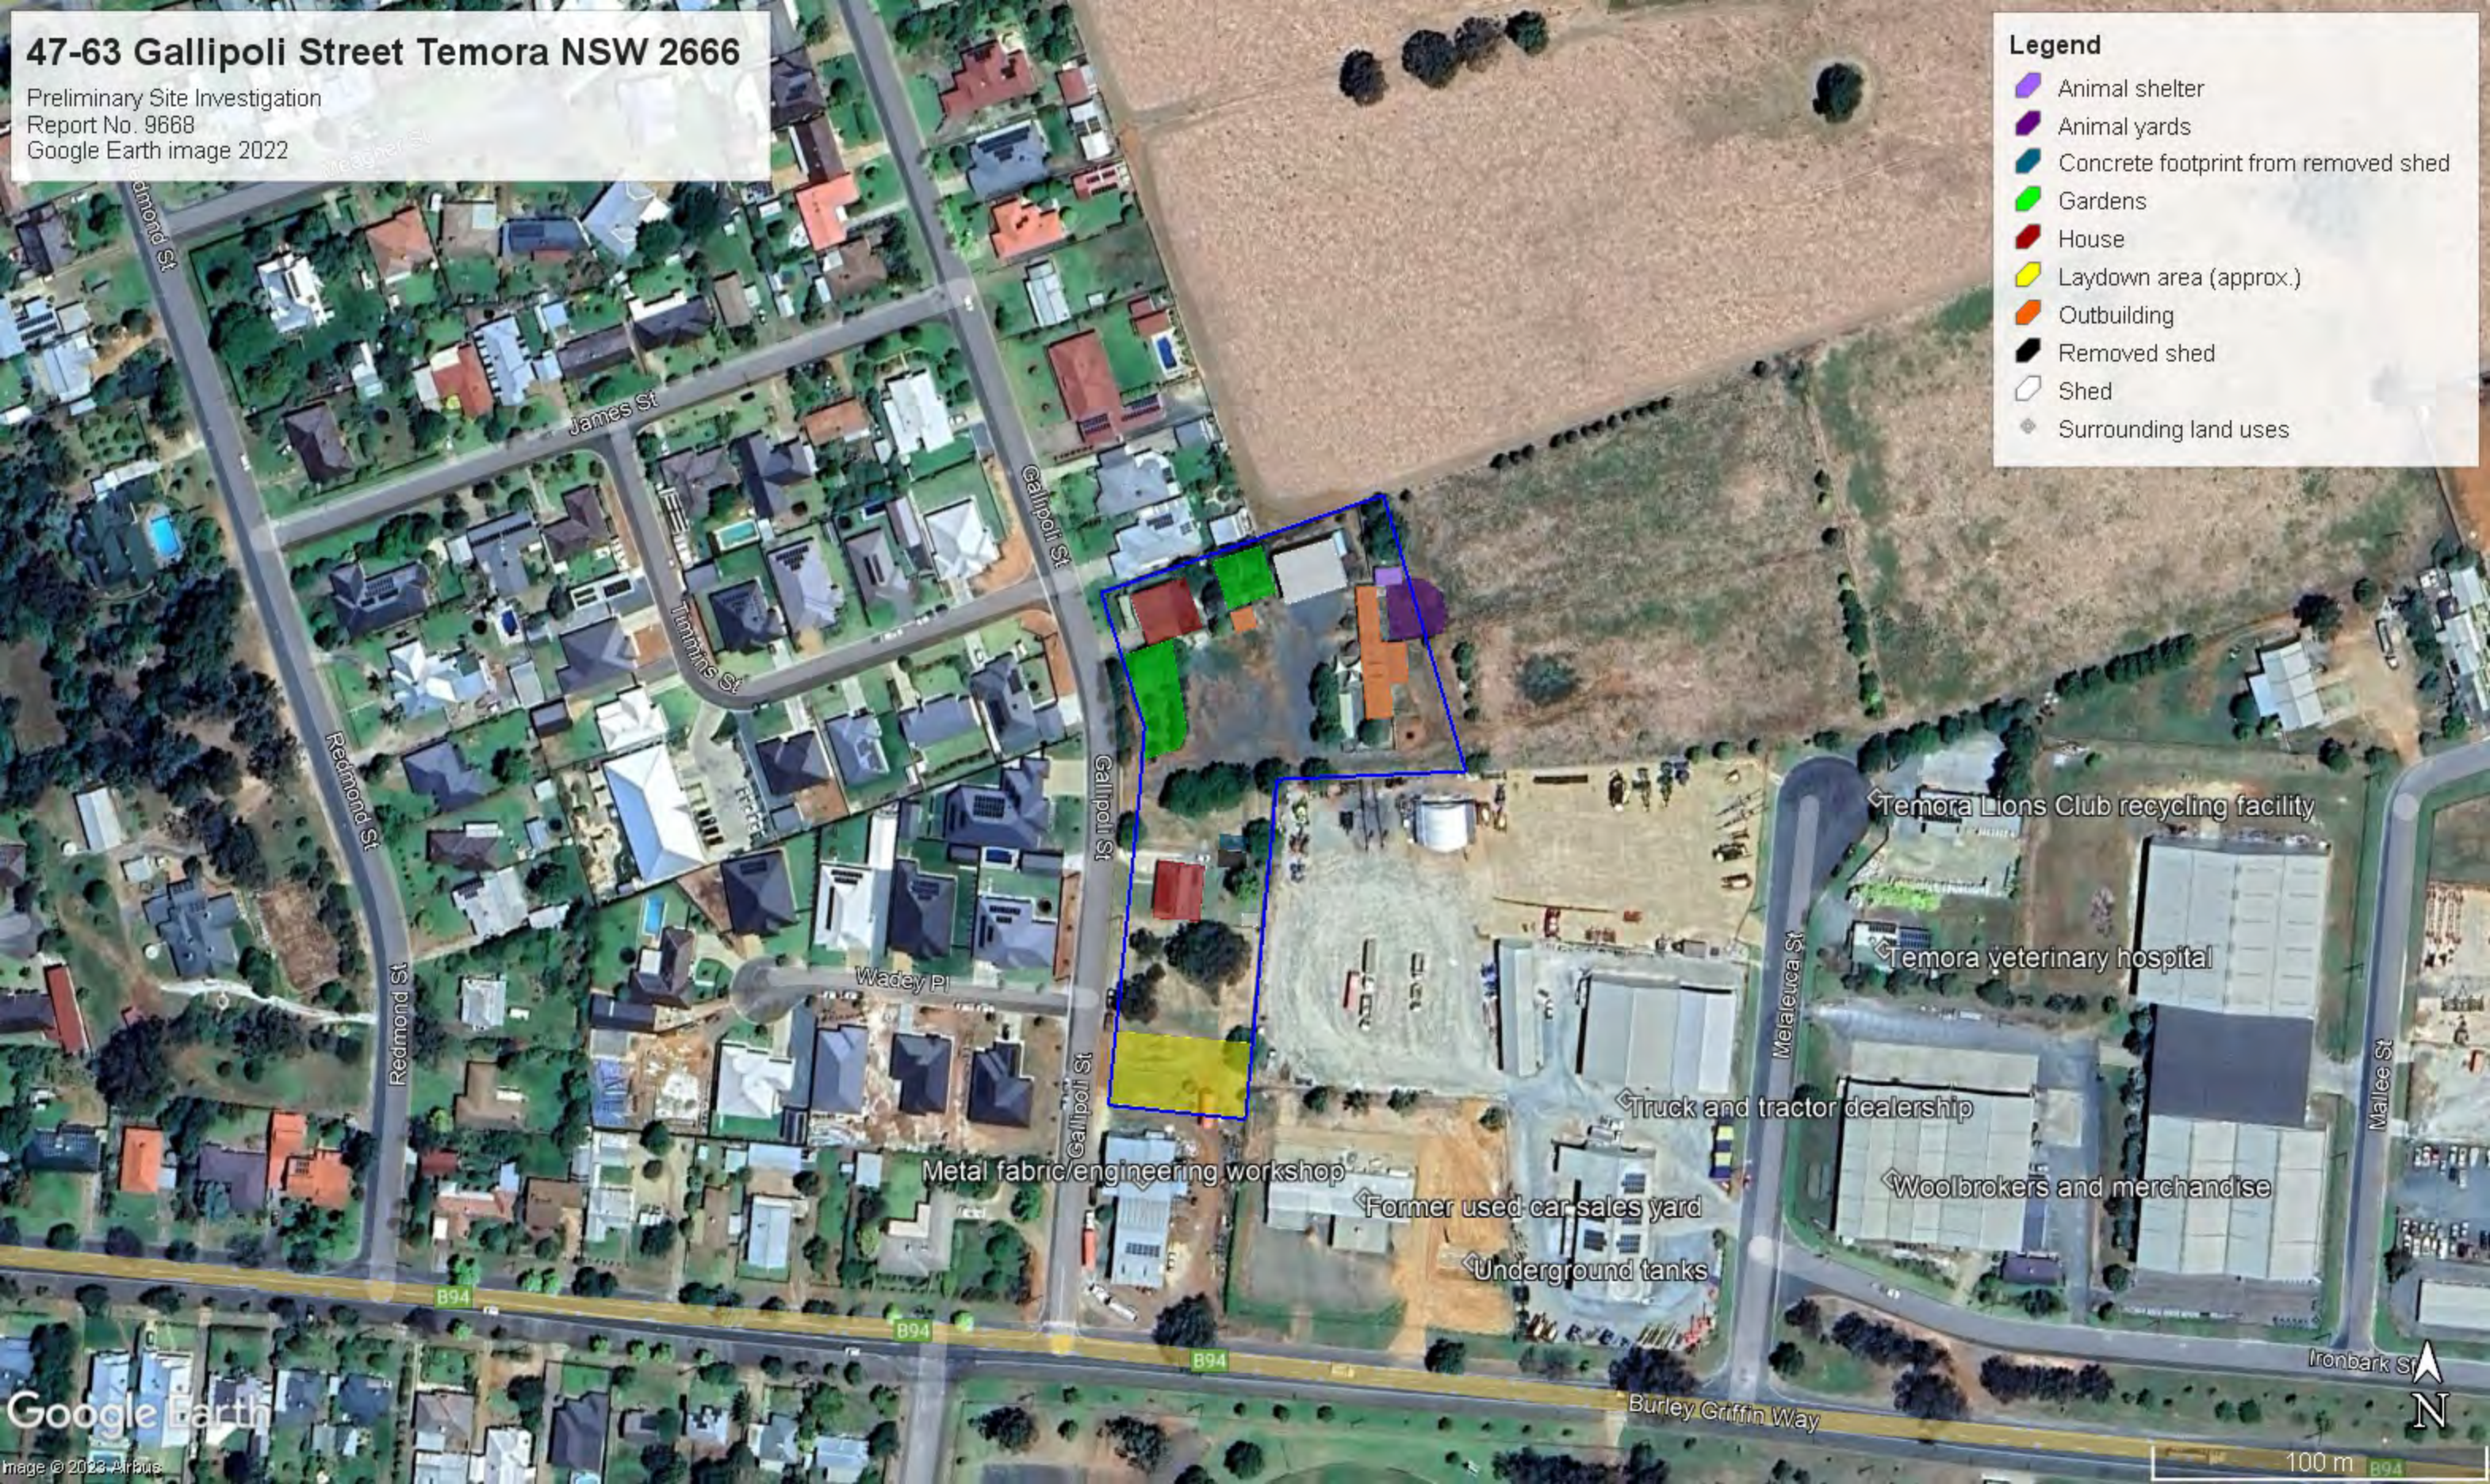
Attachment C : *Site features and surrounding land uses*

- Animal shelter
- Animal yards
- Concrete footprint from removed shed
- Gardens
- House
- Laydown area (approx.)
- Outbuilding
- Removed shed
- Shed
- Surrounding land uses

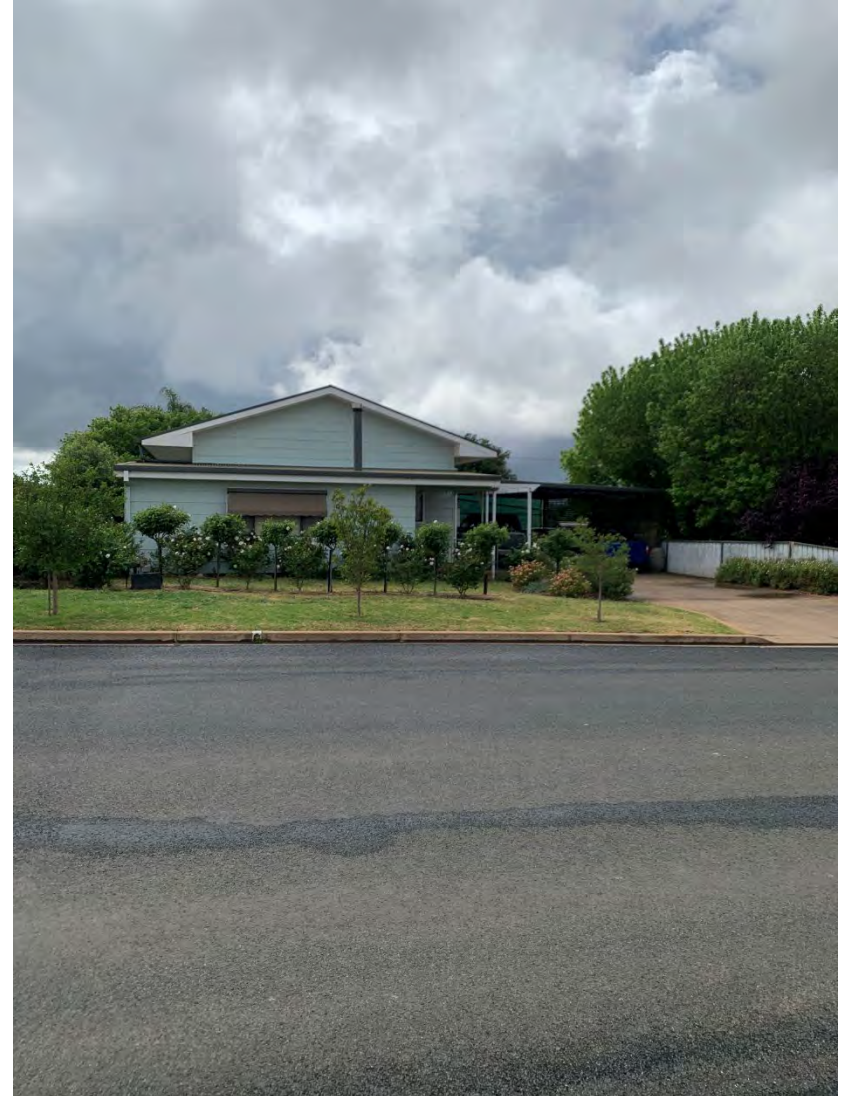
- A single storey weatherboard house with tin roof and attached carport built prior to 1961 exists in the north west corner of the lot. The house likely contains asbestos in the cladding and in the meter box although a thorough inspection for hazardous materials was outside the scope of work.

Photograph 6: Single storey weatherboard house at 47-53 Gallipoli Street, facing east.

- If the houses at 57 Gallipoli Street and 47-53 Gallipoli Street are proposed to be demolished or renovated, it is recommended that a licenced professional is engaged to undertake a hazardous building materials assessment and removal as necessary. This is normally a standard development consent condition.
- The septic system at 57 Gallipoli Street if present, will require decommissioning during development which is normally a standard development consent condition. Septic systems that are regulated by Council present low health and environmental risk when regularly inspected and serviced.

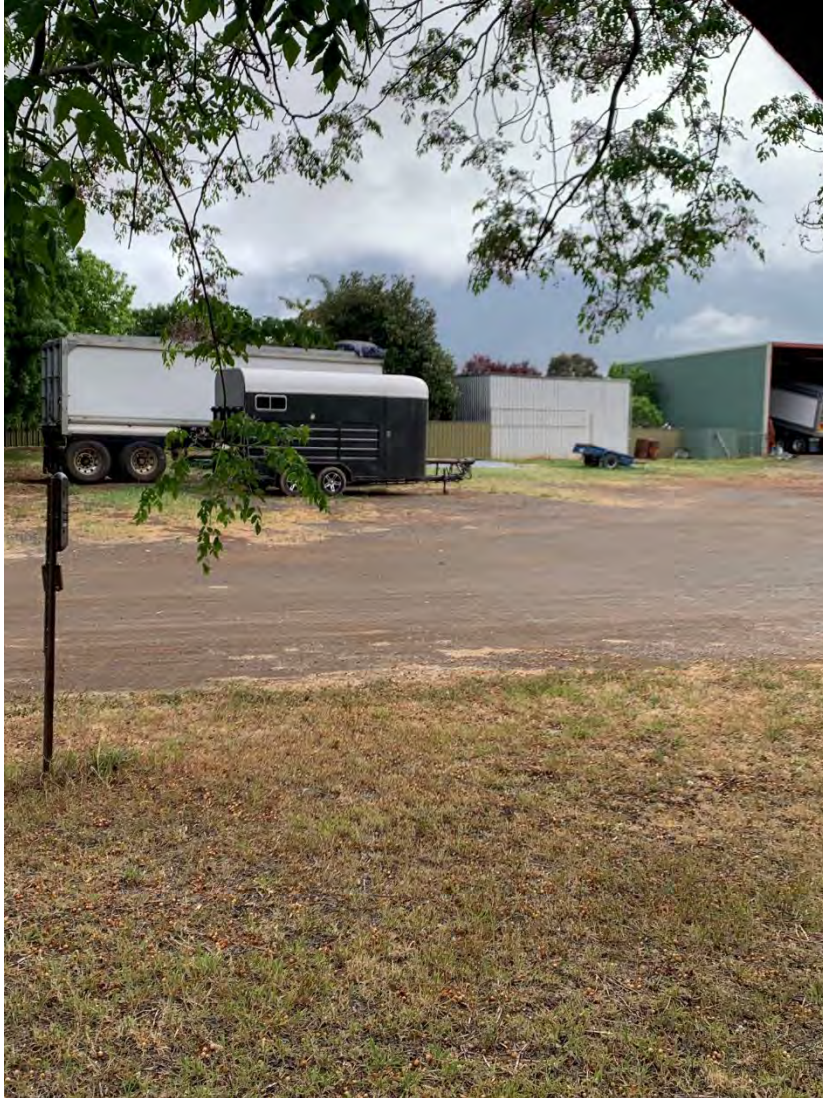
- A truck trailer, horse float and box trailer were parked to the south of the house.
- A large slab on grade steel shed to the east of the house contains another truck trailer, hay bales, steel drums, stacked tyres, pallets, and plastic intermediate bulk containers. Chemical storage is likely to be present. Fuel storage was not observed but access was compromised at the time of investigation.

Photograph 7: Truck trailer, horse float and box trailer parked to the south of the house at 47-53 Gallipoli Street, facing north.

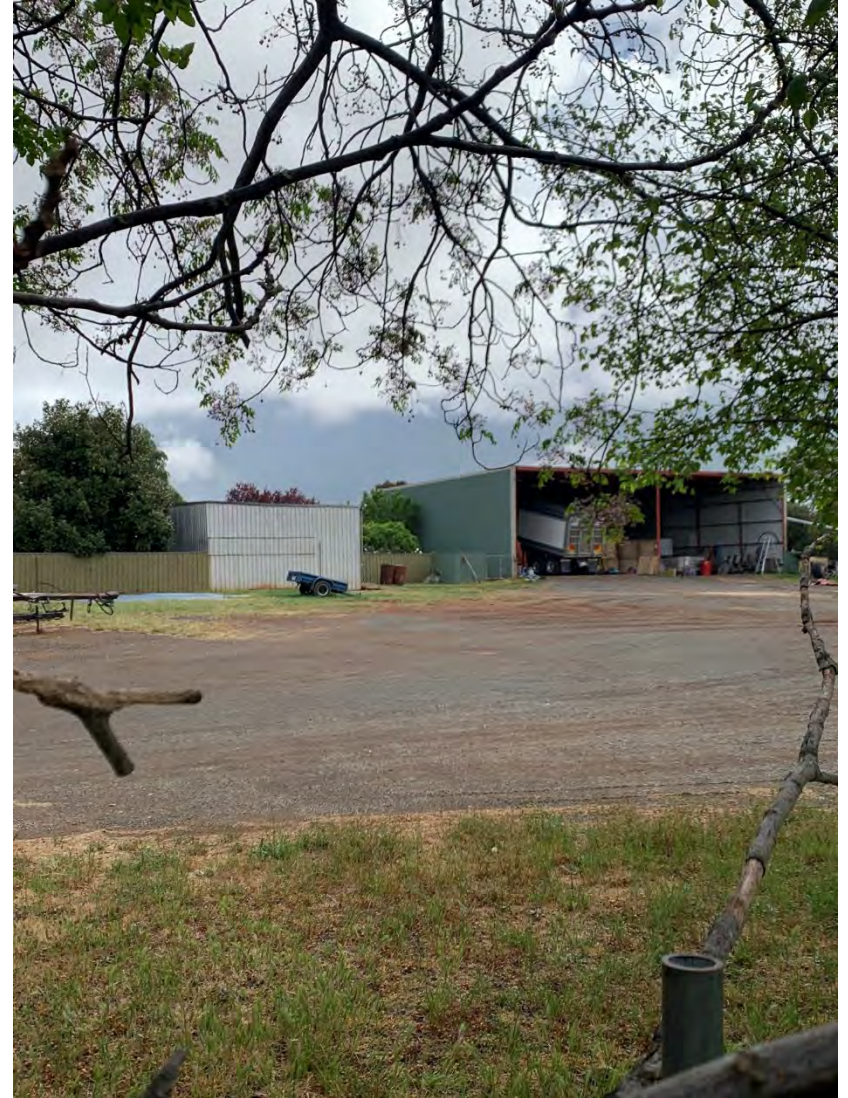
Photograph 8: Large slab on grade shed to the east of the house at 47-53 Gallipoli Street, facing north.

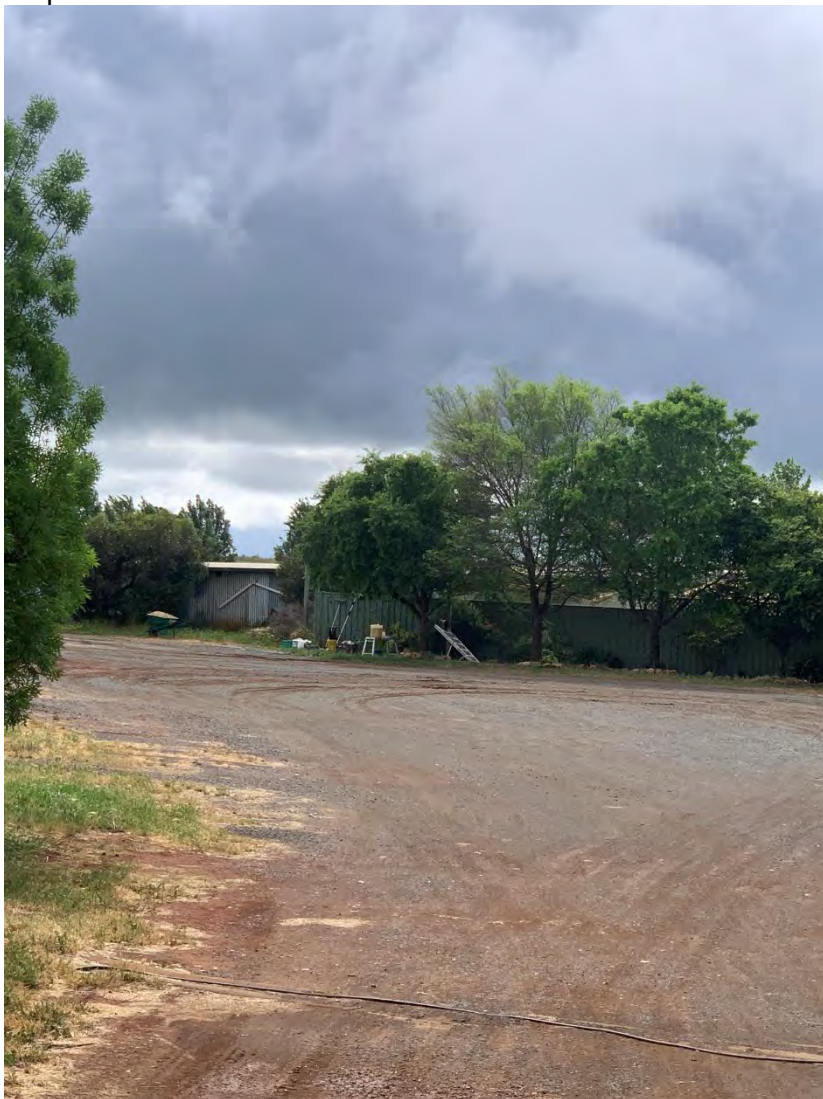
- Chemical storage in the shed is likely and household chemicals, cleaning supplies and weed management supplies were observed in front of the large outbuilding. However, these sources are assessed to be low risk as the chemicals are stored in or near the slab on grade shed and any potential spills or leaks are considered to be localised.

Photograph 9: Household chemicals, cleaning supplies and weed management supplies in front of the large building at 47-53 Gallipoli Street, facing north east.

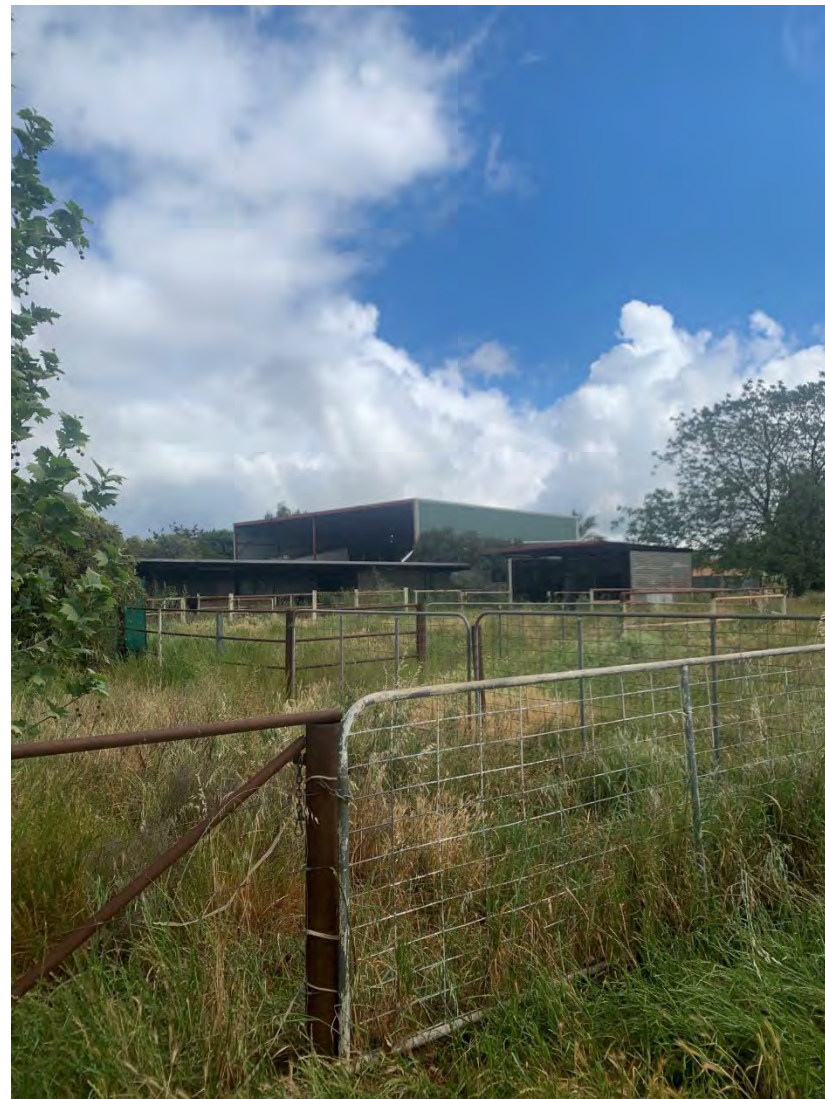
Photograph 10: Animal shelter and attached yard at 47-53 Gallipoli Street, facing north west.

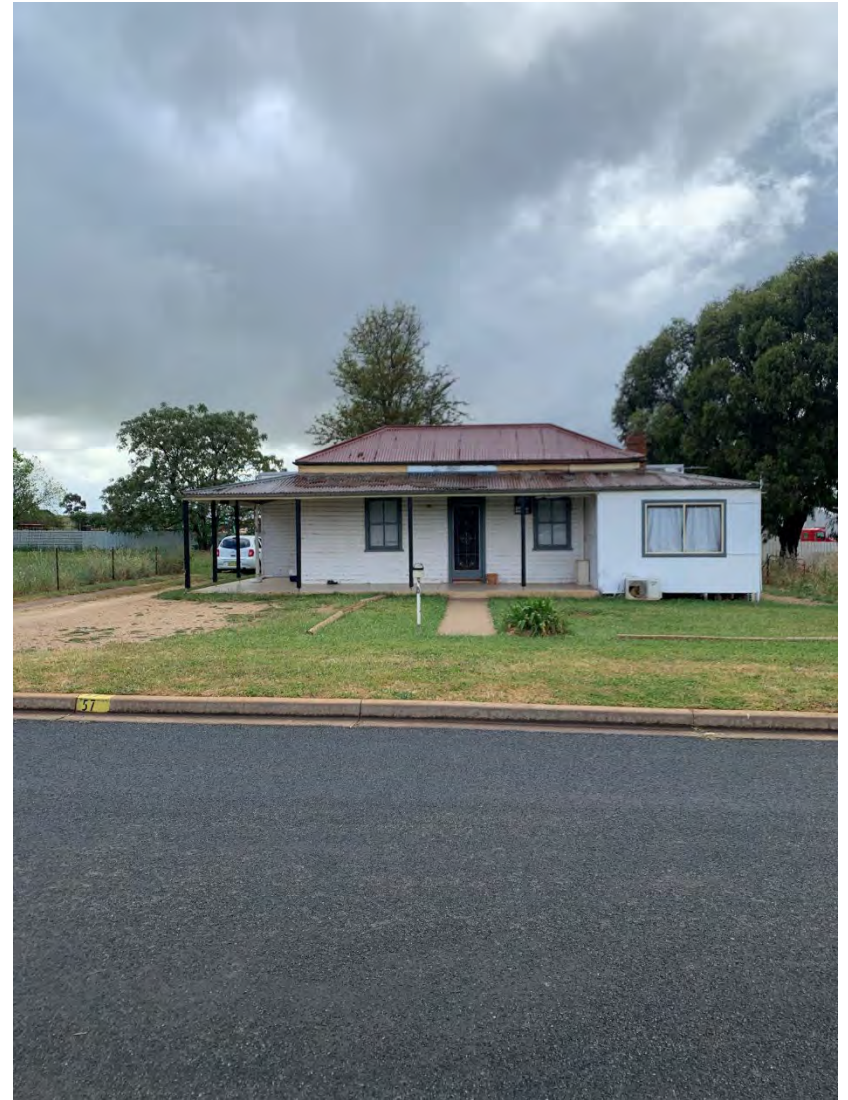
Photograph 12: Single storey weatherboard house at 57 Gallipoli Street, facing east.

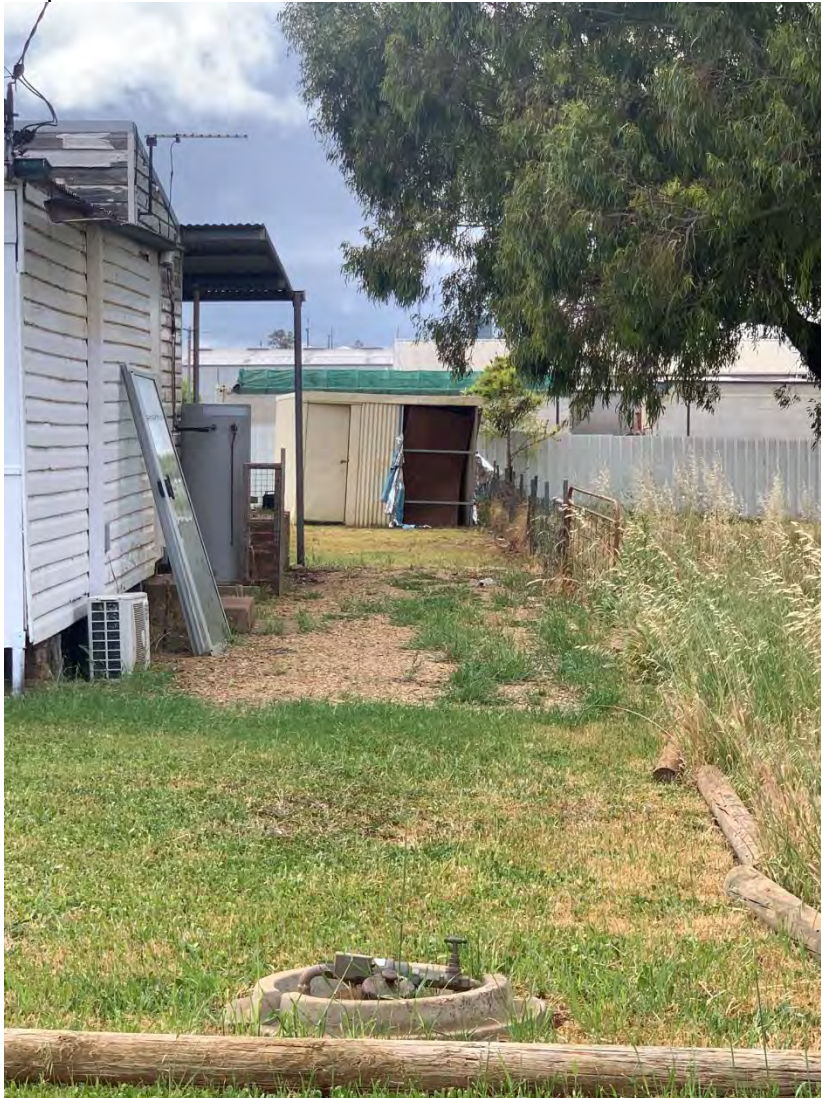
Photograph 13: Small shed in the north east corner of the rear yard at 57 Gallipoli Street, facing east.

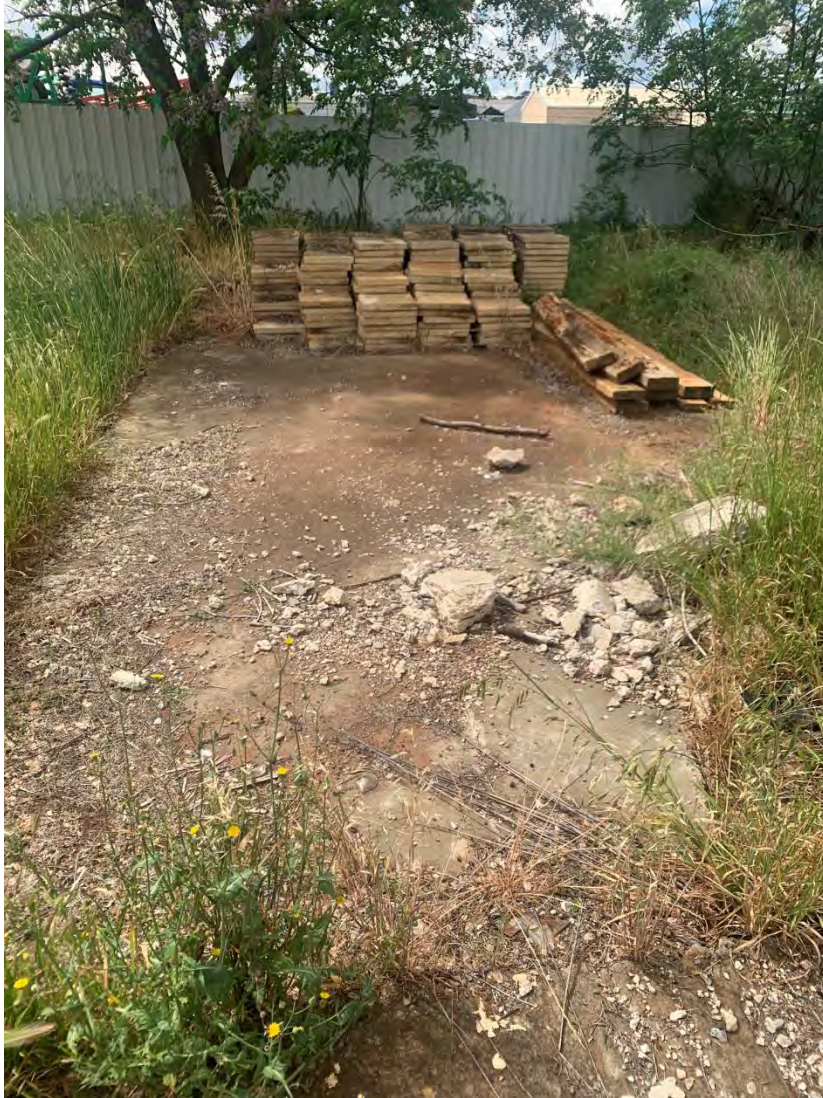
Photograph 15: Concrete pad in the north east corner of Lot 1 55 Gallipoli Street, facing east.

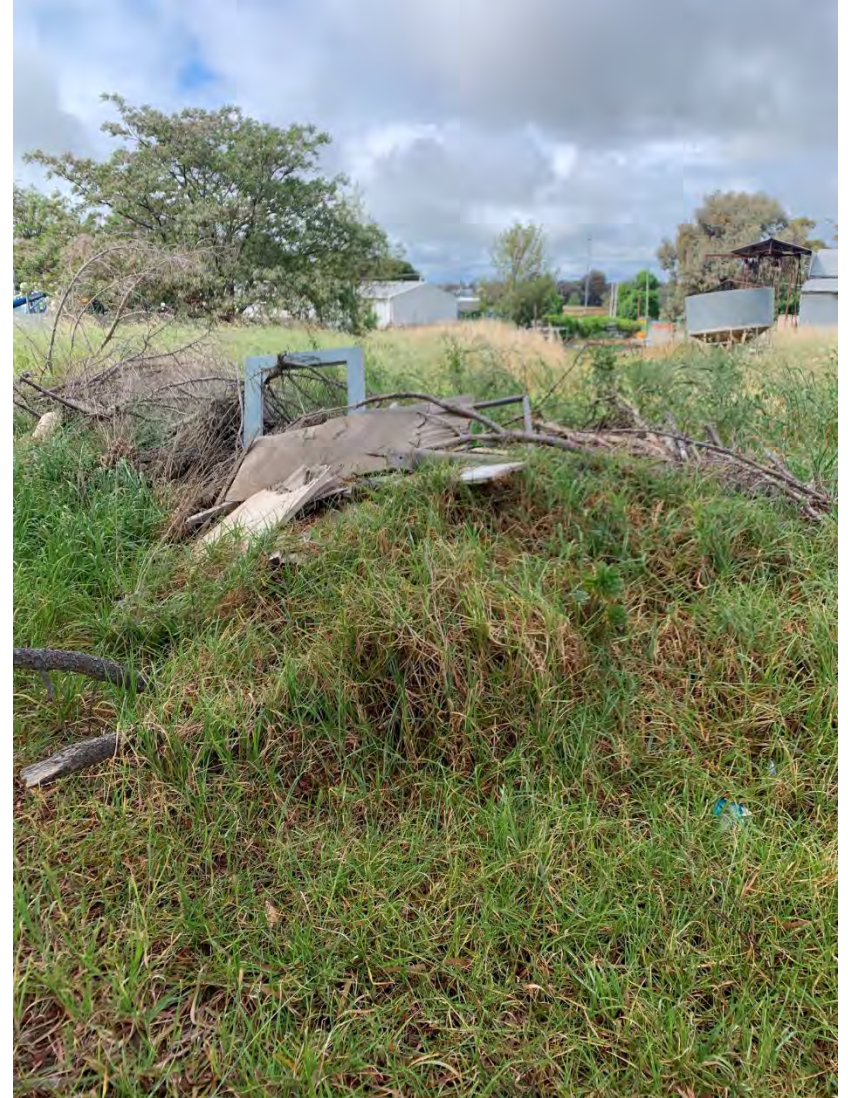
Photograph 16: Stockpile of branches and scrap wood on Lot 3 59-63 Gallipoli Street, facing south east.

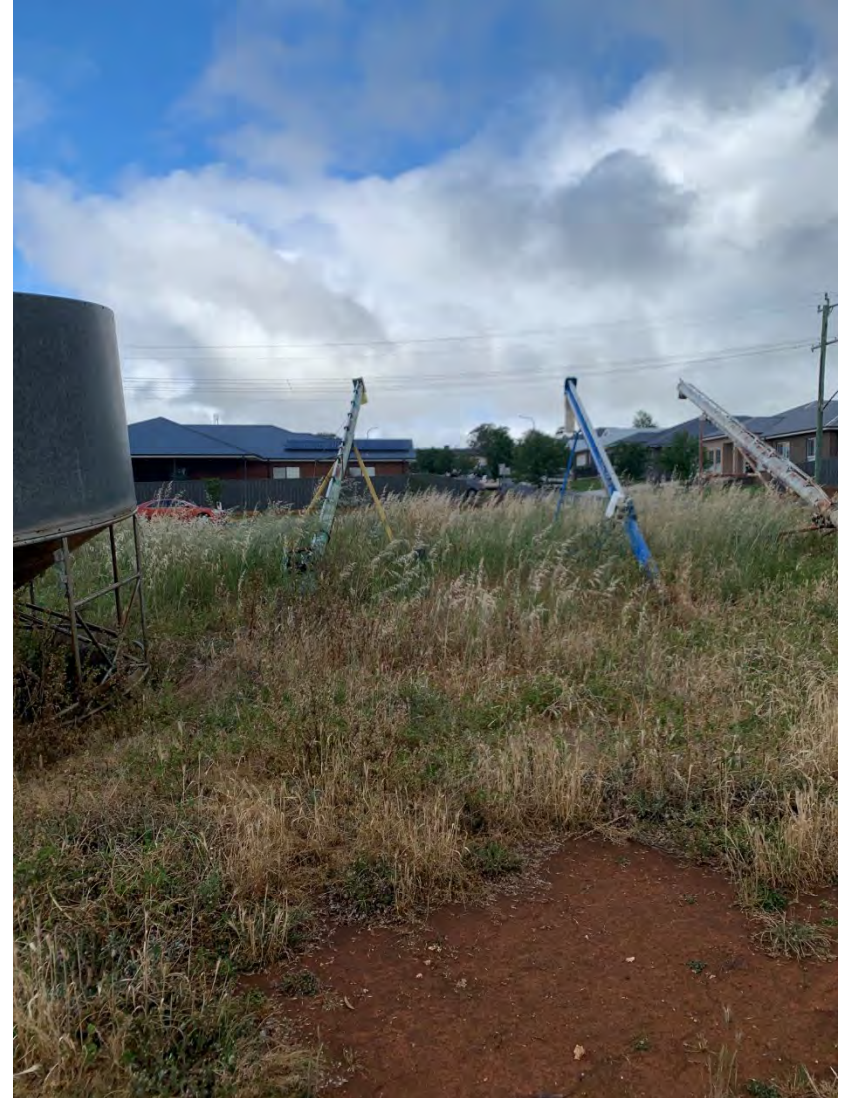
- Lot 5 is currently being used as a laydown area for grain augers, machinery parts, steel drums, a silo, and a small incinerator. This area is likely used by the adjacent metal fabrication/engineering workshop to the south. No fuel storage was observed. No spills or staining from fuel and oil were observed on the areas of bare ground however, thick grass hampered a thorough inspection of the majority of the site surface.

Photograph 18: Laydown area at Lot 5 59-63 Gallipoli Street,
facing west.

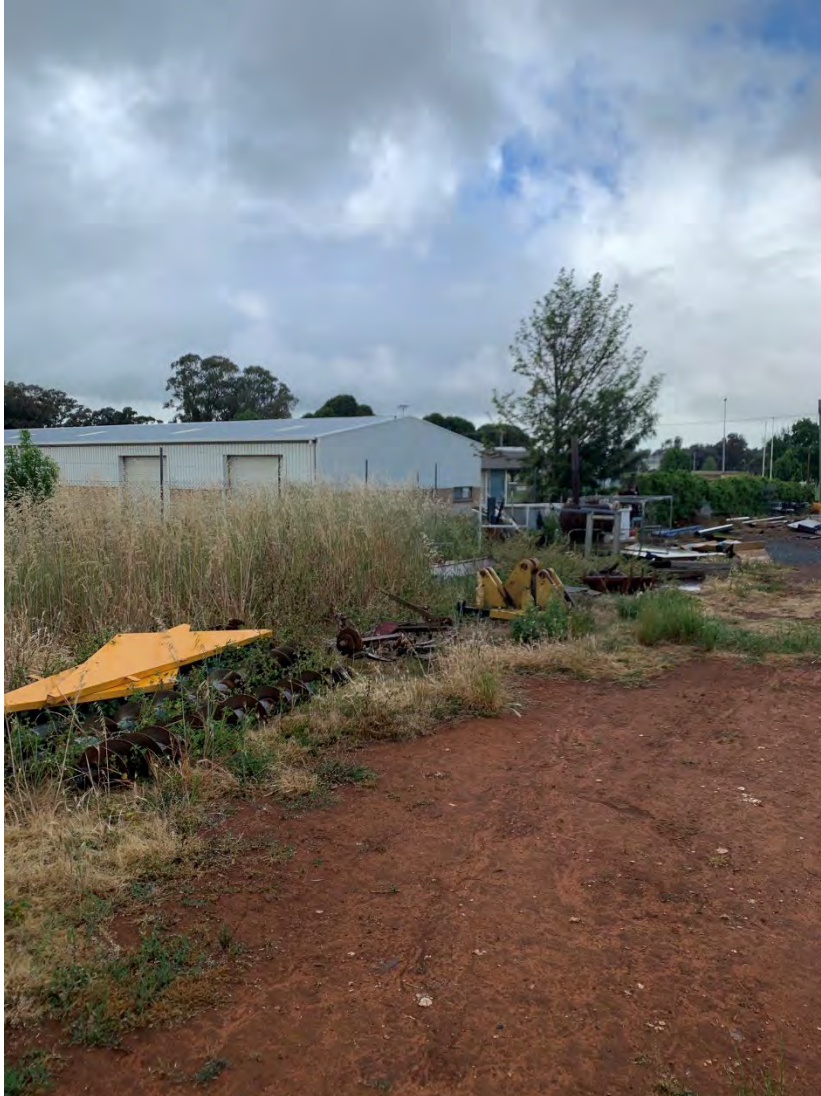
- Gross contamination from fuel and oil leaks and spills at 59-63 Gallipoli Street is considered to be unlikely as no machinery or vehicles were parked at the time of investigation and no visual or olfactory indicators of contamination were observed. However, a thorough visual inspection was hampered by thick grass.

Photograph 19: Laydown area at Lot 5 59-63 Gallipoli Street, facing south east.

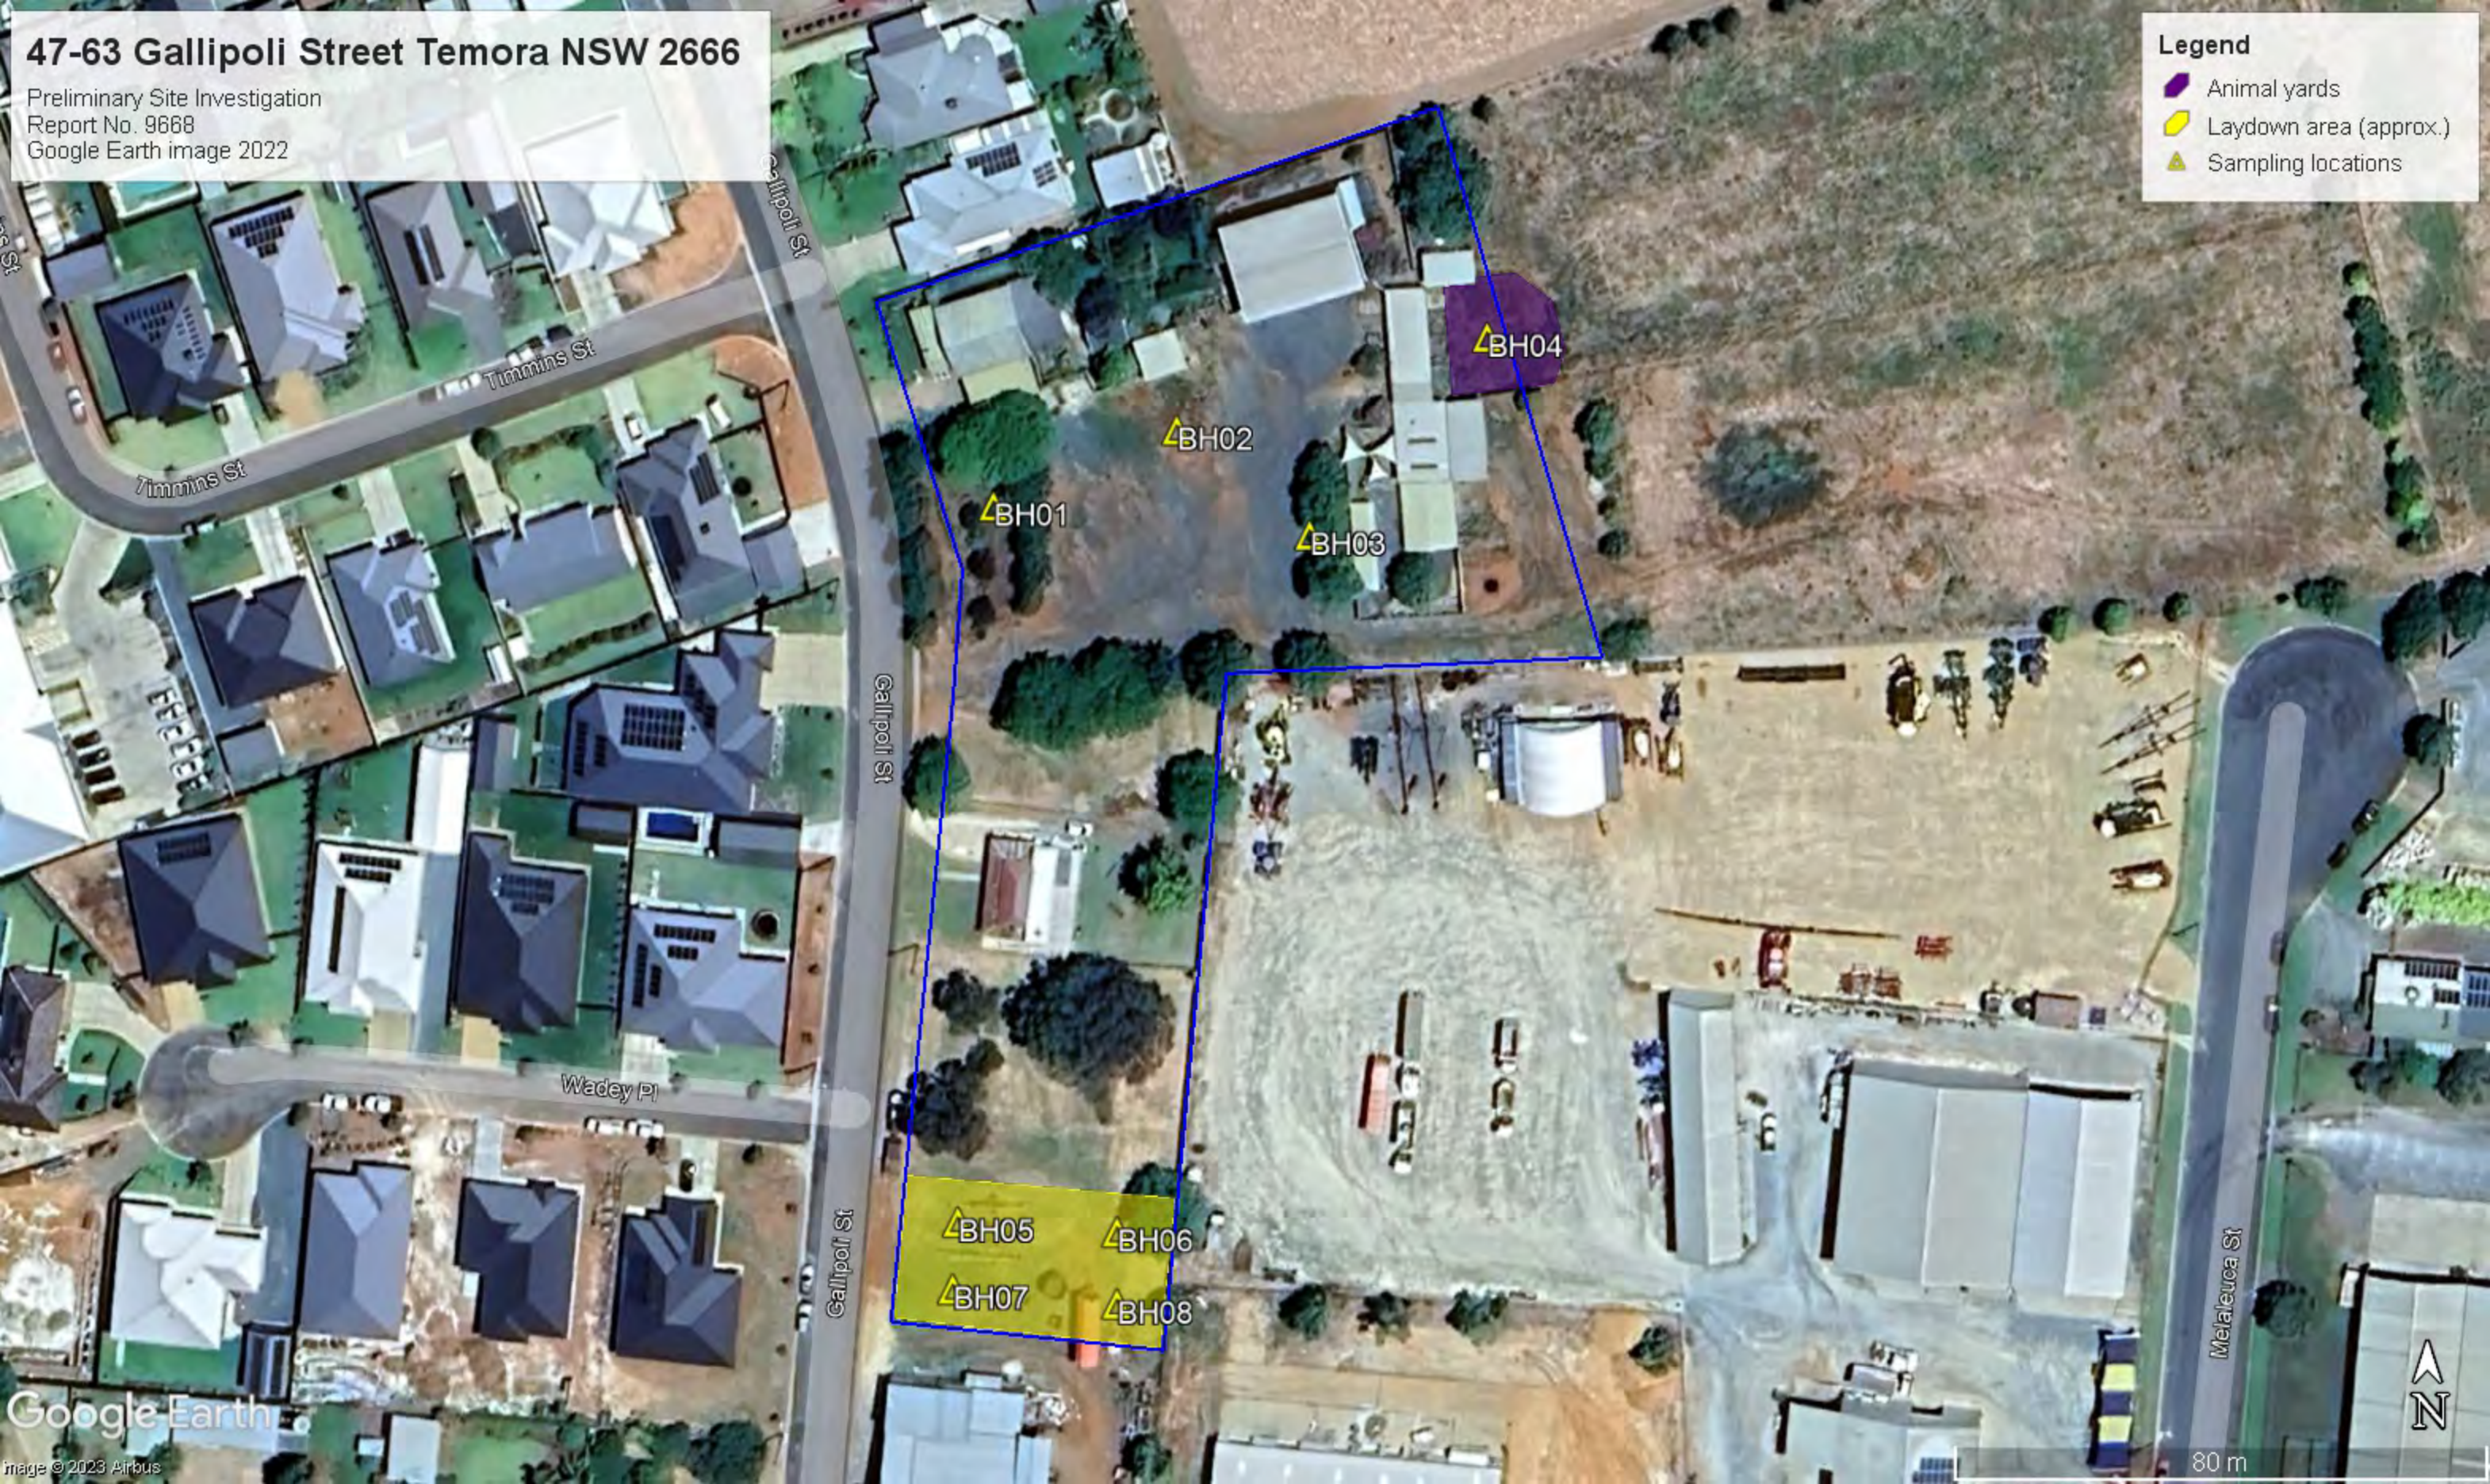
Attachment E : *Sampling locations*

- Samples 1-3: to assess the near surface soil contamination from potential persistent agricultural chemicals from the former home nursery business.
- Sample 4: to assess the near surface soil contamination from potential persistent agricultural chemicals from application in the animal yards.
- Sample 5-8: to assess the near surface soil contamination from potential fuel and oil leaks and spills in the laydown area.
