Georges Cove Marina Due Diligence Report

Aboriginal and historical due diligence report

Prepared for Mirvac | 23 April 2018

Report J17305RP1 | Prepared for Mirvac | 23 April 2018

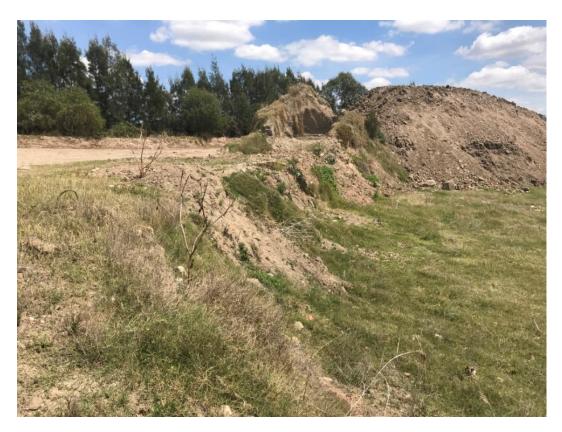
The southern project area contains a large body of water in the north-east corner and is surrounded by steep banks. The geomorphology of the land described in Section 2.1.1 is not consistent with the existing landscape. The project area has been extensively disturbed by historic earthworks, which includes excavation and fill (Plate 2.1). The deep excavations have removed large volumes of soil, which has been replaced by water.

Plate 2.1 Evidence of excavation in foreground, and introduced fill in background. View north

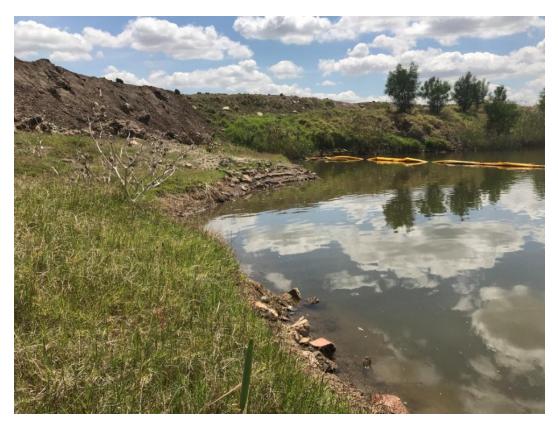
The northern project area has also been subject to a large amount of disturbance through earthworks that include substantial excavation and fill activities (Plate 2.2 and Plate 2.3). This level of disturbance has removed all the natural landforms.

Plate 2.2 Evidence of excavation and introduced fill in the northern project area. View north.

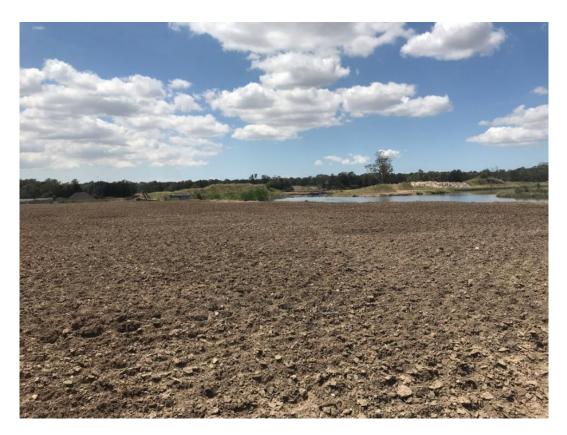
Plate 2.3 Northern project area showing evidence of excavation and introduced fill. View east.

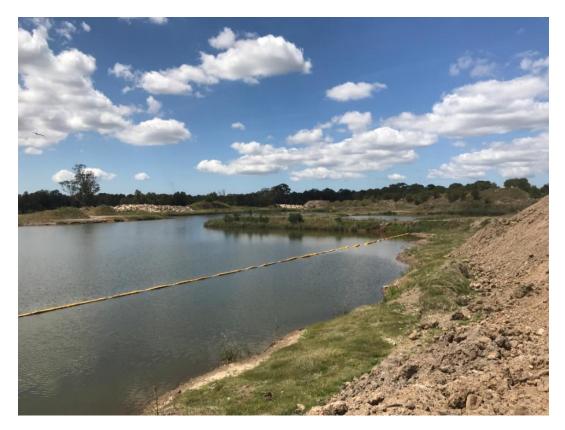
Due to the amount of degradation of native soils, transference via fill in the past and prior development of the area in large there is limited natural vegetation in the project area (Plate 2.4). There are isolated clumps of reeds and shrubs with grass coverage along the edge of the water body; no mature trees were present in the project area.

Plate 2.4 Example vegetation in the project area. View south-east

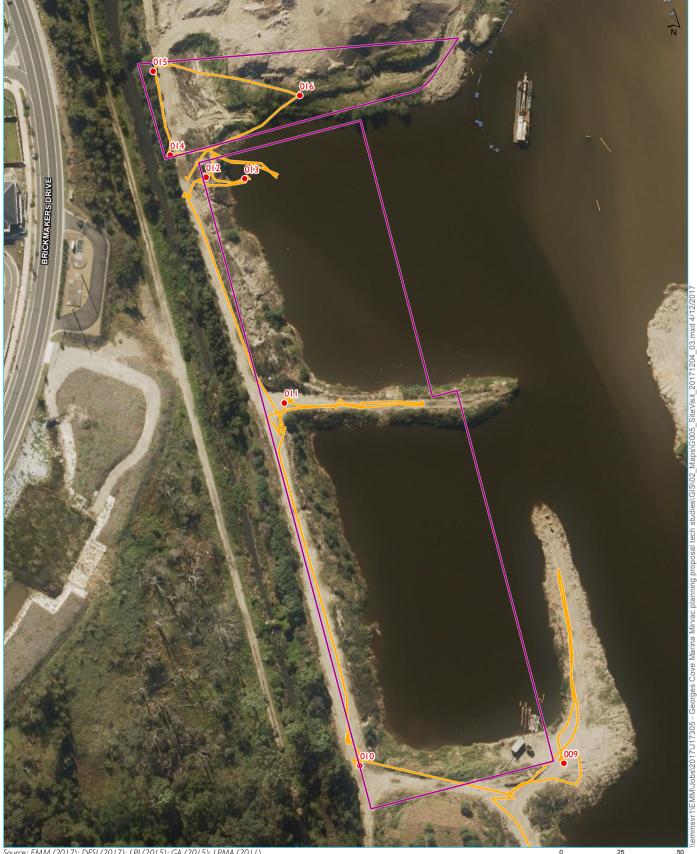
Figure 4.1

A pedestrian survey was carried out on the 10 November 2017 in good weather (Figure 4.1). A large portion of the project area was covered in water. The site has been highly disturbed, and a large amount of previous work has been carried out, including the transference of fill and deep excavation. Ground visibility was approximately 15% and the exposure approximately 5-10%. The project area held no mature trees, and a relatively small amount of native vegetation (approximately 5%).

Site inspection record

- works may proceed with caution;
- in the unlikely event that sites are discovered work should immediately cease and archaeological advice sought;
- In the event that known or suspected human skeletal remains are encountered during the activity, the following procedure will be followed:
