DUE DILIGENCE ENVIRONMENTAL ASSESSMENT

Oxley Vale Service Station

**171 Manilla Road, Oxley Vale NSW, 2340
(Lot B, DP161758)**

November 2019

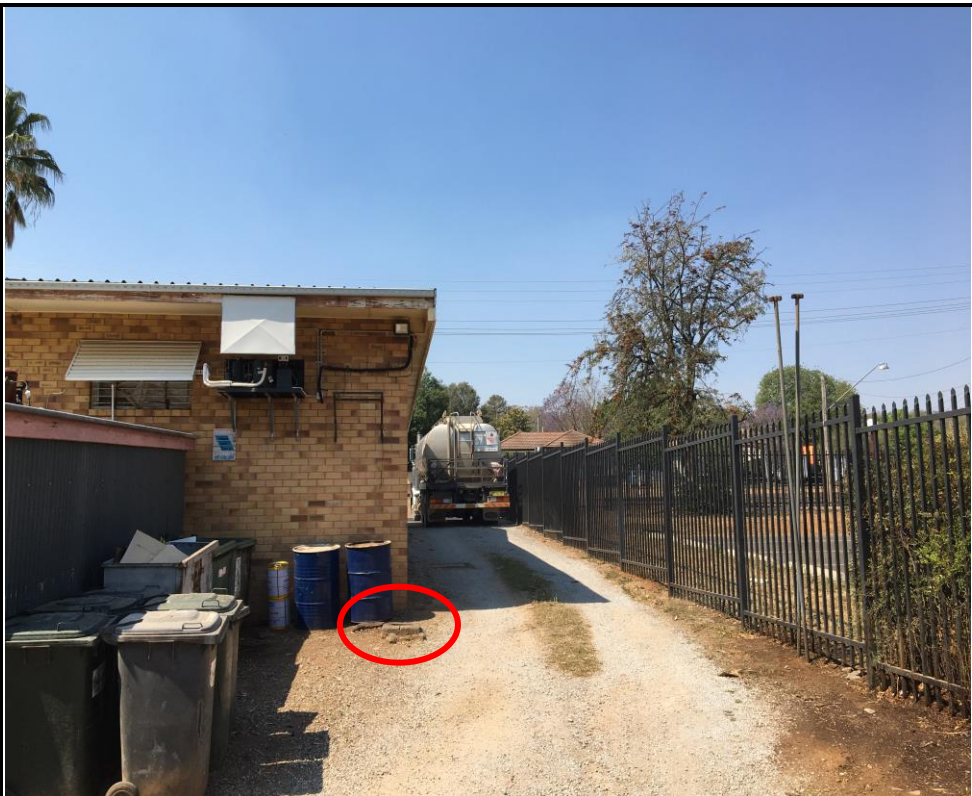
Photo No. 2	Date 29.11.2019

Description Image of the rear of the site showing the vent pipes on the lots perimeter fence line and the fill points relating to the x2 USTs (red).

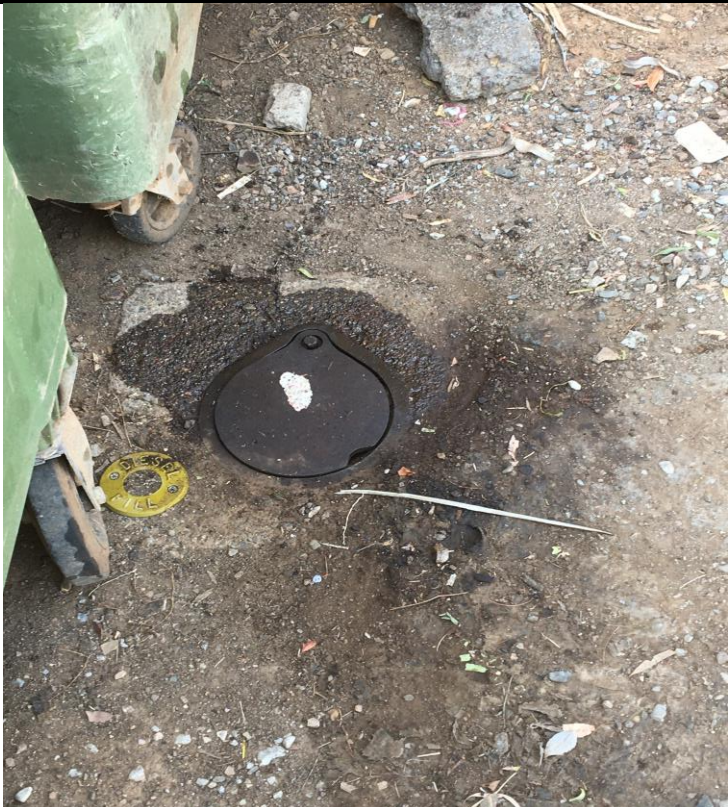
Photo No.	Date	
4	29.11.2019	
Description Additional image of the other UST fill point. Minor staining noted surrounding gatic cover.

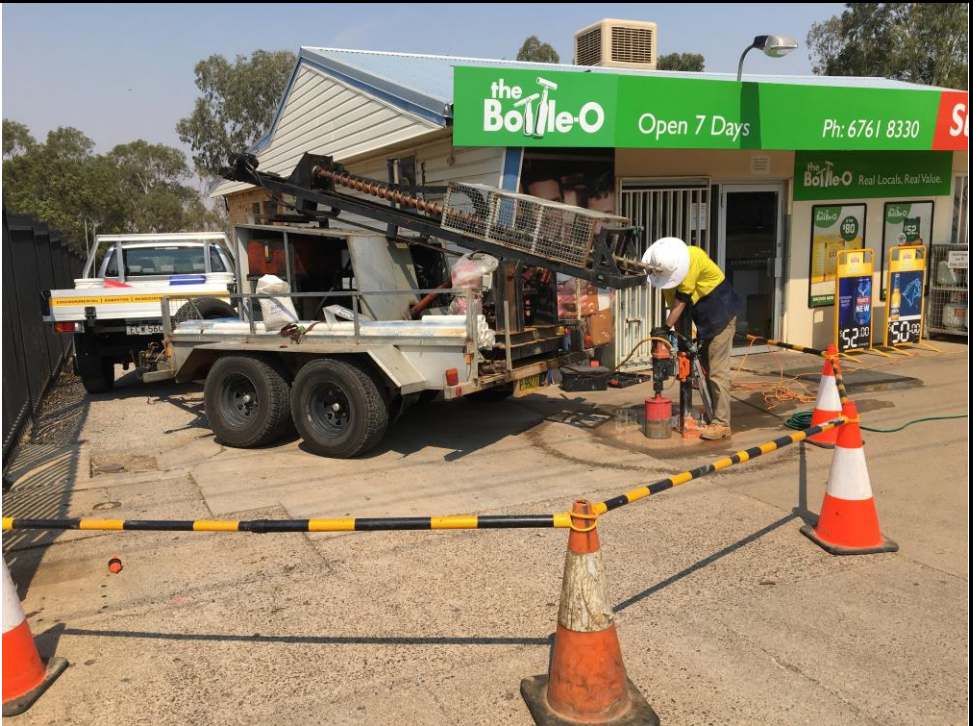
Photo No.	Date	
5	29.11.2019	
Description Image of the concrete corer working out the concrete hardstand to dill BH01 and install groundwater monitoring well MW1.

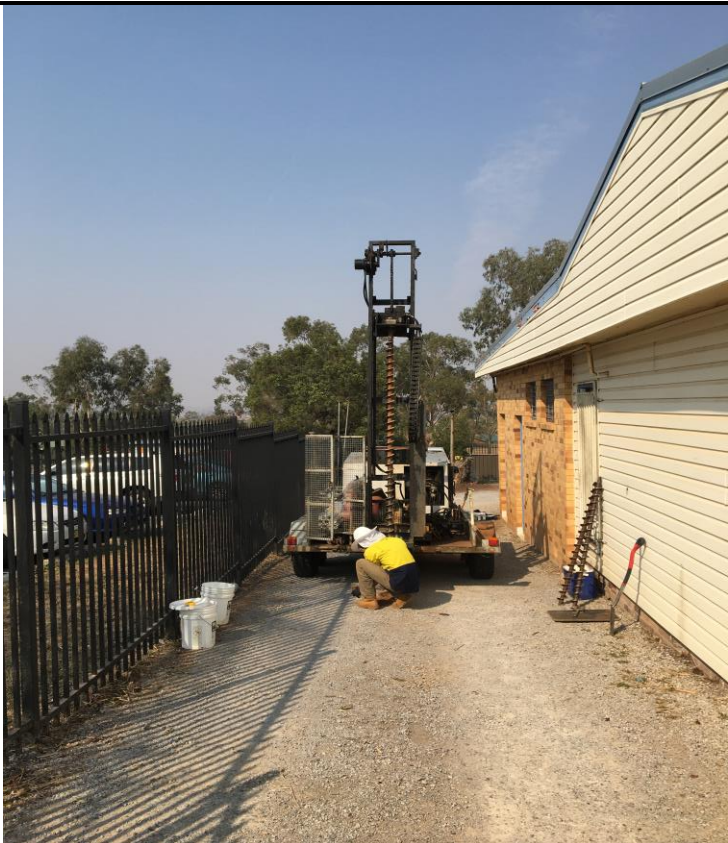
Photo No.	Date	
6	29.11.2019	
Description Drilling BH02 and Installing MW2.

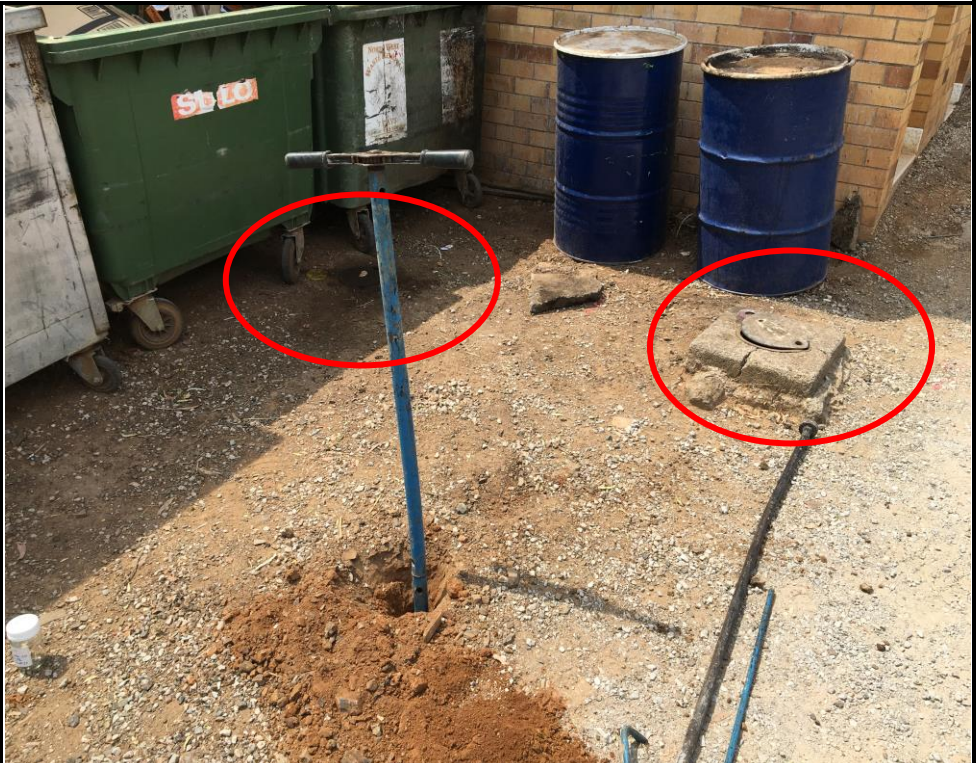
Photo No.	Date	
7	29.11.2019	
Description Location of BH03/MW3. Material in this location noted to be reworked clays over natural material.

Photo No.	Date	
8	29.11.2019	
Description Location of BH04. This location was advanced via the use of a hand auger due to the close proximity of the location to the USTs (red).

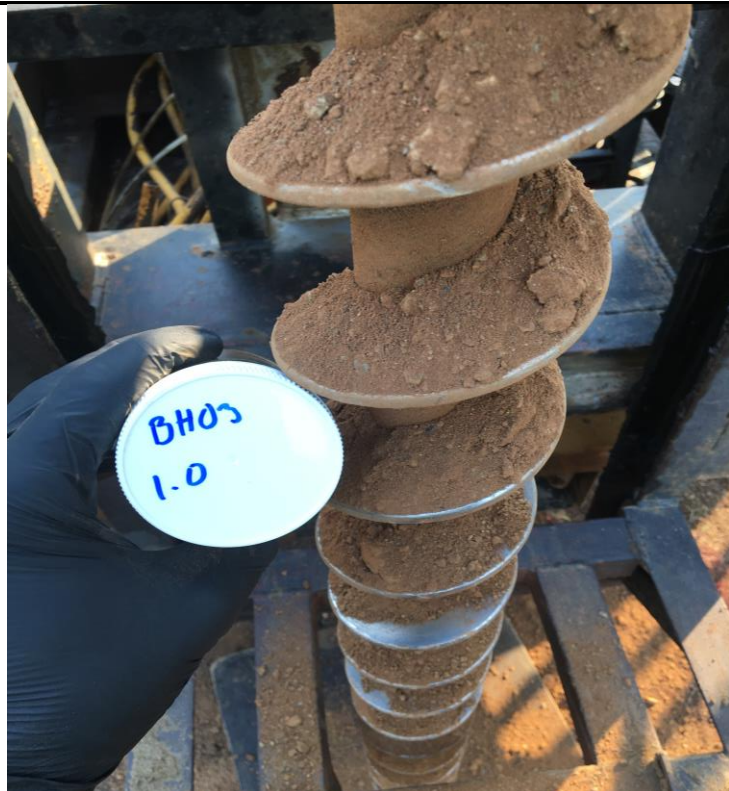
9	29.11.2019	
Description		
Typical material encountered at BH03. No visual or olfactory signs of contamination noted.

Photo No.	Date	 
10	29.11.2019	
Description <p>Material taken from BH02_2.0. Soils from 1.8 mBGL in BH02 (located in driveway) were noted to be naturally occurring clays.</p>
