## Contamination Assessment

4 - 6 Chapel Road  
Bankstown NSW

Project Number:  
**EP241-RP01**

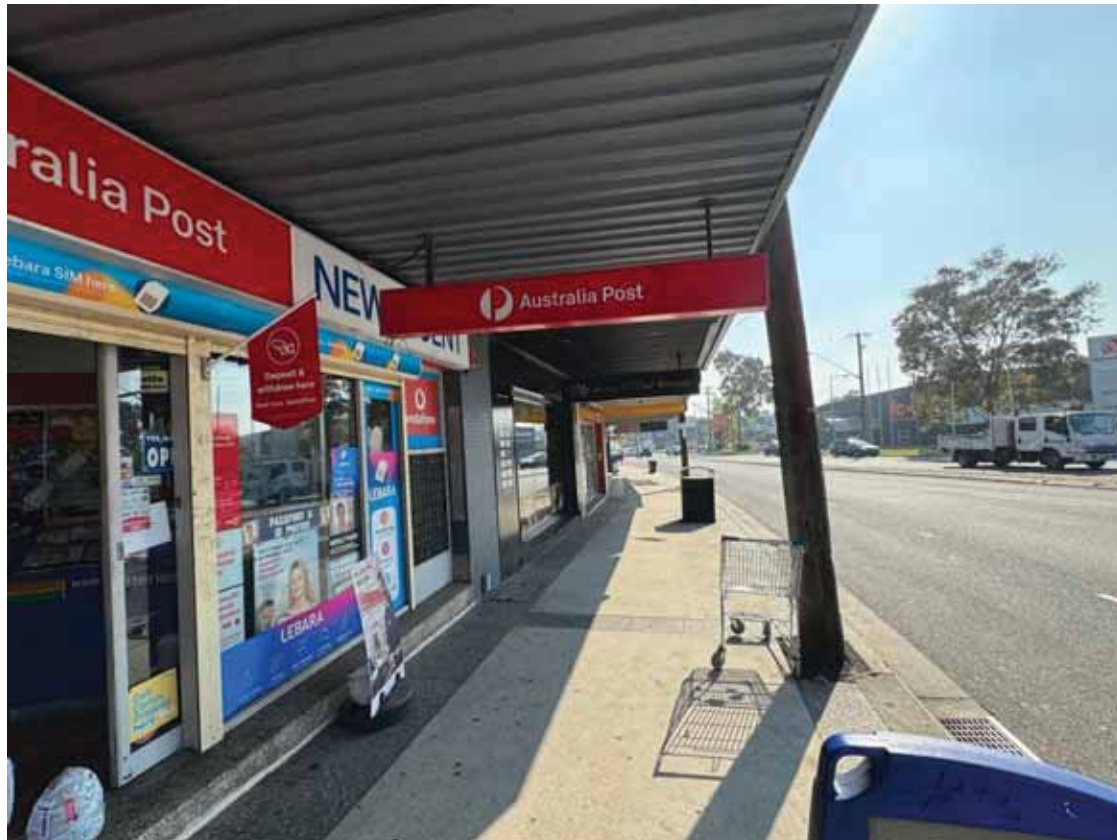
**Photograph 1:** Retail shops in the eastern portion of the Site fronting Chapel Street, facing north.

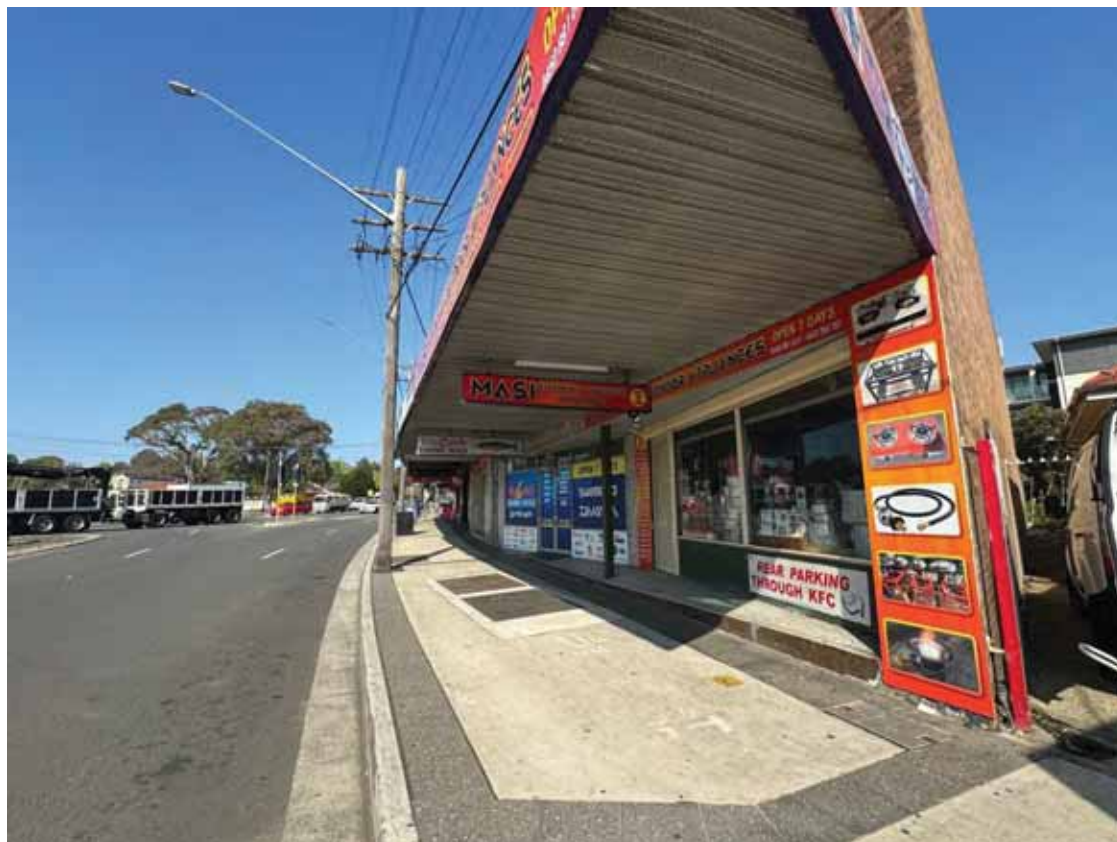
**Photograph 2:** Retail shops in the eastern portion of the Site fronting Chapel Street, facing south.

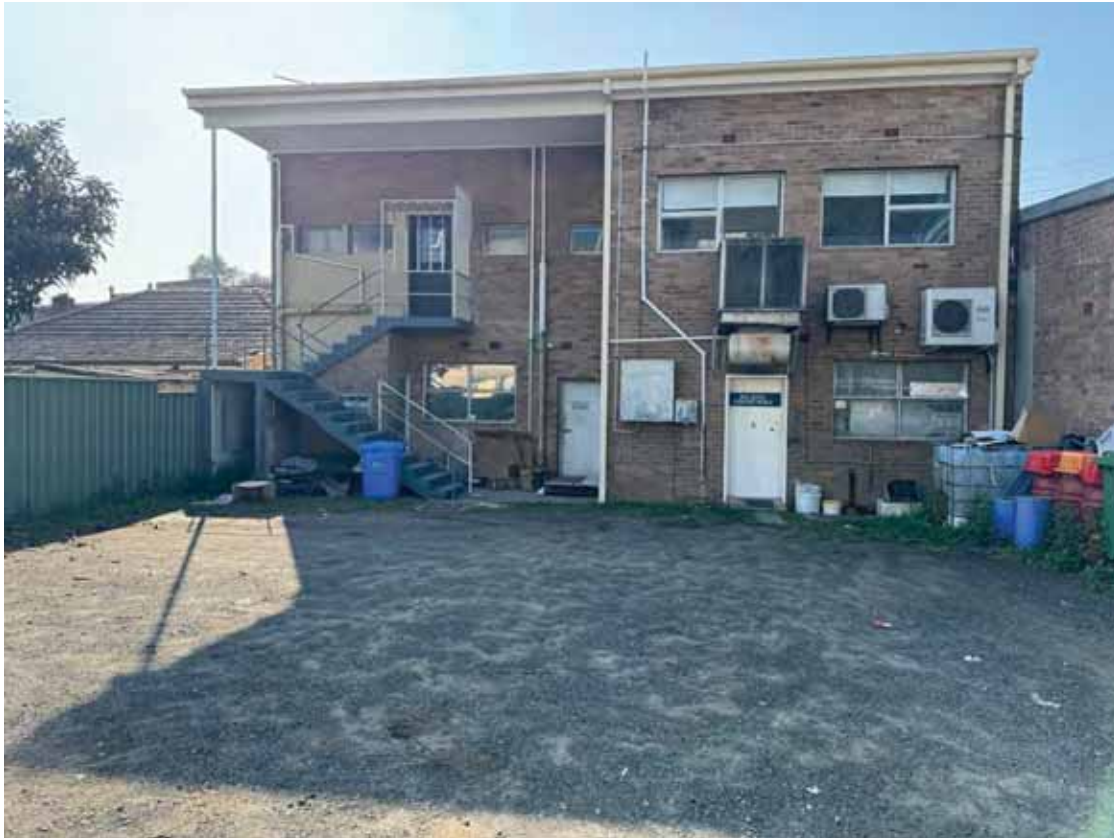
**Photograph 3:** Rear (western) side of the retail shops (showing the shops in Lot 2 DP 655844), facing east.

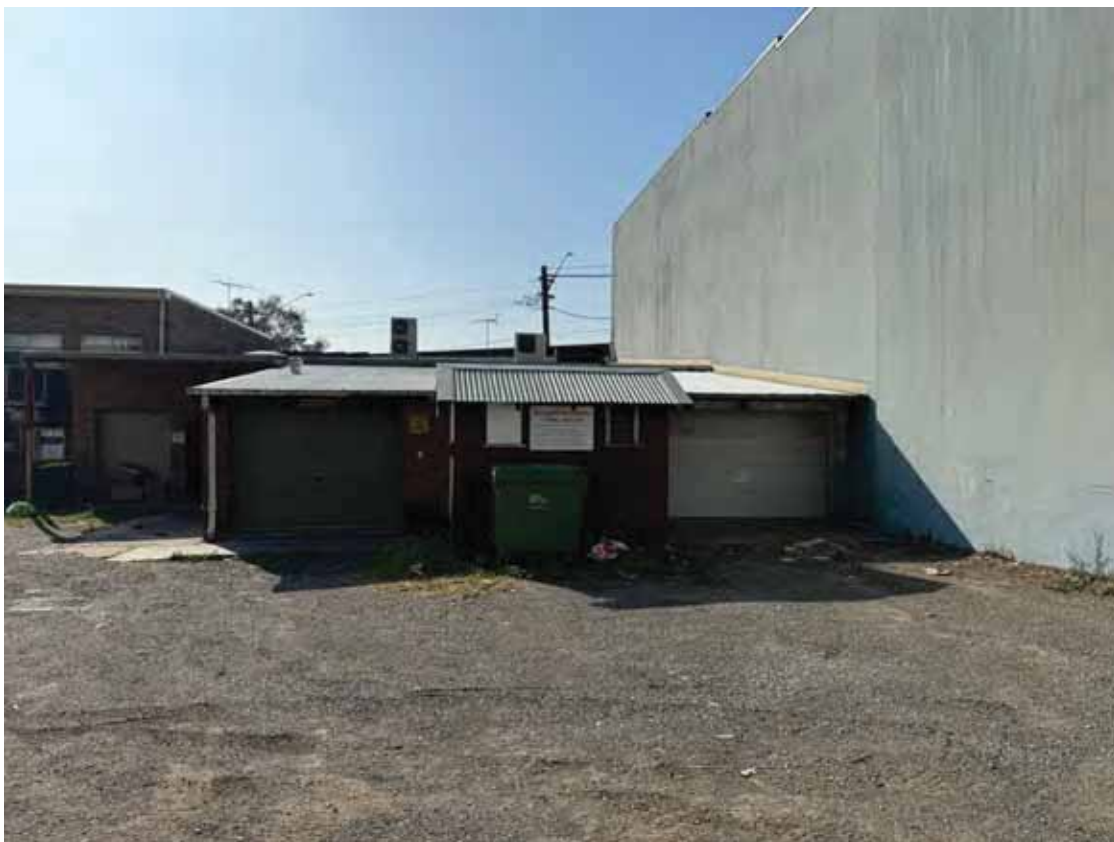
**Photograph 4:** Rear (western) side of the retail shops (showing the shops in Lot 1 DP 655843), facing east.

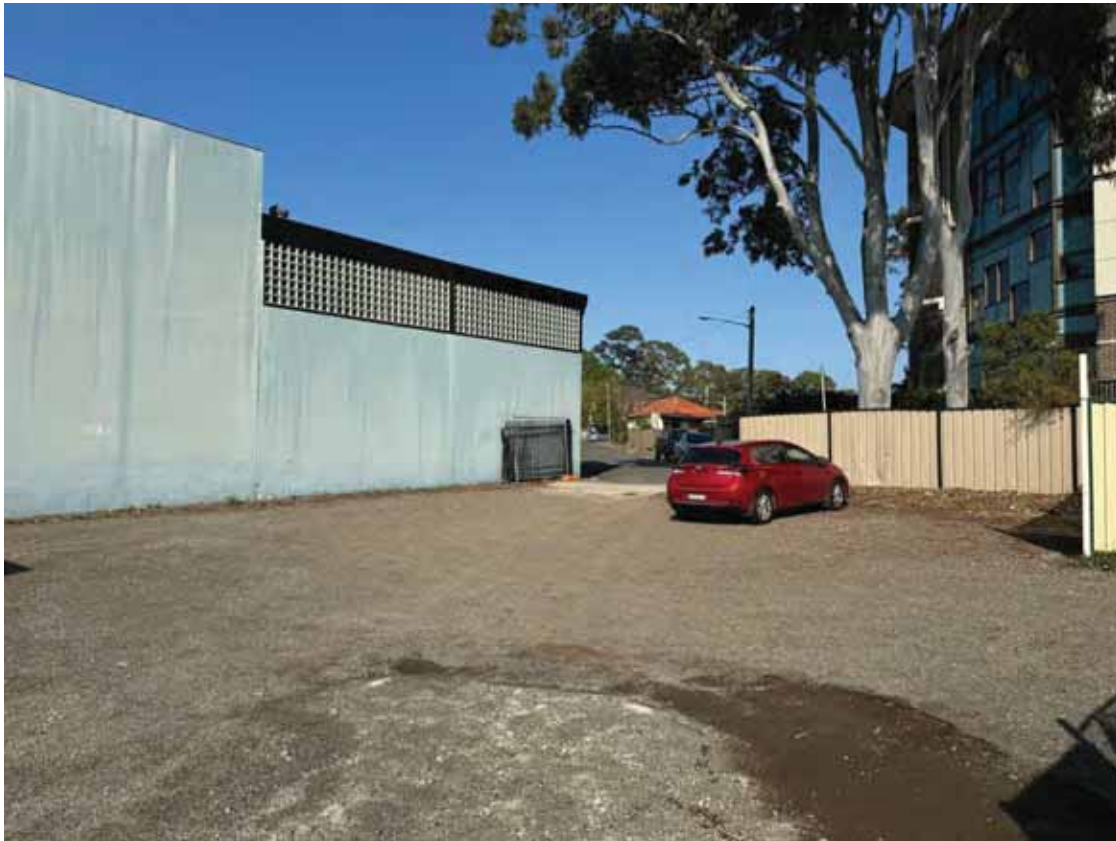
**Photograph 5:** The carpark area in the western portion of the Site facing south west, with the unnamed laneway that provides access to the carpark shown in the background.

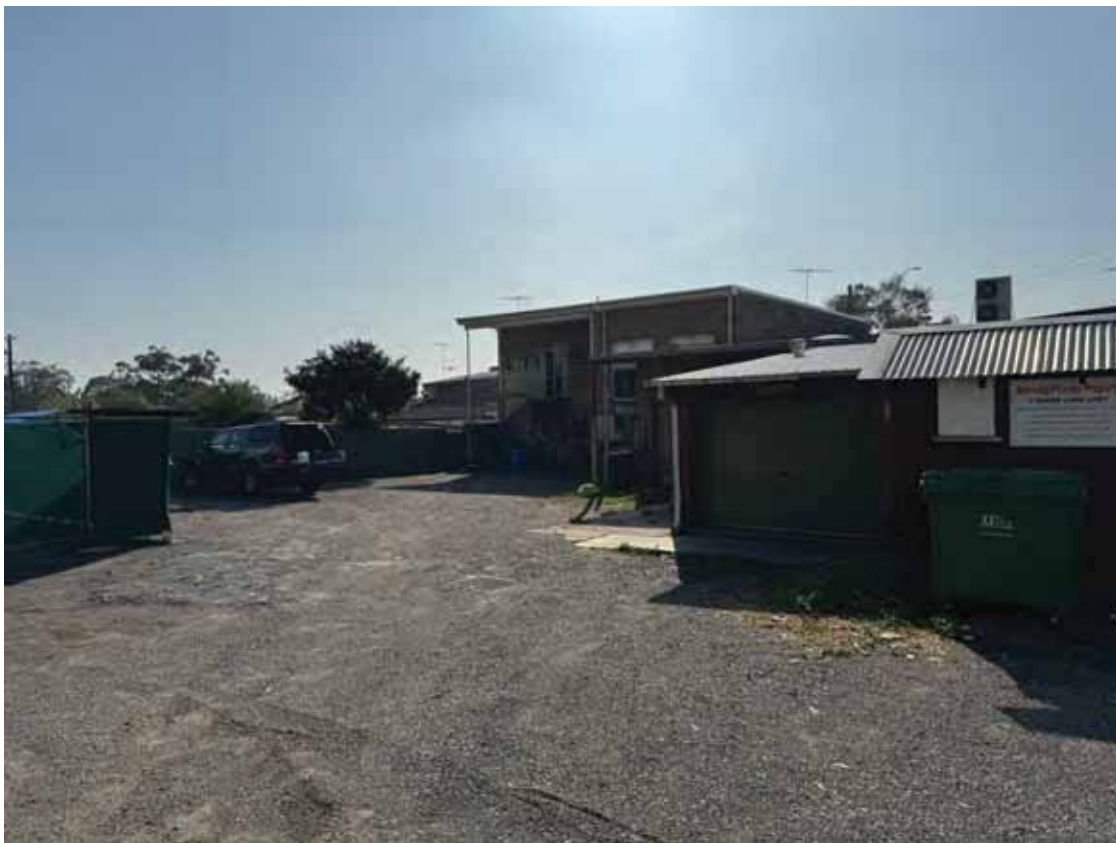
**Photograph 6:** The carpark area in the western portion of the Site facing north east, with the rear facades of the retail shops shown in the background.

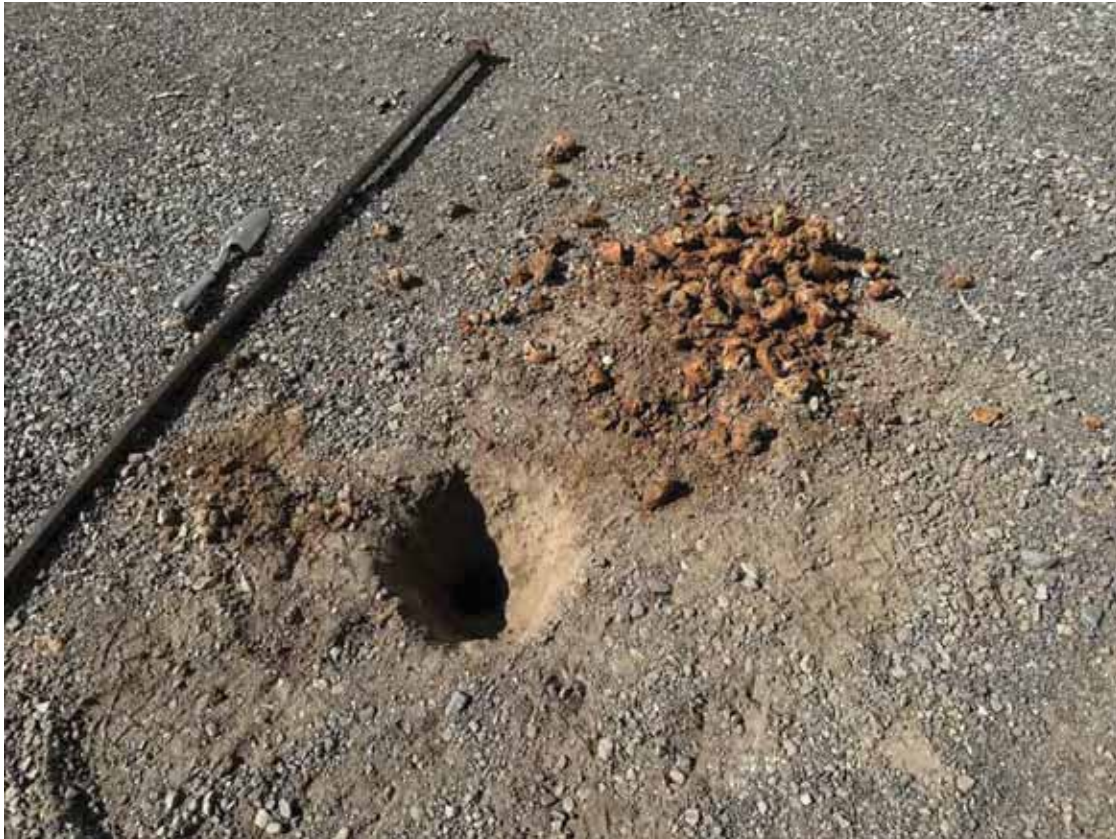
The ground surface of this portion of the Site is similar to the carpark area, where a gravel ground surface is present, although the condition of the surface was poor with areas of bare and exposed soils present. Areas of weeds were also present in this area, generally adjacent to the fences.

**Photograph 7:** Typical ground condition encountered within the western portion of the Site (carpark area).

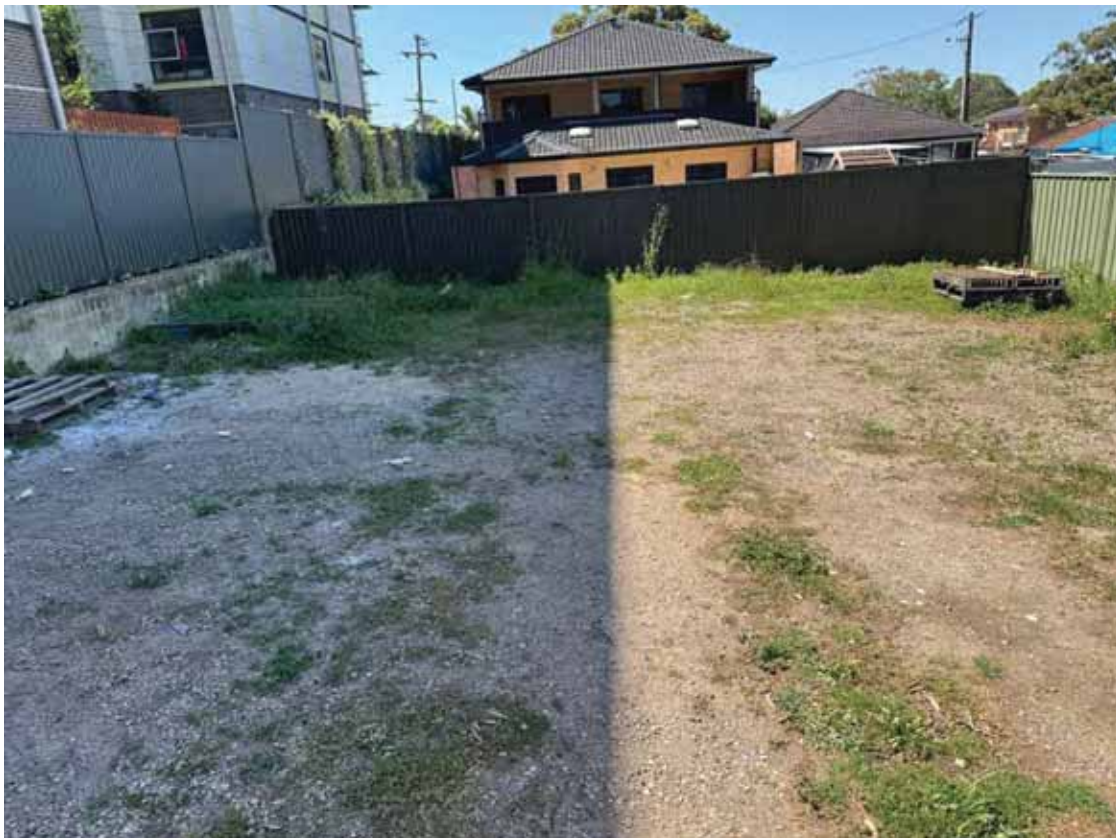
**Photograph 8:** The northern eastern portion of the Site, which is currently predominantly vacant, with minor material storage.

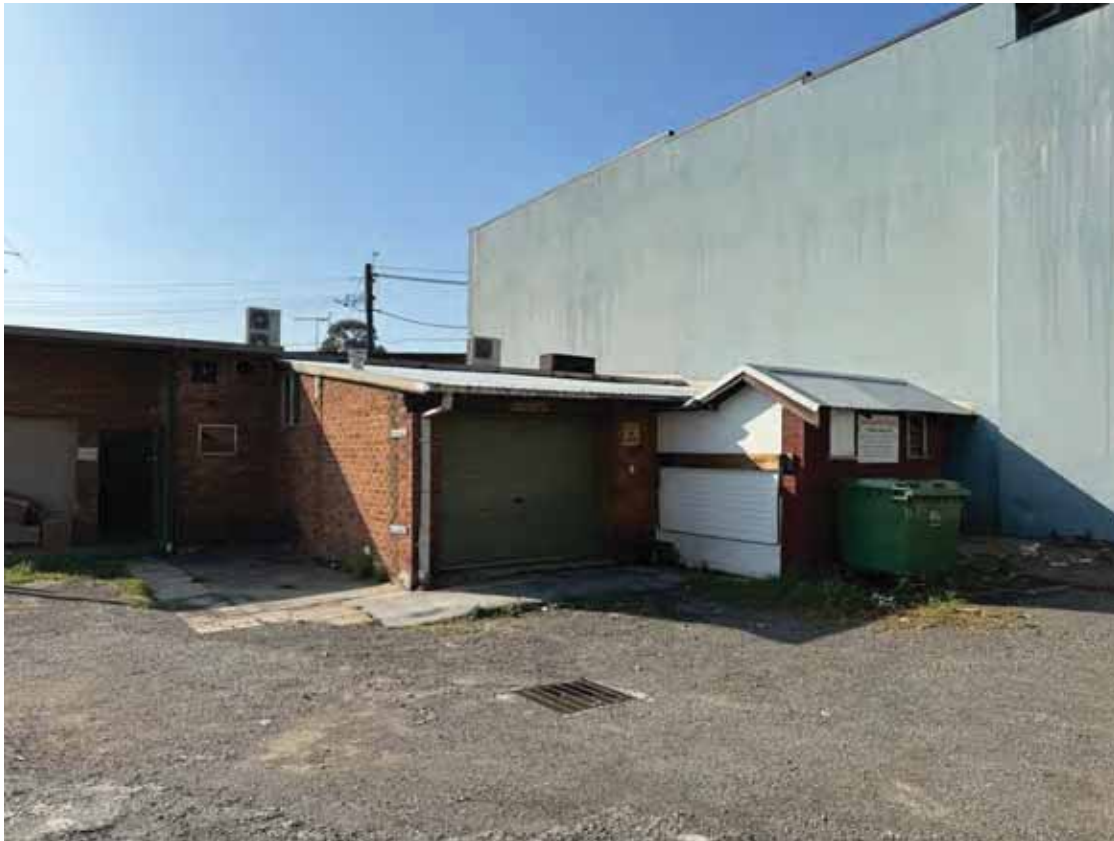
- A Section 91 Clean-up Notice issued to a former tenant of the Site (Best Yet Dry Cleaners Pty Ltd, 4a/6 Chapel Road) on 15 March 2023 (refer **Appendix H**). The Notice (ref. 1515835) related to the inappropriate storage of a hazardous dry cleaning chemical waste (perchloroethylene) being stored at the rear of the shop inside and adjacent to the garage door.

**Photograph 9:** The rear portion of the former dry-cleaning premises and the location of where it is understood that dry cleaning waste the subject of an EPA Clean-up Notice were stored (building with green roller door).

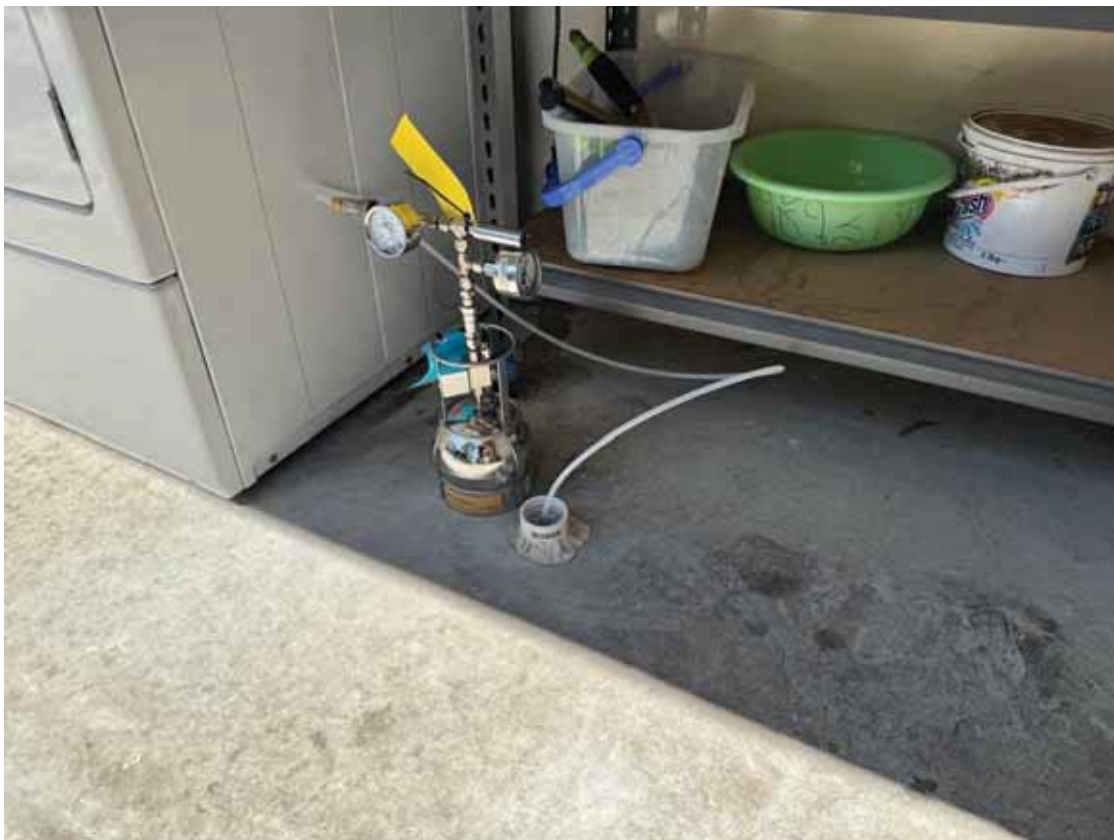
Activity	Details
Sampling Locations	<p>One (1) soil vapour monitoring point (SV1) was installed within the garage area at the rear of the now Thai Massage premises, which is the area understood to have been formerly used for the storage of dry-cleaning wastes. The Vapour Pin™ was installed into the ground level concrete pavement to facilitate the collection of a sub-slab soil vapour sample.</p> <p>The sampling location is shown in <b>Figure 2</b>.</p>
Soil Vapour Pin Installation	<p>One (1) Vapour Pin™ were installed, which is a specific soil vapour sampling apparatus constructed of stainless steel. The Vapour Pin™ was decontaminated prior to use.</p> <p>A 16mm diameter hole was drilled using a hand held drill through the concrete slab and approximately 25mm into the underlying soil.</p> <p>The drill bit was removed and the hole brushed to remove loose cuttings. The lower end of the vapour pin containing a silicon seal was tapped into the drilled hole using a rubber mallet and a protective cap was placed on the vapour pin to prevent vapour loss prior to sampling.</p> <p>A leak test was conducted through the placement of a water dam around the Vapour Pin™ installation, which was confirmed to pass the water shut out test prior to commencing sample collection.</p>

**Photograph 10:** Soil vapour sampling setup that was completed in the area the subject of the former NSW EPA Clean-up Notice.
