# Remediation action plan for DA 24/2017 at Lot 7 DP 1065574

Remediation Action Plan

**Proposed Residential Development** 146 Newbridge Road, Moorebank

> > Project 71459.06

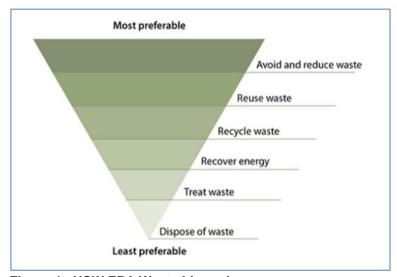
Figure 4: NSW EPA Waste hierarchy <a href="http://www.epa.nsw.gov.au/wastestrategy/waste-hierarchy.htm">http://www.epa.nsw.gov.au/wastestrategy/waste-hierarchy.htm</a>

As shown in Figure 4 below disposal of waste is the least preferred option whereas waste avoidance as proposed at this site, is the most preferable option.

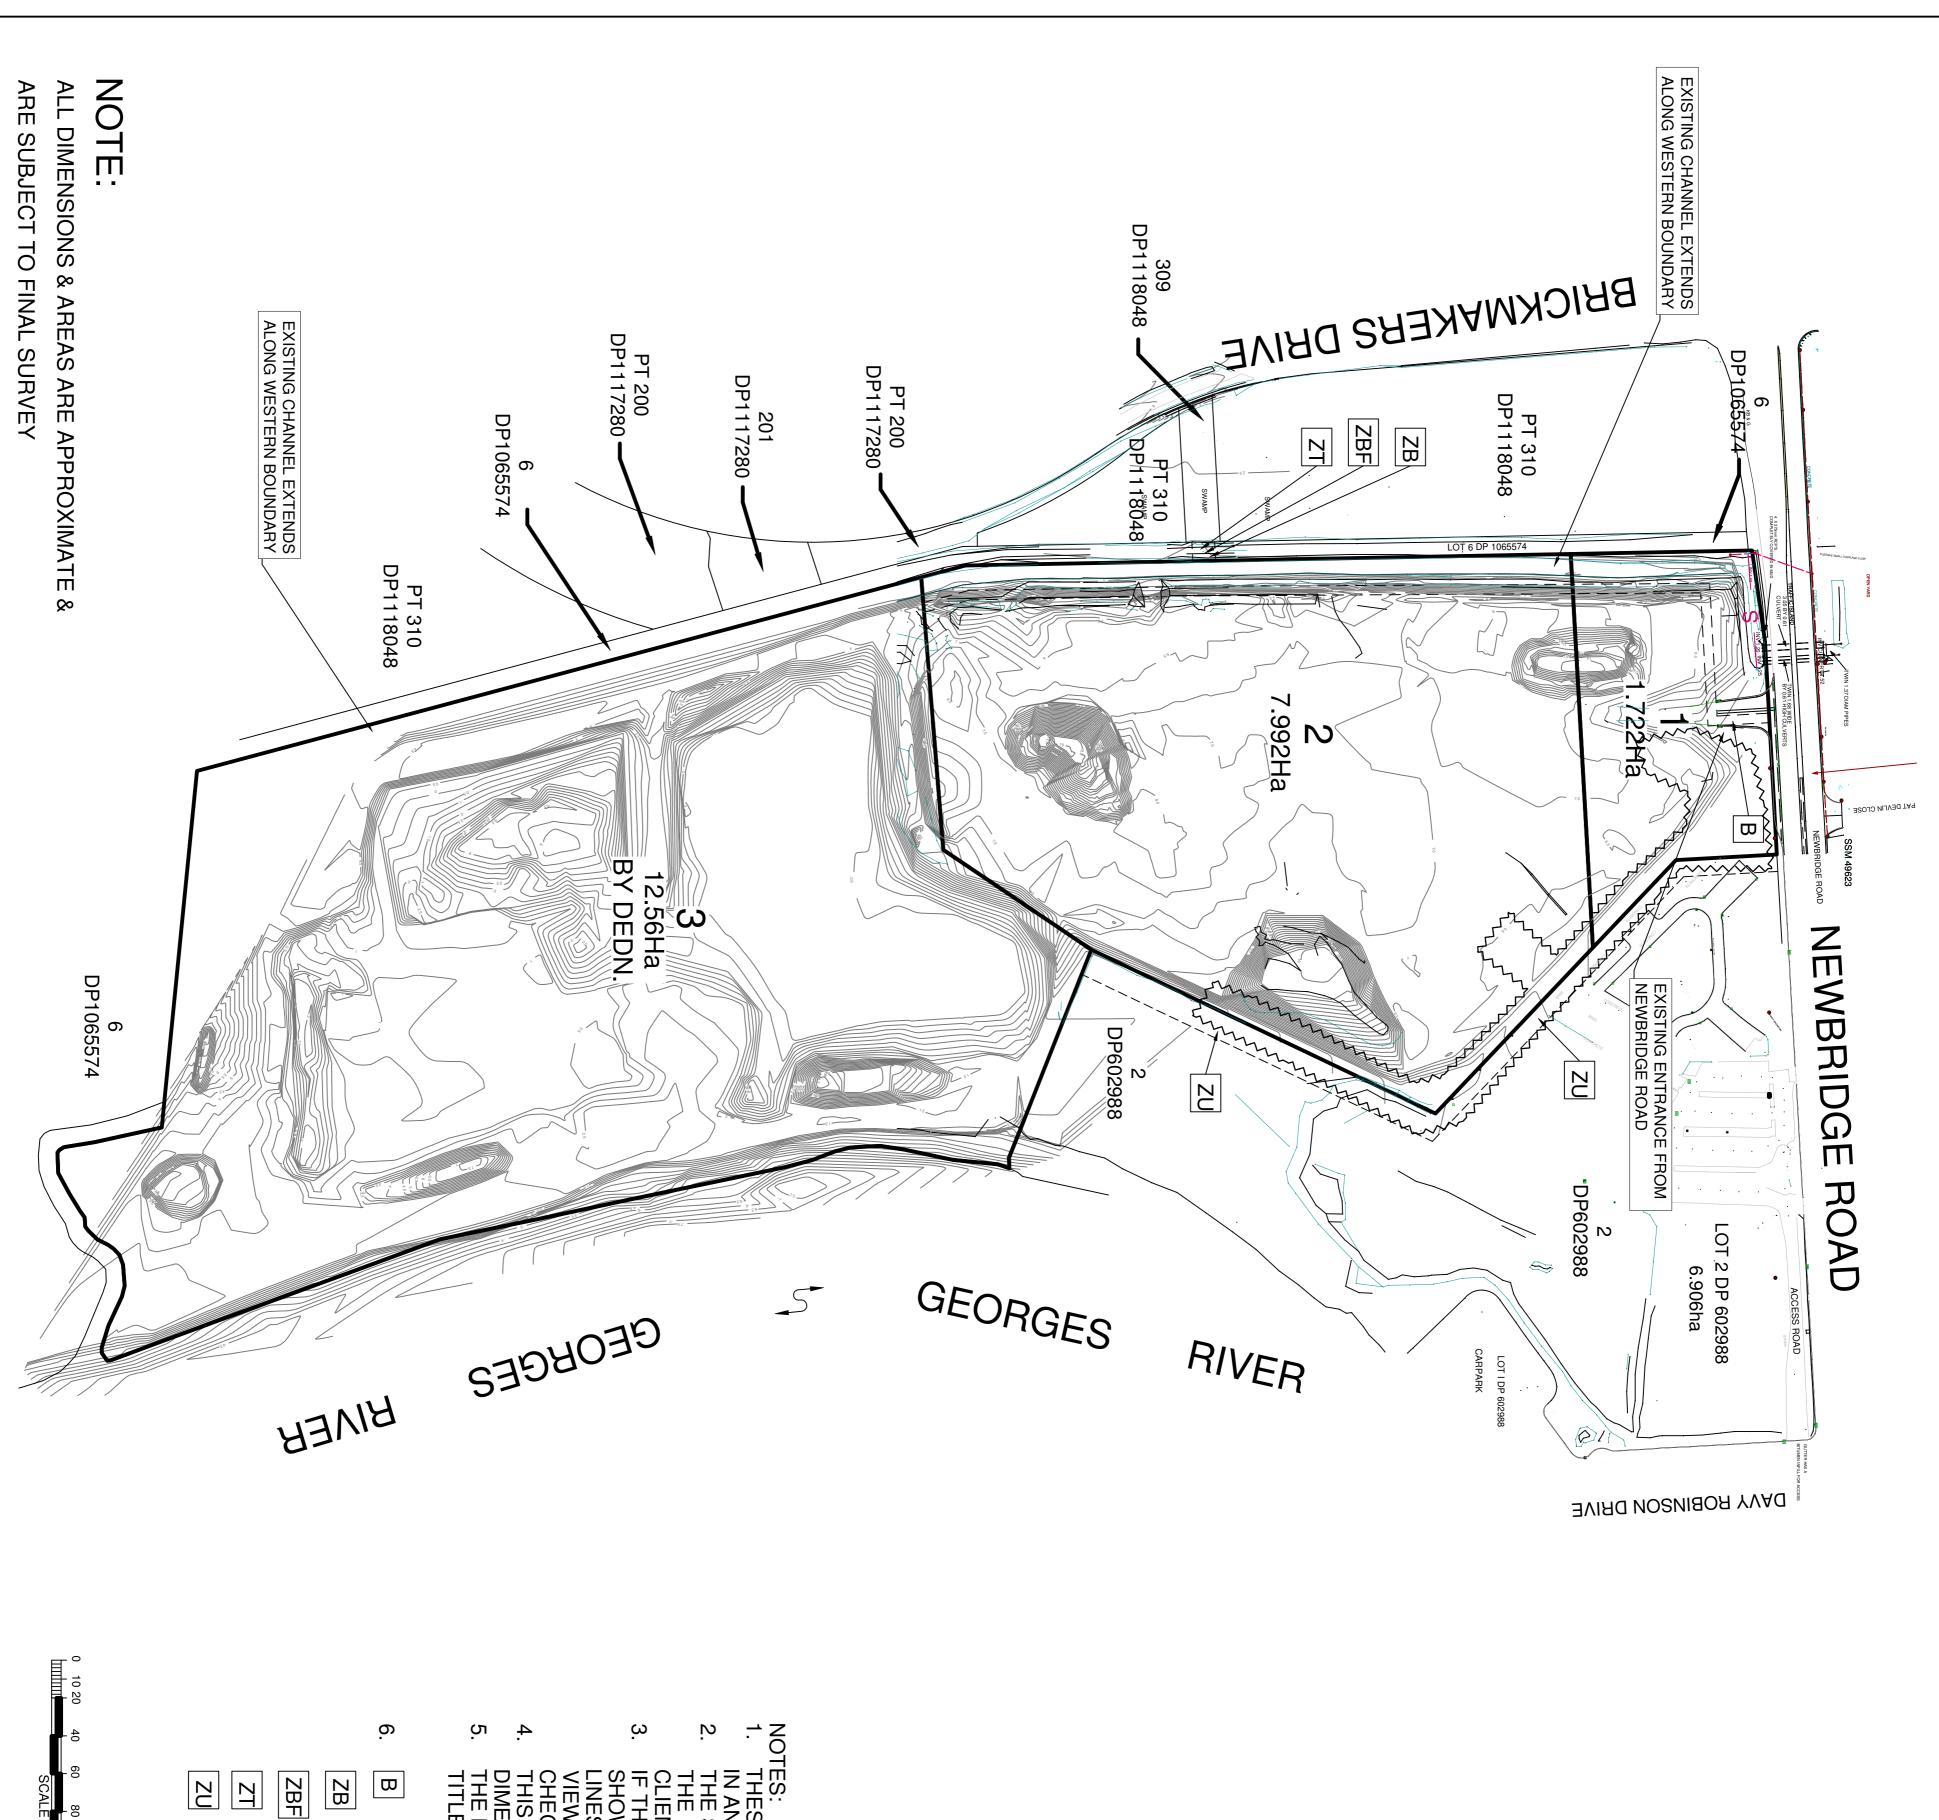
SMALLER TEMPORARY STOCKPILES HAVE NOT BEEN SHOWN HOWEVER THE AREA BENEATH A NUMBER OF THE TEMPORARY STOCKPILES WAS ASSUMED TO GRADE CONSISTENTLY BETWEEN THE BOTTOM OF THE STOCKPILES. THE THREE LARGER STOCKPILES HAVE BEEN SHOWN.

AN EXISTING SURFACE MODEL WAS CREATED USING A COMPILATION OF VARIOUS TOPOGRAPHIC SURVEYS OF THE SUBJECT SITE BY JMD INCLUDING MATERIAL STOCKPILES WHICH WERE COMPLETED FOR BENEDICT IN 2014, 2015 AND 2016 AS WELL AS A DETAIL SURVEY BY FREEBURN SURVEYORS 23-10-2013.

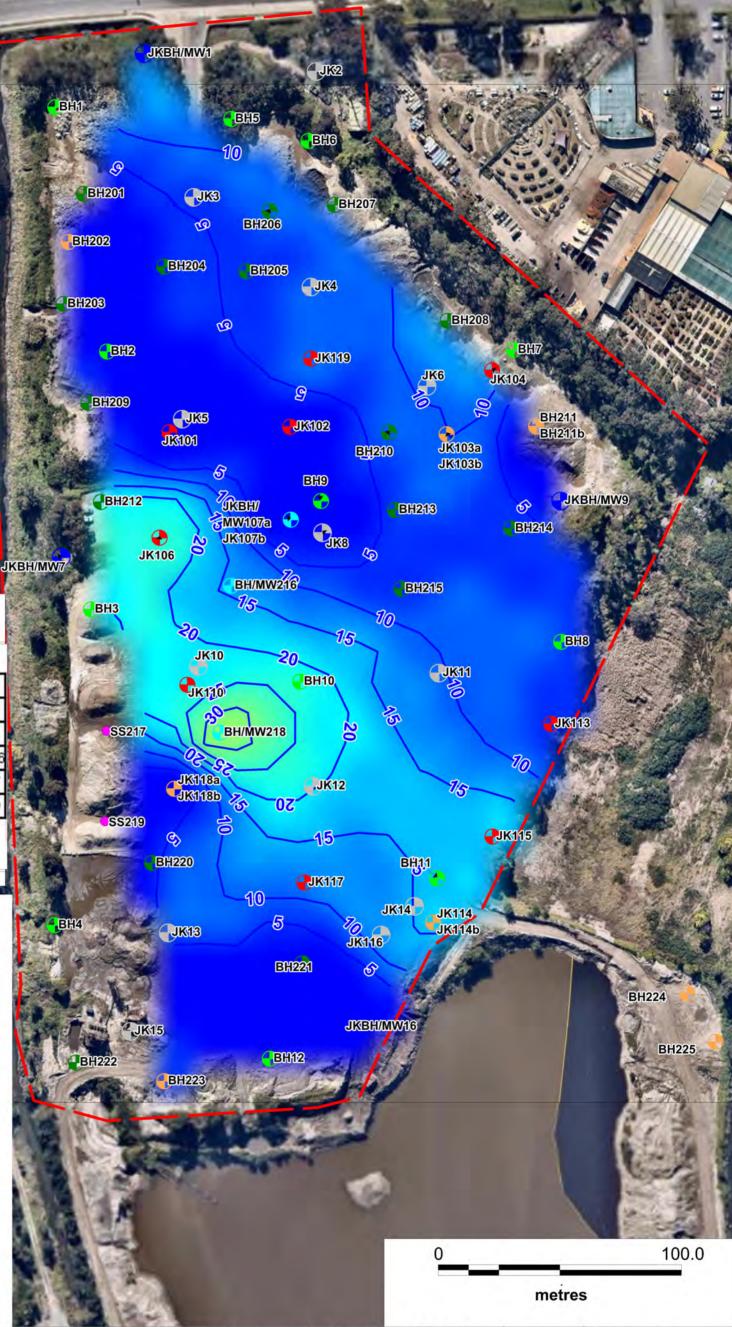
TITLE: Peak Methane Concentration Contours 27/10/15 **Detailed Site Investigation** 146 Newbridge Road, Moorebank, NSW

- **Surface Sample**
- Replacement Well
- **Shallow Gas Well**
- Borehole / Gas Well
- **Monitoring Well**
- **Borehole**
- Borehole (DP, 2002)
- Borehole (EIS, 2015)
- Borehole / Gas Well (EIS, 2015)
- **Monitoring Well Location** (EIS, 2015)

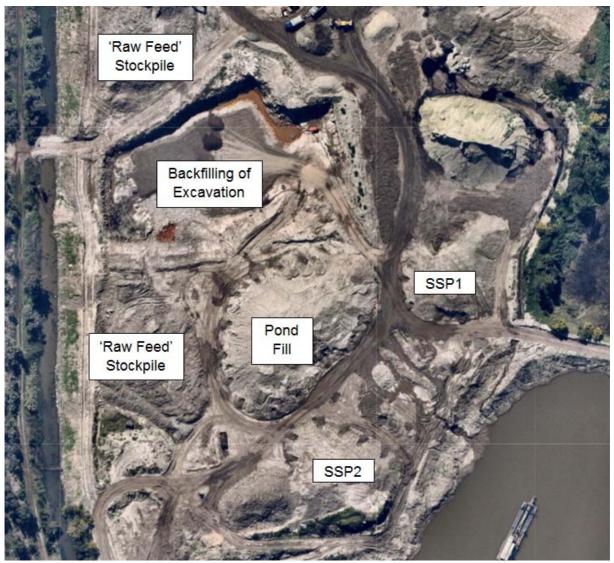
Figure 1: Aerial photograph showing SSP1, SSP2, 'pond fill', 'raw feed' stockpiles and the excavation (Source, NearMap flown 9 September 2016)

Figures 1 and 2 below, shows the areas within the site relevant to the items discussed above.

- Clarification of intention of what will be done to the 'raw feed' stockpiles identified on Figure 1.
   DP understands that these stockpiles are not suitable for backfilling in the excavation without undergoing screening as occurred with material which comprised stockpiles SSP1 and SSP2.

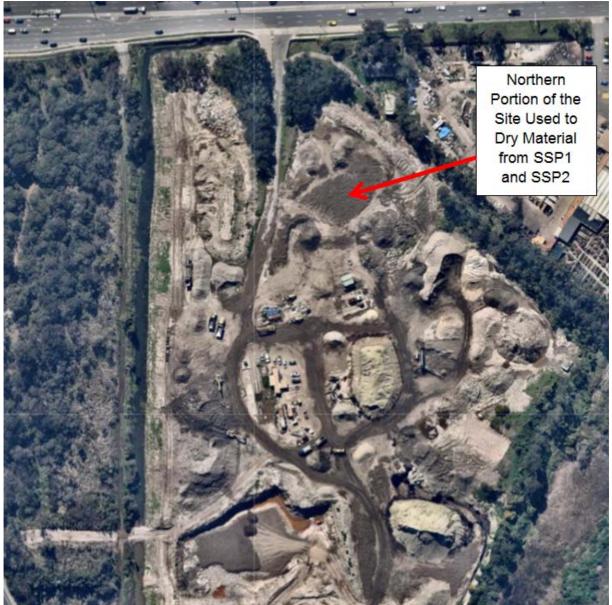
Figure 2: Aerial photograph showing northern portion of the site used to dry material from SSP1 and SSP2 (Source, NearMap flown 9 September 2016)

We understand that the excavation at the central portion of the site was surveyed prior to commencement of backfilling. Please request from the surveyors the calculated volume of the void such that reconciliation between the void and screened material can be made. The area of the excavation as shown on Figure 2 in the RAP is approximately 4500 m² and assuming an average depth of 7 m would yield a volume of 31,500 m³. Based on estimates to date, the total

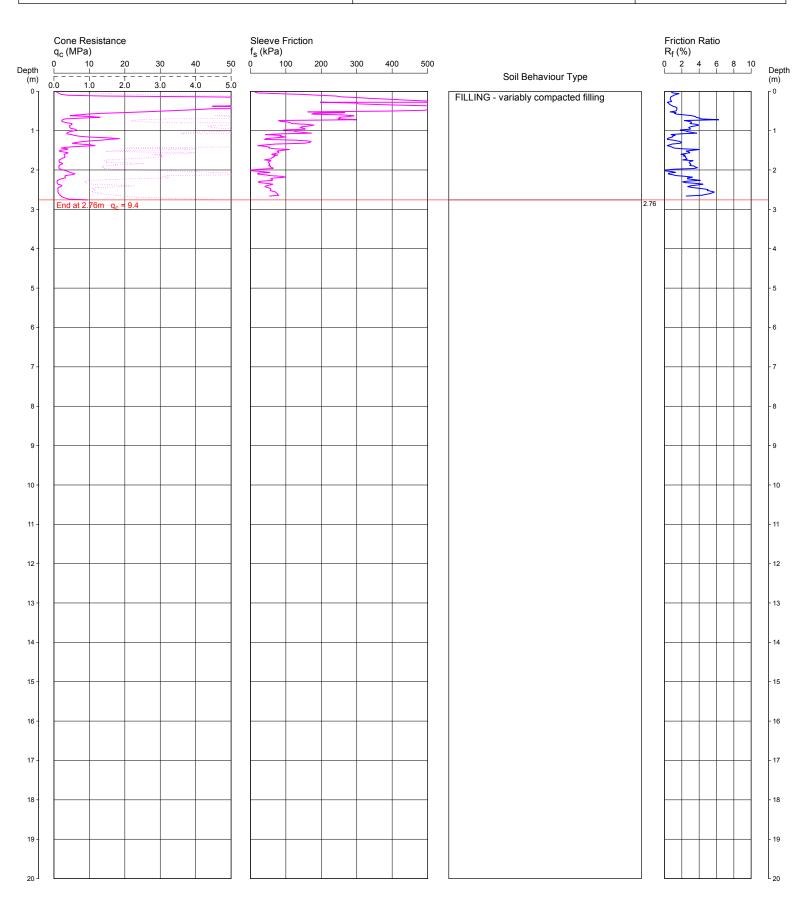
REMARKS: HOLE DISCONTINUED DUE TO BENDING IN FILLING.

NO WATER OBSERVED IN CPT HOLE AFTER WITHDRAWAL OF RODS.

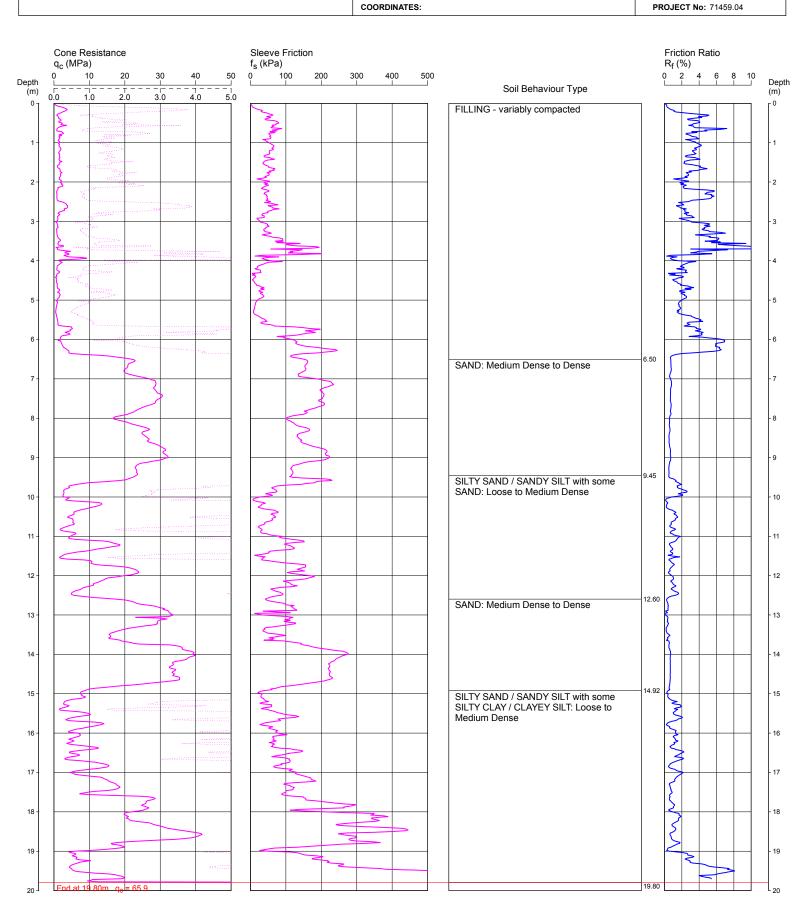
REMARKS: HOLE DISCONTINUED DUE TO CONE TIP REFUSAL.

HOLE COLLAPSE AT 4.9 m DEPTH AFTER WITHDRAWAL OF RODS.

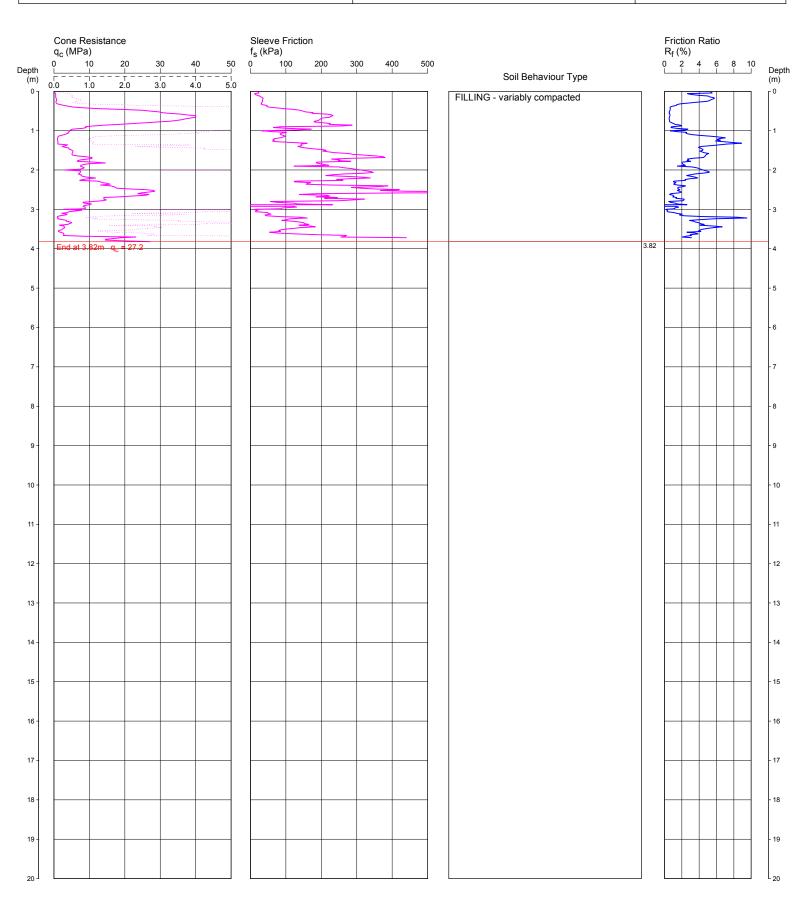
REMARKS: HOLE DISCONTINUED DUE TO OBSTRUCTION IN FILLING. NO WATER OBSERVED IN CPT HOLE AFTER WITHDRAWAL OF RODS.

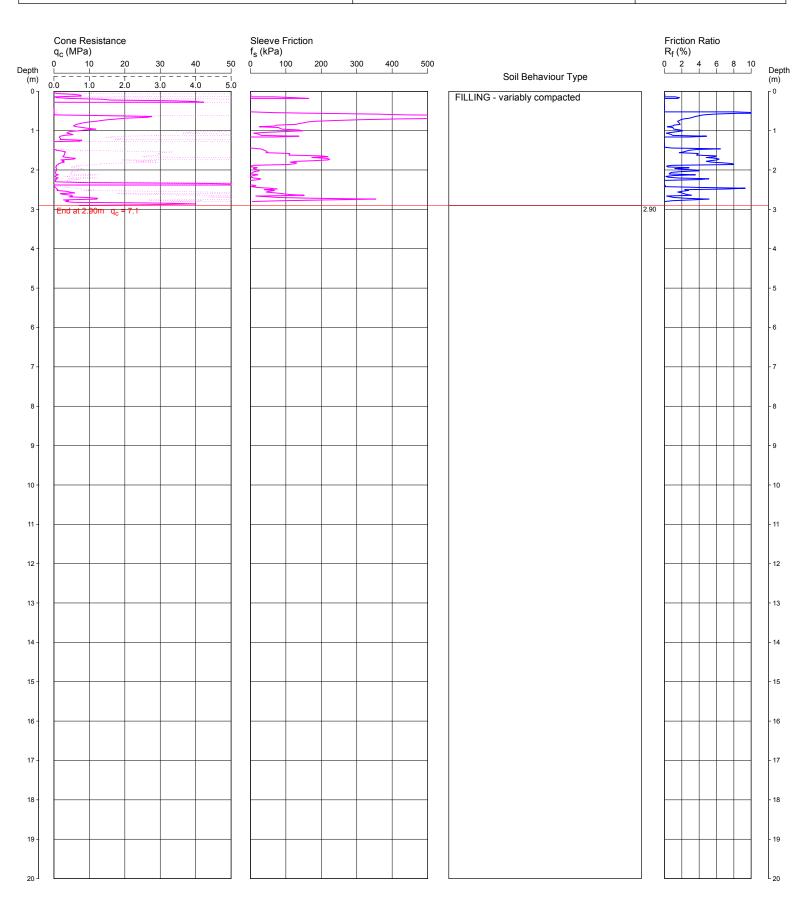
REMARKS: DUMMY CONE USED FROM 0.28 m TO 0.60 m, 1.26 m TO 1.50 m, 2.36 m TO 2.50 m AND 2.88 m TO 4.10 m DEPTH TO PENETRATE FILLING. HOLE DISCONTINUED DUE TO BENDING IN FILLING; NO WATER OBSERVED IN CPT HOLE AFTER WITHDRAWAL OF RODS.

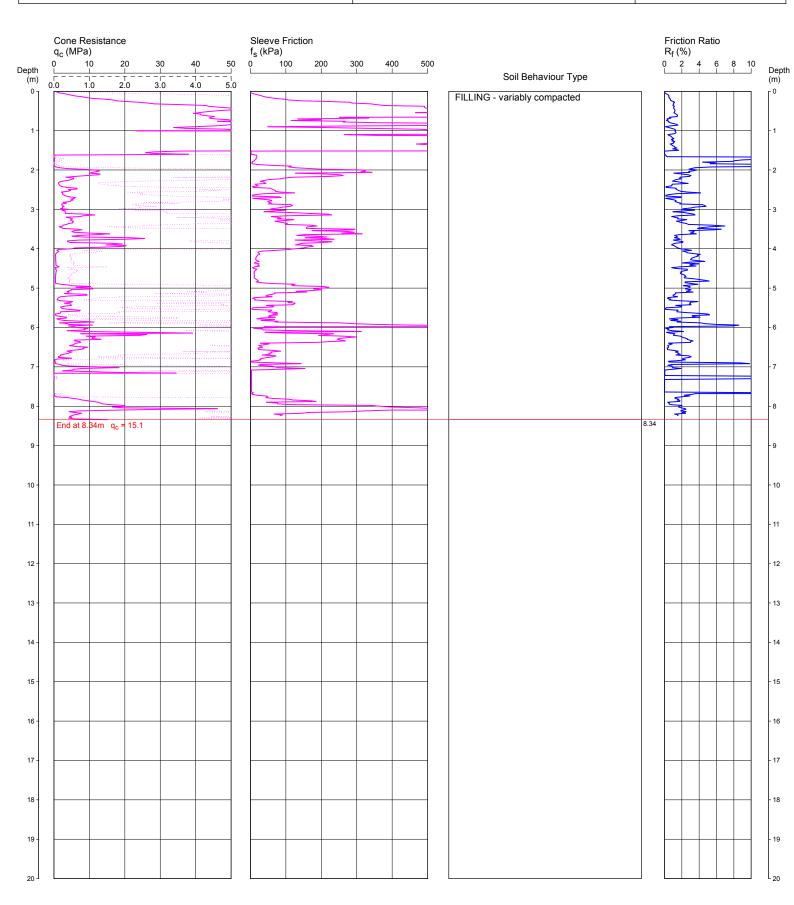
REMARKS: DUMMY CONE USED FROM 1.60 m TO 2.00 m, 7.16 m TO 7.80 m AND 8.34 m TO 10.40 m DEPTH TO PENETRATE FILLING. HOLE DISCONTINUED DUE TO REPLACEMENT WITH PIEZO-CONE; NO WATER OBSERVED IN CPT HOLE AFTER WITHDRAWAL OF RODS.

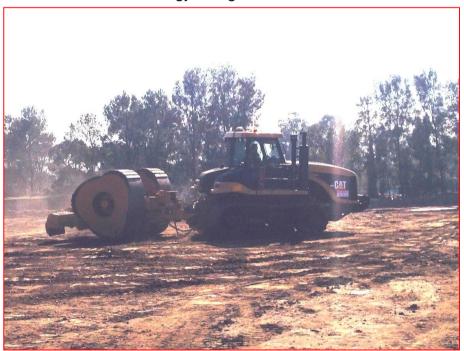
Impact compaction was used as a ground improvement means to alleviate the differential settlement in in-situ fill. The Impact Compaction was carried out using Landpac's 3-Sided Heavy Impact Compactor. Landpac's 3-Sided Heavy Impact Compactor has a Kinetic Energy rating of 160 kJ.

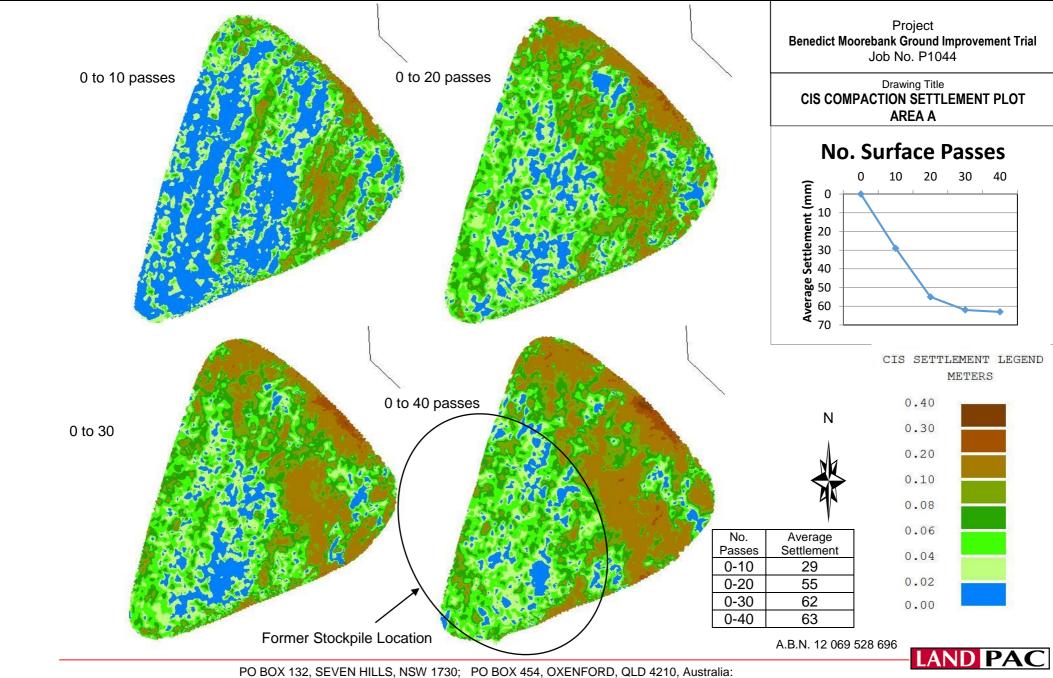
### 5. SOIL RESPONSE AND SETTLEMENT MONITORING RESULTS

Compaction settlements were measured from 0-40 passes (at 10 pass intervals) before a 'near zero' compaction settlement condition had been achieved.
