# APPENDIX 8

Wingham Urban Release Area 1

**Detailed Site Investigation - Contamination Assessment**

**Lot 92 DP1285477 Wingham Road, Wingham**

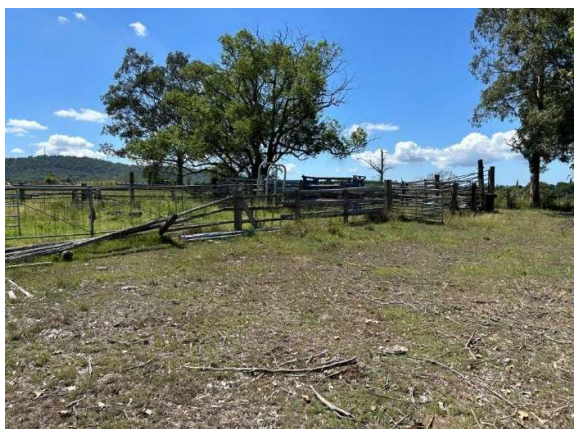
*Looking north near the site access from Wingham Road showing a cattle yard and livestock loading area.*

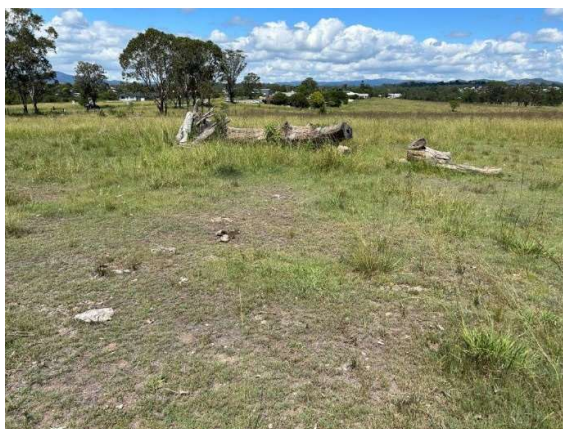
*Looking west showing an area of disturbed ground in the foreground and a vegetation stockpile in the background.*

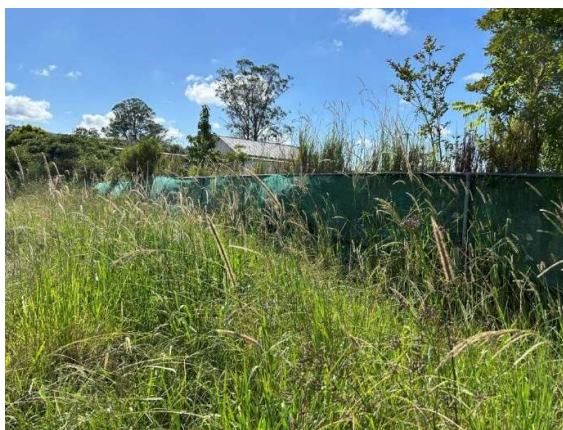
*Looking south-east at the rear of the former service station located at 1038 Wingham Road. The service station site has been remediated.*

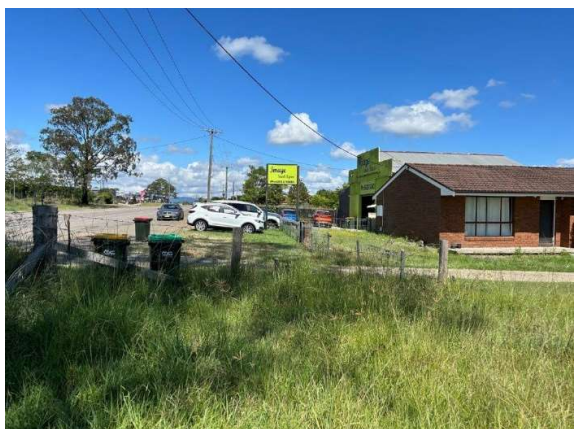
*Looking west in the southern part of the site showing an existing residence and operating smash repairer respectively which bound the site.*

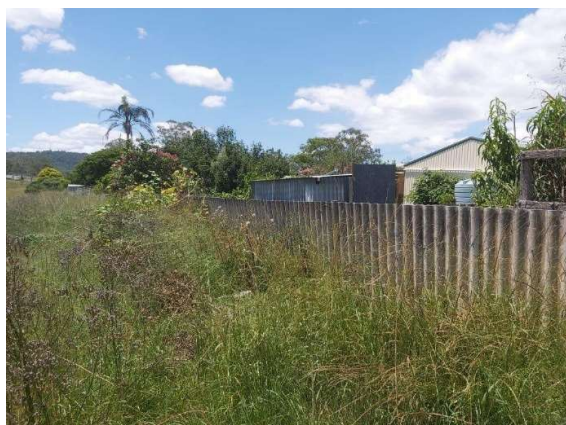
*Looking east in the southern part of the site showing a fence at the rear of some of the existing residences which is potential ACM.*

Some of the fencing at the rear of the residences which form the southern perimeter of the subject site could potentially be ACM. It would therefore be prudent to consult with the owners of these fences to ascertain if they are ACM and, if found to be so, discuss their removal and replacement. Should it be proposed to remove these fences during development of the site, an experienced occupational hygienist or environmental consultant should be sought to screen the fence materials for the presence of ACM. It is noted no fragments of these materials were observed on the ground surface at the time of investigation.

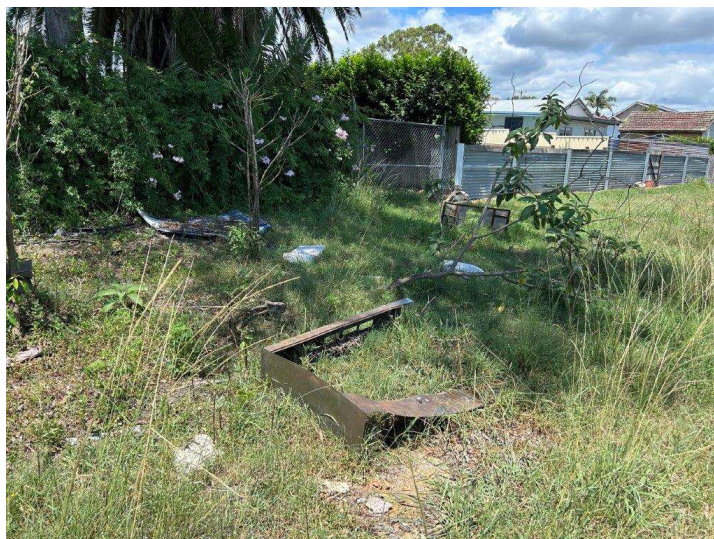
*Looking south-west in the southern part of the site showing a stockpile of waste materials located at the rear of No. 1058 Wingham Road.*

The recommendations made by PSI remain valid. However, waste materials including an old car bonnet, scrap metal, timber, concrete, vegetation, mattresses, timber, rope, plastic and domestic rubbish stockpiled at the rear of No. 1058 Wingham Road in the southern part of the site which were identified during the PSI are understood to have since been removed. The cattle yard and livestock loading area located to the east of the smash repairer near the intersection with Youngs Road, should be removed and appropriately disposed of, if and when it is no longer actively used.

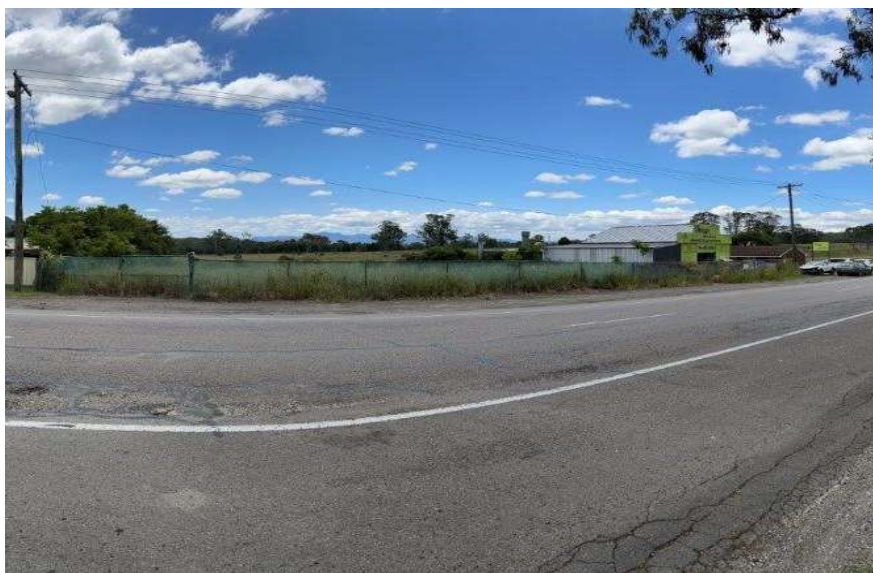
Street view on Wingham Road showing the former service station site (green fencing) and adjoining operating smash repairer to the east (yellow signage).

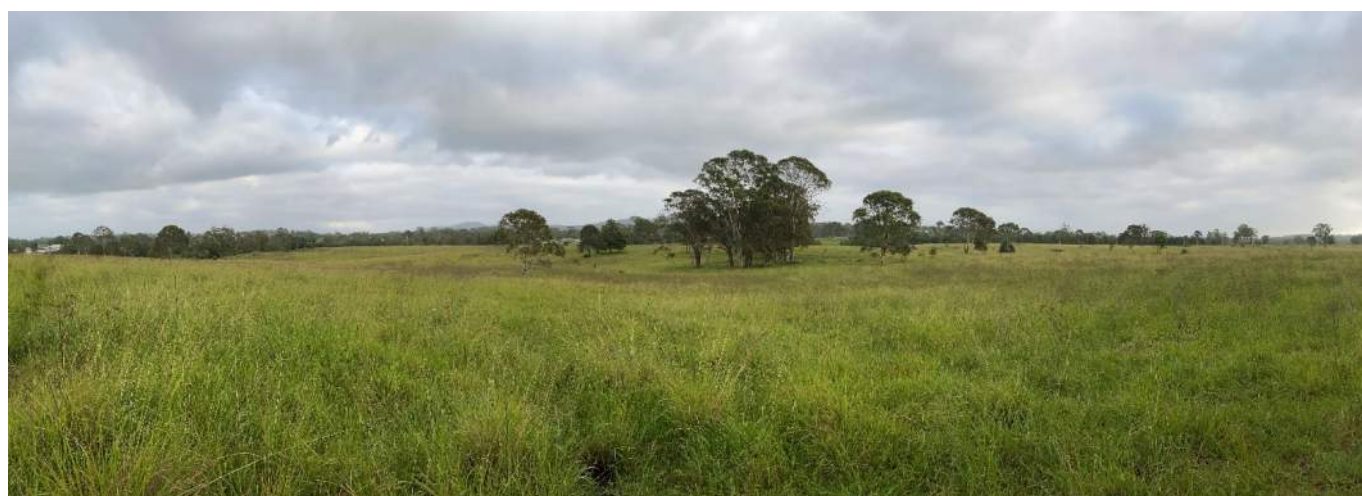
**Photograph 1** – Panoramic image taken from adjacent to the sites southern boundary panning west through east

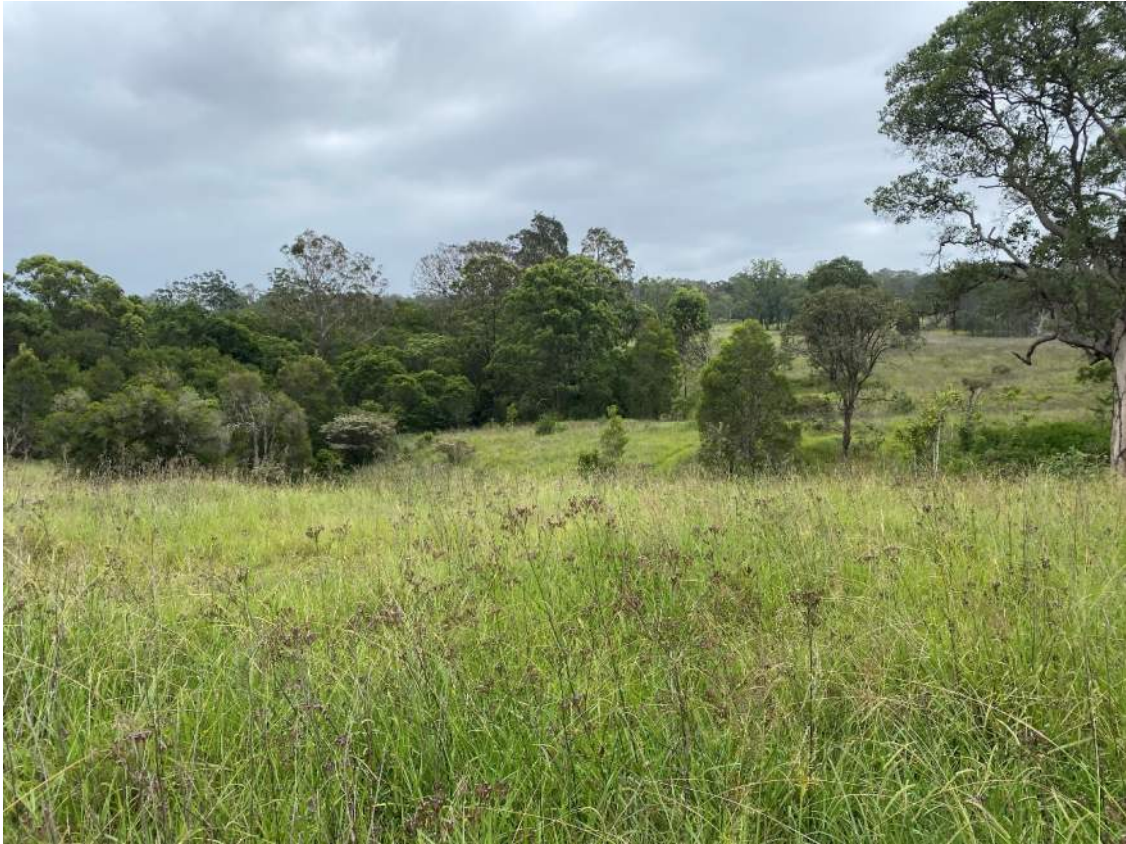
**Photograph 2** – taken in the northern portion of the site noting tree density adjacent to Cedar Party Creek

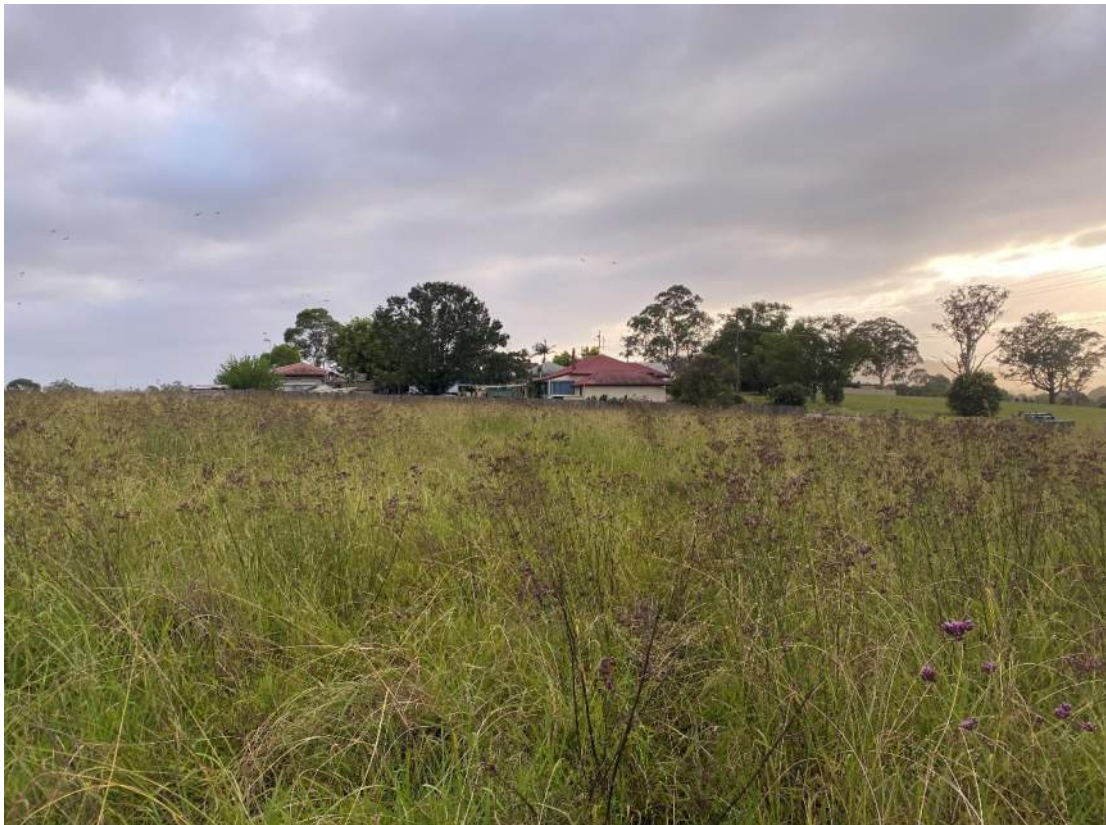
**Photograph 3** – taken in the western portion of the site looking east across existing bordering residential Lots – note Wingham Road to the right
