# **REMEDIATION ACTION PLAN (RAP)**

**ELAMBRA WEST**

**48 CAMPBELL STREET  
LOT 2 / DP 1168922  
GERRINGONG, NSW, 2534**

Prepared For: **Allen Price & Scarratts c/ Pearce & Campbell**  
Project Number: **ENRS2069**  
Date: **February 2022**

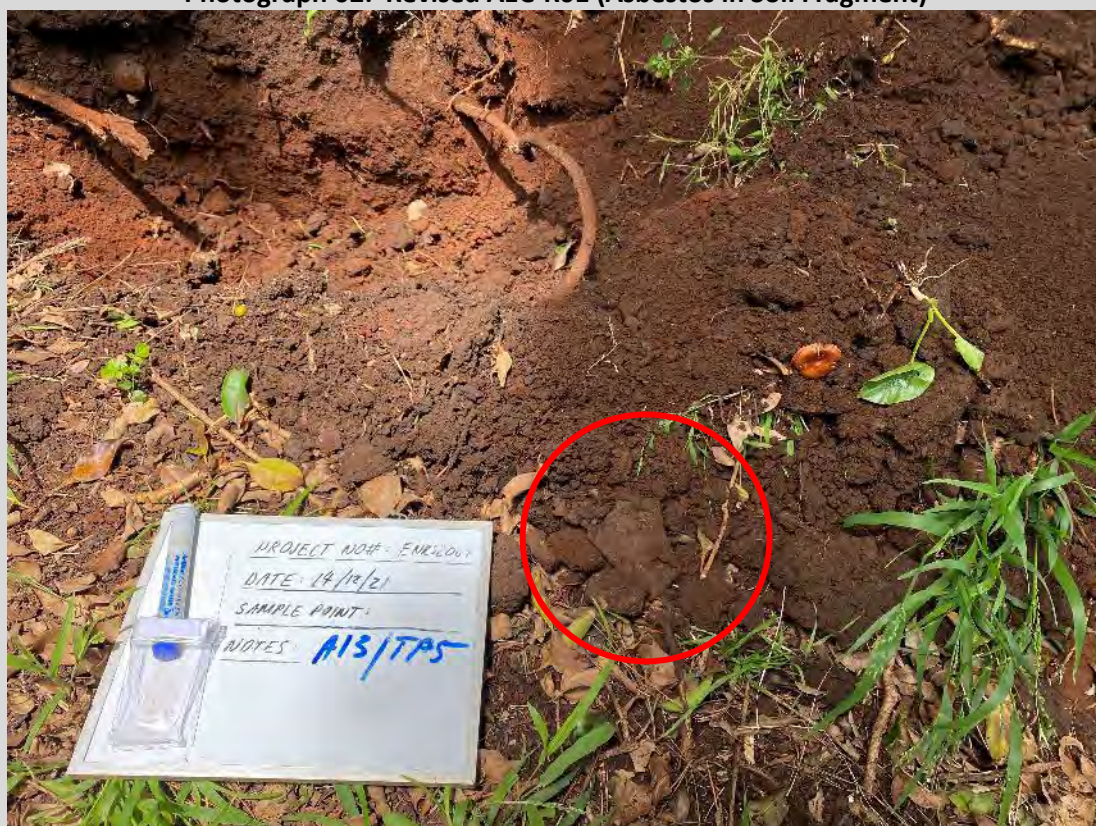
Photograph 02: Revised AEC-R01 (Asbestos in Soil Fragment)

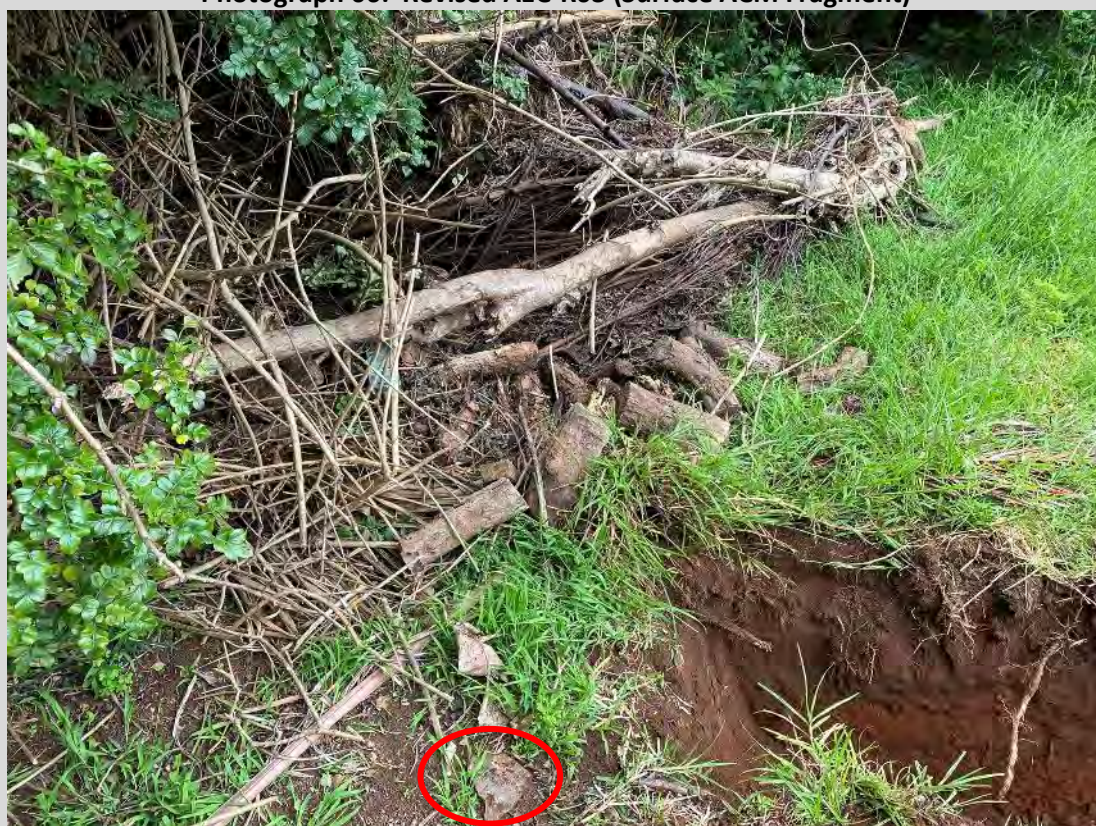
**Photograph 06: Revised AEC-R03 (Surface ACM Fragment)**

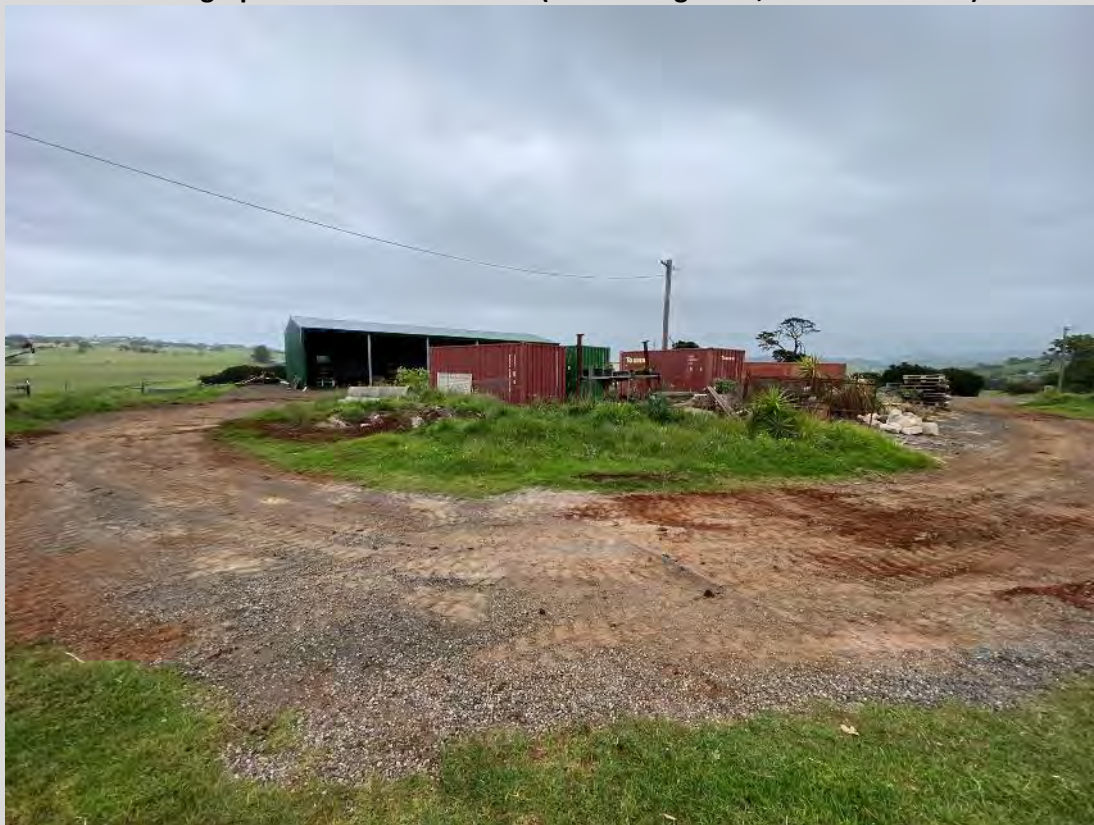
**Photograph 07: Revised AEC-R04 (Gravel Ring Road, Friable Asbestos)**

- **Excavate Contaminated Material** – Excavate remaining asbestos impacted soil from areas delineated in **Figure 7** and **Figure 8**. Note, material from AEC-R04 is to be placed at the base of the encapsulation cell. Works may require supervision by an experienced contaminated land professional to identify and separate Fill/items not suitable for encapsulation. The disturbance of asbestos contaminated soil to be conducted under asbestos removal control conditions with PPE and dust suppression. Load asbestos materials directly into encapsulation area. Should material be required to be stockpiled temporarily the stockpile shall be managed in accordance with **Section 11.6** of this document;

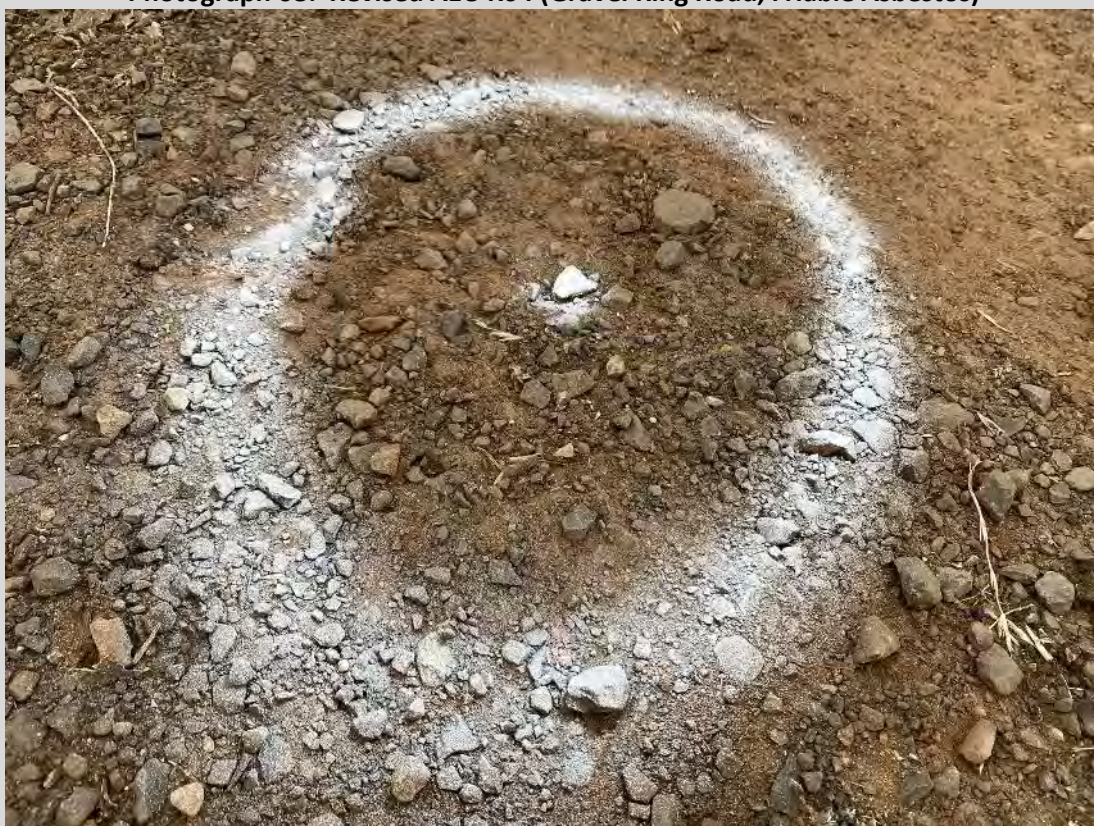
**Photograph 08: Revised AEC-R04 (Gravel Ring Road, Friable Asbestos)**

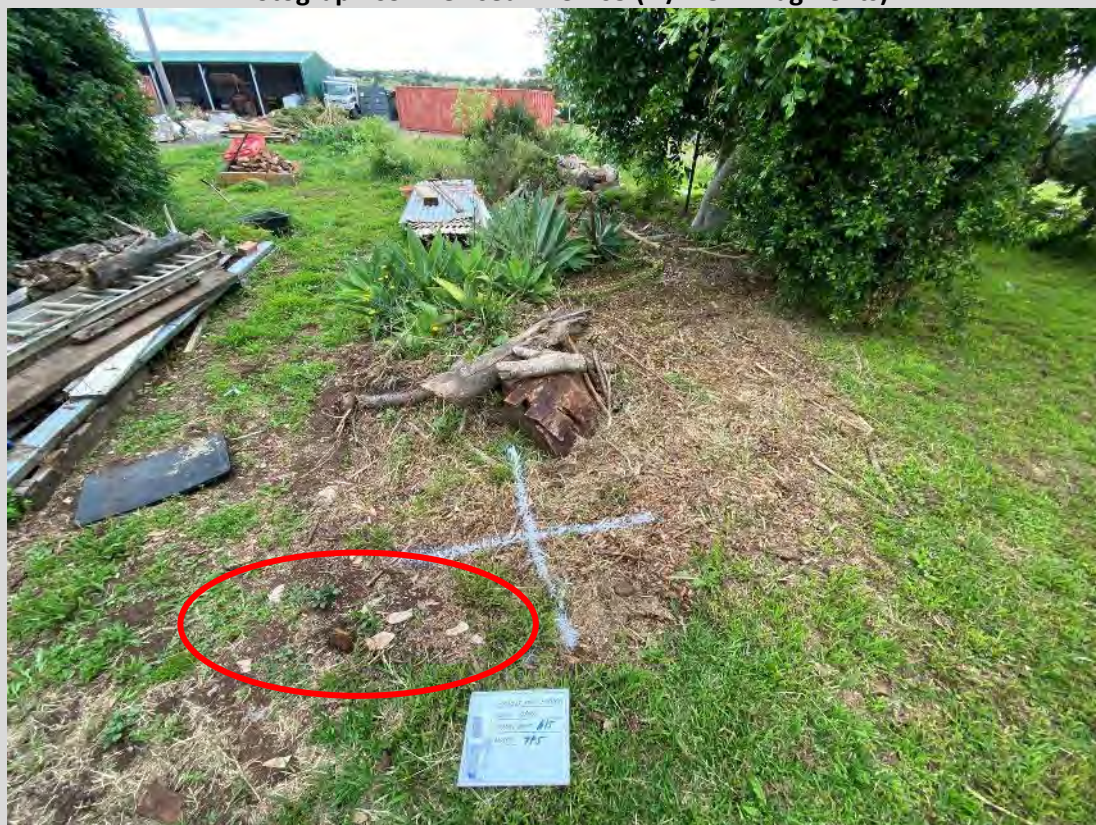
**Photograph 09: Revised AEC-R05 (w/ ACM Fragments)**

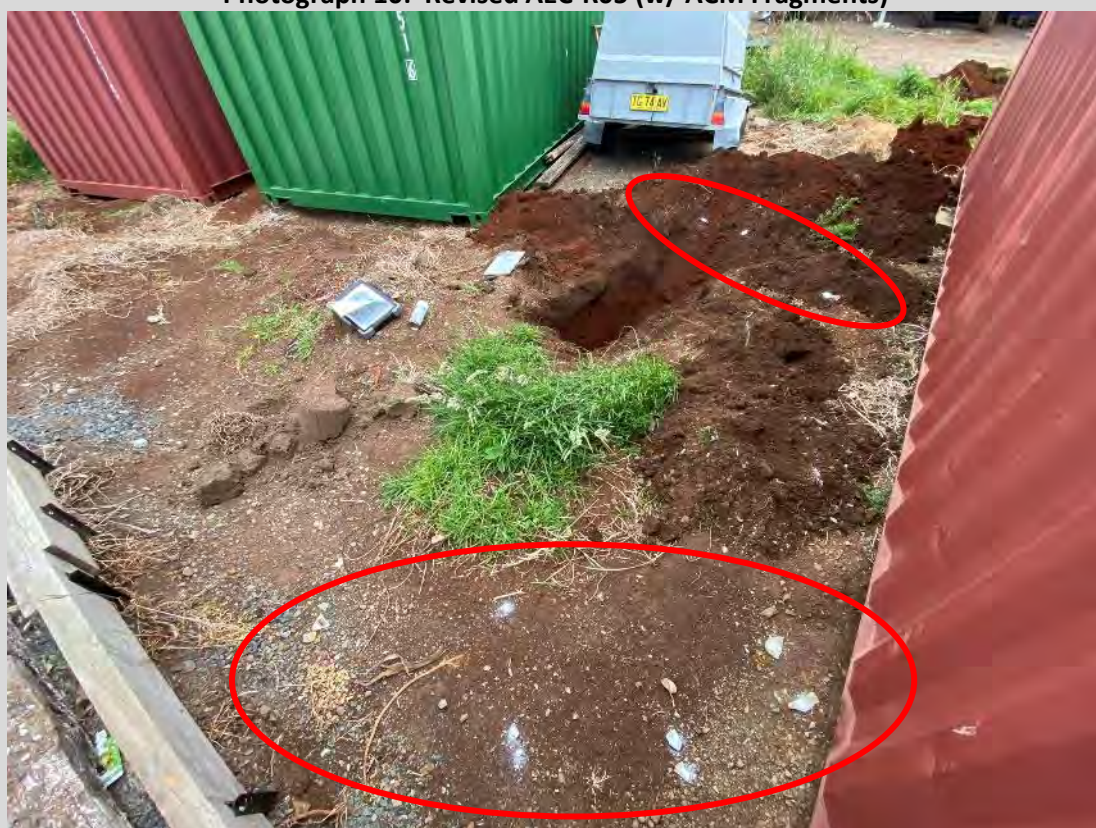
**Photograph 10: Revised AEC-R05 (w/ ACM Fragments)**

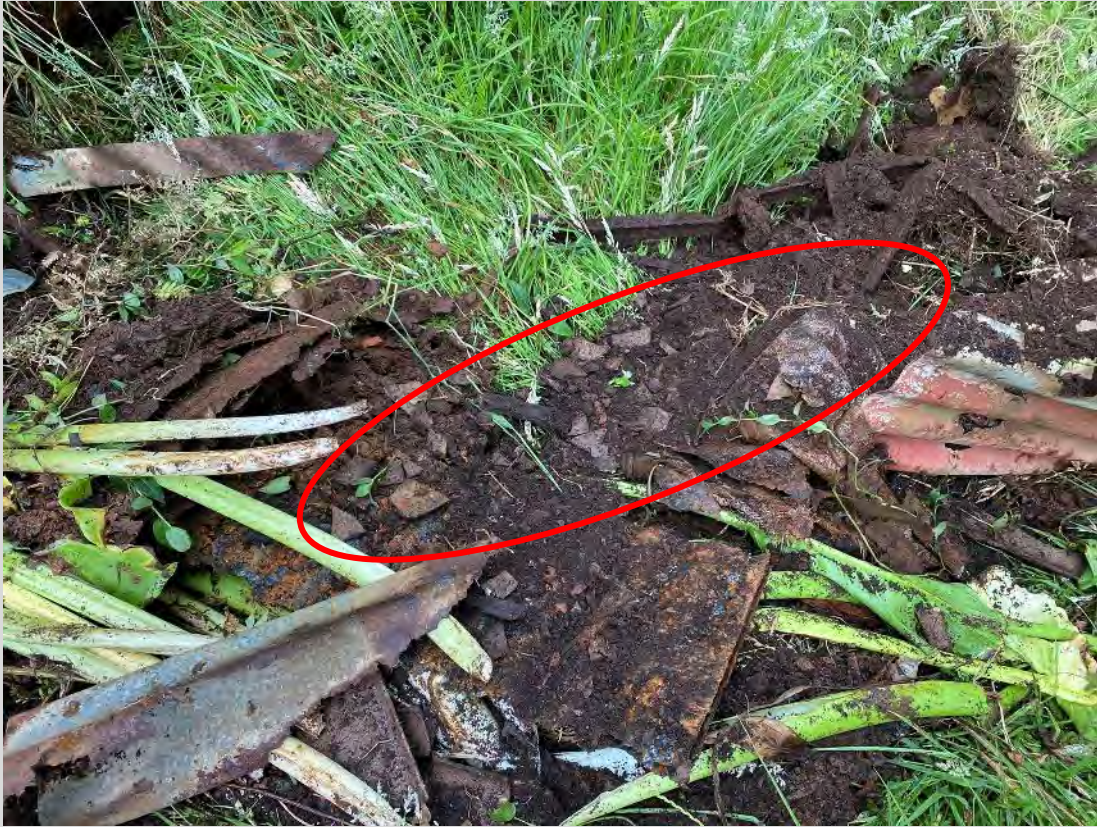
**Photograph 13: Revised AEC-R06 (w/ ACM Fragments)**
