### **Mosman Masterplan – Desktop Phase 1 Environmental Site Assessments**

162A Spit Road, Mosman NSW

| | Project Name: | Stage 1 Preliminary Site Investigation | | Figure Date: | 14 July 2026 |
| | Project Location: | 162A Spit Road, Mosman NSW | | Report Number: | 3861-PSI-01-140726.v1f |

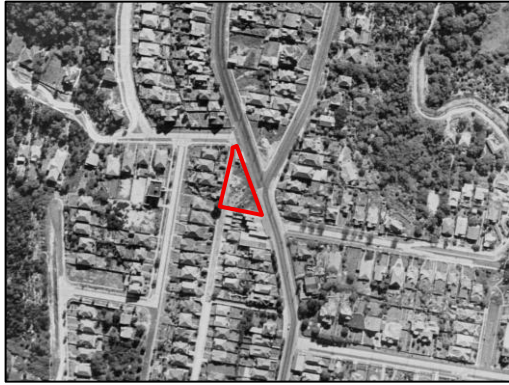
**Historical Aerial 1.** 1943 historical aerial imagery of the site.

| Image Date | Site Features | Surrounding Land Use Settings |
|---|---|---|
| 1943 | The site is observed to comprise landscaped land with a structure to the north of the site. | Dense low-density residential district with roadways observed. A commercial/industrial property observed to the south of the site and roadways directly along the remaining site boundaries. |

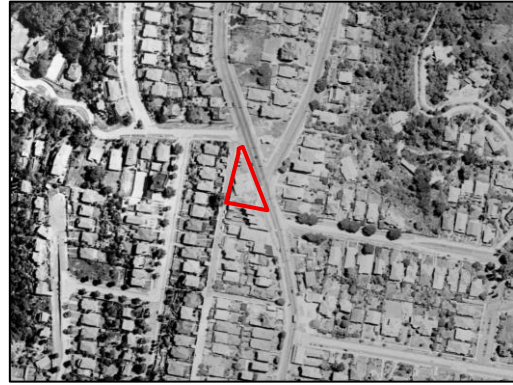
| Image Date | Site Features | Surrounding Land Use Settings |
|---|---|---|
| 1955 | Demolition of the northern structure and construction of a commercial structure(s) to the centre of the site is observed. | No significant changes observed. |

**Historical Aerial 2.** 1955 historical aerial imagery of the site.

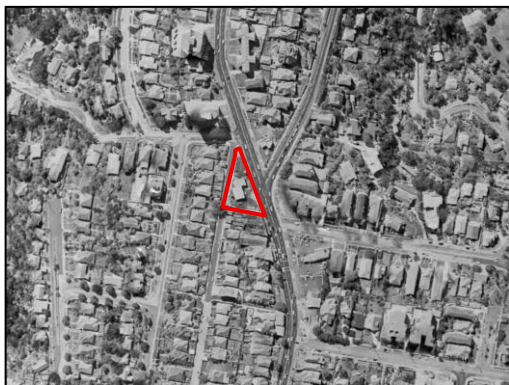
**Historical Aerial 3.** 1965 historical aerial imagery of the site.

| Image Date | Site Features | Surrounding Land Use Settings |
|---|---|---|
| 1965 | No significant changes observed. | Upgrade to 'Spit Road' observed to the eastern site boundary. Demolition of previous structures and construction of commercial and high-density residential structures observed to the north and southeast. |

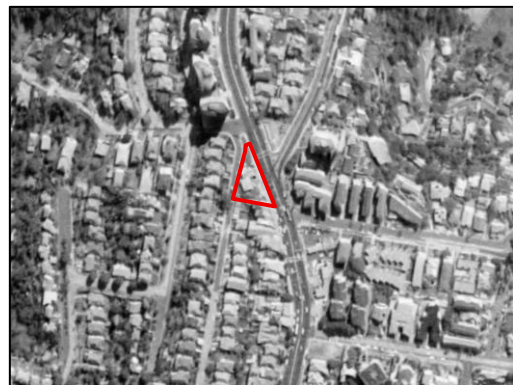
| Image Date | Site Features | Surrounding Land Use Settings |
|---|---|---|
| 1975 | No significant changes observed. | Further commercial and high-density residential structures observed to the north and southeast. |

**Historical Aerial 4.** 1975 historical aerial imagery of the site.

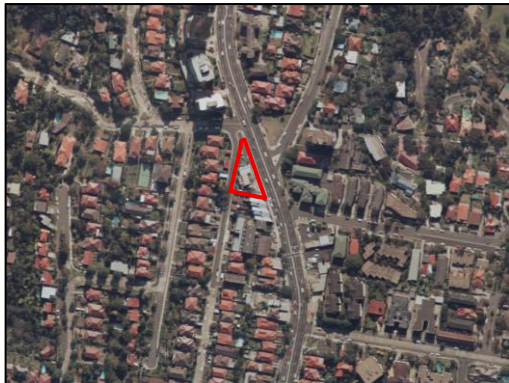
**Historical Aerial 5.** 1982 historical aerial imagery of the site.

| Image Date | Site Features | Surrounding Land Use Settings |
|---|---|---|
| 1982 | No significant changes observed. | No significant changes observed. |

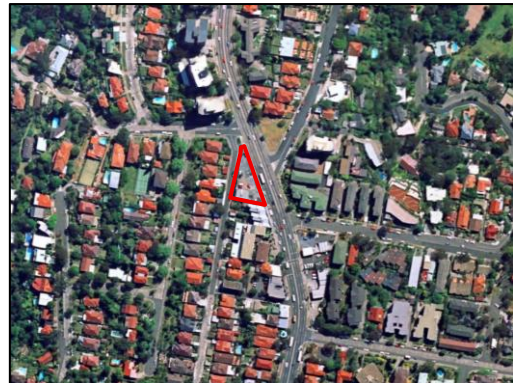
**Historical Aerial 6.** 1994 historical aerial imagery of the site.

| Image Date | Site Features | Surrounding Land Use Settings |
|---|---|---|
| 1994 | Observations included demolition of previous structure(s) and construction of a smaller commercial structure to the southwest. | No significant changes observed. |

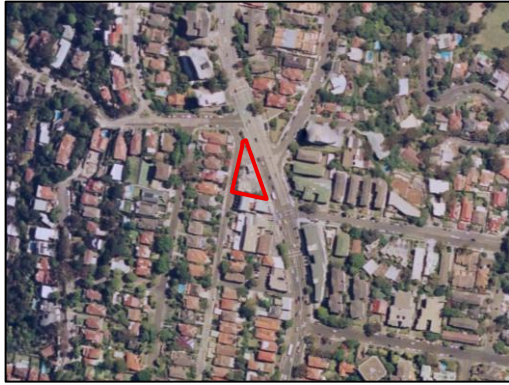
**Historical Aerial 7.** 2005 historical aerial imagery of the site.

| Image Date | Site Features | Surrounding Land Use Settings |
|---|---|---|
| 2005 | An additional structure in the centre of the site observed. | Demolition of existing commercial structures and construction of a large commercial building to the southeast observed. |

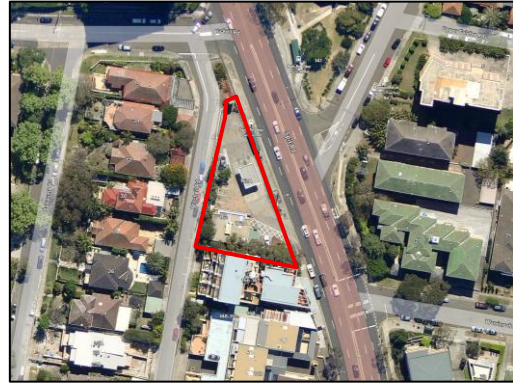
| Image Date | Site Features | Surrounding Land Use Settings |
|---|---|---|
| 2013 | The site is observed to consist of hardstand with landscaping to the north of the site, a building to the southwest and petrol pumps to the centre of the site. | No significant changes observed. |

**Historical Aerial 8.** 2013 historical aerial imagery of the site.

Due to the likely presence of petroleum contamination, waste classification of the soils may result in hazardous or restricted waste. Due to the site history, soils cannot be classified as virgin excavated natural material (VENM). If no contamination is found within the soils, following waste classification per NSW EPA 2014, the soils may meet criteria for excavated natural material (ENM) or General Solid Waste (GSW). Waste management and testing costs must be factored into budgeting.

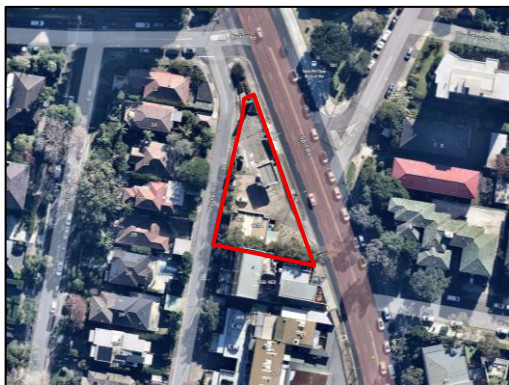
**Historical Aerial 9.** 2026 historical aerial imagery of the site.

| Image Date | Site Features | Surrounding Land Use Settings |
|---|---|---|
| 2026 | No significant changes observed. | No significant changes observed. |
