Stevens Group Pty Ltd

VEGETATION MANAGEMENT PLAN

Lot 4 & 5 DP 838537
Pat O'Leary Drive, Kelso

FLOOD STUDY
Pat O'Leary Drive proposed development
Kelso, N.S.W.

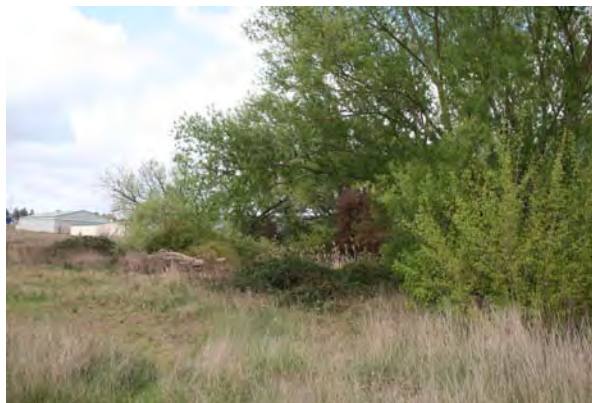
Photo 2: *Salix Spp.* adjacent to creek.

The creek in the subject area is in a poor state with Willows, Apple Trees, Chinese Elm and other exotics forming the upper strata and the lower strata being comprised of Blackberry and African Box-thorn and introduced grasses. The creek banks are unstable with erosion evident where the root systems of the Willows are not stabilising the soil. Detritus stuck in the trees indicates that the in a heavy rainfall the creek can have heavy flows rates. Aquatic and macrophyte weeds are evident in the creek itself with Bullrush and *Alternanthera Spp.* being identified on site.

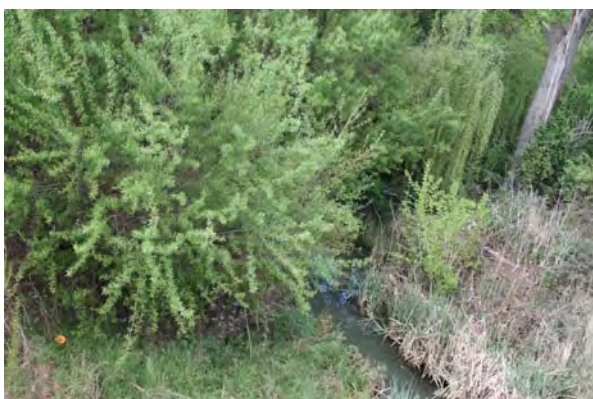
Photo 3: Photograph taken from roadbridge showing creek line and weed infestation.

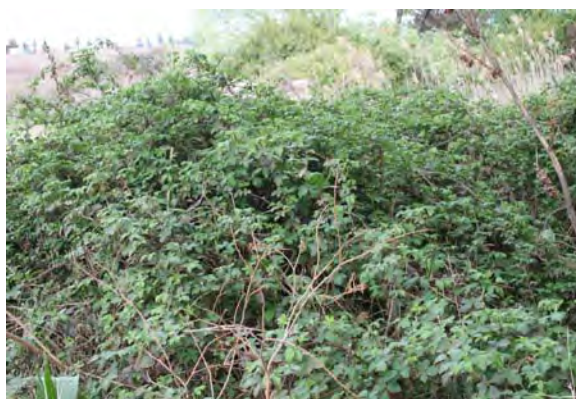
Photo 4: Heavy stands of *Rubus Spp.* are prevalent adjacent to the creek.

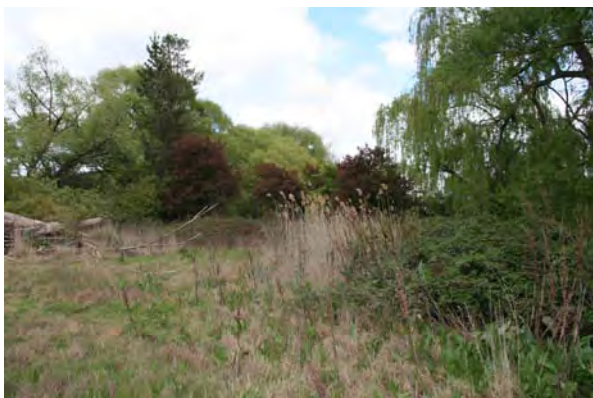
Photo 5: Stands of *Malus Spp.* and *Salix Spp.*

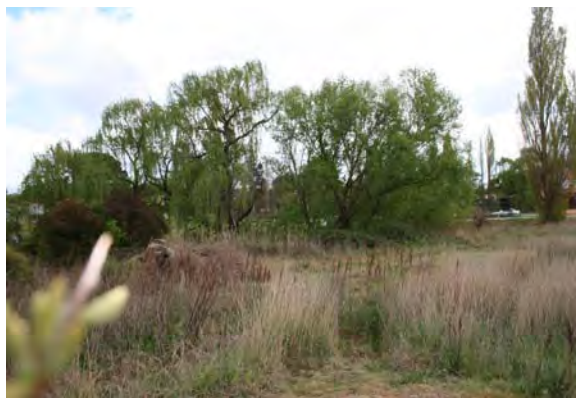
Photo 6: Looking north towards the roadbridge with stands of *Salix Spp.* heavily present to the site.

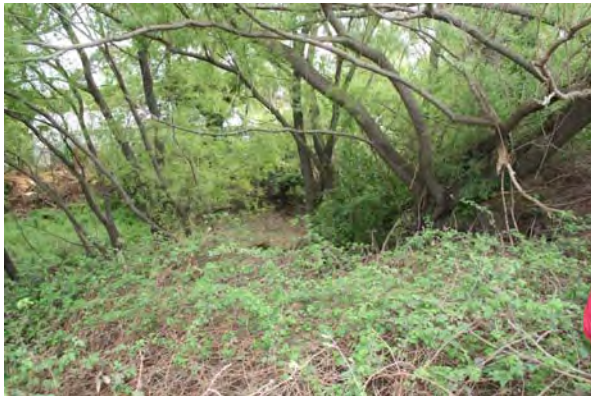
Photo 6: Looking into the creek bed from the top of bank.

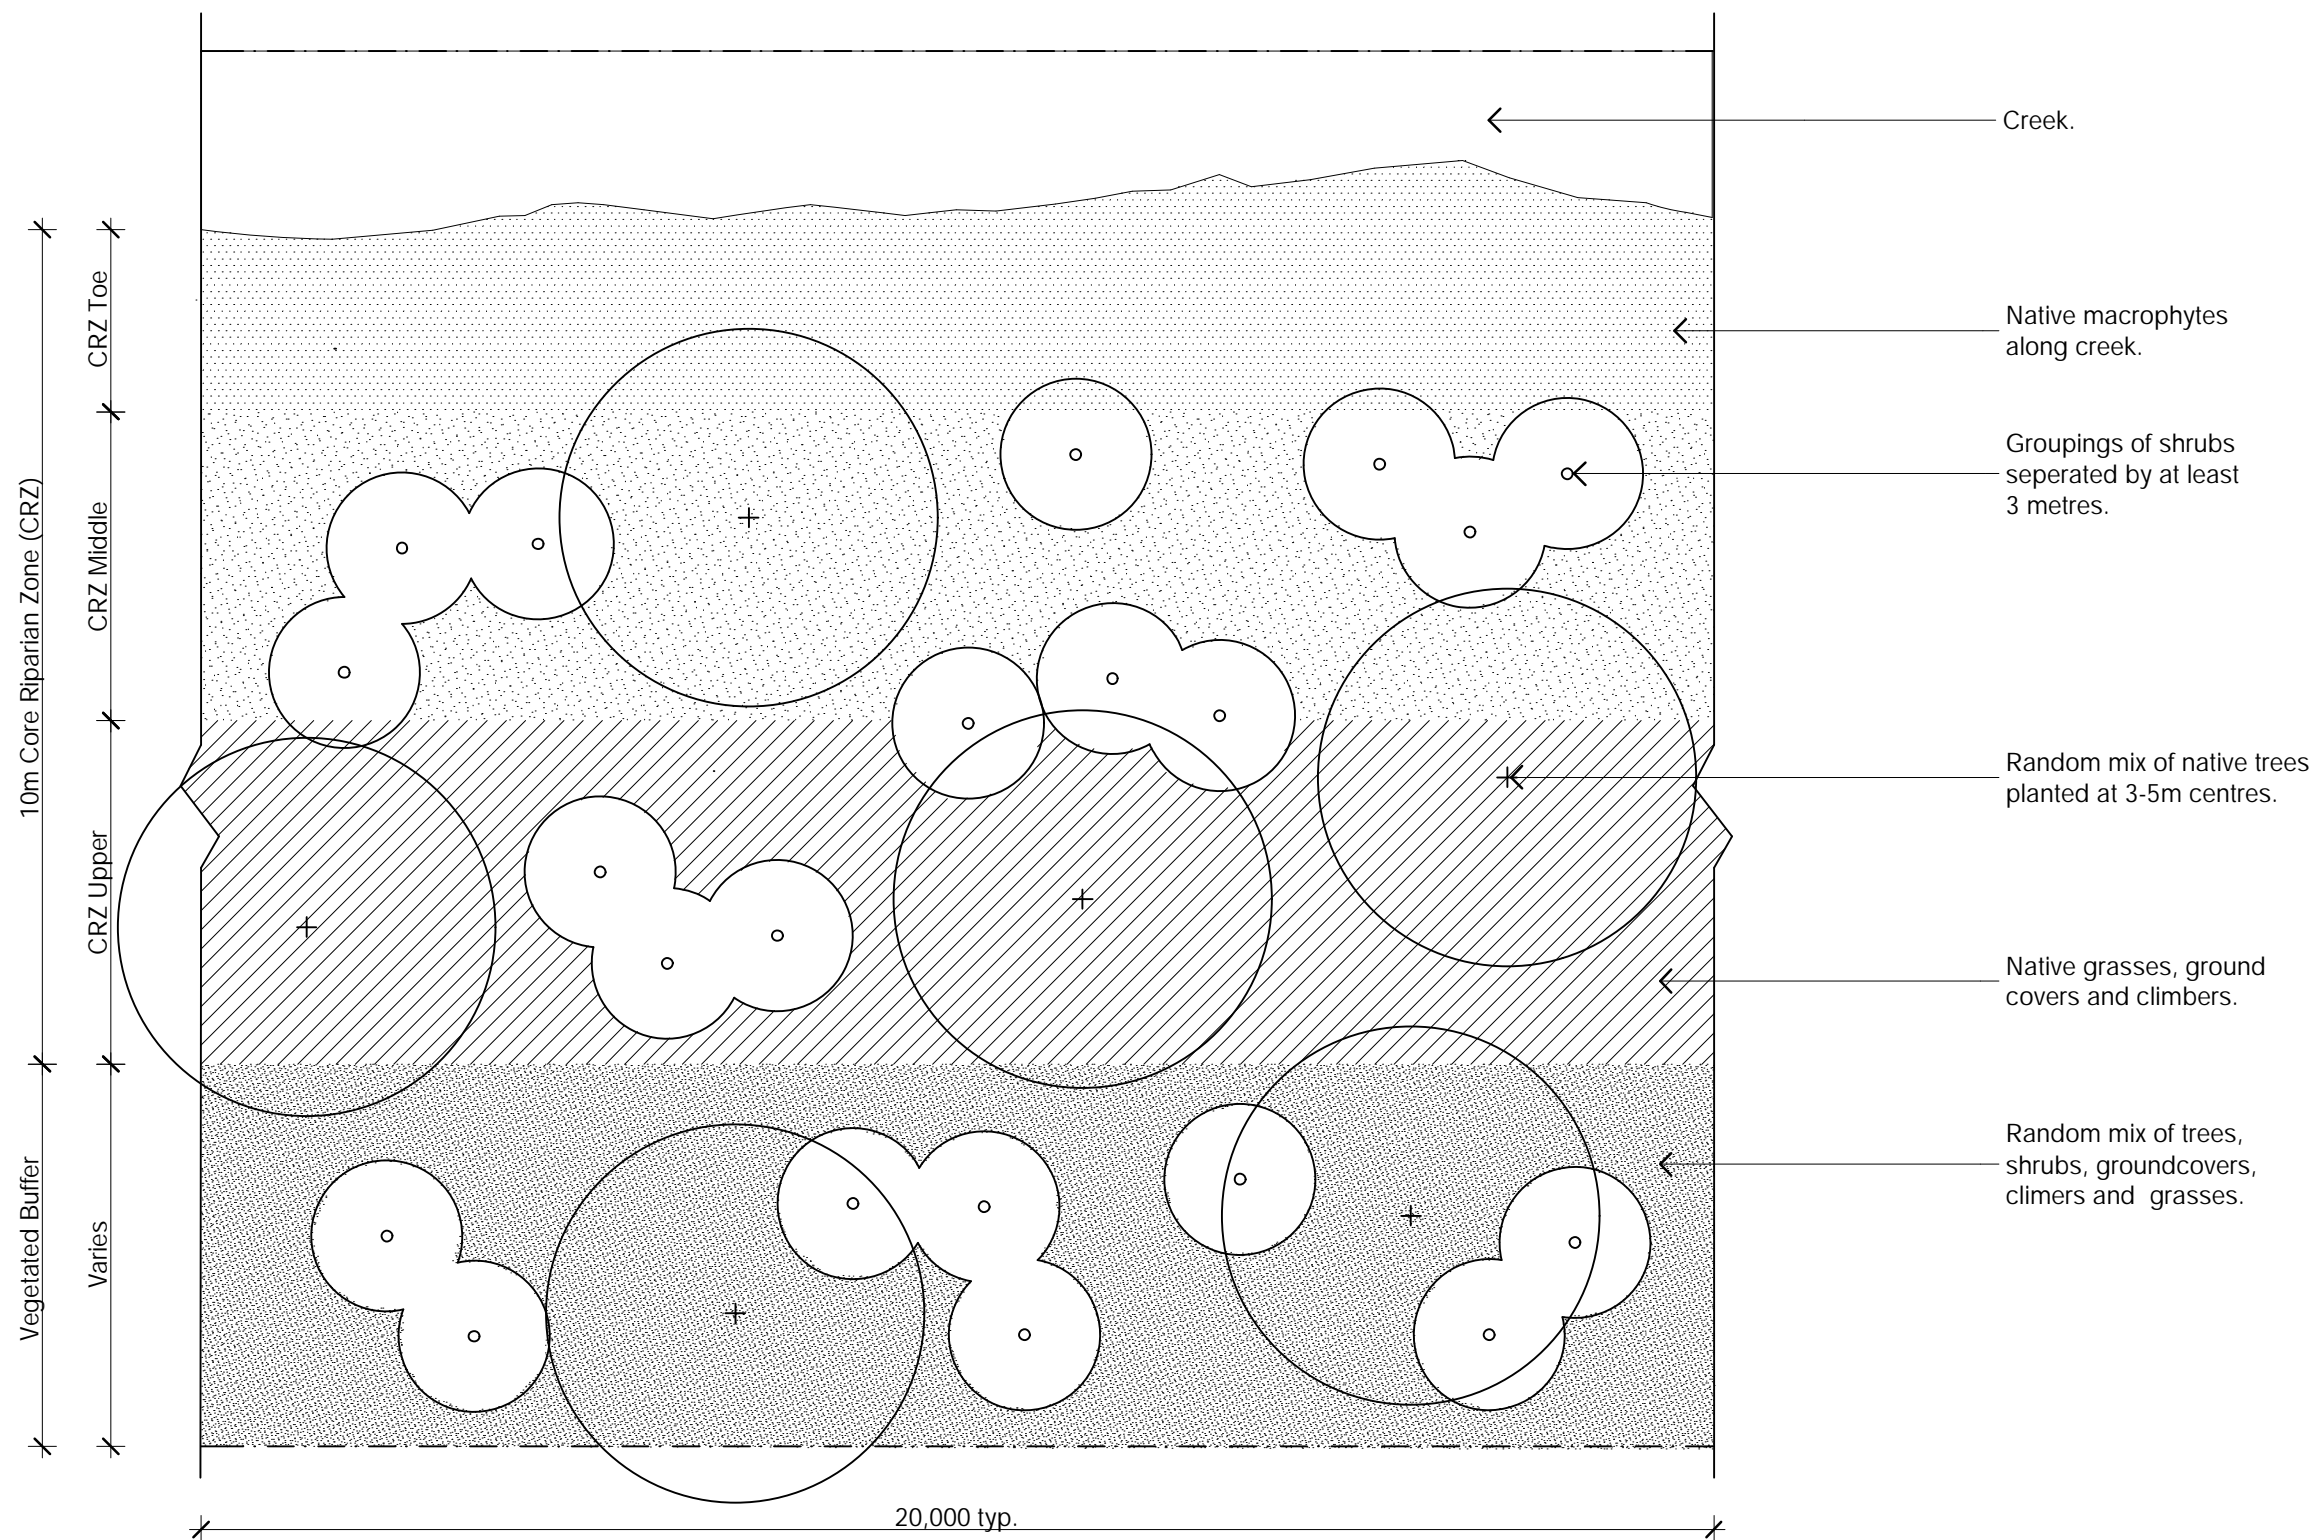
DETAIL 1 - TYPICAL RIPARIAN CORRIDOR PLAN 1:100

KEY	SPECIES	SIZE	SPACING
MACROPHYTES			
	Juncus usitatus	Tubestock	4/m ²
	Eleocharis sphacelata	Tubestock	4/m ²

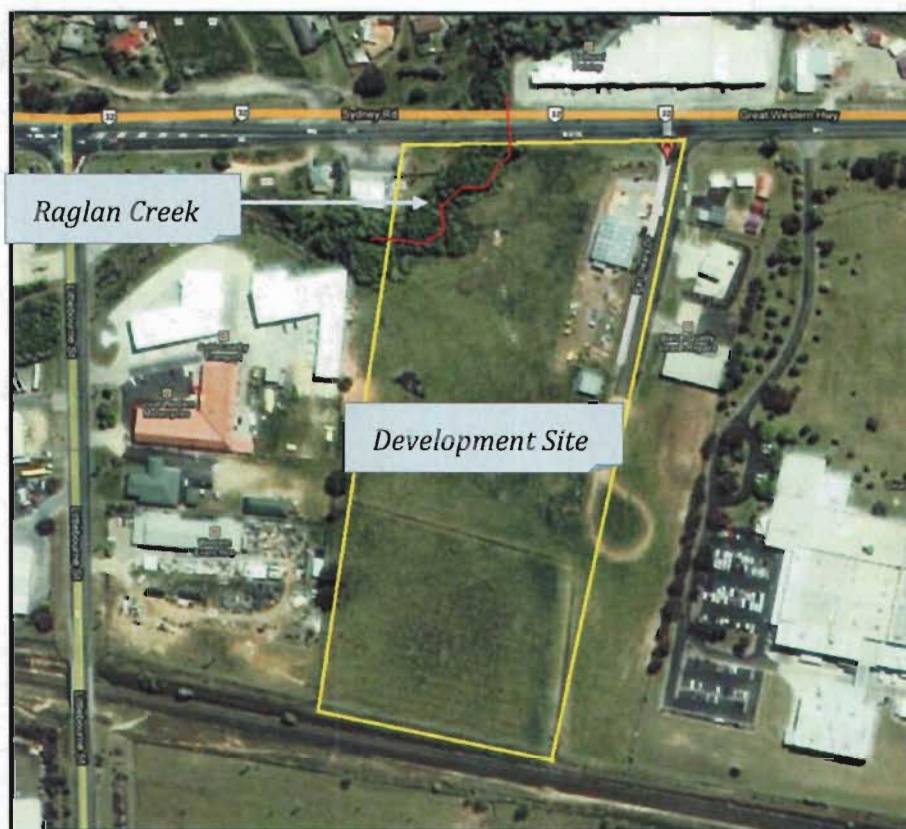
Figure 1 Pat O'Leary Drive Proposed Development Site. The Red Line Represents The Stretch Of Raglan Creek Being Modelled

The proposed development site is bounded by Pat O'Leary Drive, the Great Western Highway and the railway line in Kelso, NSW and incorporates a total area of approximately 5.78 Ha. From site observations, the majority of the site has been cleared of natural vegetation, with grass now covering much of the site. The site has very little vegetation growth with the exception of the north-western boundary where Raglan Creek traverses the site. This channel has very dense vegetation growth and the channel itself is quite deep, approximately 4m, with steep banks. The deep geometry allows it to contain relatively high flows compared to the runoff derived from the contributing catchment. Figure 1 below depicts the proposed development site and Raglan Creek.

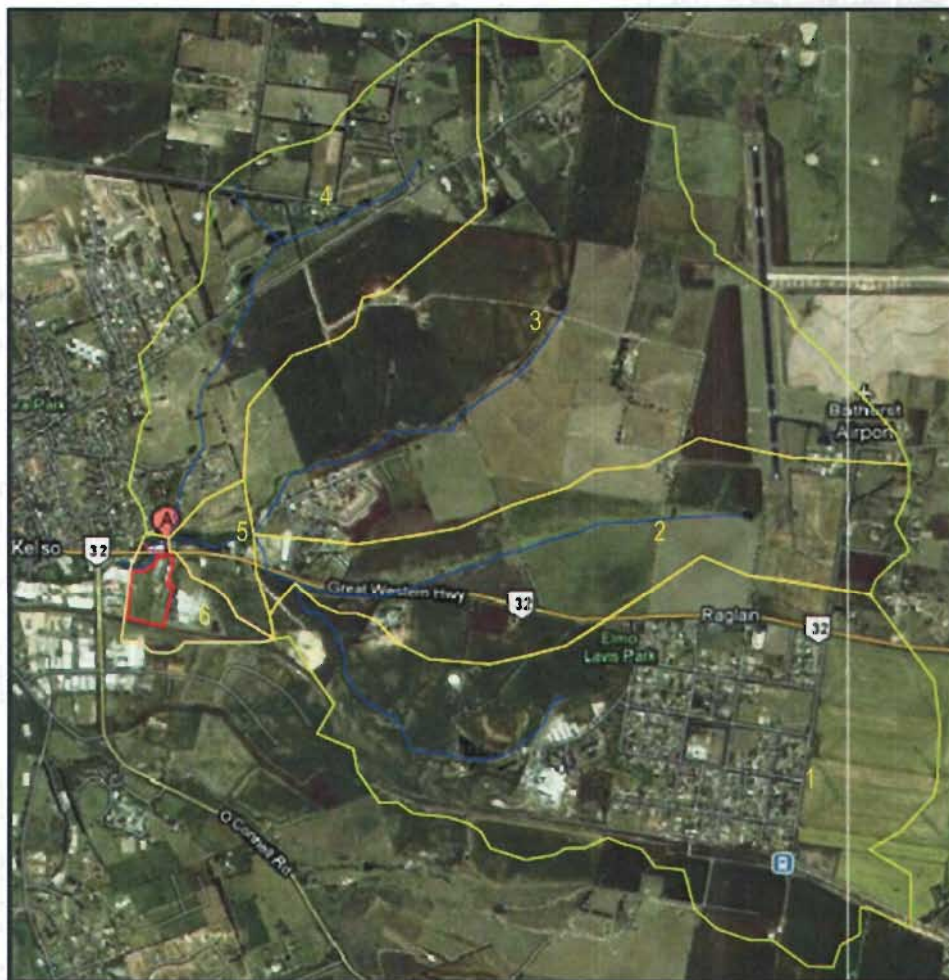
Figure 2 Sub Catchments Entering Raglan Creek, The Red Polygon Represents Pat O'Leary Drive Proposed Development Site.

streams. The other catchment, which is to be altered by the proposed development, contributes to Raglan Creek at station 79.43 as opposed to the entrance of the site for modelling purposes. These subcatchments are illustrated in Figure 2 below.

From Figure 2 above it can be seen that subcatchment 1 routes into subcatchment 2. Subcatchments 2 and 3 route into 5 and subcatchments 4 and 5 then flow along Raglan Creek traversing the development site. Subcatchment 6 then enters Raglan Creek partway within the site.
