Proposed Telecommunications Facility located at Lot 1 DP 114469, 15C Jetty Point Drive, Murrays Beach, NSW, 2281

Planning Report

Additional Information for DA1601/2010 - Telecommunications Facility Lot 1 DP 114469. 15C Jetty Point Drive, Murrays Beach, NSW, 2281

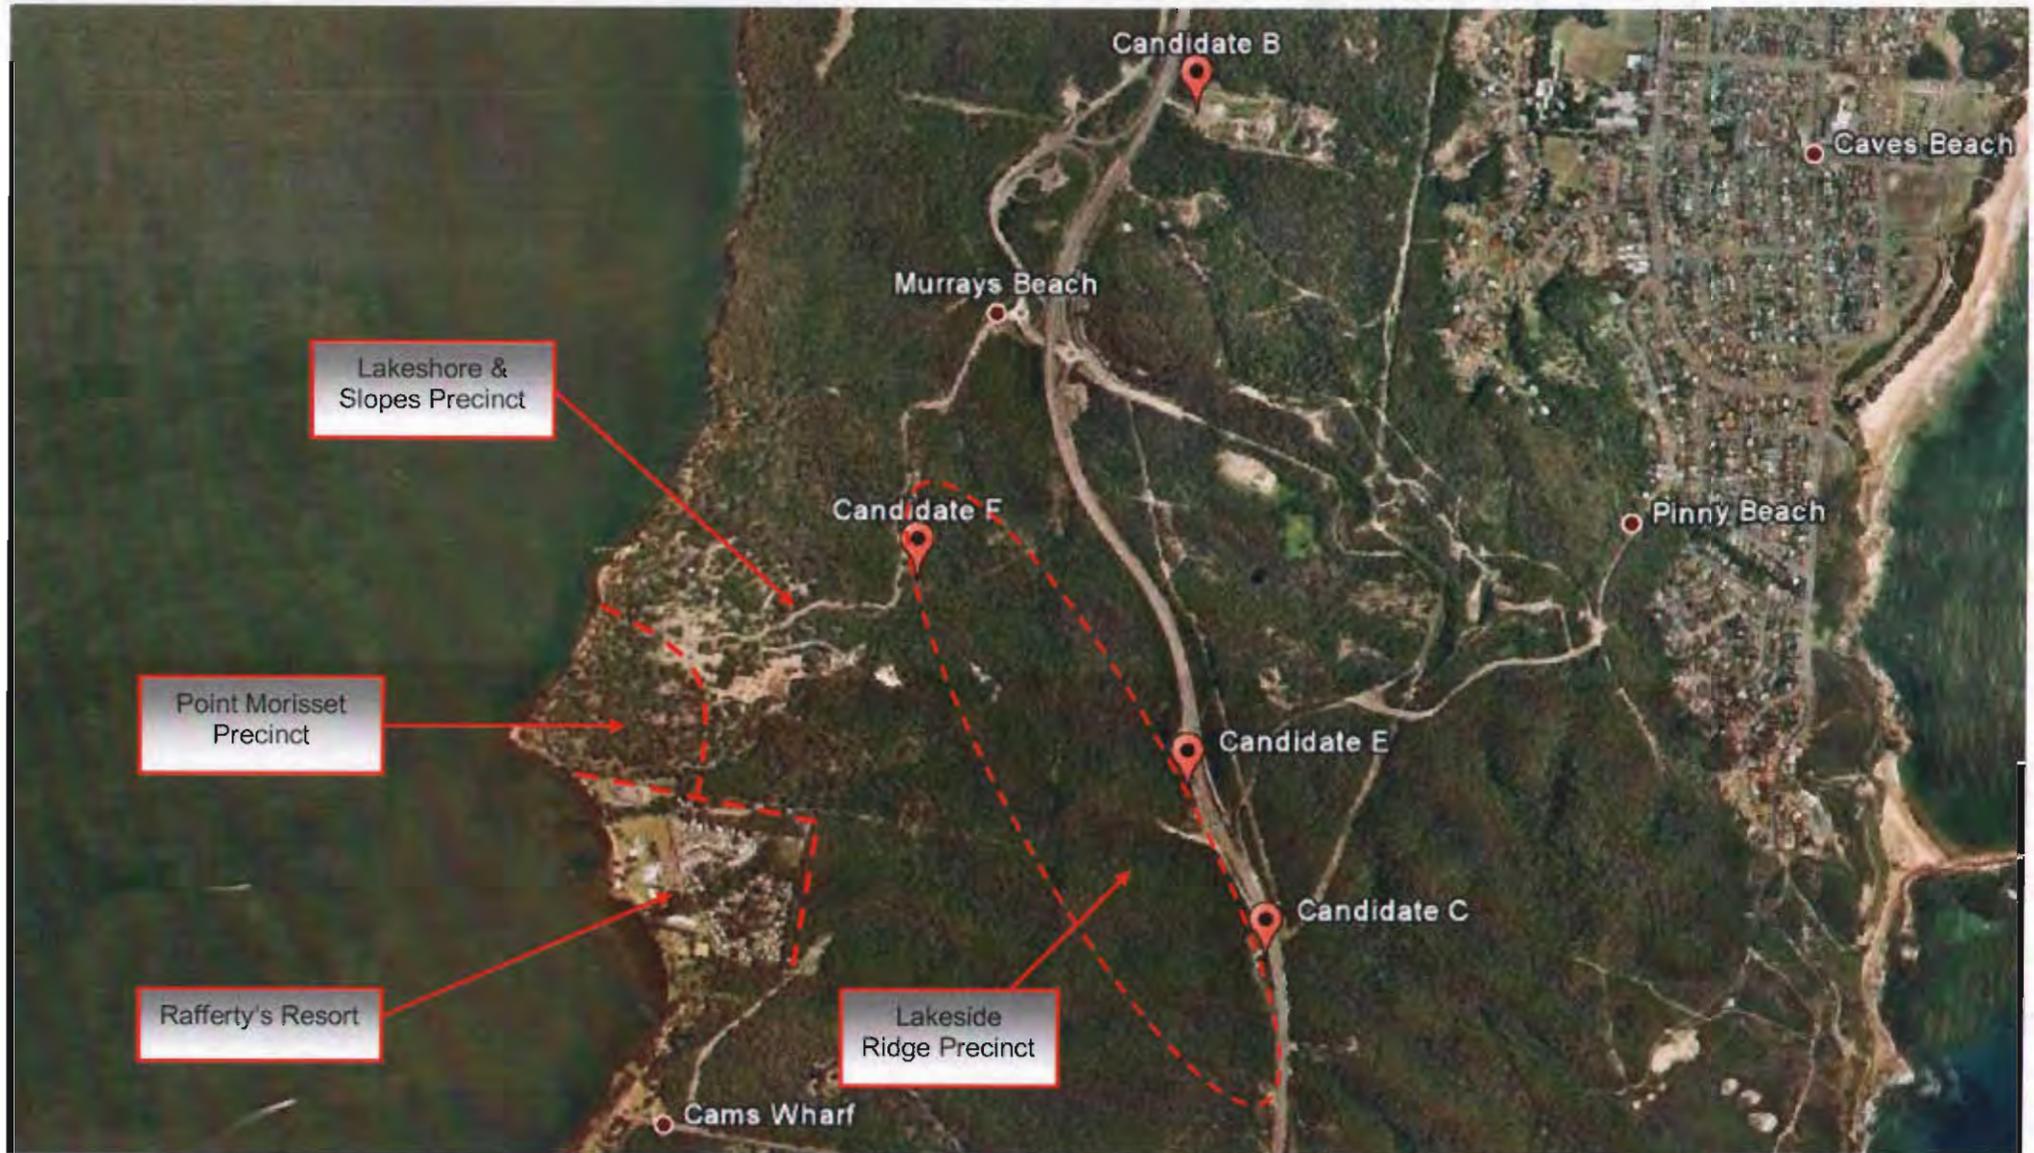
Figure 1 – Map of Candidates within the North Wallarah area.

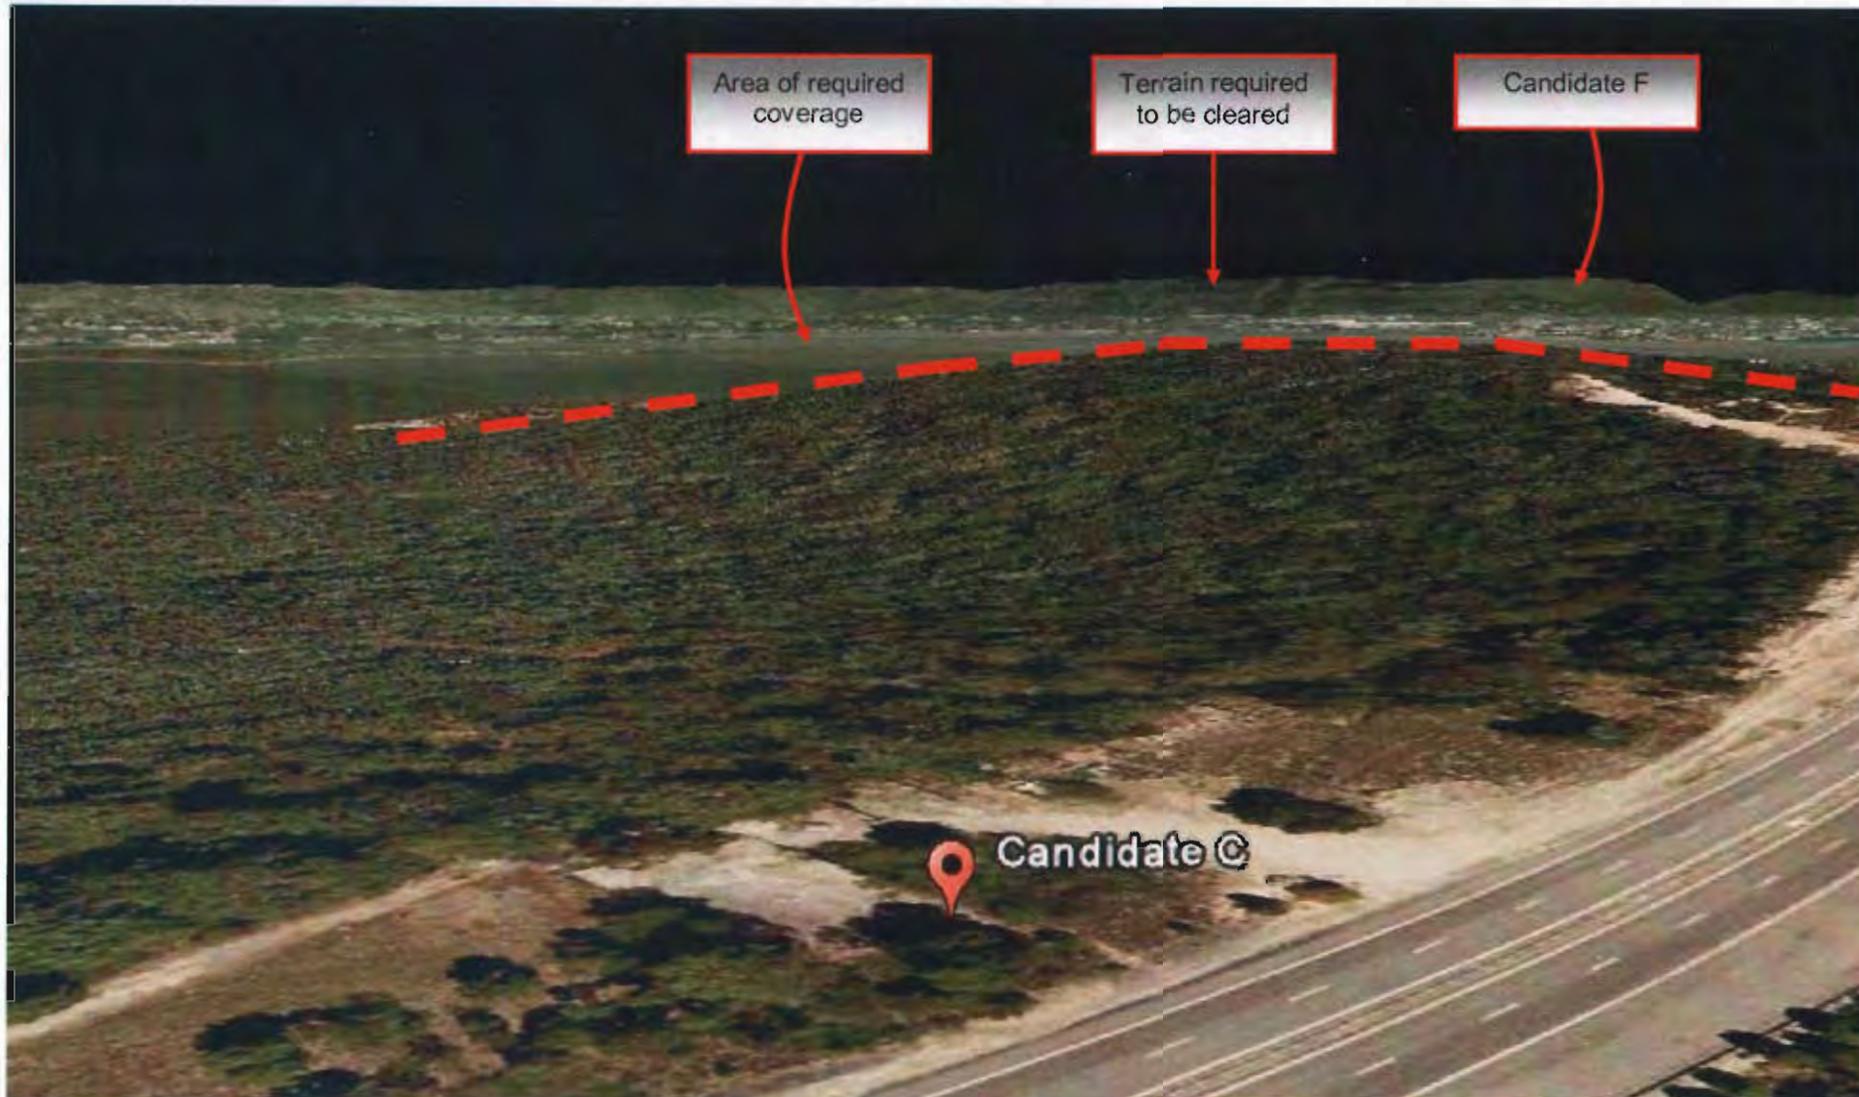
Figure 4- Google Earth image showing the terrain constraints blocking the target coverage from candidate C

- This site will not work from a coverage perspective and will not meet network coverage requirements. If we view Figure 5 we can see the target coverage area outlined in pink. The coverage from a facility in this location is shown in blue.
- It can be clearly seen that a facility in this location will not provide the necessary coverage to satisfy demand which is the driving force behind this project.
- The lack of coverage relates to the terrain in the area, which we can see in Figure 4 rises up to the north-west, blocking signal into the north. Because of this terrain the site cannot alone fulfil coverage objectives, which means another site would be required within the target area (in the approximate location of the selected candidate), thereby causing a proliferation of towers within the general area.

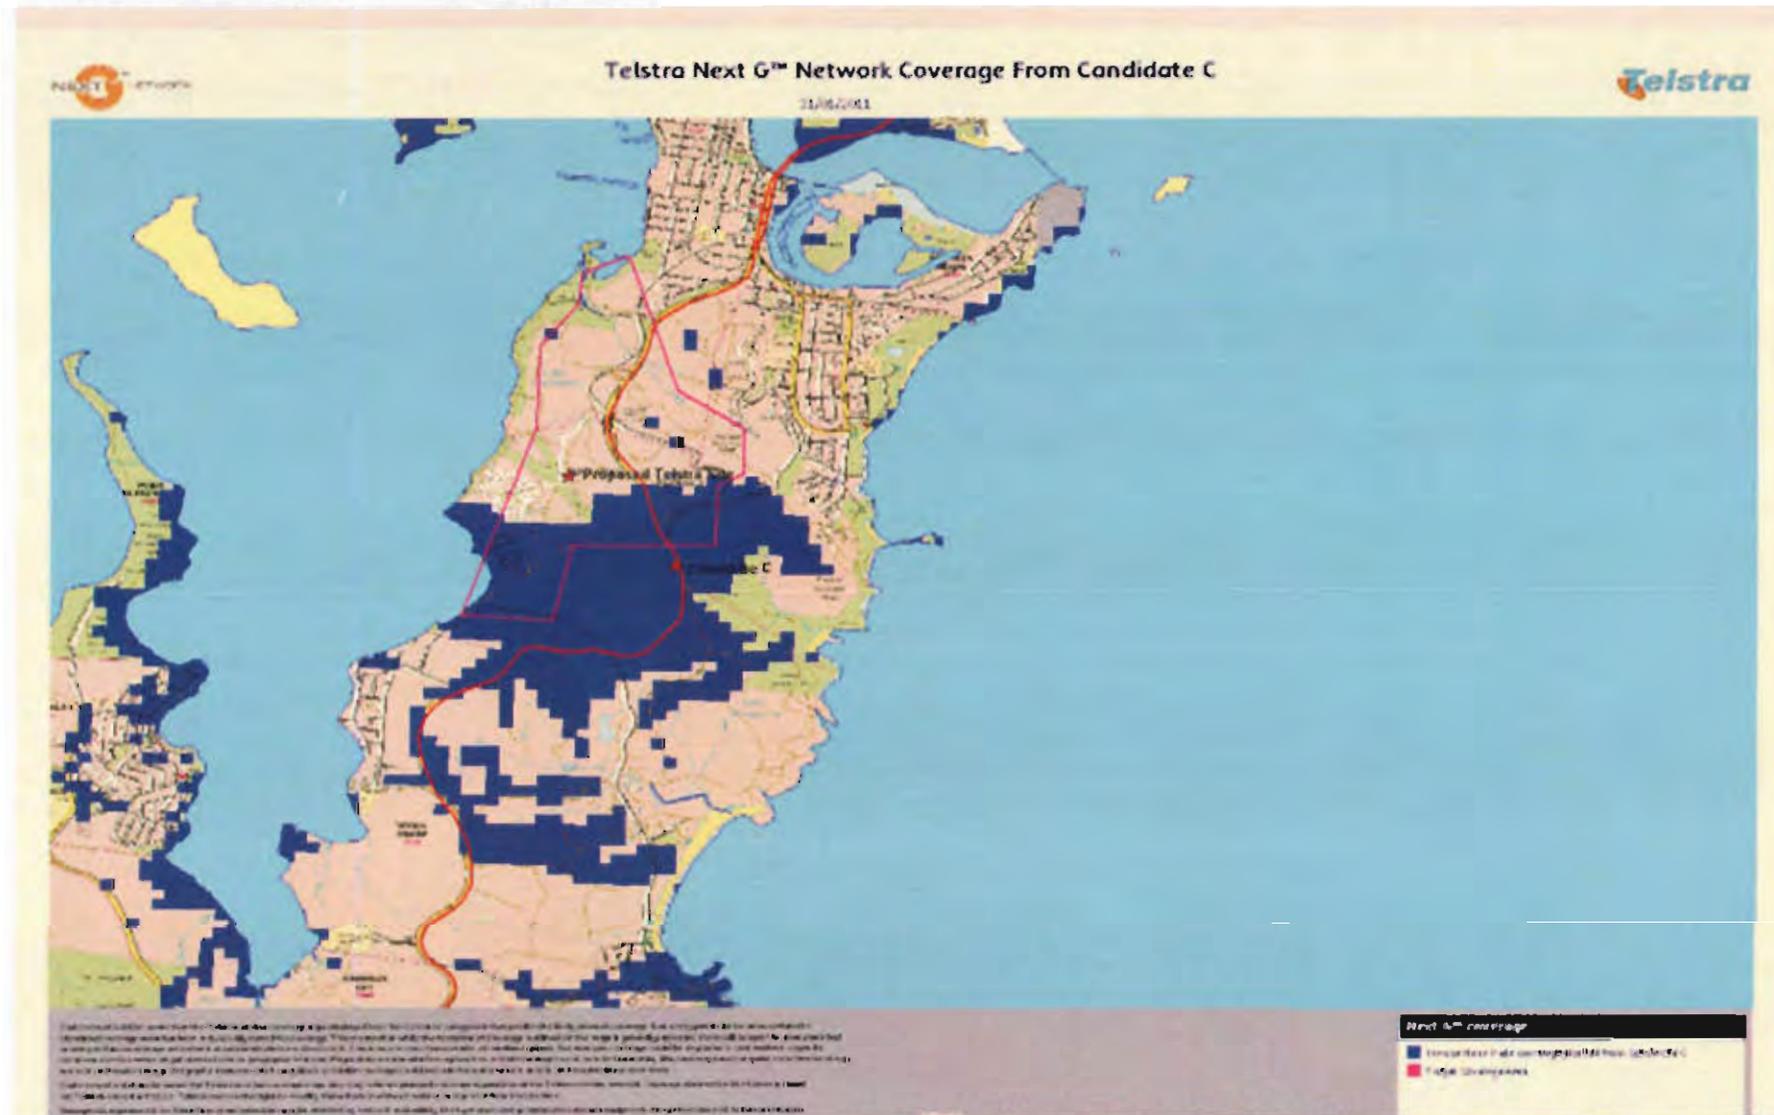
Figure 5 - Map showing proposed Coverage from candidate C- Note the pink edged target area is not affected by the coverage from C shown in blue.

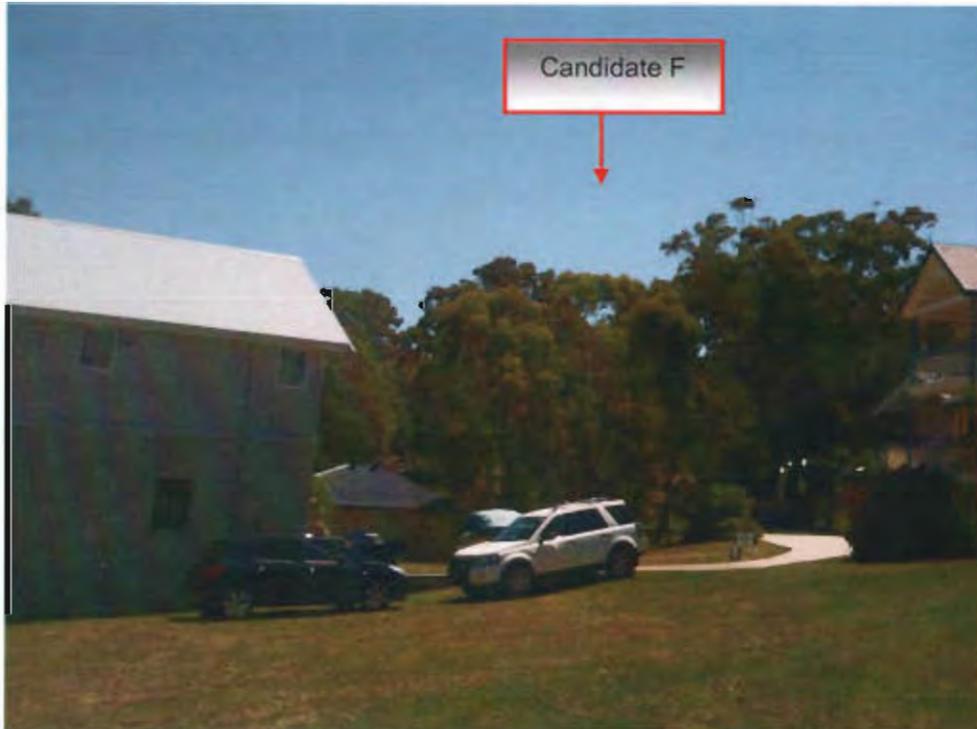
Figure 6 – Photograph looking north-east towards Candidate F taken from within Rafferty's resort

Figures 6 and 7 demonstrate the view obtained from within Rafferty's Resort looking north-east towards Candidate F. Figure 6 was taken approximately 850m south-west of the site. The photograph is of an existing view corridor between two dwellings within the Resort. The terrain and vegetation in the areas between these two points obscure views of Candidate F. The mature tree line surrounding the Resort provides effective visual screening of the facility.

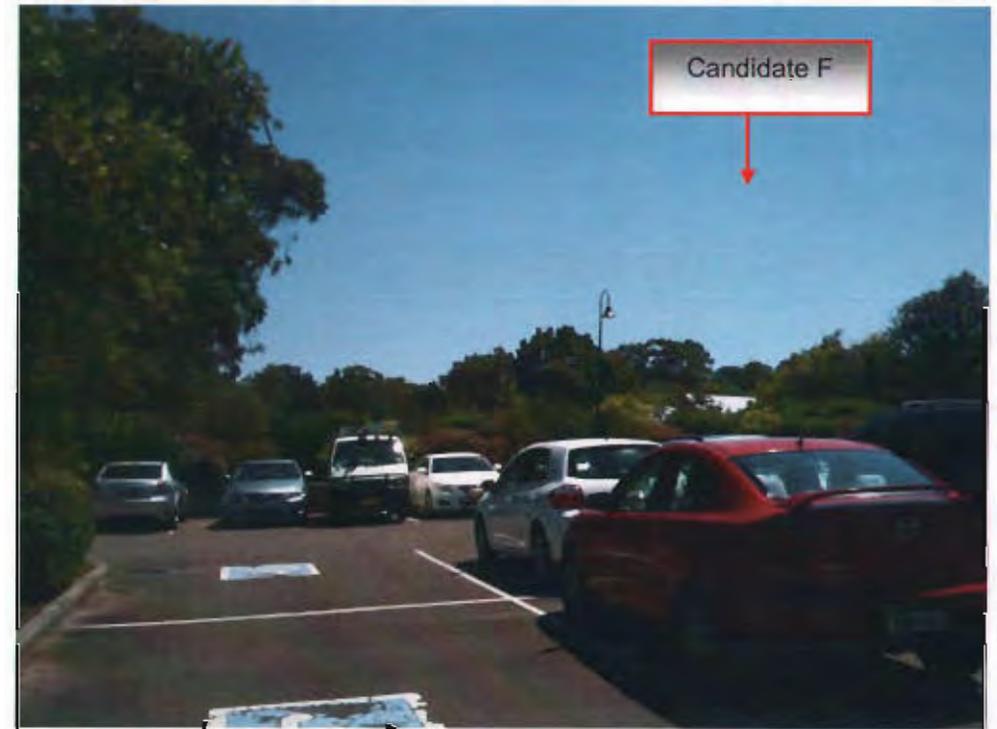
Figure 7 – Photograph of looking north-east towards Candidate F taken from the resort car park.

Figure 7 below was taken further south, approximately 950m from Candidate F within the Resort's car park on the eastern side of The Rafferty's Resort Convention Centre 1. From this position there are no views of the ridgeline or bushland located at Candidate F. The mature vegetation surrounding and located throughout the Resort provide effective visual screening from the north and north-eastern direction.

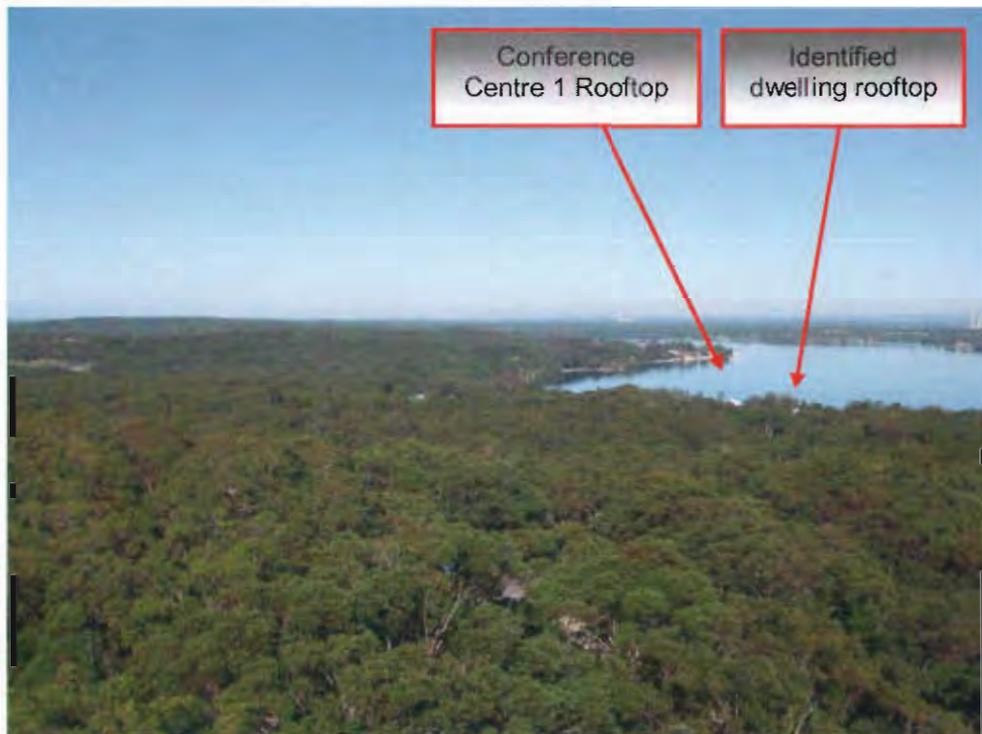
Figure 8 – Photograph looking south-west from 35m in height above Candidate F.

The visual impact of the proposed telecommunications facility at Candidate F in the areas to the south of Jetty Point Drive is minimal. A balloon was raised to the height of the proposed facility (35m) and photos of the surrounding area were taken. Figure 8 below displays the view to the south of Candidate F looking towards Rafferty's Resort, Lakeside Ridge Precinct and parts of the Lakeshore & Slopes Precinct. As seen in Figure 8, the facility, at its highest point will have little visual impact on the Resort and surrounding area. The Convention Centre and dwelling are labelled within the image, with only the tips of the buildings being visible from this height. The facility will not be visible from street level. This is due to the terrain and the mature vegetation that covers the area.

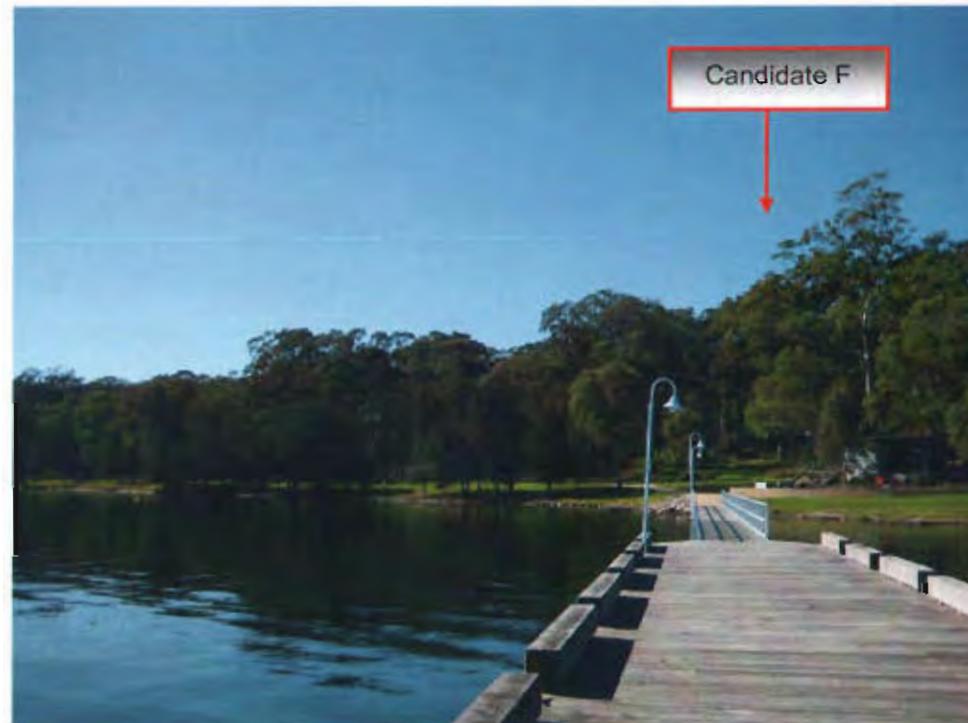
Figure 9 – Photograph looking east from the Jetty looking towards Candidate F.

Point Morisset Precinct and the areas to the west of Candidate F will experience minimal loss of visual amenity. With the balloon elevated to 35m in height above Candidate F, images were taken from the along the shore line and throughout Point Morisset Precinct to assess the visual impact a telecommunications facility at Candidate F may have. As seen below in Figure 9, the balloon at 35m in height is not visible in the eastern skyline. The dense and mature tree line throughout the precinct provides effective screening of the slimline monopole from this location.

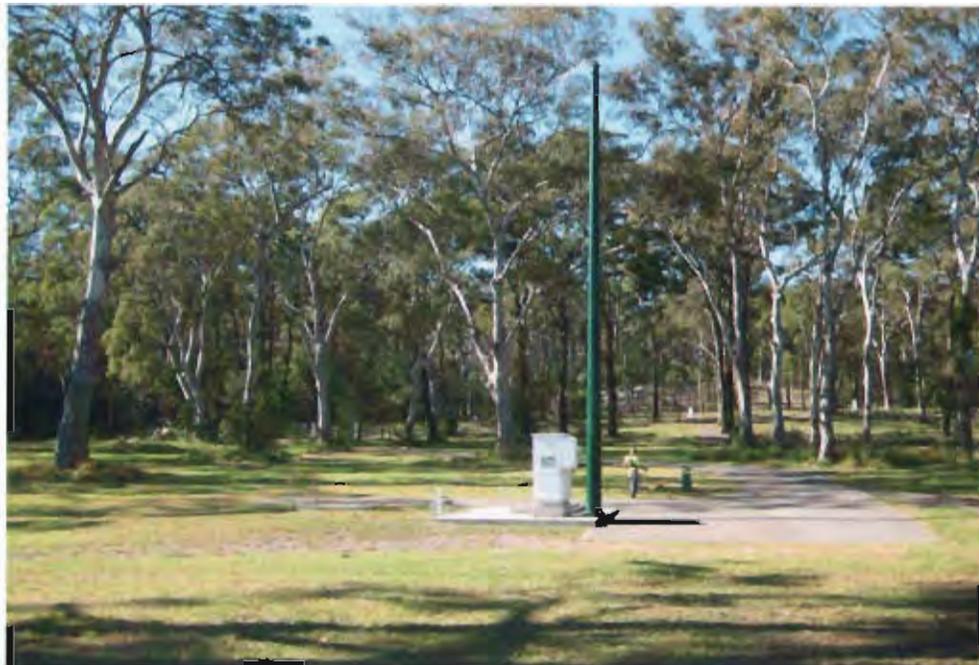
Figure 10 – Photograph taken from approximately 630m west-nor-west of Candidate F looking east.

Moving a further 200m north-east from the jetty, there is no detrimental impact on the scenic quality obtained from this area. The mature trees visible in Figure 10 below provide screening from Candidate F. The balloon at 35m in height is not visible from this viewpoint. The dense tree canopy aids greatly in reducing the visual impact a facility may have. There are some small pockets where parts of the proposed facility at Candidate F will be partially visible. However, due to the colour, design and distance from the development, the slimline monopole will have a minimal detrimental impact of the visual quality of the area.

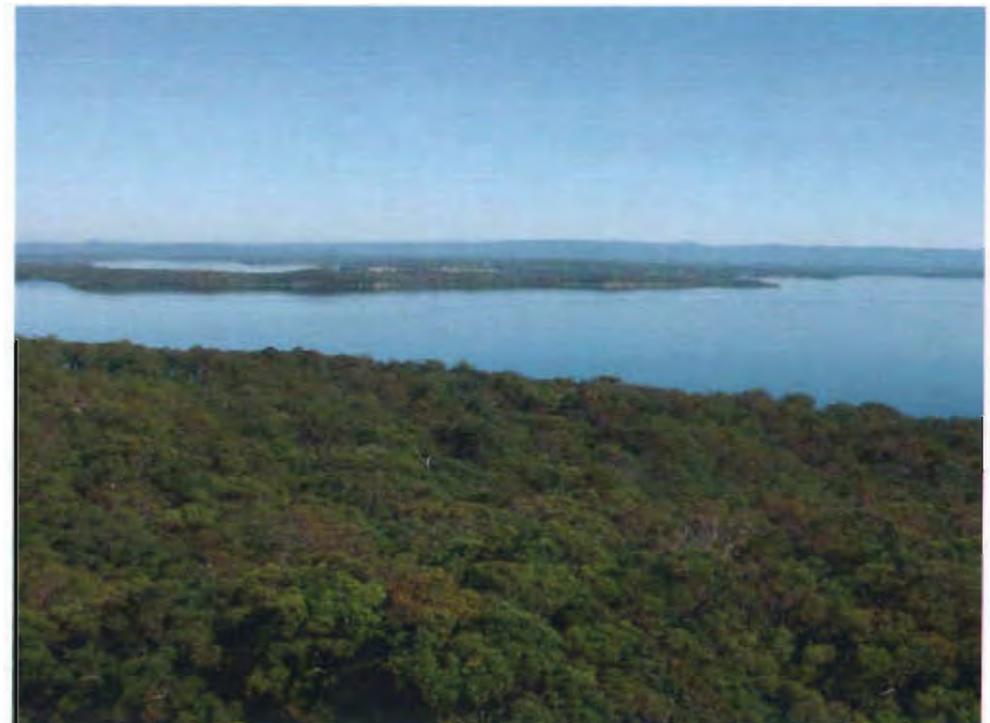
Figure 11 – Photograph looking west towards Point Morriset Precinct and the shoreline. Taken from 35m in height above Candidate F.

Figure 11 below is a photograph taken looking west from 35m in height above Candidate F. The shoreline, jetty, dwellings and other features of the built environment throughout the precinct are not visible from this vantage point. The terrain and dense tree canopy assist in screening the facility from the view corridors and lines of sight identified in these areas. It is expected that the visual and scenic impact of the proposed telecommunications facility at Candidate F will be minimal.

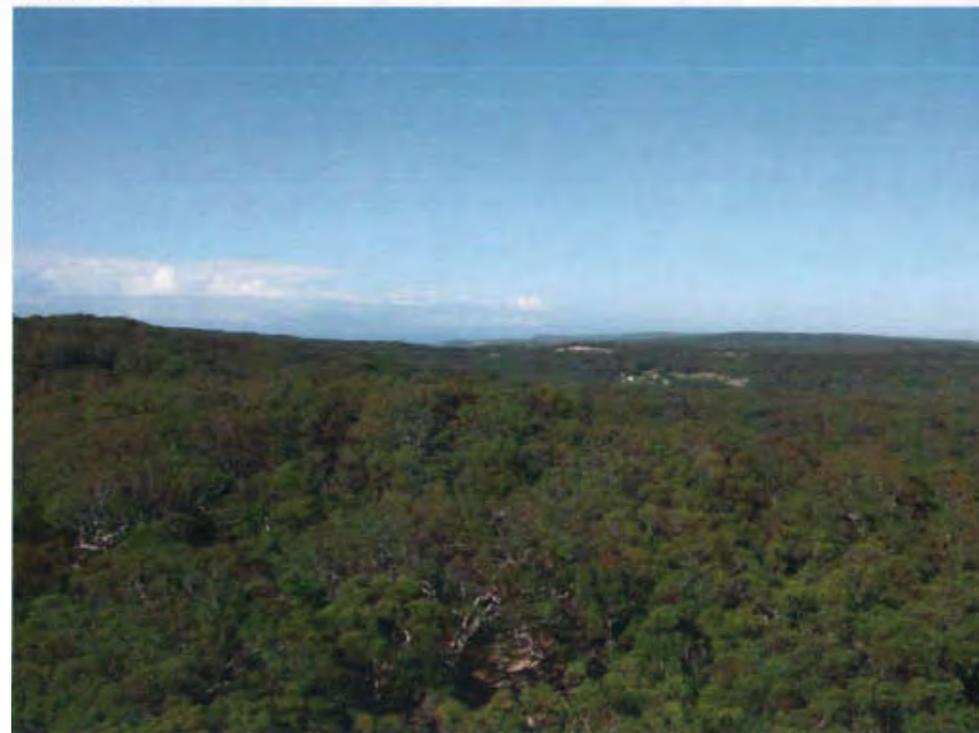
Figure 12 – Photograph looking south from 35m in elevation above Candidate F.

The proposed Telstra facility has been sited on land with an existing water reservoir. In an attempt to minimise the impact on the surrounding area, the facility has been located amongst existing infrastructure. Figure 12 demonstrates views obtained from the 35m mark looking south along the Lakeside Ridge Precinct and parts of the Lakeshore & Slopes Precinct. The land is currently undeveloped and is covered with mature trees consisting of dense canopies which will provide visual screening for the facility. There are pockets of no vegetation which will be developed. Here, parts of the proposed facility will be visible, particularly in the areas in close proximity to the facility and reservoir; and the southern side of the precinct will experience a small loss of visual amenity. Overall though, it is considered that a telecommunications facility at Candidate F will have a small visual impact on the Lakeside Ridge Precinct, and only on properties immediately adjacent to its location, with terrain and vegetation screening it from afar.

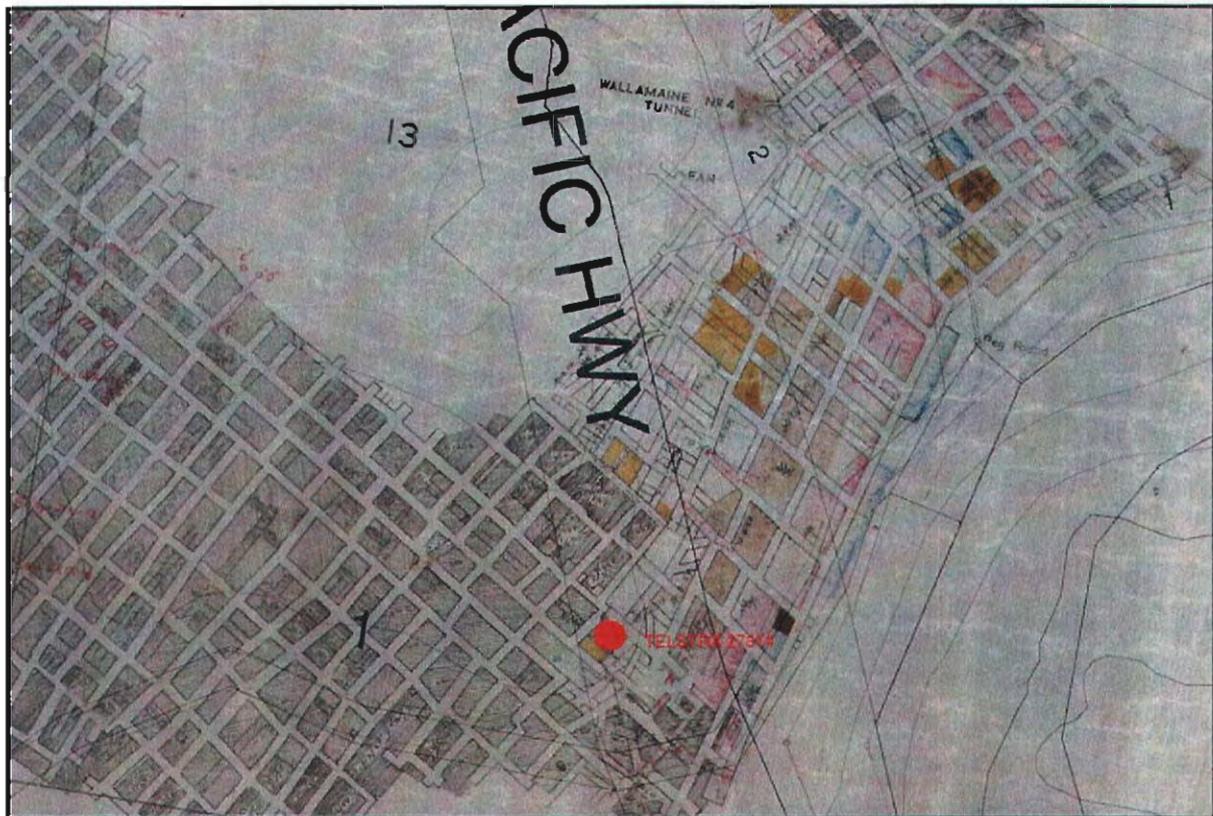
Figure 1: Location of Telstra Site 27814 in relation to recorded coal mine workings. (Details of mine workings are an extract from RT 633 and only show details near the site.)

Prior to commencing the field investigations, a desktop review of information obtained from the Mine Subsidence Board (MSB) and the DPI-Minerals was undertaken. In particular, Record Trace RT633 showing the layout of the local Wallamaine Colliery was used to assess the likely presence of workings in close proximity to the proposed telecommunications tower site. Details of the workings near the site are reproduced from the RT in Figure 1.

Inspection of the scanned RT633 image indicates that the mine surveyor referenced the underground workings to surface features such as site and road reserve boundaries. This enabled the RT633 plan to be georeferenced to the modern surface cadastre on the basis of conspicuous features common on both. The location of the proposed telecommunications tower was then plotted from the co-ordinates given in Drawing N 27814, Sheet G2 provided by the client.

- The Telstra Site 27814 is located near the No. 4 tunnel into the Wallamaine Colliery. The tunnel entrance is marked with the date 9/2/53 (presumably 1953). The surface level immediately outside the tunnel is noted as about RL 206.85 feet whilst the reduced level inside the tunnel near the first cross bord is RL 212.7 feet.
- The Wallamaine Colliery in the vicinity of Telstra Site 27814 occupies a crescent shaped ridge.
- The crescent shape of the mine is similar to the shape of the ground contours indicating that the mine was situated on a ridge and that the seam has a limited lateral extent at the site, probably due to sub crop and limited depth of cover. The total length of the crescent is at least 1400 m and the maximum width about 300 m as on the RT633 image.

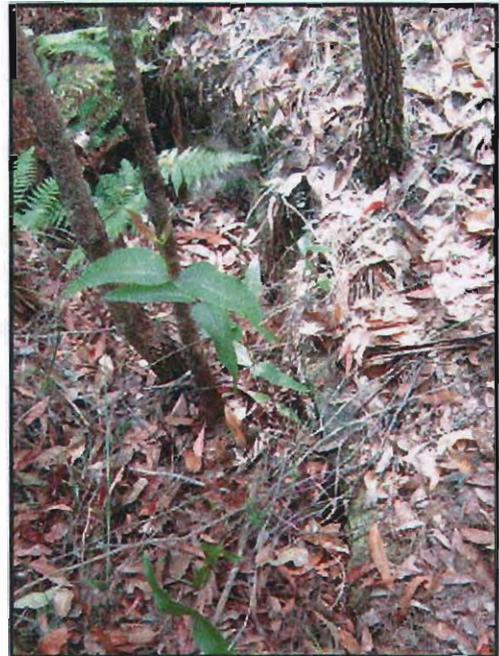
Pothole subsidence approximately 10 m to the west of Telstra Site 27814. A step indicating a relative vertical displacement of at least 0.7 m was noted at the southern end of this feature, and this is shown to the right of text.

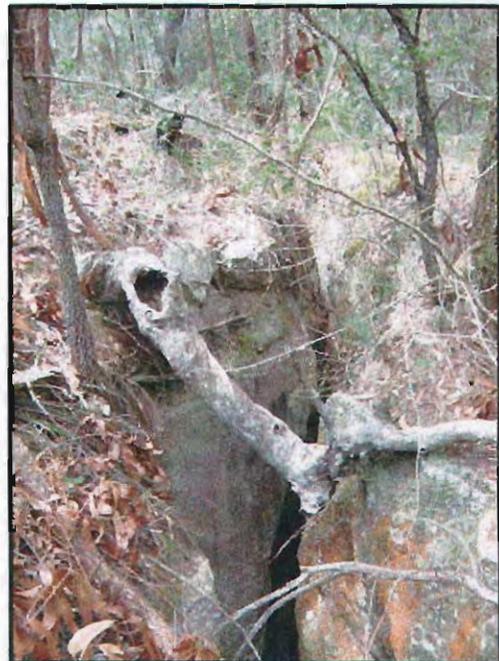
Numerous large cracks in an area about 150 m to the north-northwest of the Telstra Site 27814. The cracks were up to 0.5 m wide and estimated to be up to 5 m deep in many parts, although it is likely that the cracks extend in an en echelon manner to an even greater depth. The rock exposed in the upper portion of the crack comprised medium strength sandstone. The extensive nature of these cracks suggests that the roof above the mine workings has completely collapsed in this area. Reference to the MAPINFO GIS model of the workings suggests that these features are close to the goaf edge of the pillar extraction area where differential subsidence and tensile strains will be concentrated.

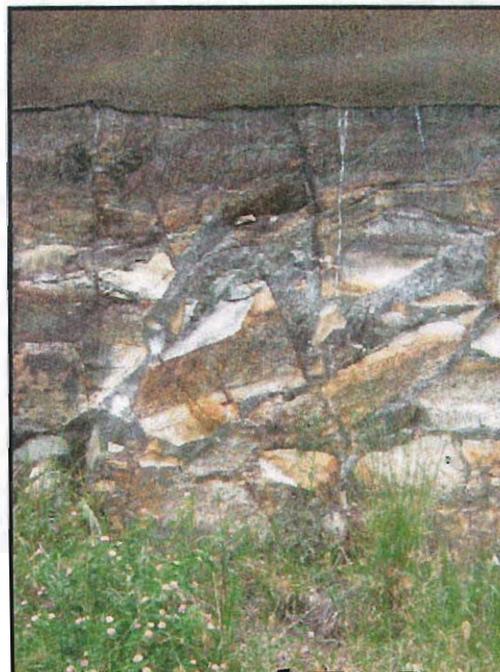
Evidence of grouting of workings within the sides of the road cutting some 30 – 50 m to the east of Telstra Site 27814. Parts of the cutting have been protected with a covering of shotcrete. However in some areas where bare rock is exposed broken sandstone fragments that have been grouted with a cement matrix are visible. It is assumed that this grouting was undertaken to stabilise the batters prior to excavation of the cutting. The picture to the right shows part of the rock exposed on the eastern side of the road cutting.

The evidence of mine subsidence in the area is consistent with the conditions anticipated following the review the review of the RT633 record trace. Grouting of areas adjacent to the Pacific Highway has been undertaken some time prior to carrying out excavation associated with the road construction. The lateral extent of the stabilisation (grouting) works is not known.

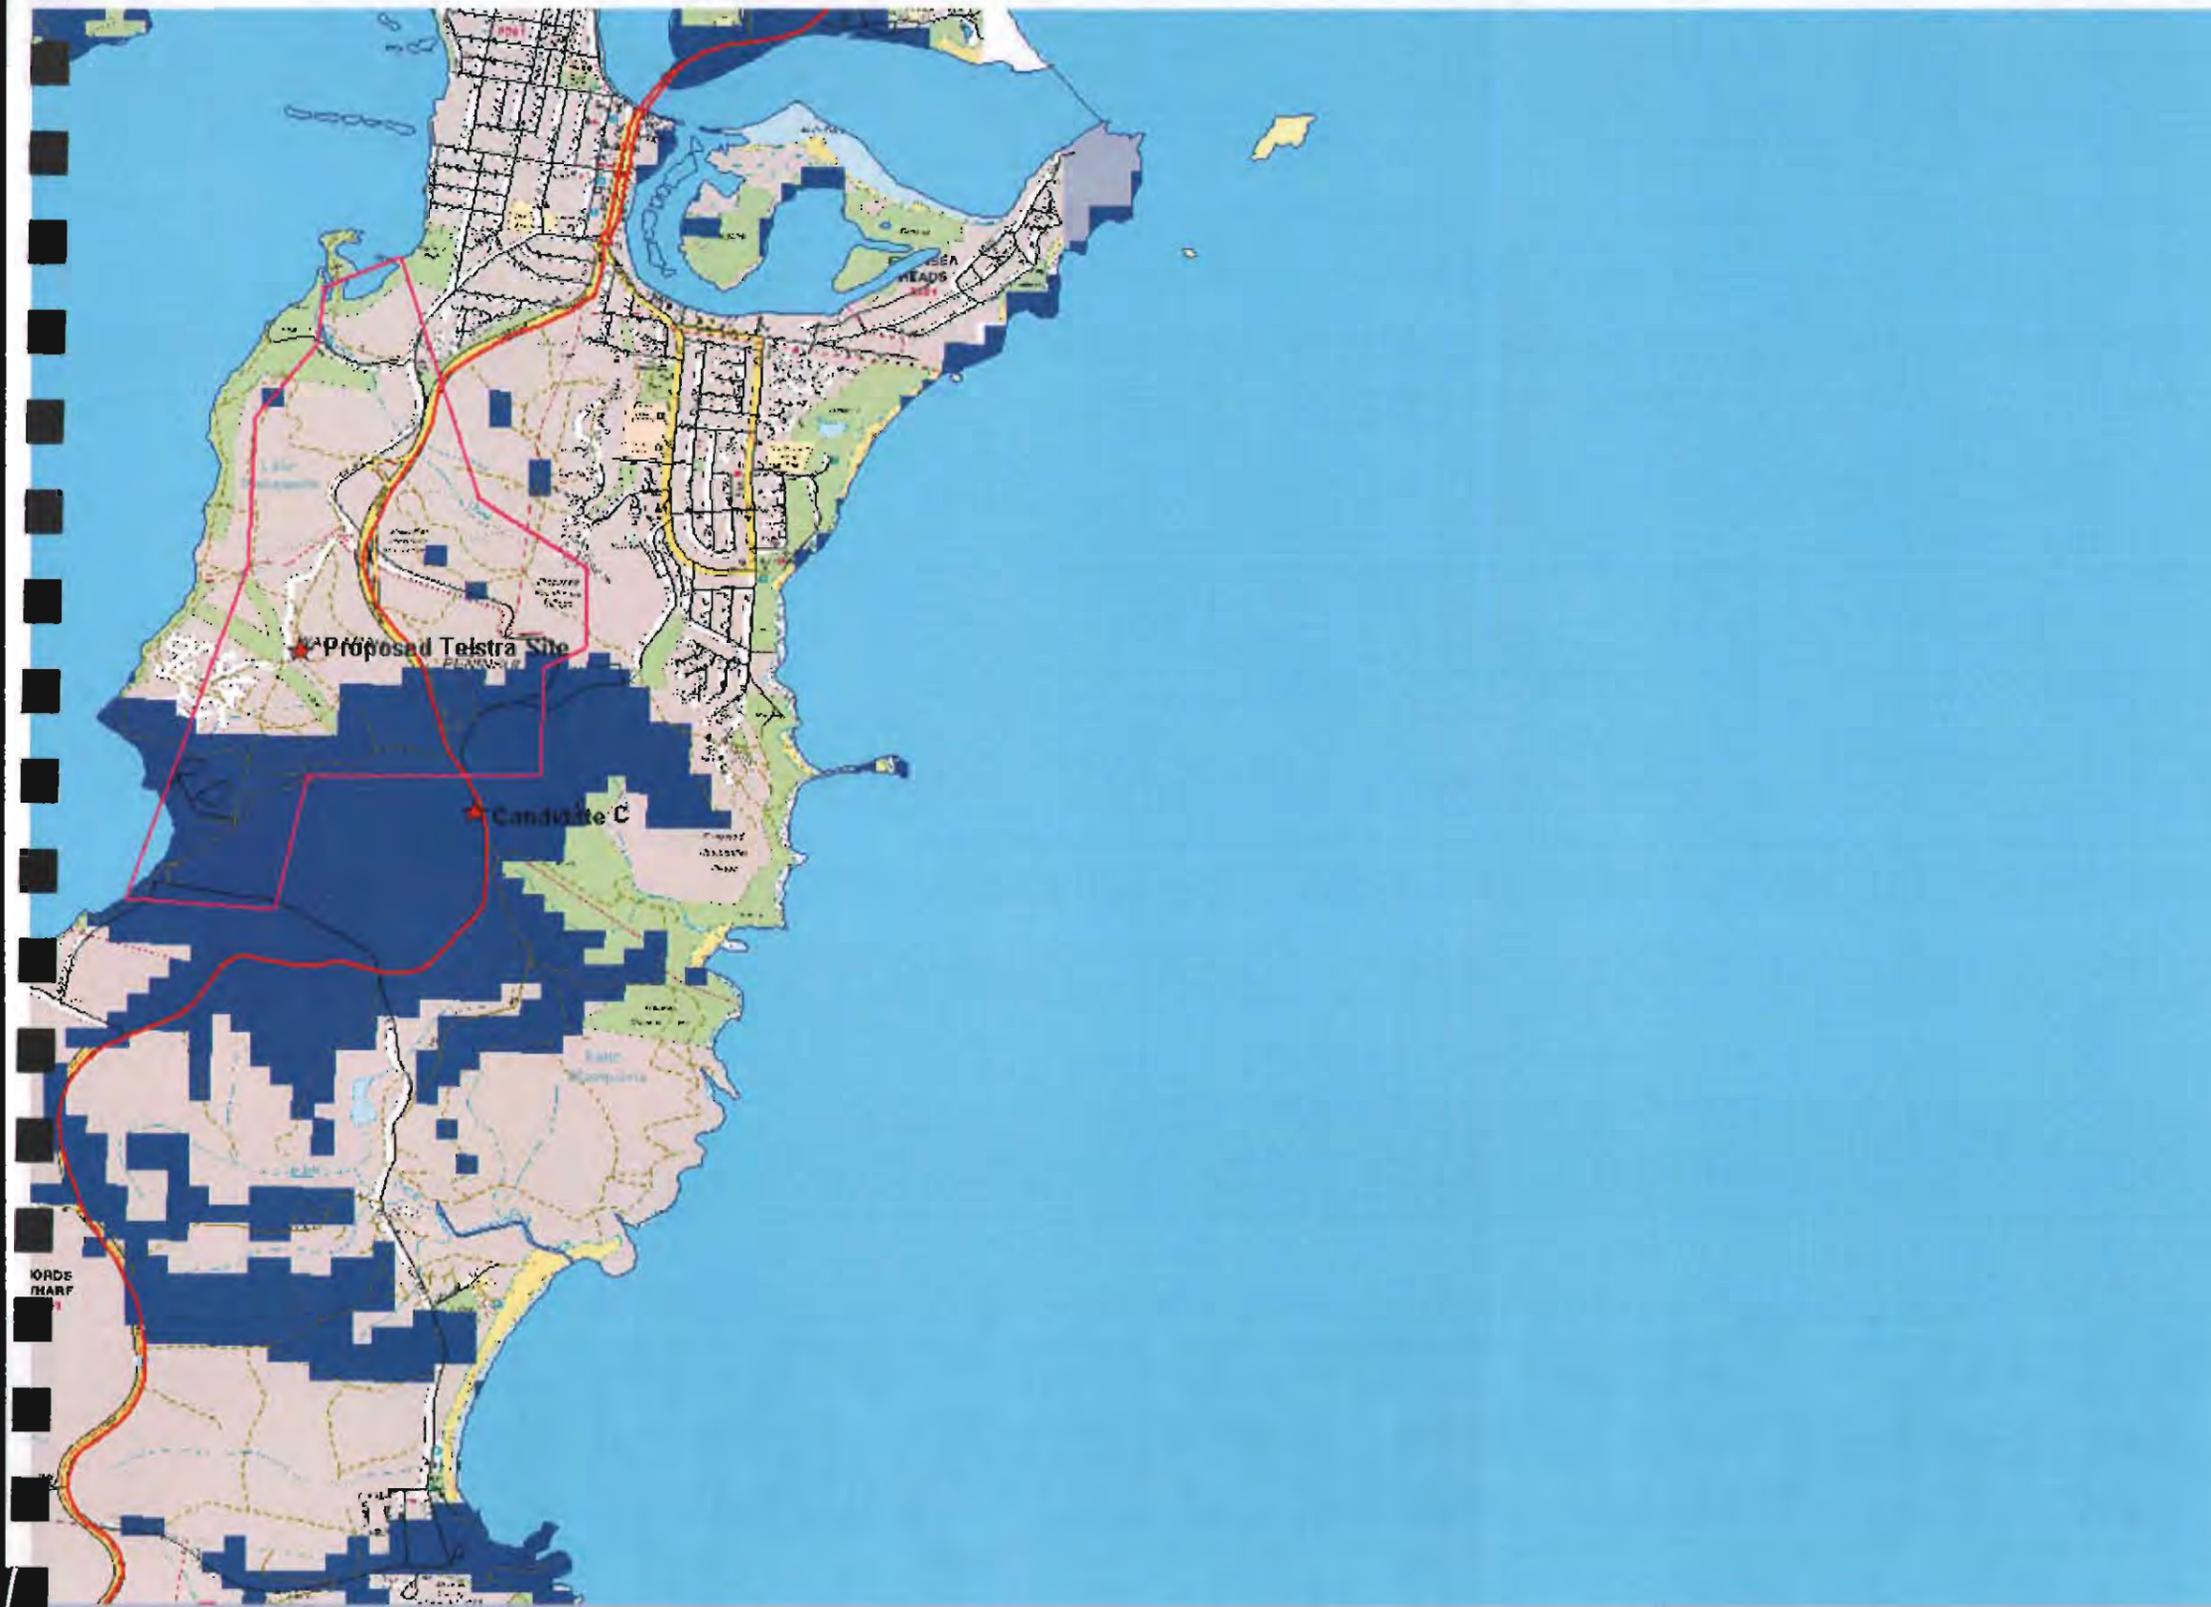
Telstra Next G™ Network Coverage From Candidate C

Generated using tools that predict the likely area of coverage. Not every particular location within the footprint of coverage outlined on the map is generally accurate, there will be specific areas described on a characteristic of wireless systems. For example, coverage could be degraded or not existent in specific areas which may block or inhibit coverage could include basements, lifts, underground car parks, concrete buildings, could include formations such as hills and mountains or even trees.
