HERITAGE VALUES ASSESSMENT

PROPOSED DEMOLITION AND DEVELOPMENT

32 - 34 CHURCH STREET
WOLLONGONG

January 2012
Job No.: 2012.1694

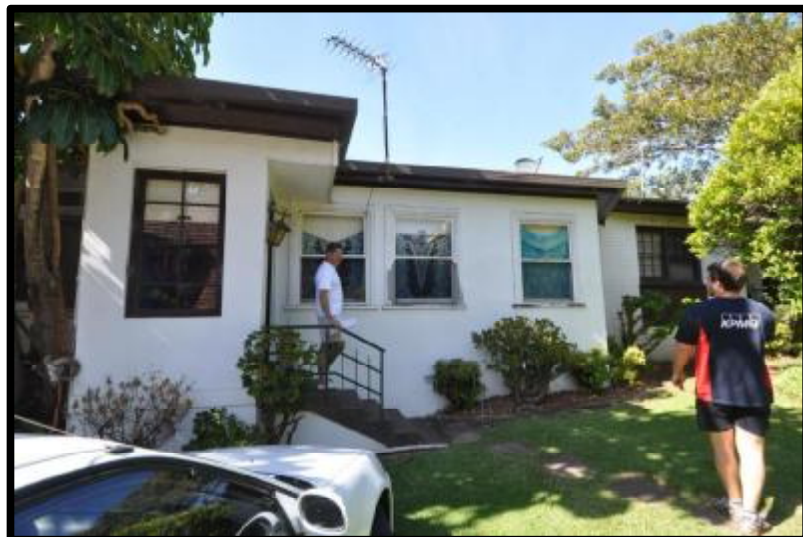
32 Church Street Wollongong was originally constructed as a single storey dwelling and has since been converted for use as three separated residential units. The design of the building is consistent with a heavily modified and extended dwelling and can be separated into two distinct areas being:

32 Church Street is comprised of a single storey east-west orientated building. The majority of the building has a green tiled hipped roof with wide over hanging eaves, except for the enclosed verandah which has a flat roof.

Figure 3: 32 Church Street, Wollongong.
(Source: Rappoport Pty Ltd, December 2011)

Rappoport Pty Ltd recommends the current condition of the two properties is captured through photographic archival recording prepared in accordance with the guidelines prepared by the Heritage Branch of NSW Office of Environment & Heritage prior to the commencement of work. This will ensure that a lasting record of the current phase of occupation is available for future reference.

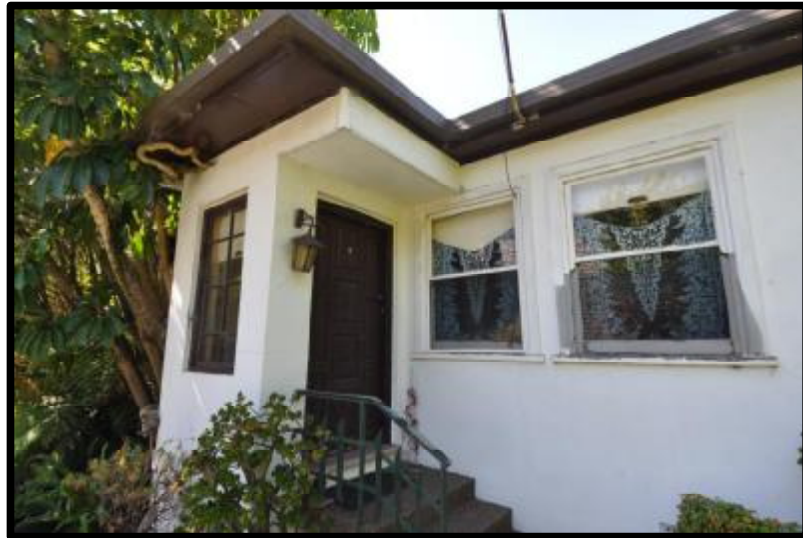
Figure 4: Detail of wide overhanging eaves and entry porch to one of the apartments.
(Source: Rappoport Pty Ltd, 2011)

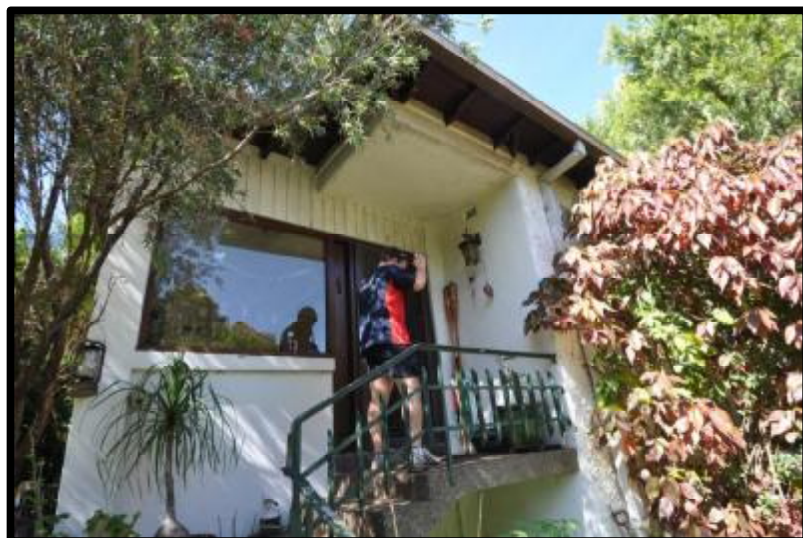
Figure 5: Entry to enclosed verandah.
(Source: Rappoport Pty Ltd, 2011)

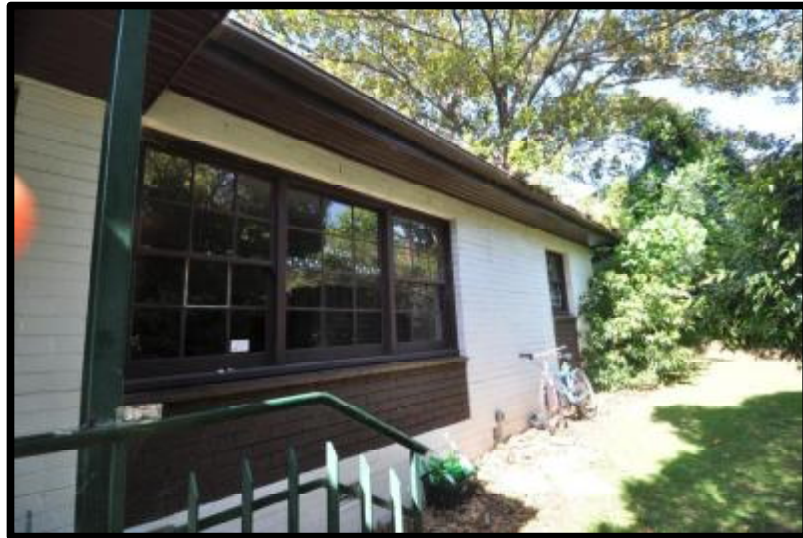
The 1930s section of the building is clad in painted render while the 1960s addition is comprised of painted brick, with a timber infill to the gable end.

Figure 6: Detail of exterior of the property. This section of the property is thought to have been added in the 1960s/70s.
(Source: Rappoport Pty Ltd, 2011)

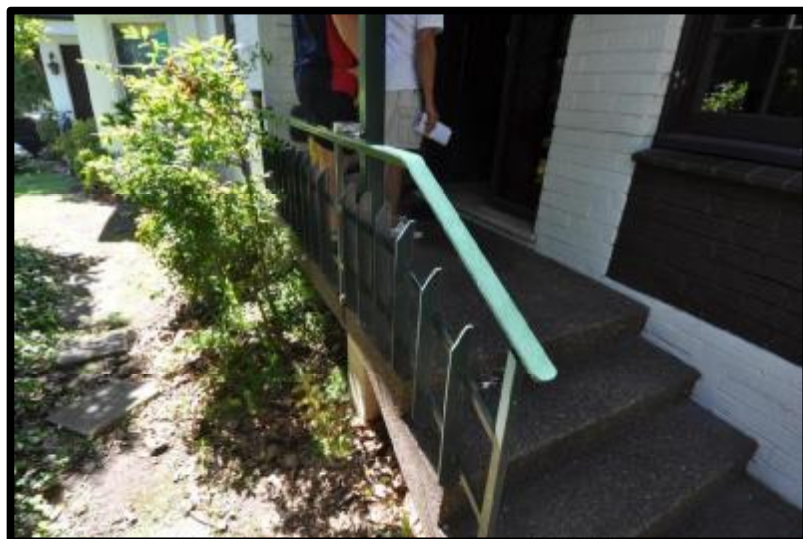
Each of the units is accessed by a separate elevated entry. The external pebble dash steps are bounded by a decorative metal balustrade and terrazzo door step, the details of which are consistent to each dwelling suggesting that these were added in the later development phase.

Figure 7: Detail of metal balustrade and pebblecrete entry steps.
(Source: Rappoport Pty Ltd, 2011)

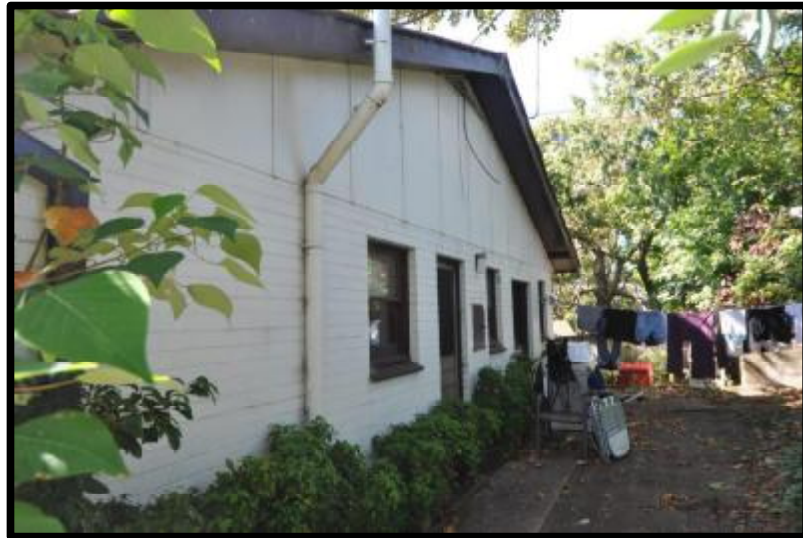
Figure 8: Gable end of building consistent with 1960s/70s development.
(Source: Rappoport Pty Ltd, 2011)

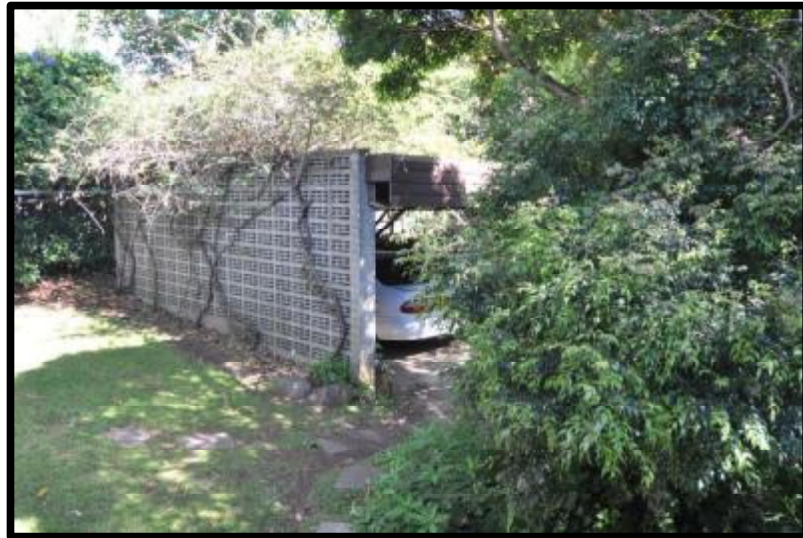
The grounds of the property contain a long concrete driveway, large carport with decorative breeze blocks side wall, large lawn areas and a decorative brick fence to the Church Street boundary with bricked in central pedestrian opening.

Figure 10: Breeze block wall to end of car port.
(Source: Rappoport Pty Ltd, 2011)

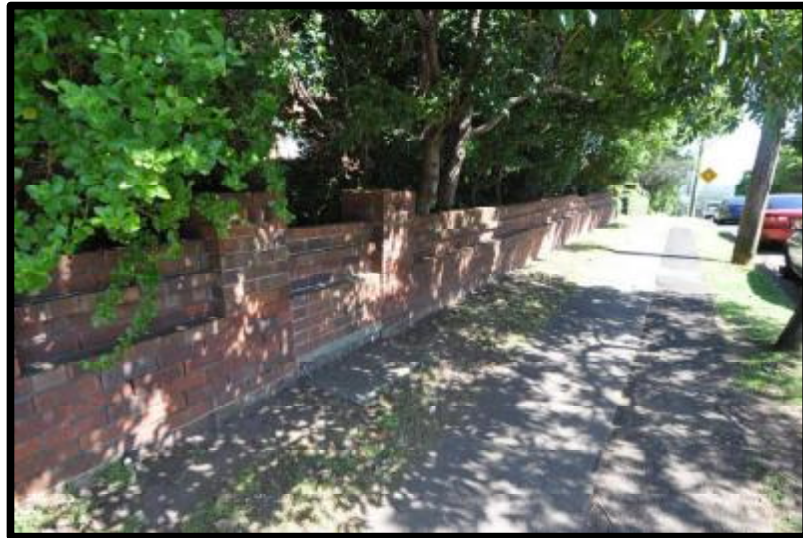
Figure 12: Brick fence defines the church street boundary. Note the original pedestrian entry to the centre of the wall
(Source: Rappoport Pty Ltd, 2011)

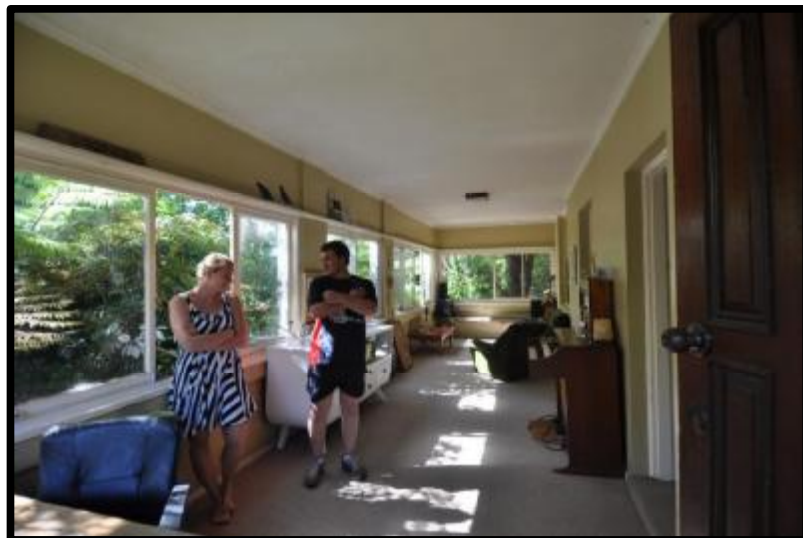
The entry porch of the 1930s component, leads into sun room running the full width of the property. The exterior window details of the sun room are consistent with late 1960s early 1970s period suggesting that the sunroom was enclosed around the same time as the property was extended. The internal wall of the sun room contains a set of 3 sliding sash windows which are believed to be original to the 1930s structure.

Figure 13: 1930s Apartment: Interior detail of enclosed verandah.
(Source: Rappoport Pty Ltd, 2011)

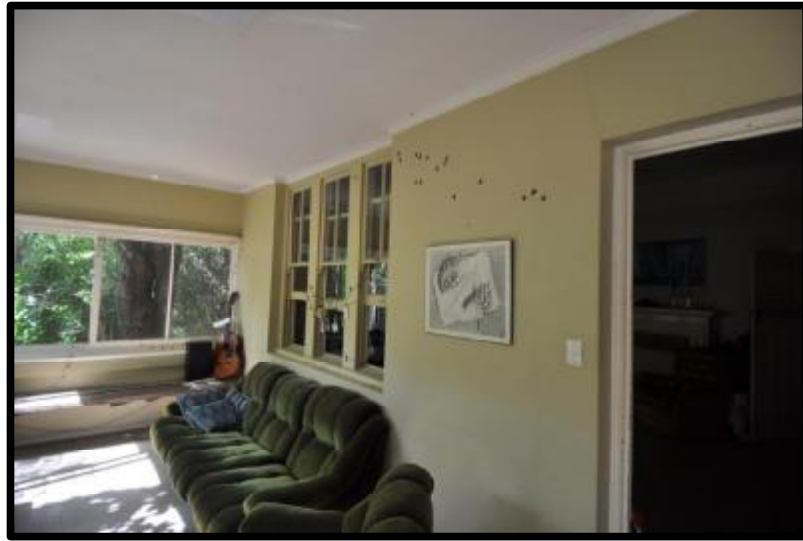
Figure 14: 1930s Apartment: Detail of three sliding sash windows thought to be original to the 1930s phase of development.
(Source: Rappoport Pty Ltd, 2011)

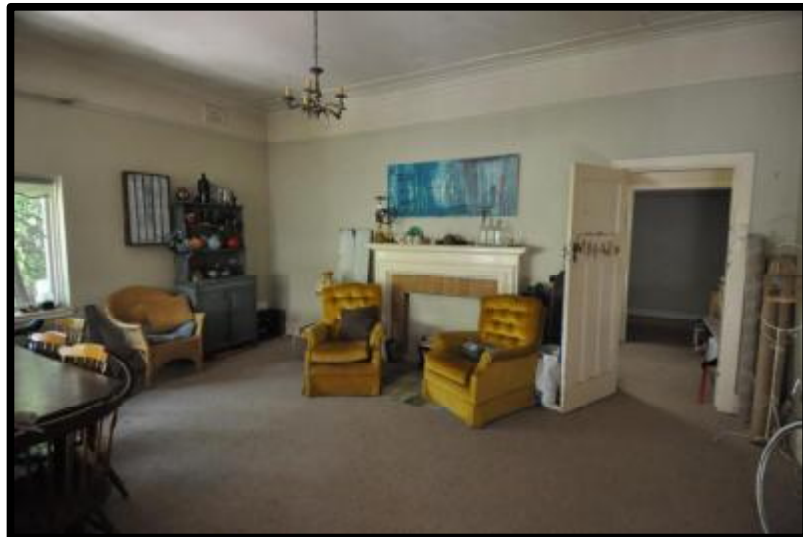
The lounge area of this unit contains several features which appear to date from the original construction including, the fireplace, internal door and moulded cornice. This room is not without alteration and a sliding aluminium window has been inserted to the southern wall. The kitchen contains what is thought to be an original arched window and the bedroom contains a timber batten ceiling and further evidence of an enclosed verandah. Many of these surviving internal details are indicators of the Inter-war Georgian Revival Style however the exterior of

Figure 15: 1930s Apartment: Living area note the door, fireplace and cornice all of which are consistent with 1930s design.
(Source: Rappoport Pty Ltd, 2011)

Response - The building at 32 Church Street does not demonstrate a high degree of creative or technical achievement. While the interior of the 1930s apartment does contain some elements which are indicators of the Inter-War Georgian Revival Style they are not considered to be outstanding and nor do they translate to the exterior of the building. Furthermore, the building has undergone substantial alteration and addition, to make it suitable for use as multiple dwellings, these alterations have further degraded the properties aesthetic appearance and removed its original architectural features.

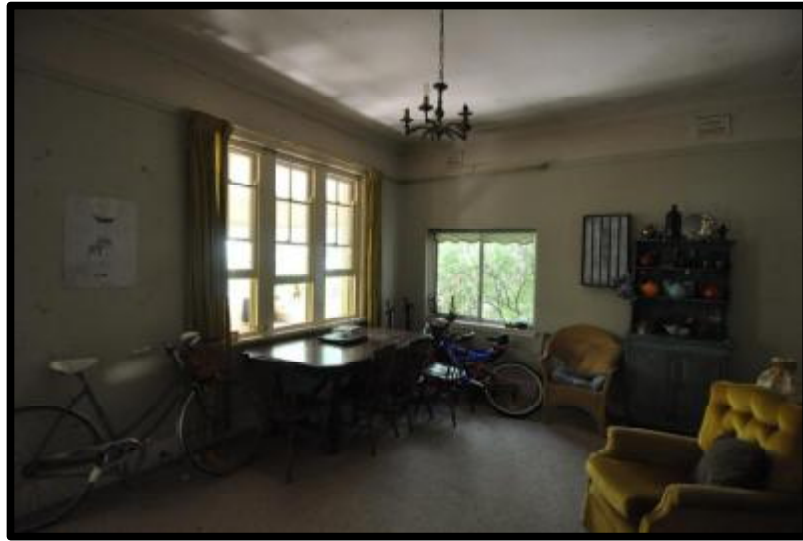
Figure 16: 1930s Apartment: Sliding sash windows as viewed from the interior. It is presumed that the sliding aluminium windows was added at the same time that verandah was enclosed.
(Source: Rappoport Pty Ltd, 2011)

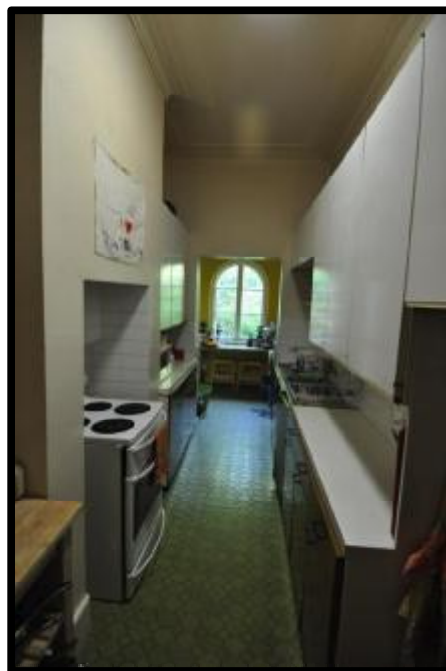
Figure 17: 1930s Apartment: Galley Kitchen note the fireplace to the left of the picture and the arched window to the centre of the picture. (Source: Rappoport Pty Ltd, 2011)

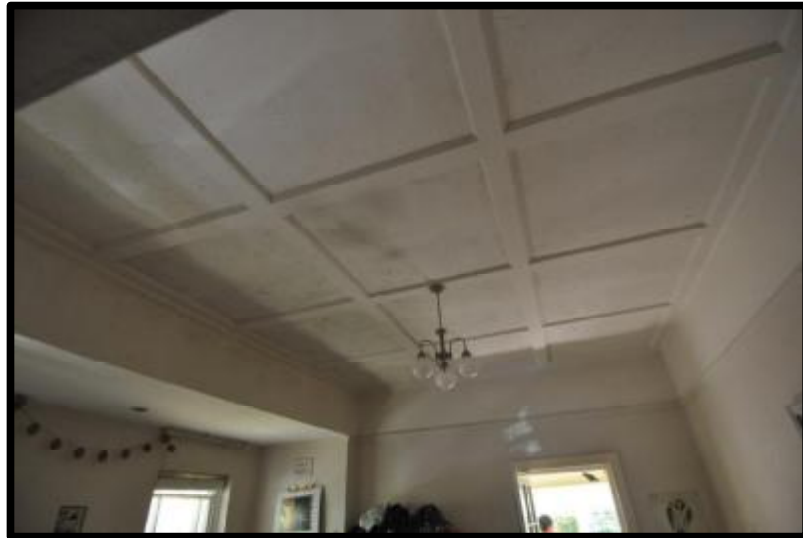
Figure 18: 1930s Apartment: 1930s Timber Batten ceiling.
(Source: Rappoport Pty Ltd, 2011)

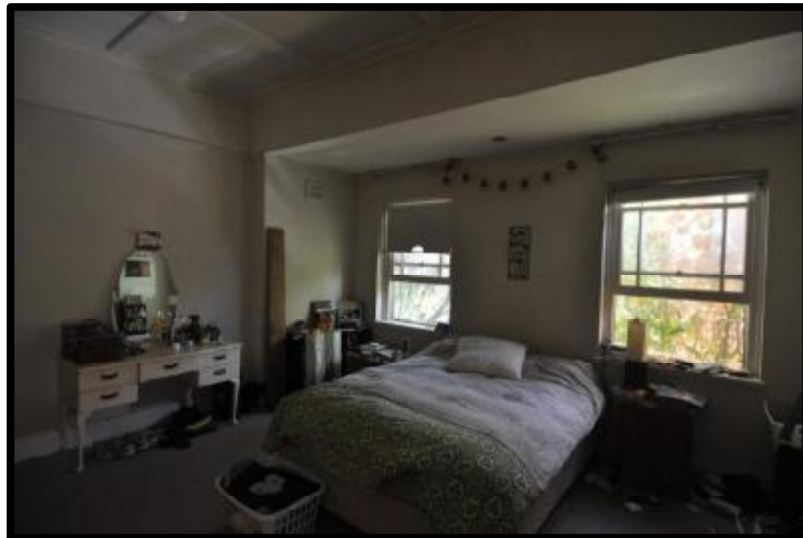
Figure 19: 1930s Apartment: The bedroom appears to have been extended into an enclosed verandah. (Source: Rappoport Pty Ltd, December 2011)

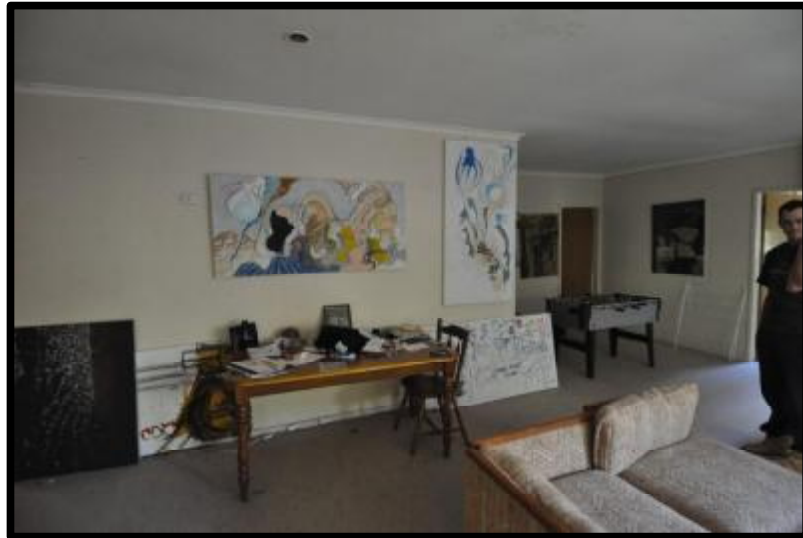
By contrast the interior of the 1960s/70s apartments contain few decorative elements. Visual inspection of these apartments confirm that they were designed as apartments and have no connection to the original dwelling i.e. they were not part of a former extended living area which was converted for use as apartments.

Figure 20: 1960s/70s Apartment: Note the lack of cornices, joinery or other design features.
(Source: Rappoport Pty Ltd, 2011)

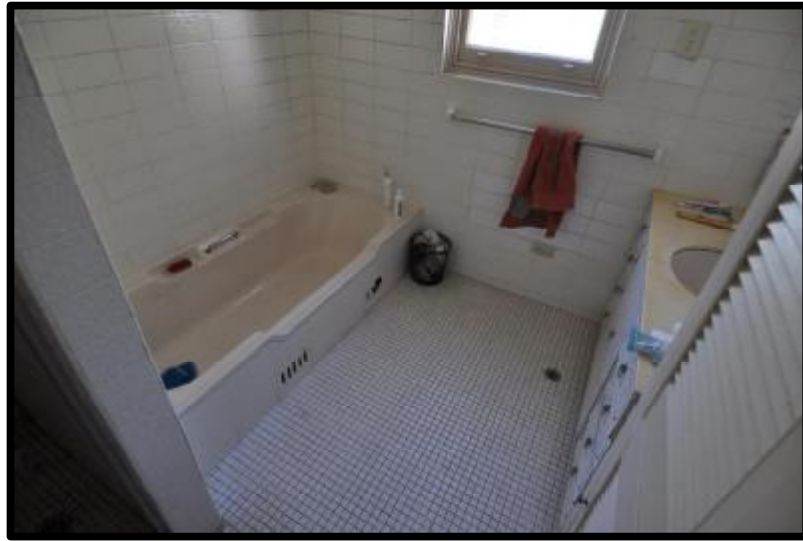
Figure 22: 1960s/70s Apartment: Sunken bath and tiles consistent with late 1960s design.
(Source: Rappoport Pty Ltd, 2011)

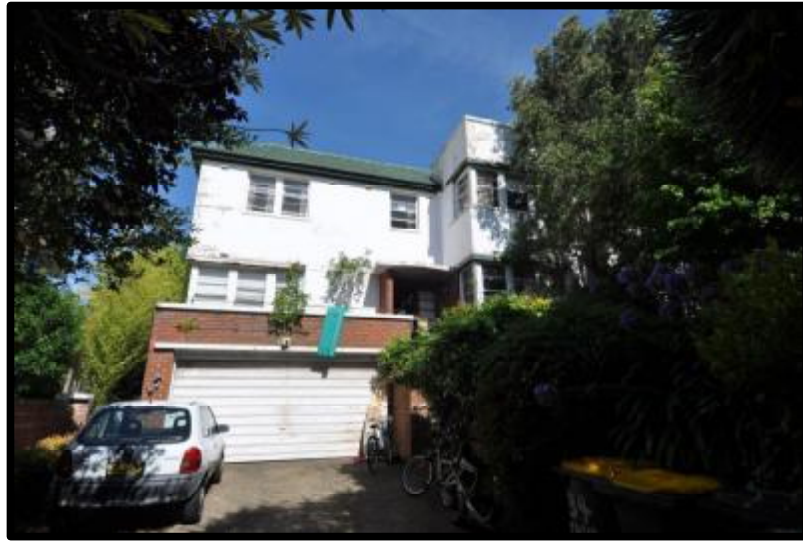
34 Church Street is an elevated two storey building, the exterior of which is clad with painted render. The dwelling is set under a green tiled hipped roof. The windows are sliding sash and the main entry is set under a small porch. The exterior of the building is showing signs of wear and tear and has been subject to a deferred maintenance schedule.

Figure 23: 34 Church Street, Wollongong.
(Source: Rappoport Pty Ltd, December 2011)

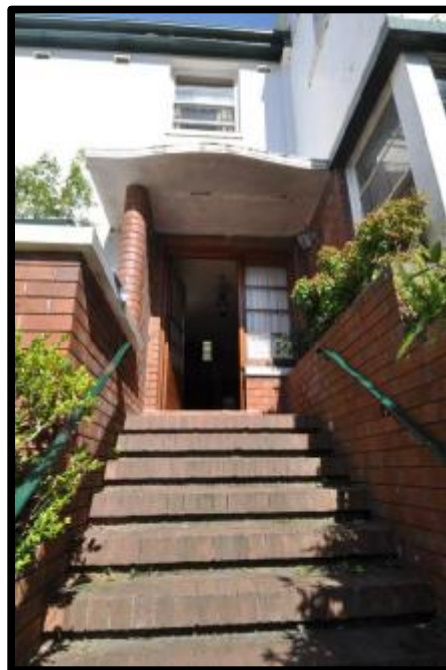
Figure 24: Steps to entry porch and front door. Note the curved supporting wall of the porch.
(Source: Rappoport Pty Ltd, 2011)

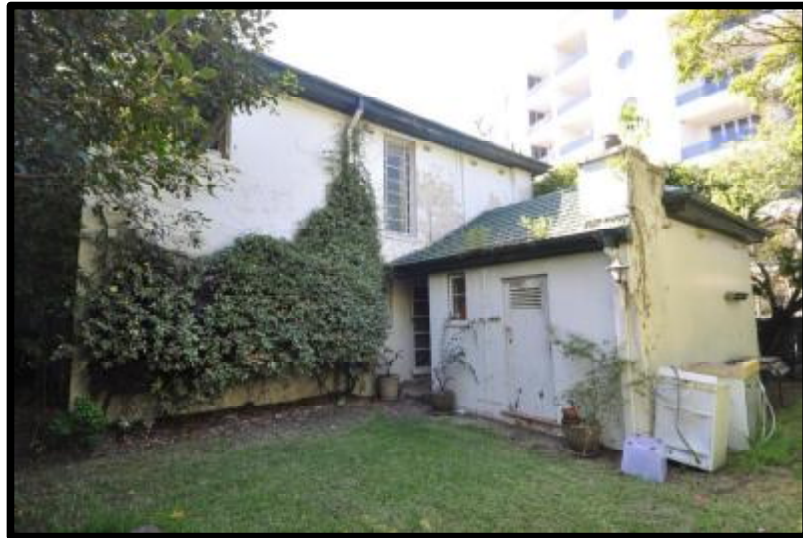
Figure 25: Rear of 34 Church Street with separate laundry extension.
(Source: Rappoport Pty Ltd, 2011)

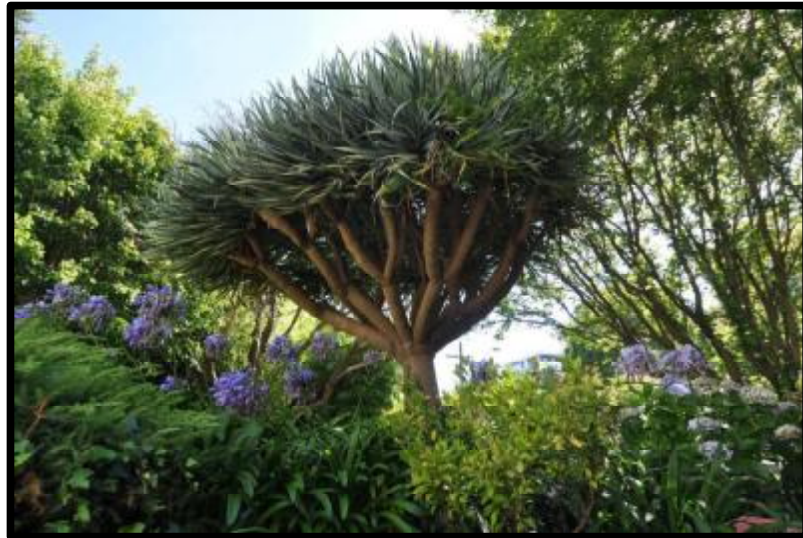
Figure 27: Hints of former landscaping can be seen around the now minimally maintained garden.
(Source: Rappoport Pty Ltd, 2011)

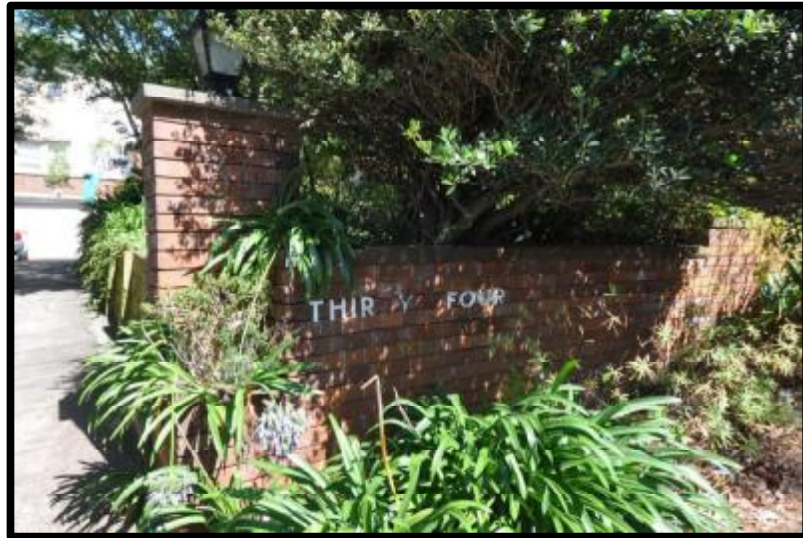
The Church Street boundary of the property is defined by a brick fence which also acts as a retaining wall to the front terraced garden. The concrete driveway leads to an exposed brick double garage. To the immediate north of the garage are the main steps leading to the single opening entry door, with adjoining glazed side windows. The porch is topped by a concrete slab roof and supported by an exposed brick wall which has a decorative rounded edge.

Figure 29: Detail of brick fence to Church Street boundary.
(Source: Rappoport Pty Ltd, 2011)

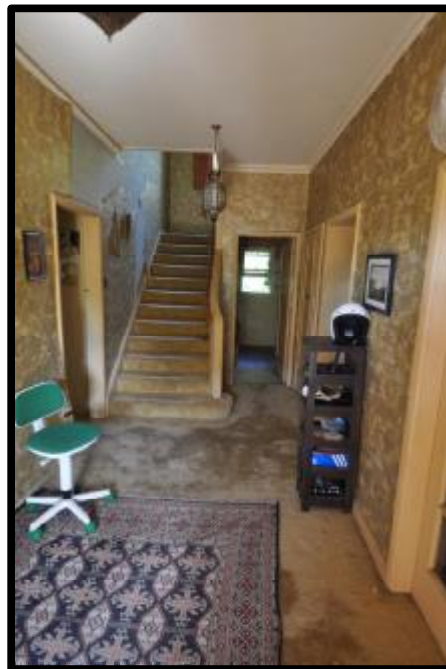
Front door opens on to a large hallway. The hallway contains stairs to the upper level and several doors accessing each of the lower level rooms.

Figure 30: Main entry hall of 34 Church Street containing stairs and doors to living areas.
(Source: Rappoport Pty Ltd, 2011)

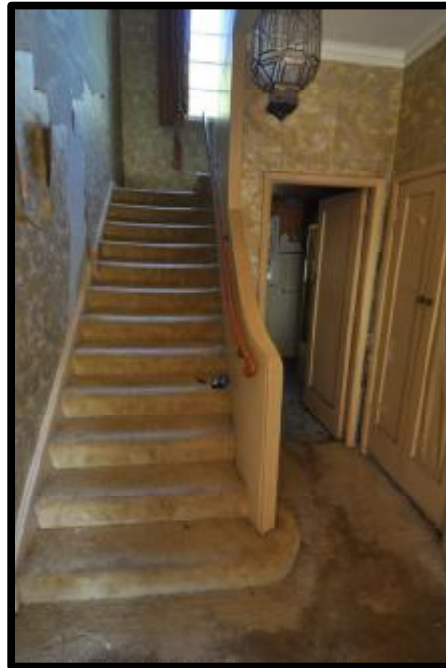
This building contains few original features and those which survive are thought to be the light pendants, layout and half-turn stair which is lit by a full length window.

Figure 33: The half-turn staircase leading to the upstairs bedroom accommodation
(Source: Rappoport Pty Ltd, 2011)

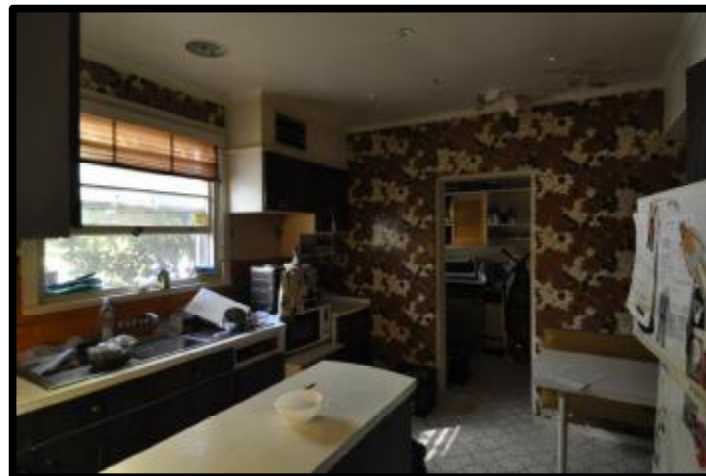
The interior has also been subject to a schedule of deferred maintenance the paint work and wall paper are both seen to be peeling from the walls.

Figure 34: Interior of the kitchen which has not been updated in some time.
(Source: Rappoport Pty Ltd, 2011)

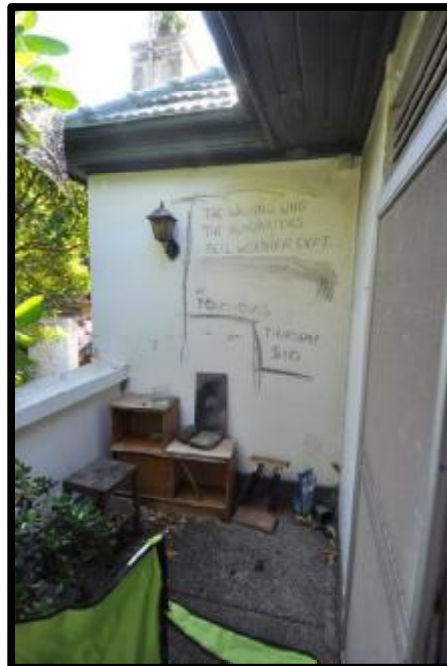
Figure 38: Upper level balcony. Note the wide overhanging eaves.
(Source: Rappoport Pty Ltd, 2011)

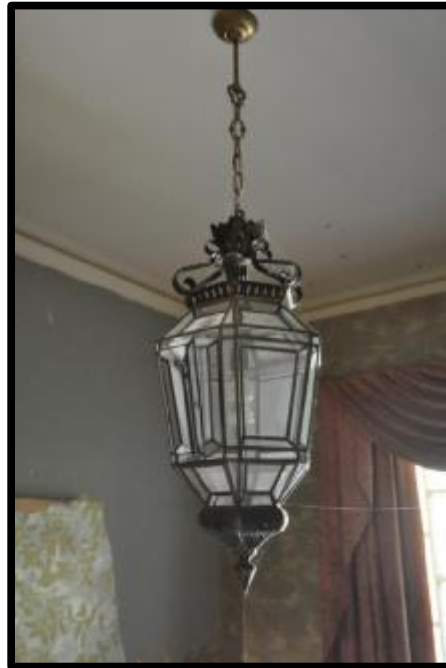
Figure 39: 1930s style light fitting (thought to be original to the property).
(Source: Rappoport Pty Ltd, 2011)

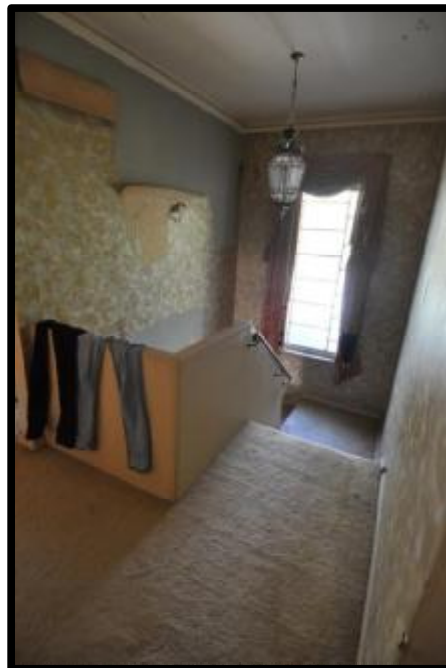
Figure 40: Half-turn stair as viewed from upper level landing.
(Source: Rappoport Pty Ltd, 2011)

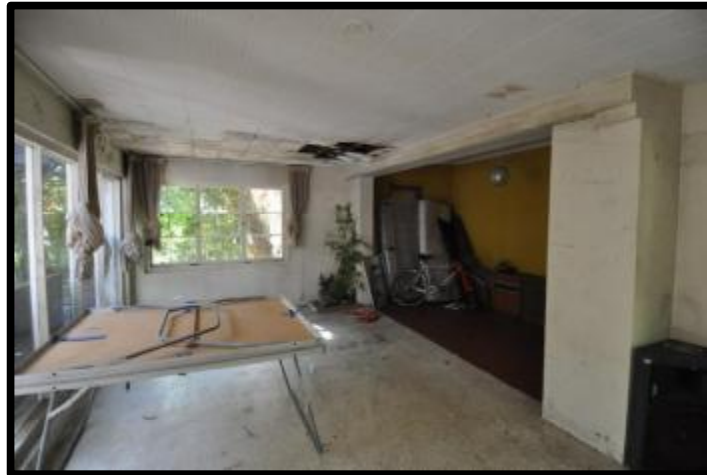
Additional living accommodation has been added by means of an externally accessed sun room to the lower level this too is in poor condition.

Figure 43: The wall to the right is thought to be the original external wall of the property and the room is a later extension. Note the damage of the ceiling.
(Source: Rappoport Pty Ltd, 2011)
