REMEDIATION ACTION PLAN
SENOIRS HOUSING PROJECT, CROYDON
PREPARED FOR CATHOLIC HEALTHCARE LIMITED
REPORT ID: CES120209-CHC-01-D
Revision 1.0

**REMEDIATION ACTION PLAN
SENIORS HOUSING PROJECT
CROYDON AVENUE, CROYDON, NSW
PREPARED FOR CATHOLIC HEALTHCARE LIMITED**

Report ID: CES120209-CHC-01-D

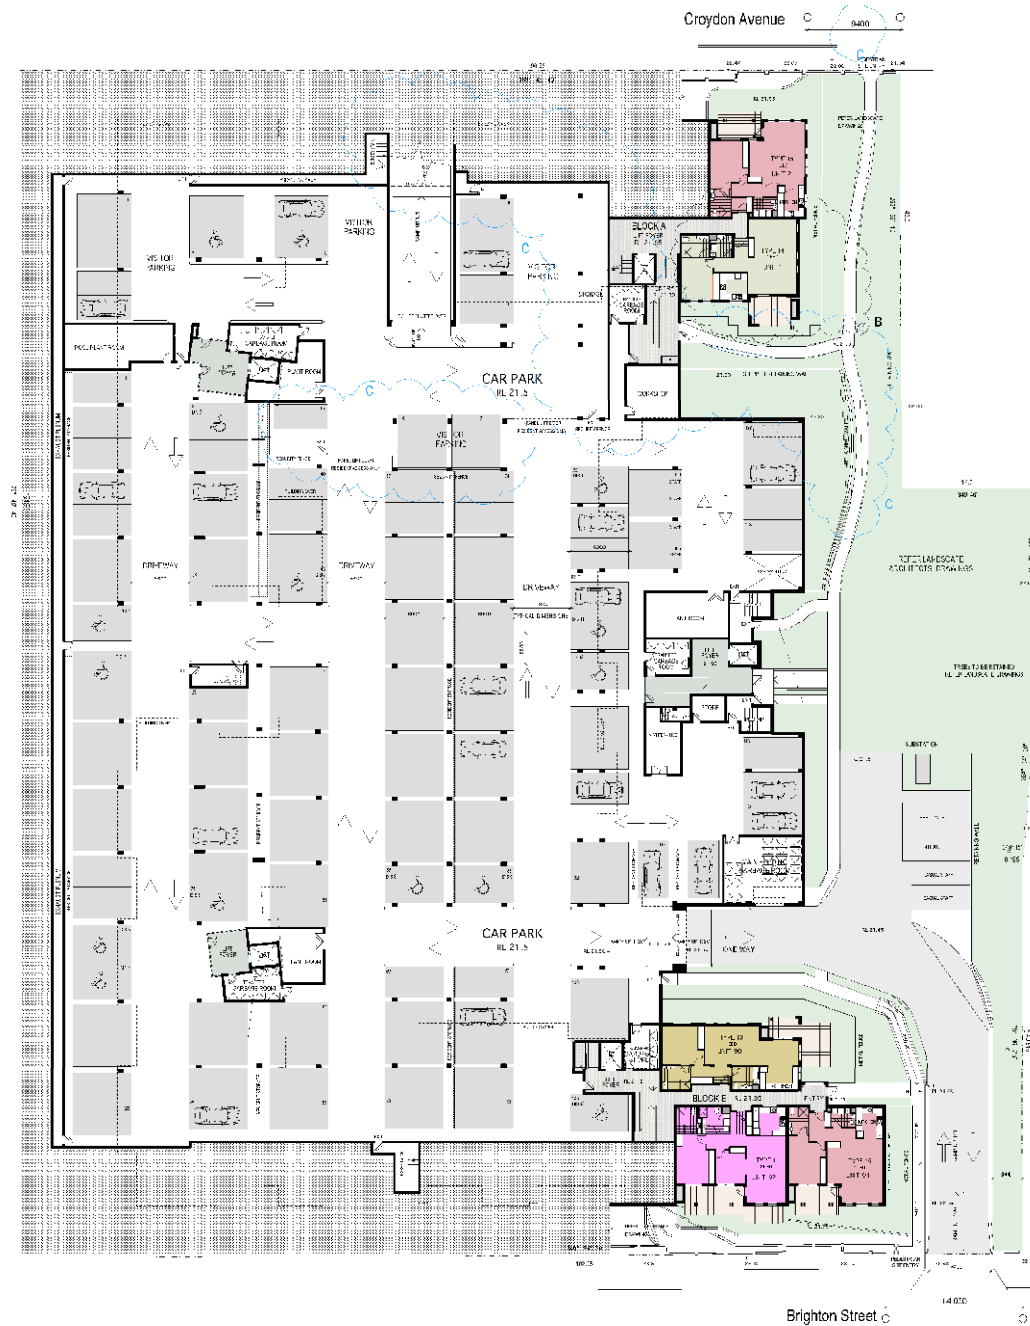
Source: Campbell Luscombe Architects drawing entitled
'Basement Car Park Level Floor Plan RL21.5'
Revision C dated 14/10/2011

Because the proposed development of the site requires the excavation of basement car parking over the greater part of the site, the remediation of the hot-spot and surrounding fill material will be achieved as part of the site civil works. Therefore, further testing of the fill materials in the
