Wonawinta Mine

**Manuka-Yarranvale Road (SR14)
&**

Cobar-Bedooba Road (SR13)

Council Road Upgrade Report

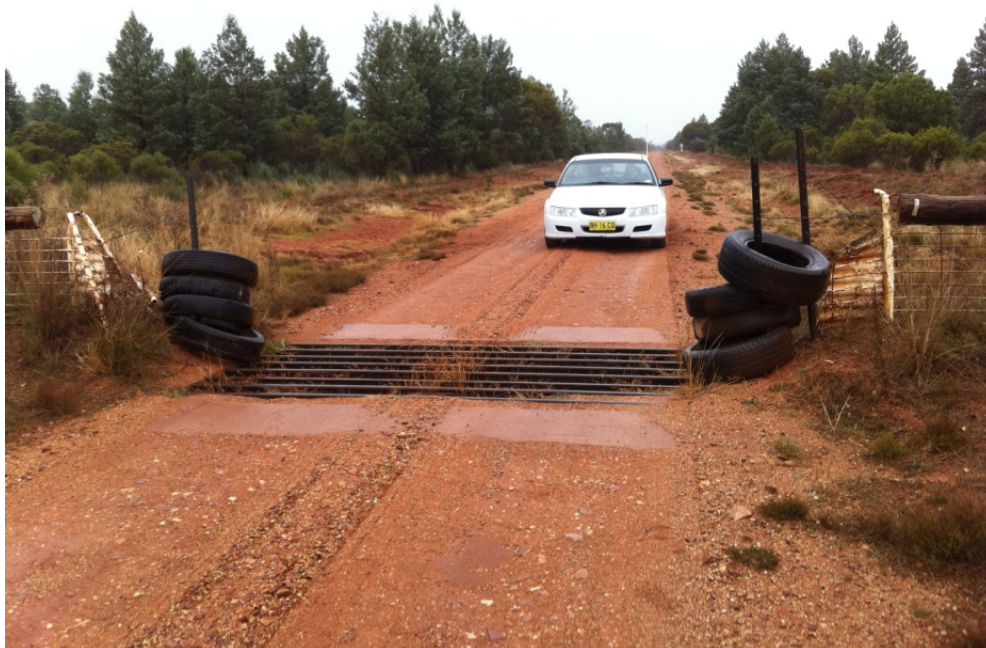
Figure 2.0 Existing pavement formation

In general each road has a 'central ridge' and there is evidence of minor superelevation on some of the major horizontal curves. Each of the existing roads has a formation width of 7.0m-8.0m, comprising a 5.0m-6.0m 'traffic surface' and 1.0m-1.5m shoulders. There are formed profiled table drains on either side of the trafficable pavement formation. Figure 2.0 indicates a typical formation profile of the existing roads.

From our visual inspections and assessments the existing pavement 'traffic surface' and shoulders are generally in good condition, however some sections of the current pavement are showing moderate signs of distress mainly relating to the floodway areas. The extent of the pavement that is showing signs of distress is estimated to be 5km. The pavement's current condition indicates the remainder of existing trafficable pavement formation profile is performing adequately under the existing local traffic conditions.

Subsequently considering the expected AADT movements during the construction period, we suggest a pavement formation width of 8.0m consisting of a 6.0m 'traffic surface' and 1.0m shoulders is suitable.

Based on our review and assessment, we recommend that a 150mm compacted thickness layer of weathered sandstone (sourced from the project site) or similar be provided on the 6.0m wide 'traffic surface' to the existing pavement sections showing moderate signs of distress (approximately 5km of pavement). In addition to these works, grading to the existing pavement would be provided where minor signs of rutting or surface defects are showing. This grading and maintenance work would be also carried out at regular intervals over the life of the mine.

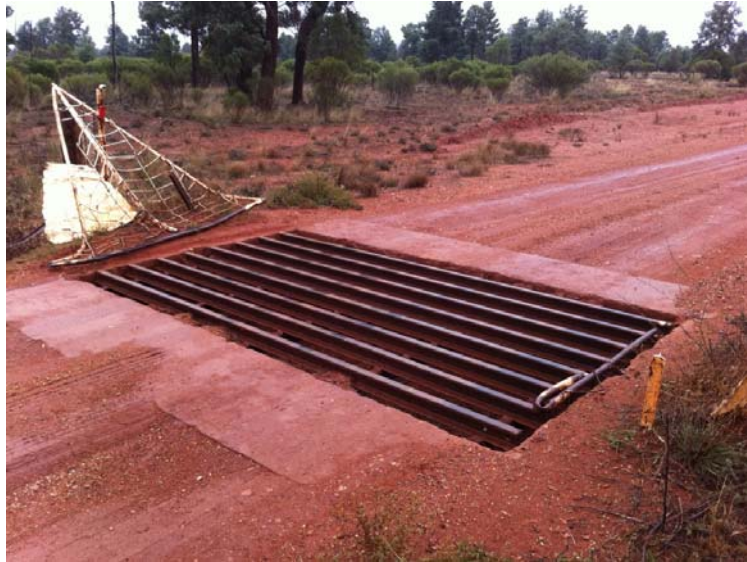
Figure 3.0 Typical Cattle Grid Crossing

There are a number of cattle grid (Figure 3.0) and floodway crossings of both Manuka-Yarranvale Road (SR14) and Cobar-Bedooba Road (SR13), in addition Sandy Creek (Figure 4.0) traverses the Manuka-Yarranvale Road (SR14) approximately 11.5kms west of the Barrier Highway (Kidman Way).

Typically the cattle grid crossings are 3.0m-4.0m wide and located on straight sections of the roads. We recommend that maintenance works be undertaken at each crossing including repair works to the existing structure/fencing where required, pit cleaning and grading/forming of the abutting pavement. In addition to the maintenance works it is also suggested that signage be erected to notify road users of the oncoming grid crossing. It is anticipated that road users pull over to allow single vehicle passing of the grids as per the current arrangement.
