# LAND CONTAMINATION ASSESSMENT

# STAGE 1 PRELIMINARY INVESTIGATION

Submission to Ballina Shire Council

PROPOSED SAND EXTRACTION INDUSTRY at Lot 32 DP 1151612
Newrybar Swamp Road, Lennox Head

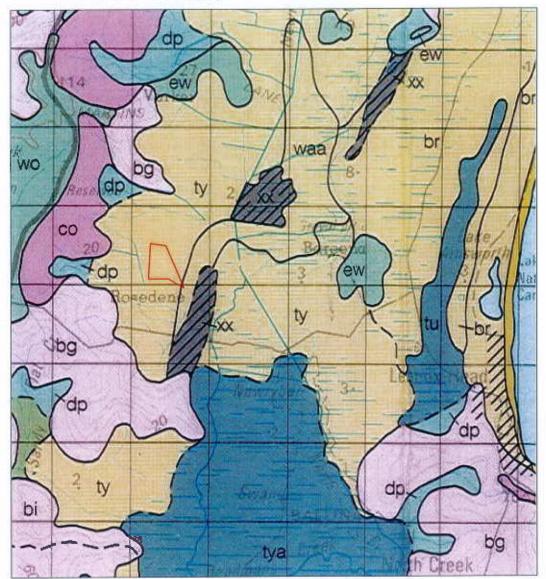
Figure 2 - Soils Map - (Morand, 1994)

Soils maps for the area were obtained from *Soil Landscapes of the Lismore-Ballina* (Morand, 1994) which map the land proposed to be used for the sand extraction quarry as:

# "Ty - Tyagrah" landscape

- Landscape Quaternary estuarine alluvium overlain by and/or mixed with Quaternary (Pleistocene) sands. Sands are generally aeolian, originating from the adjacent beach ridge systems. Slopes 0-1%, watertables within 100-200cm, elevation 2-5m.
- Soils dark course sand. Soil pH 4.5-5.0, occasionally 7.0-7.5.

# "waa - Wardell" landscape

Landscape – Quaternary (Pleistocene) sand sheets and barrier dunes consisting of aeolian and marine quartz sands. Slope 1-3%, elevation 5-6m. Areas shown as waa are very low isolated transgressive sand dunes that are now stabilised. These dunes have formed inland of the inner barrier. Historic sandmining has occurred in places and these areas are marked on the below map as Disturbed Terrain (xx).

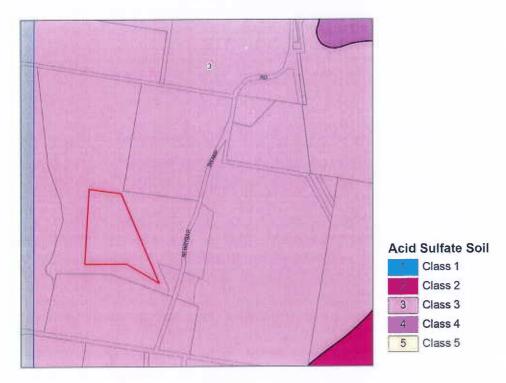
Figure 3: ASS Map (Source BSC DBLEP 2011)

The elevated areas of the site are mapped as being Class 3 Acid Sulfate Soils (ASS) as indicated in **Figure 3** below. Therefore works more than 1m below the natural ground surface are likely to have an ASS impact. As proposed works will involve excavation to 6m below ground level (mbgl), an Acid Sulfate Soils Management Plan has been prepared as part of the EIS documentation.

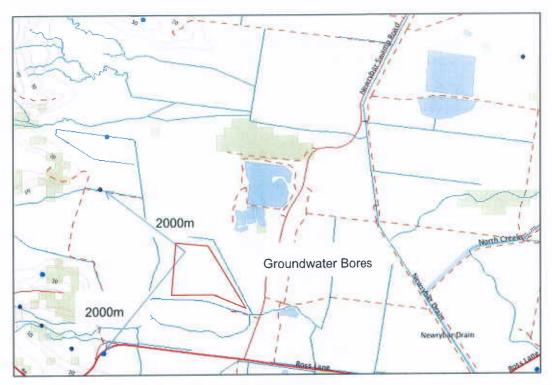
Figure 4: Groundwater resources (Accessed 16/05/12 <a href="https://www.nratlas.nsw.gov.au">www.nratlas.nsw.gov.au</a> © 2012)

A search of existing licensed groundwater bores was undertaken on 16th May 2012 using the NSW Natural Resources Atlas (NRA) website (DNR). The search indicates that no groundwater bores are located within 250m of the proposed development. The closest bores are located approximately 2000m to the west and south west. A map showing the groundwater resources is

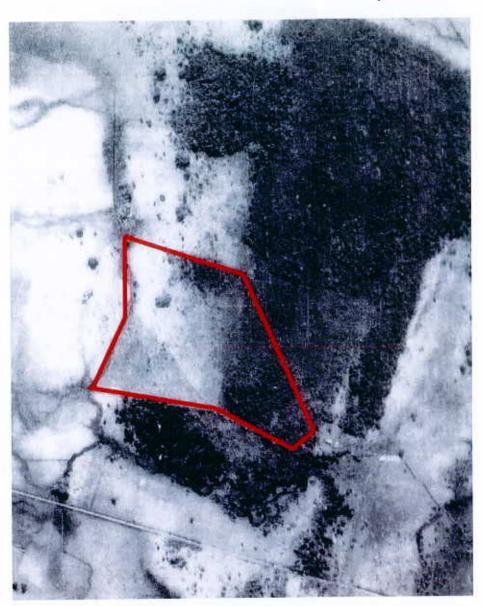
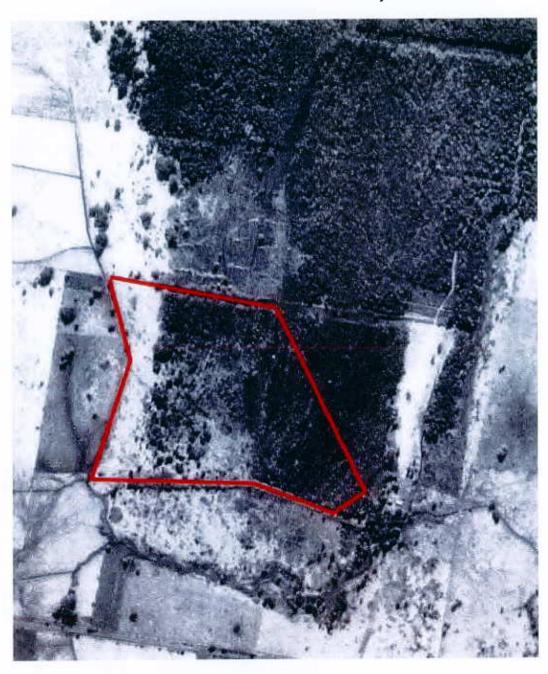
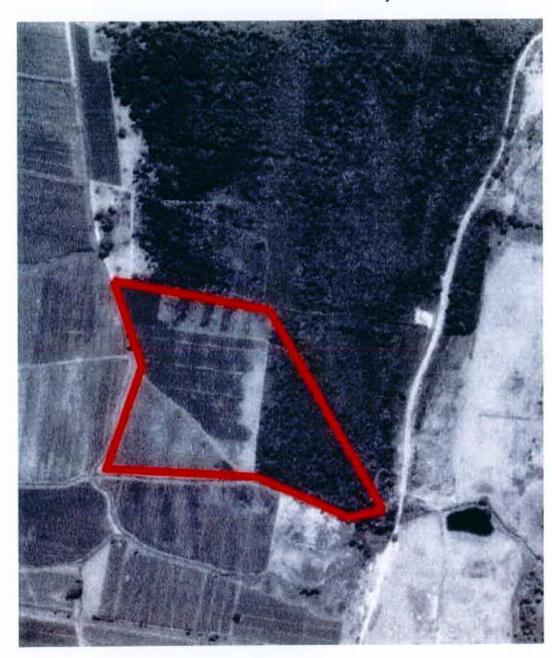
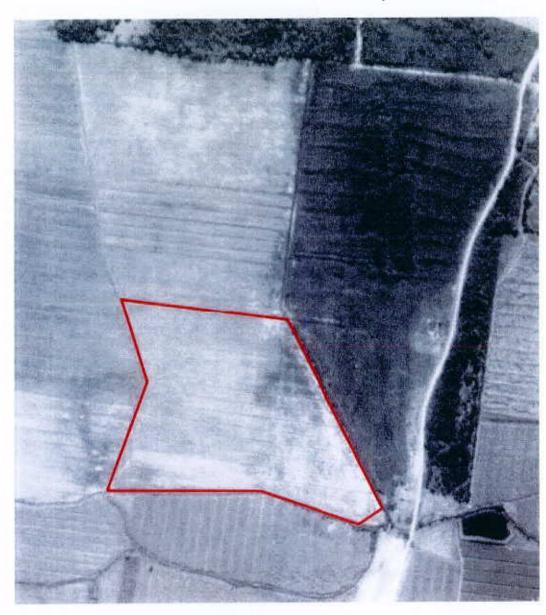
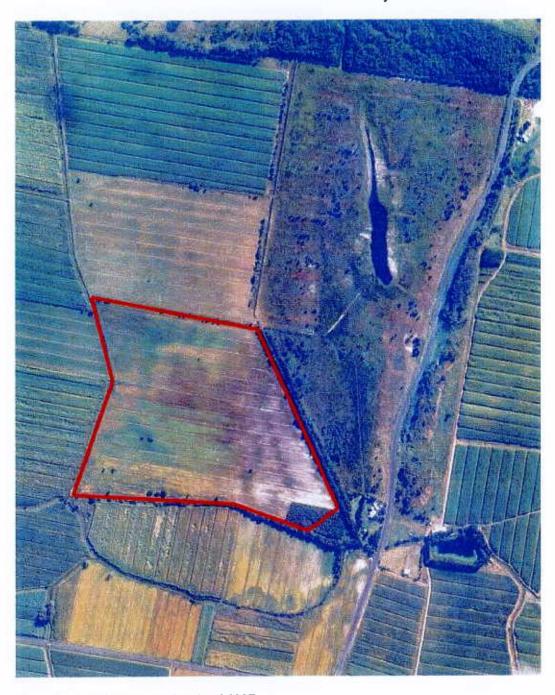
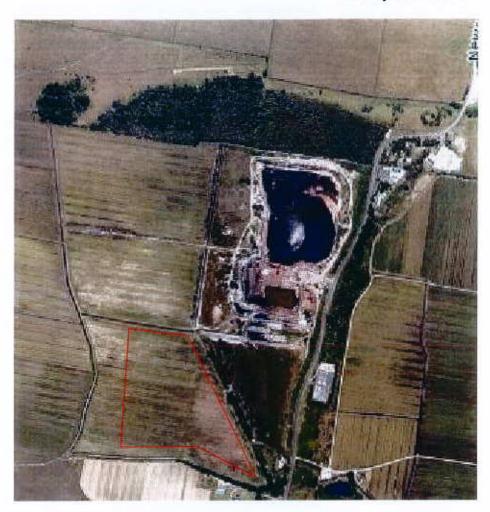
Copies of the historical aerial photographs are provided in **Figure 5** to **Figure 10**. A summary of the aerial photography is presented in **Table 2** below:

Table 2: A	Historical Aerial Photographs Observations
1947	Vegetation visible on approximately one third of property in south eastern corner
	Less vegetation to the west
	Ross Lane visible to the south
	Drainage has not be formalised over the site
	Cleared area to the east of the site – possible sand mining
1967	Vegetation visible on majority of site
	Scrubby regrowth over the western side of the property
	Some improvements to drainage to the north of the subject area
1979	Sugar cane / crop on western portion of property
	Drainage line visible/ thickly vegetated on eastern half of property
	Formalised drainage over site as part of sugar cane use
	Pond has appeared to the east – probable sand mining activity
1987	Property totally cleared of vegetation
	Planted with sugar cane
	All drainage lines have been improved and straightened
	Paddocks have been contoured to facilitated drainage
1997	Sugar cane visible on whole property except small portion in south

eastern corner of property
	'Pond' area visible on lot 33. No mining activity seen
	House has been built between the site and Newrybar swamp road
	Scattered vegetation regrowth visible
2012	Sugar cane visible on whole property with possible grazing areas
	Electrical substation has been built to the east of Newrybar Swamp Road
	Sand extraction from Lot 33 well underway
	House / shed built to the south
	Drainage lines maintained, contour drains on paddocks evident
	Vegetation regrowth evident to east of proposed extraction area

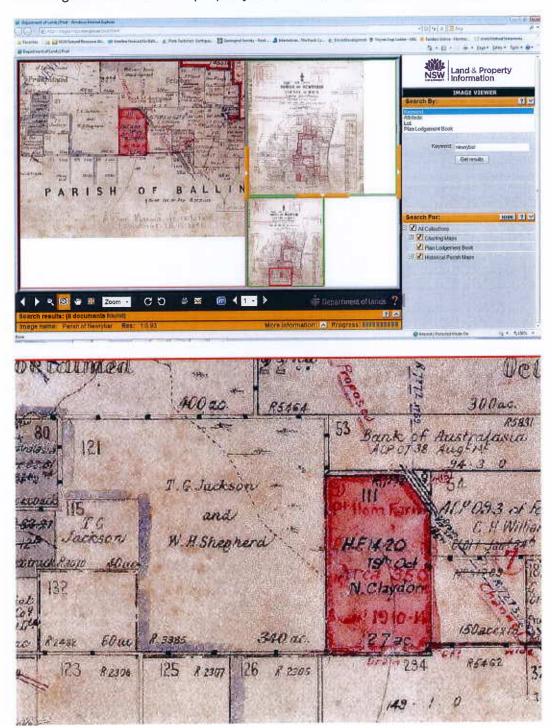
Figure 11: Historic Parish Map Newrybar 1908 (LPI, accessed 16<sup>th</sup> May 2012)

The Parish Map for Newrybar was obtained from the LPI. This map is presented in **Figure 11**. This map shows the location of the Newrybar Drain. The original owners of the property were TG Jackson & WH Shepherd.

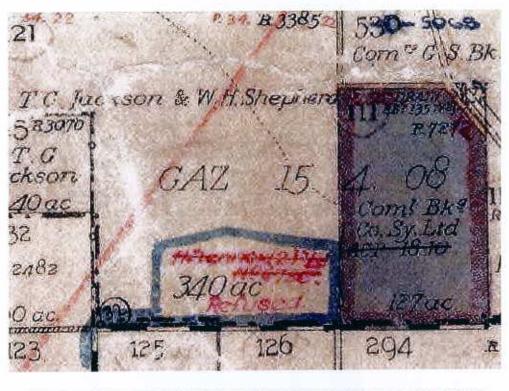
Figure 12: Newrybar Parish Map 1937

Newrybar Parish map from 1937 shows a gazettal of a Public Road on the subject land (**Figure 12**). The dotted line through the property is the drainage line which still exists today.

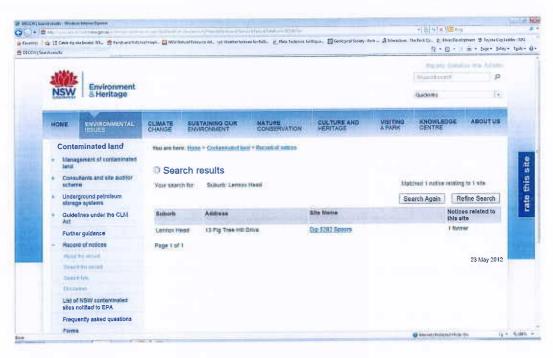
Figure 14: OEH Contaminated Land Register

The OEH's Contaminated Land – Record of Notices was searched (accessed on the 22nd May 2012) for the area surrounding the site and the only record identified for the site or surrounding area is a dip site in Figtree Hill Drive Lennox Head as per **Figure 14.** It is believed that this dip has subsequently been remediated.

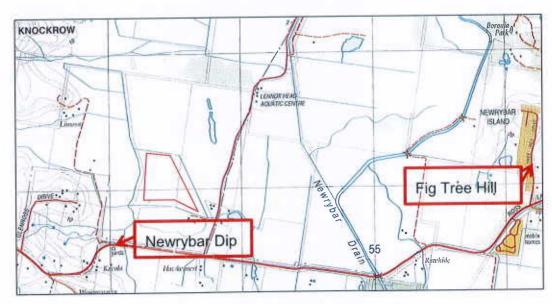
Figure 15: Location of Dip Sites

The NSW Primary Industries Science and Research: Cattle Tick Dip Site locator indicates that two cattle dips are located in the vicinity, one of which is adjacent to the site. The location of the dip sites is shown in **Figure 15**.

A 200m radius investigation zone is recommended around cattle tick dip sites (DIPMAC 1995). As the property is approximately 350m from the Newrybar dip site no further investigation is warranted.

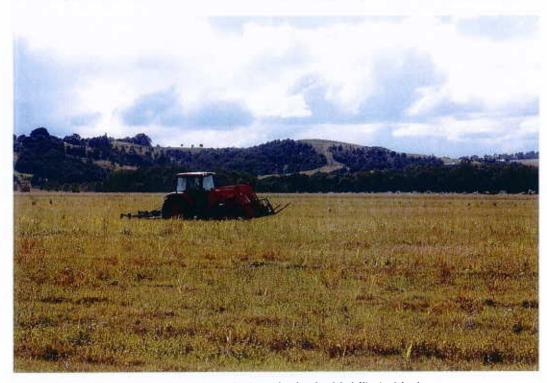
Based on the site history and the aerial imagery, the site has been primarily used for producing sugar cane. Cattle and horses have also been grazed.

Figure 16 – Photo showing site area being slashed with hills behind.

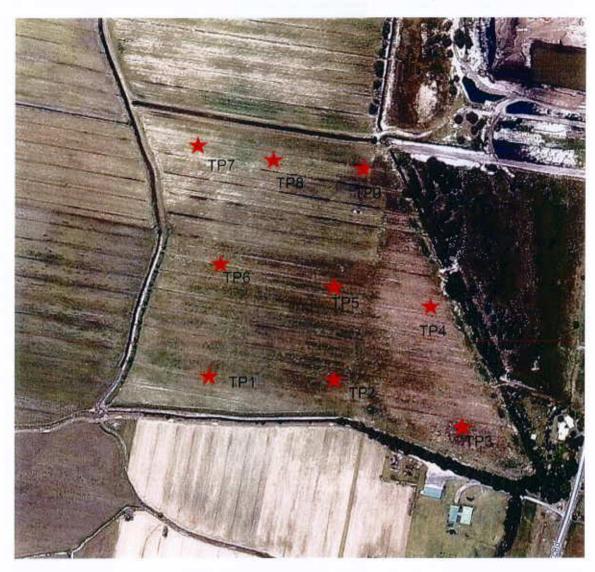
Figure 17: Soil Sample Locations

The field sampling investigation was conducted on the 11<sup>th</sup> May 2012. This involved the collection of 9 samples. The location of the sampling is shown in **Figure 17**. The samples were collected from below the root zone to 150mm below ground level in accordance with the *Sampling Design Guidelines* (EPA, 1995). Compositing details are shown in **Table 5**.
