Appendix 4

Geotechnical Investigations February and December 2012

Geotechnical Investigation for Proposed Waste Management Facility, Nyngan

Bogan Shire Council

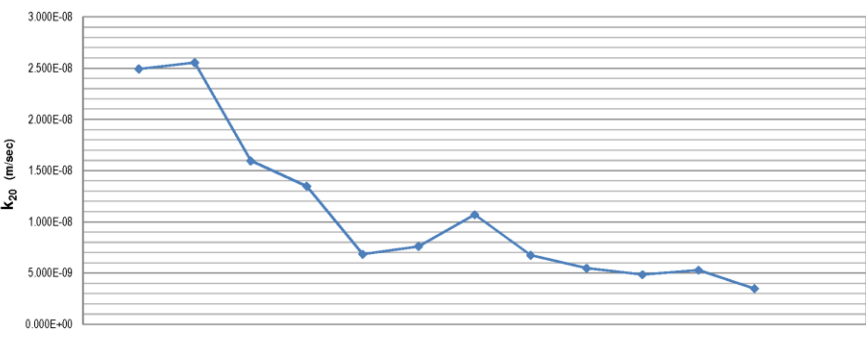
FALLING HEAD PERMEABILITY TEST REPORT			
Test Method AS 1289 6.7.2, 5.1.1			
Client:	Bogan Shire Council	Job No:	12-047
Client Address:	PO Box 221, Nyngan, NSW, 2825	Sample No:	8010
		Report No:	01-FHP
Project Location:	Proposed Waste Management Facility, Nyngan	Date Tested:	08/02/2012
		Source:	TP1 0.80-1.00m
SAMPLE DETAILS			
Sample Number:	8010	Sampling Method:	Sampled in accordance with AS1289.6.7.2
Date Sampled:	06/02/2012	Material Type:	Soil
Date Tested:	08/02/2012	Sample Location:	TP1 0.80-1.00m
Sampled By:	Macquarie Geotechnical staff	Sample Description:	Silty/Sandy CLAY
Remarks:			
RESULTS OF TESTING			
Compaction Method	AS1289.5.1.1 - Standard Compaction		
Maximum Dry Density (t/m ³)	1.73	Hydraulic Gradient	0.0
Optimum Moisture Content (%)	18.2	Surcharge (kPa)	0.0
Placement Moisture Content (%)	18.1	Head Pressure Applied (kPa)	0.0
Moisture Ratio (%)	99.6	Water Type	Tap
Placement Dry Density (t/m ³)	1.70	Percentage Material Retained/Sieve Size (mm)	0 % on 9.5 mm

Density Ratio (%)	98.1	Sample Height and Diameter (mm)	103.81 by 100.33 mm
PERMEABILITY $k_{(20)} = 3.48E-09 \text{ (m/sec)}$			
Permeability

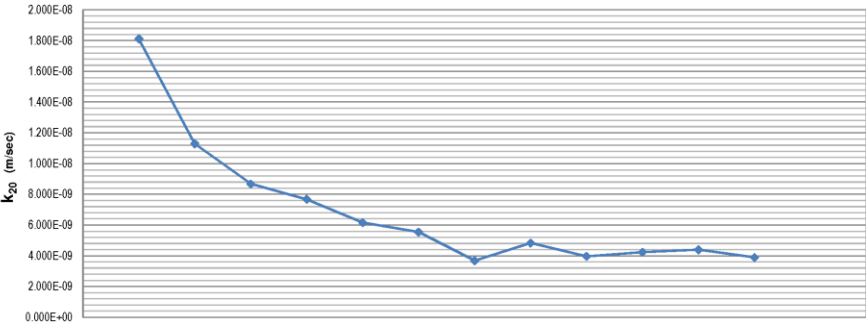
FALLING HEAD PERMEABILITY TEST REPORT			
Test Method AS 1289 6.7.2, 5.1.1			
Client:	Bogan Shire Council	Job No:	12-047
Client Address:	PO Box 221, Nyngan, NSW, 2825	Sample No:	8012
		Report No:	03-FHP
Project Location:	Proposed Waste Management Facility, Nyngan	Date Tested:	08/02/2012
		Source:	TP3 0.80-1.00m
SAMPLE DETAILS			
Sample Number:	8012	Sampling Method:	Sampled in accordance with AS1289.6.7.2
Date Sampled:	06/02/2012	Material Type:	Soil
Date Tested:	08/02/2012	Sample Location:	TP3 0.80-1.00m
Sampled By:	Macquarie Geotechnical staff	Sample Description:	Silty/Sandy CLAY
Remarks:			
RESULTS OF TESTING			
Compaction Method	AS1289.5.1.1 - Standard Compaction		
Maximum Dry Density (t/m ³)	1.74	Hydraulic Gradient	0.0
Optimum Moisture Content (%)	18.1	Surcharge (kPa)	0.0
Placement Moisture Content (%)	17.9	Head Pressure Applied (kPa)	0.0
Moisture Ratio (%)	99.1	Water Type	Tap
Placement Dry Density (t/m ³)	1.71	Percentage Material Retained/Sieve Size (mm)	0 % on 9.5 mm

Density Ratio (%)	98.1	Sample Height and Diameter (mm)	103.7 by 98.87 mm
PERMEABILITY $k_{(20)} =$ 3.90E-09 (m/sec)			
Permeability

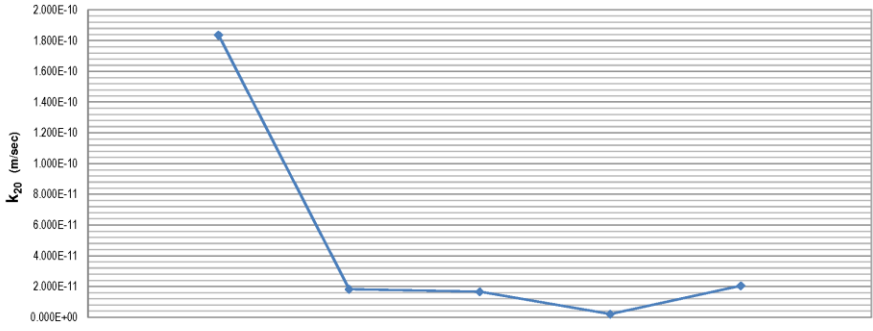
FALLING HEAD PERMEABILITY TEST REPORT			
Test Method AS 1289 6.7.2, 5.1.1			
Client:	Bogan Shire Council	Job No:	12-047
Client Address:	PO Box 221, Nyngan, NSW, 2825	Sample No:	8015
		Report No:	06-FHP
Project Location:	Proposed Waste Management Facility, Nyngan	Date Tested:	08/02/2012
		Source:	TP6 0.80-1.00m
SAMPLE DETAILS			
Sample Number:	8015	Sampling Method:	Sampled in accordance with AS1289.6.7.2
Date Sampled:	06/02/2012	Material Type:	Soil
Date Tested:	08/02/2012	Sample Location	TP6 0.80-1.00m
Sampled By:	Macquarie Geotechnical staff	Sample Description	Silty/Sandy CLAY
Remarks:			
RESULTS OF TESTING			
Compaction Method	AS1289.5.1.1 - Standard Compaction		
Maximum Dry Density (t/m ³)	1.72	Hydraulic Gradient	0.0
Optimum Moisture Content (%)	18.3	Surcharge (kPa)	0.0
Placement Moisture Content (%)	18.1	Head Pressure Applied (kPa)	0.0
Moisture Ratio (%)	98.9	Water Type	Tap
Placement Dry Density (t/m ³)	1.69	Percentage Material Retained/Sieve Size (mm)	0 % on 9.5 mm

Density Ratio (%)	98.3	Sample Height and Diameter (mm)	103.8 by 99.69 mm
PERMEABILITY $k_{(20)} = 2.05E-11$ (m/sec)			
Permeability

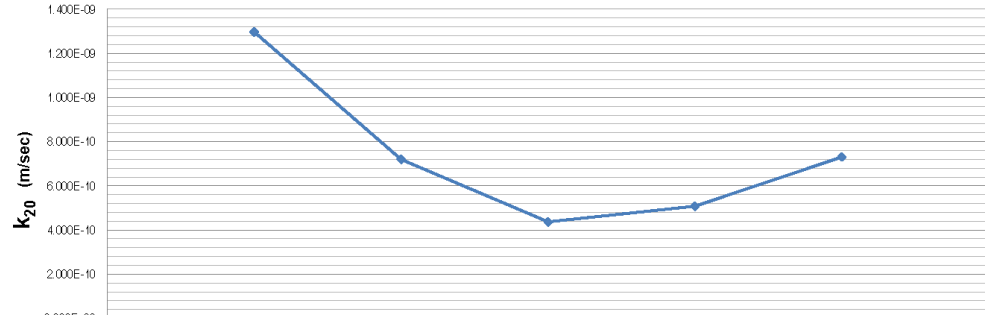
FALLING HEAD PERMEABILITY TEST REPORT			
AS1289 6.7.2			
Client:	Bogan Shire Council	Source:	TP9 0.8-1.0m
Address:	PO Box 221, Nyngan, NSW 2825	Sample Description:	Sandy CLAY
Project:	Nyngan	Report No.:	09-FHP
Job No.:	12-047	Lab No.:	9721 #1
Test Procedure:			
<input checked="" type="checkbox"/> AS1289 6.7.2 Soil strength and consolidation tests - Determination of a soil - Falling head method for a remoulded specimen <input checked="" type="checkbox"/> AS1289 5.1.1 Soil compaction and density tests - Determination of the dry density/moisture content relationship of a soil using standard compactive effort			
Sampling:		Sampled by Macquarie Geotechnical Staff in accordance with AS1289 1.1	
		Date Sampled:	23/11/2012
Preparation: Prepared in accordance with AS1289 1.1			
RESULTS OF TESTING			
Maximum Dry Density (t/m ³)	1.66	Hydraulic Gradient	0.0
Optimum Moisture Content (%)	20.0	Surcharge (kPa)	0.0
Placement Moisture Content (%)	19.8	Head Pressure Applied (kPa)	0.00

Moisture Ratio (%)	99.1	Compaction	Standard
Placement Dry Density (t/m ³)	1.63	Percentage Material Retained/Sieve Size (mm)	0 % on 9.5 mm
Density Ratio (%)	98.2	Sample Height and Diameter (mm)	104 x 98mm
PERMEABILITY $k_{(20)} =$ 7.31E-10 (m/sec)			
Permeability

Remarks/Comments			
4% Hydrated Lime

Based on the stabilisation results hydrated lime did not achieve the target permeability on all the samples, there could be the option to stabilise the material at a higher blend than the trials, however this wouldn't be recommended due to variations in the clay mineralogy which may not respond as well to the hydrated lime and also the potential of making the soil brittle and prone to cracking.

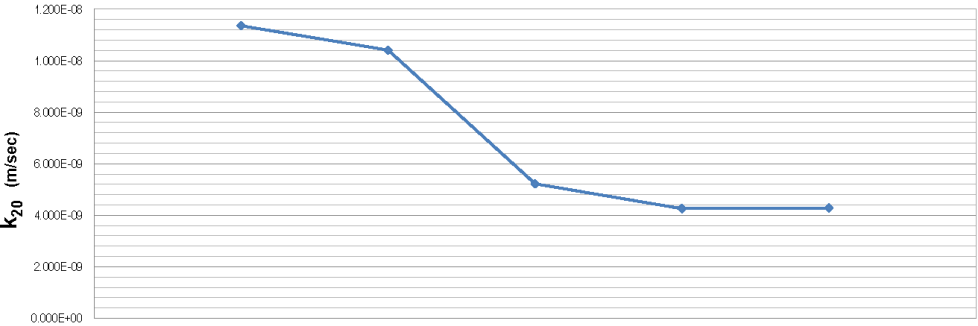
FALLING HEAD PERMEABILITY TEST REPORT			
AS1289 6.7.2			
Client:	Bogan Shire Council	Source:	TP10 0.8-1.0m
Address:	PO Box 221, Nyngan, NSW 2825	Sample Description:	Sandy CLAY
Project:	Nyngan	Report No.:	10-FHP
Job No.:	12-047	Lab No.:	9722 #1
Test Procedure:			
<input checked="" type="checkbox"/> AS1289 6.7.2 Soil strength and consolidation tests - Determination of a soil - Falling head method for a remoulded specimen <input checked="" type="checkbox"/> AS1289 5.1.1 Soil compaction and density tests - Determination of the dry density/moisture content relationship of a soil using standard compactive effort			
Sampling:		Sampled by Macquarie Geotechnical Staff in accordance with AS1289 1.1	
		Date Sampled:	23/11/2012
Preparation: Prepared in accordance with AS1289 1.1			
RESULTS OF TESTING			
Maximum Dry Density (t/m ³)	1.71	Hydraulic Gradient	0.0
Optimum Moisture Content (%)	18.0	Surcharge (kPa)	0.0
Placement Moisture Content (%)	17.9	Head Pressure Applied (kPa)	0.00

Moisture Ratio (%)	99.6	Compaction	Standard
Placement Dry Density (t/m ³)	1.68	Percentage Material Retained/Sieve Size (mm)	0 % on 9.5 mm
Density Ratio (%)	98.1	Sample Height and Diameter (mm)	164 x 98mm
PERMEABILITY $k_{(20)} =$ 4.28E-09 (m/sec)			
Permeability

Remarks/Comments			
4% Hydrated Lime

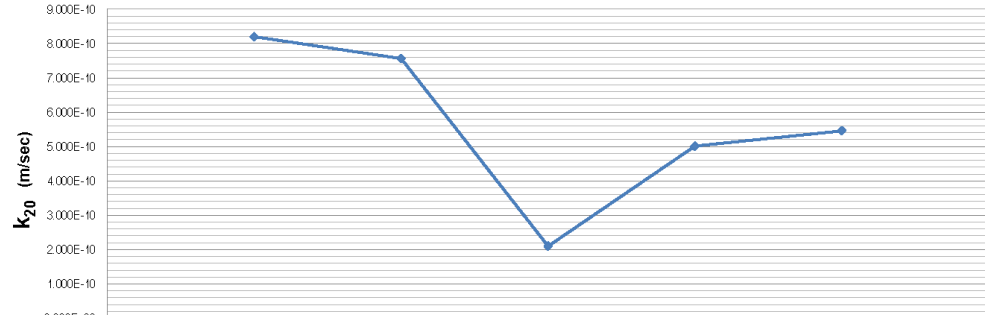
FALLING HEAD PERMEABILITY TEST REPORT			
AS1289 6.7.2			
Client:	Bogan Shire Council	Source:	TP11 0.8-1.0m
Address:	PO Box 221, Nyngan, NSW 2825	Sample Description:	Sandy CLAY
Project:	Nyngan	Report No.:	11-FHP
Job No.:	12-047	Lab No.:	9723 #1
Test Procedure:			
<input checked="" type="checkbox"/> AS1289 6.7.2 Soil strength and consolidation tests - Determination of a soil - Falling head method for a remoulded specimen <input checked="" type="checkbox"/> AS1289 5.1.1 Soil compaction and density tests - Determination of the dry density/moisture content relationship of a soil using standard compactive effort			
Sampling:		Sampled by Macquarie Geotechnical Staff in accordance with AS1289 1.1	
		Date Sampled:	23/11/2012
Preparation: Prepared in accordance with AS1289 1.1			
RESULTS OF TESTING			
Maximum Dry Density (t/m ³)	1.75	Hydraulic Gradient	0.0
Optimum Moisture Content (%)	17.5	Surcharge (kPa)	0.0
Placement Moisture Content (%)	17.5	Head Pressure Applied (kPa)	0.00

Moisture Ratio (%)	99.9	Compaction	Standard
Placement Dry Density (t/m ³)	1.71	Percentage Material Retained/Sieve Size (mm)	0 % on 9.5 mm
Density Ratio (%)	97.9	Sample Height and Diameter (mm)	103 X 98mm
PERMEABILITY $k_{(20)} =$ 5.46E-10 (m/sec)			
Permeability

Remarks/Comments			
2% Hydrated Lime

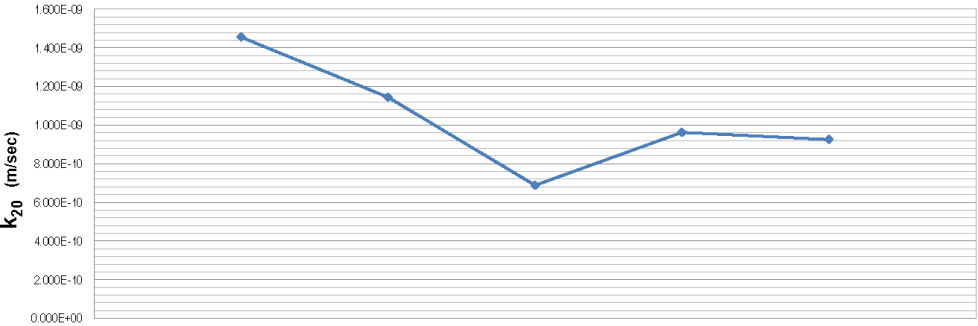
FALLING HEAD PERMEABILITY TEST REPORT			
AS1289 6.7.2			
Client:	Bogan Shire Council	Source:	TP12 0.8-1.0m
Address:	PO Box 221, Nyngan, NSW 2825	Sample Description:	Sandy CLAY
Project:	Nyngan	Report No.:	12-FHP
Job No.:	12-047	Lab No.:	9724 #1
Test Procedure:			
<input checked="" type="checkbox"/> AS1289 6.7.2 Soil strength and consolidation tests - Determination of a soil - Falling head method for a remoulded specimen <input checked="" type="checkbox"/> AS1289 5.1.1 Soil compaction and density tests - Determination of the dry density/moisture content relationship of a soil using standard compactive effort			
Sampling:		Sampled by Macquarie Geotechnical Staff in accordance with AS1289 1.1	
		Date Sampled:	23/11/2012
Preparation: Prepared in accordance with AS1289 1.1			
RESULTS OF TESTING			
Maximum Dry Density (t/m ³)	1.66	Hydraulic Gradient	0.0
Optimum Moisture Content (%)	21.0	Surcharge (kPa)	0.0
Placement Moisture Content (%)	21.2	Head Pressure Applied (kPa)	0.00

Moisture Ratio (%)	100.8	Compaction	Standard
Placement Dry Density (t/m ³)	1.63	Percentage Material Retained/Sieve Size (mm)	0 % on 9.5 mm
Density Ratio (%)	97.9	Sample Height and Diameter (mm)	104 x 98mm
PERMEABILITY $k_{(20)} =$ 9.26E-10 (m/sec)			
Permeability

Remarks/Comments			
2% Hydrated Lime

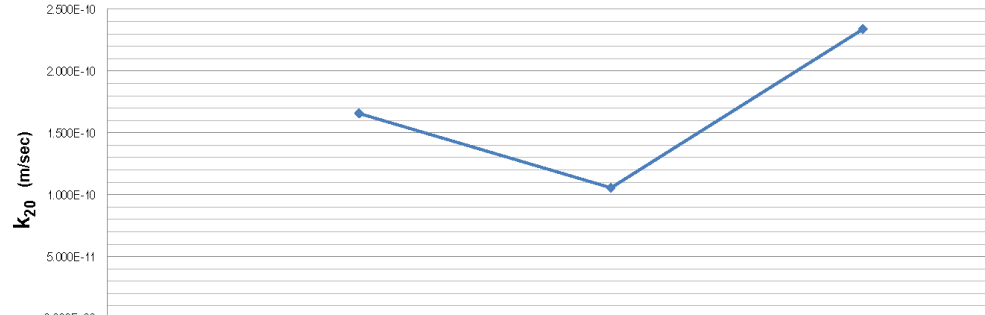
FALLING HEAD PERMEABILITY TEST REPORT			
AS1289 6.7.2			
Client:	Bogan Shire Council	Source:	TP7 0.8-1.0m
Address:	PO Box 221, Nyngan, NSW 2825	Sample Description:	Sandy CLAY
Project:	Nyngan	Report No.:	13-FHP
Job No.:	12-047	Lab No.:	9719 #2
Test Procedure:			
<input checked="" type="checkbox"/> AS1289 6.7.2 Soil strength and consolidation tests - Determination of a soil - Falling head method for a remoulded specimen <input checked="" type="checkbox"/> AS1289 5.1.1 Soil compaction and density tests - Determination of the dry density/moisture content relationship of a soil using standard compactive effort			
Sampling:		Sampled by Macquarie Geotechnical Staff in accordance with AS1289 1.1	
		Date Sampled:	23/11/2012
Preparation: Prepared in accordance with AS1289 1.1			
RESULTS OF TESTING			
Maximum Dry Density (t/m ³)	1.70	Hydraulic Gradient	0.0
Optimum Moisture Content (%)	18.6	Surcharge (kPa)	0.0
Placement Moisture Content (%)	18.2	Head Pressure Applied (kPa)	0.00

Moisture Ratio (%)	98.1	Compaction	Standard
Placement Dry Density (t/m ³)	1.67	Percentage Material Retained/Sieve Size (mm)	0 % on 9.5 mm
Density Ratio (%)	98.3	Sample Height and Diameter (mm)	104 x 98mm
PERMEABILITY $k_{(20)} =$ 2.34E-10 (m/sec)			
Permeability

Remarks/Comments 2% Bentonite

The bentonite trials for both 1% & 2% all met the target permeability and based on the trial blends undertaken we would recommend that the insitu and stockpiled material is stabilised with 2% bentonite.

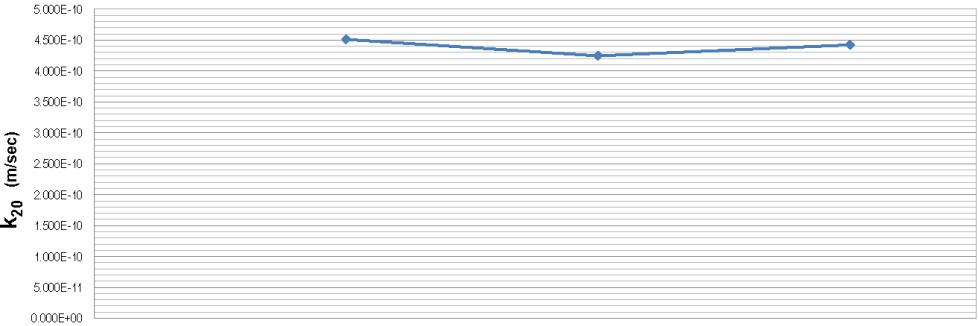
FALLING HEAD PERMEABILITY TEST REPORT			
AS1289 6.7.2			
Client:	Bogan Shire Council	Source:	TP10 0.8-1.0m
Address:	PO Box 221, Nyngan, NSW 2825	Sample Description:	Sandy CLAY
Project:	Nyngan	Report No.:	16-FHP
Job No.:	12-047	Lab No.:	9722 #2
Test Procedure:			
<input checked="" type="checkbox"/> AS1289 6.7.2 Soil strength and consolidation tests - Determination of a soil - Falling head method for a remoulded specimen <input checked="" type="checkbox"/> AS1289 5.1.1 Soil compaction and density tests - Determination of the dry density/moisture content relationship of a soil using standard compactive effort			
Sampling:		Sampled by Macquarie Geotechnical Staff in accordance with AS1289 1.1	
		Date Sampled:	23/11/2012
Preparation: Prepared in accordance with AS1289 1.1			
RESULTS OF TESTING			
Maximum Dry Density (t/m ³)	1.71	Hydraulic Gradient	0.0
Optimum Moisture Content (%)	18.0	Surcharge (kPa)	0.0
Placement Moisture Content (%)	17.9	Head Pressure Applied (kPa)	0.00

Moisture Ratio (%)	99.6	Compaction	Standard
Placement Dry Density (t/m ³)	1.68	Percentage Material Retained/Sieve Size (mm)	0 % on 9.5 mm
Density Ratio (%)	98.1	Sample Height and Diameter (mm)	164 x 98mm
PERMEABILITY $k_{(20)} =$ 4.42E-10 (m/sec)			
Permeability

Remarks/Comments 2% Bentonite

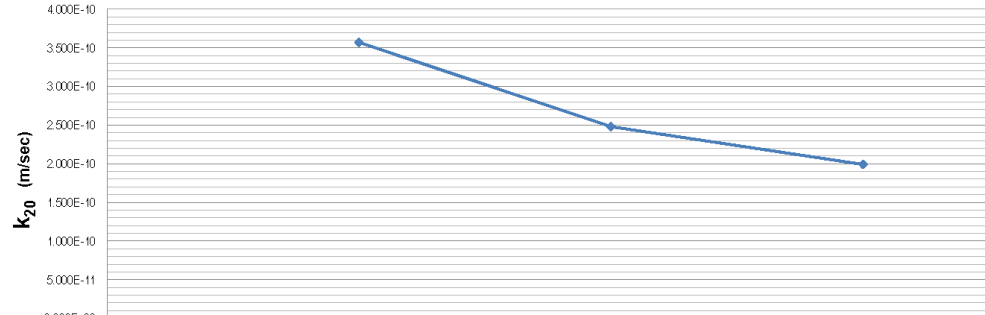
FALLING HEAD PERMEABILITY TEST REPORT			
AS1289 6.7.2			
Client:	Bogan Shire Council	Source:	TP11 0.8-1.0m
Address:	PO Box 221, Nyngan, NSW 2825	Sample Description:	Sandy CLAY
Project:	Nyngan	Report No.:	17-FHP
Job No.:	12-047	Lab No.:	9723 #2
Test Procedure:			
<input checked="" type="checkbox"/> AS1289 6.7.2 Soil strength and consolidation tests - Determination of a soil - Falling head method for a remoulded specimen <input checked="" type="checkbox"/> AS1289 5.1.1 Soil compaction and density tests - Determination of the dry density/moisture content relationship of a soil using standard compactive effort			
Sampling:		Sampled by Macquarie Geotechnical Staff in accordance with AS1289 1.1	
		Date Sampled:	23/11/2012
Preparation: Prepared in accordance with AS1289 1.1			
RESULTS OF TESTING			
Maximum Dry Density (t/m ³)	1.75	Hydraulic Gradient	0.0
Optimum Moisture Content (%)	17.5	Surcharge (kPa)	0.0
Placement Moisture Content (%)	17.5	Head Pressure Applied (kPa)	0.00

Moisture Ratio (%)	99.9	Compaction	Standard
Placement Dry Density (t/m ³)	1.71	Percentage Material Retained/Sieve Size (mm)	0 % on 9.5 mm
Density Ratio (%)	97.9	Sample Height and Diameter (mm)	103 X 98mm
PERMEABILITY $k_{(20)} =$ 1.99E-10 (m/sec)			
Permeability

Remarks/Comments 1% Bentonite

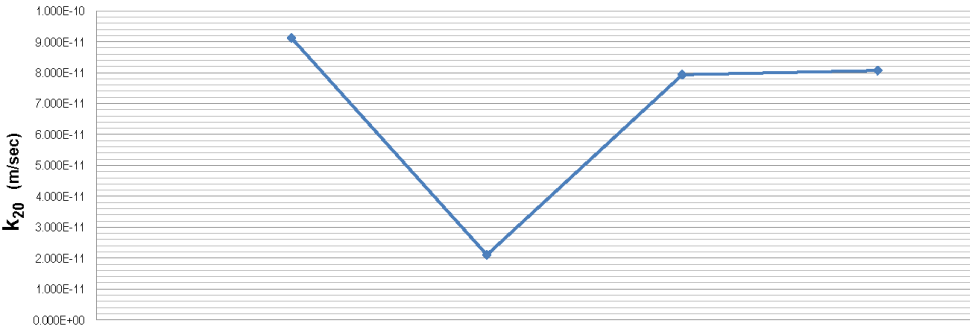
FALLING HEAD PERMEABILITY TEST REPORT			
AS1289 6.7.2			
Client:	Bogan Shire Council	Source:	TP12 9.8-1.0m
Address:	PO Box 221, Nyngan, NSW 2925	Sample Description:	Sandy CLAY
Project:	Nyngan	Report No.:	18-FHP
Job No.:	12-047	Lab No.:	9724#3
Test Procedure:			
<input checked="" type="checkbox"/> AS1289 6.7.2 Soil strength and consolidation tests - Determination of a soil - Falling head method for a remoulded specimen <input checked="" type="checkbox"/> AS1289 5.1.1 Soil compaction and density tests - Determination of the dry density/moisture content relationship of a soil using standard compactive effort			
Sampling:		Sampled by Macquarie Geotechnical Staff in accordance with AS1289 1.1	
		Date Sampled:	23/11/2012
Preparation: Prepared in accordance with AS1289 1.1			
RESULTS OF TESTING			
Maximum Dry Density (t/m ³)	1.66	Hydraulic Gradient	0.0
Optimum Moisture Content (%)	21.0	Surcharge (kPa)	0.0
Placement Moisture Content (%)	20.5	Head Pressure Applied (kPa)	0.00

Moisture Ratio (%)	97.7	Compaction	Standard
Placement Dry Density (t/m ³)	1.63	Percentage Material Retained/Sieve Size (mm)	0 % on 9.5 mm
Density Ratio (%)	97.9	Sample Height and Diameter (mm)	104 x 98 mm
PERMEABILITY $k_{(20)} =$ 8.07E-11 (m/sec)			
Permeability

Remarks/Comments 1% Bentonite
