## waterway impact study

OXFORD FALLS SENIORS  
LIVING FACILITY

Lot 1113 DP 752038  
BARNES ROAD  
FRENCHS FOREST

September 2014  
(REF: A14054WIS)

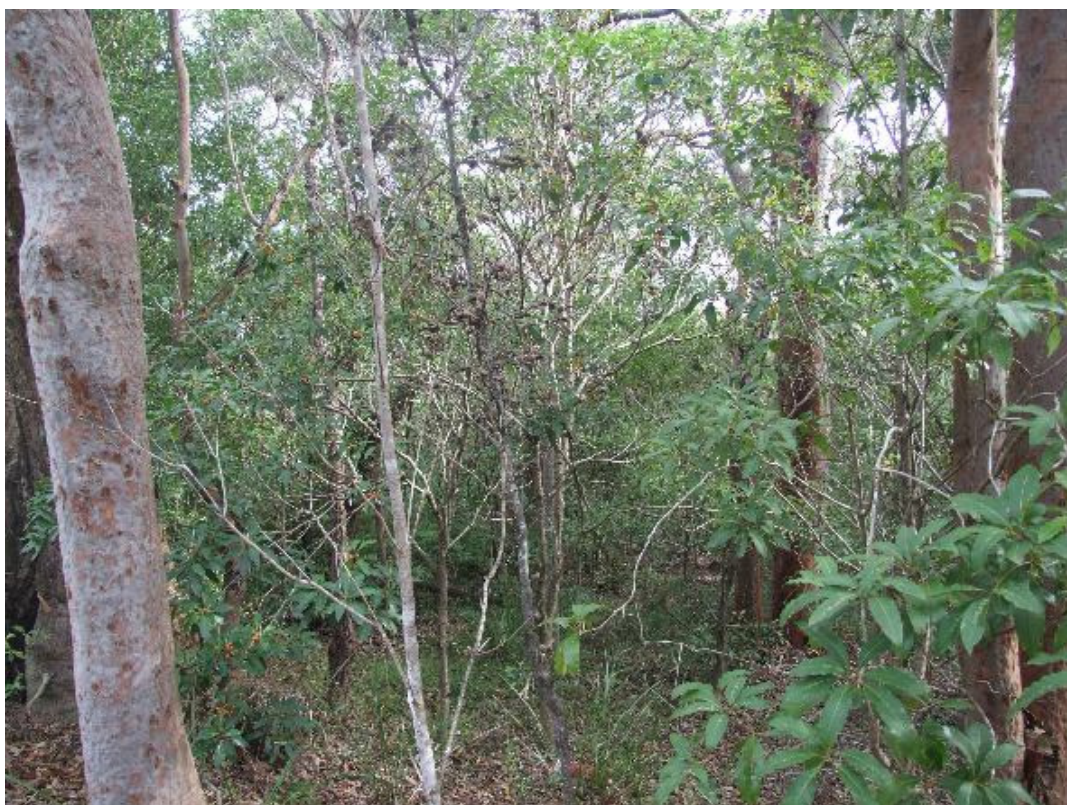
**Photo 1** – Peppermint – Angophora Woodland / Open Forest vegetation adjacent to Oxford Falls Road, part of the better condition vegetation

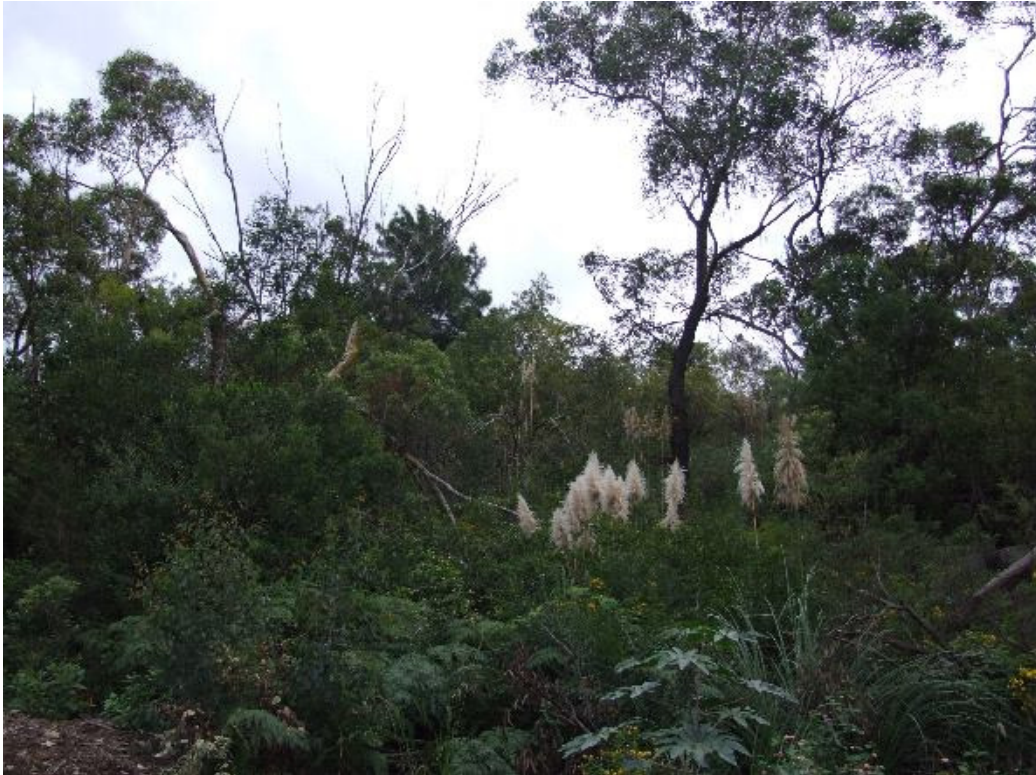
**Photo 2** – Peppermint – Angophora Woodland / Open Forest vegetation in the central western portion of the subject site containing a high level of exotic plant disturbance\

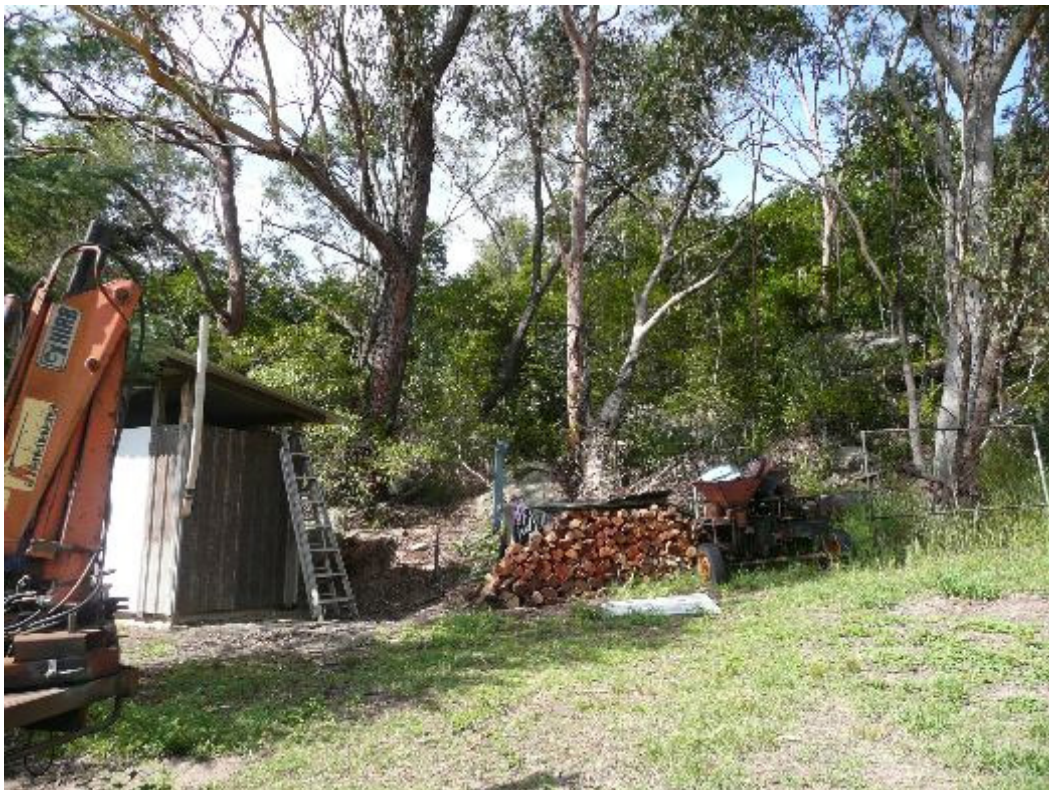
**Photo 3** – Heavily impacted zone in the middle of the Peppermint – Angophora Woodland / Open Forest

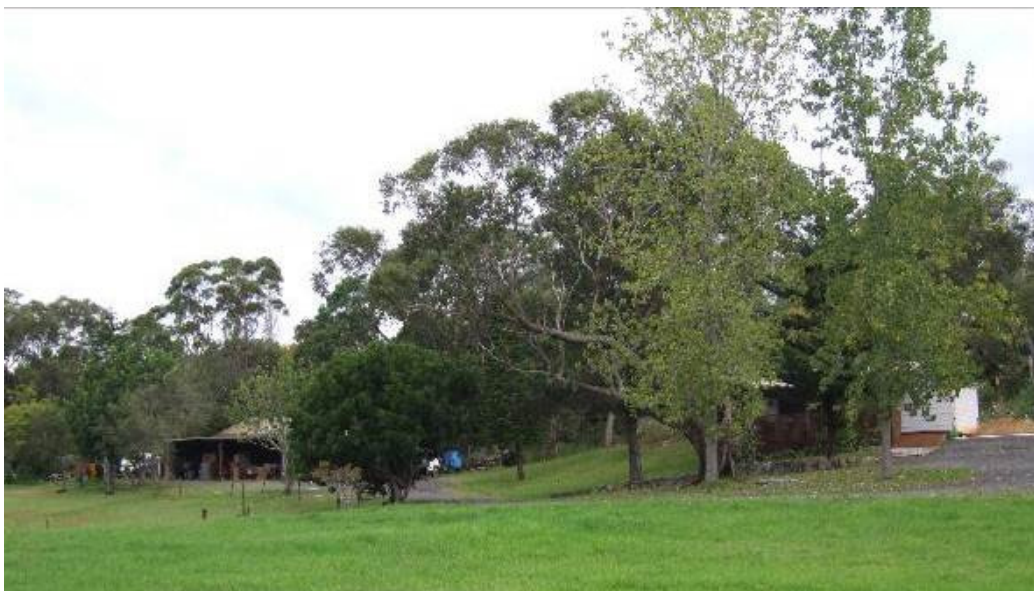
**Photo 4** – Some scattered trees (mostly planted) in close proximity to one of the existing dwellings.

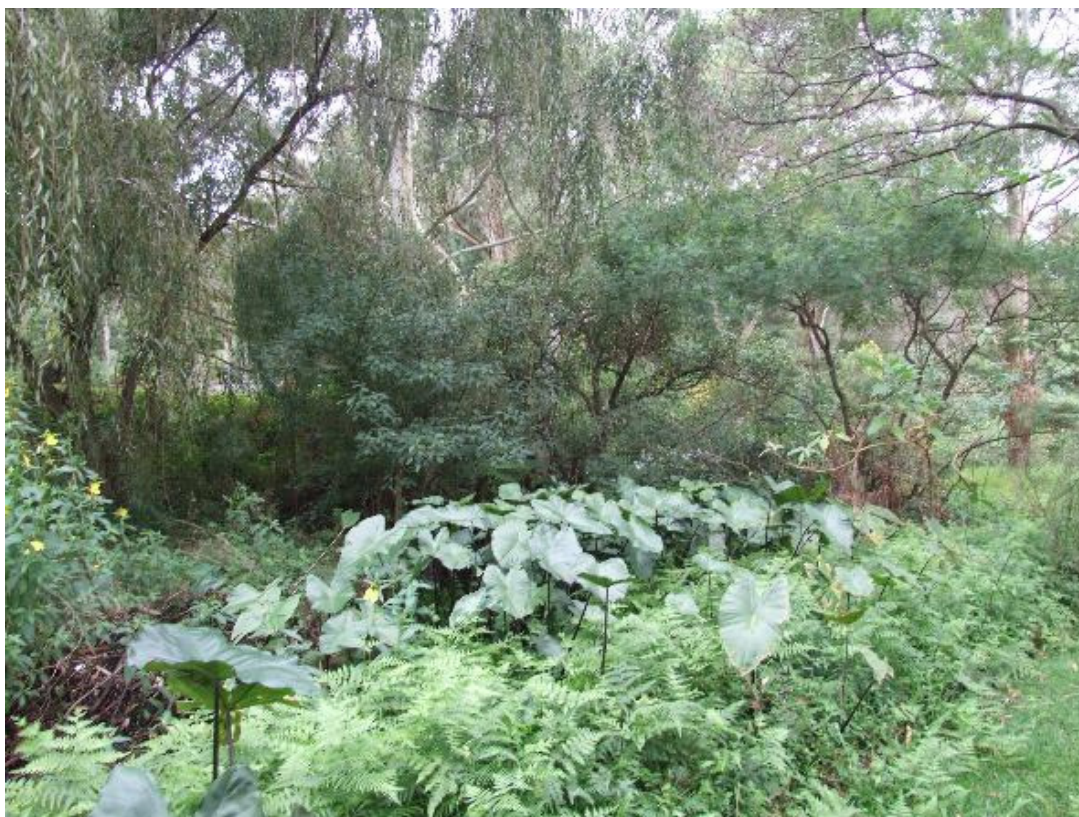
**Photo 5** – Riparian vegetation approximately 30m south of the existing car park for the tennis academy

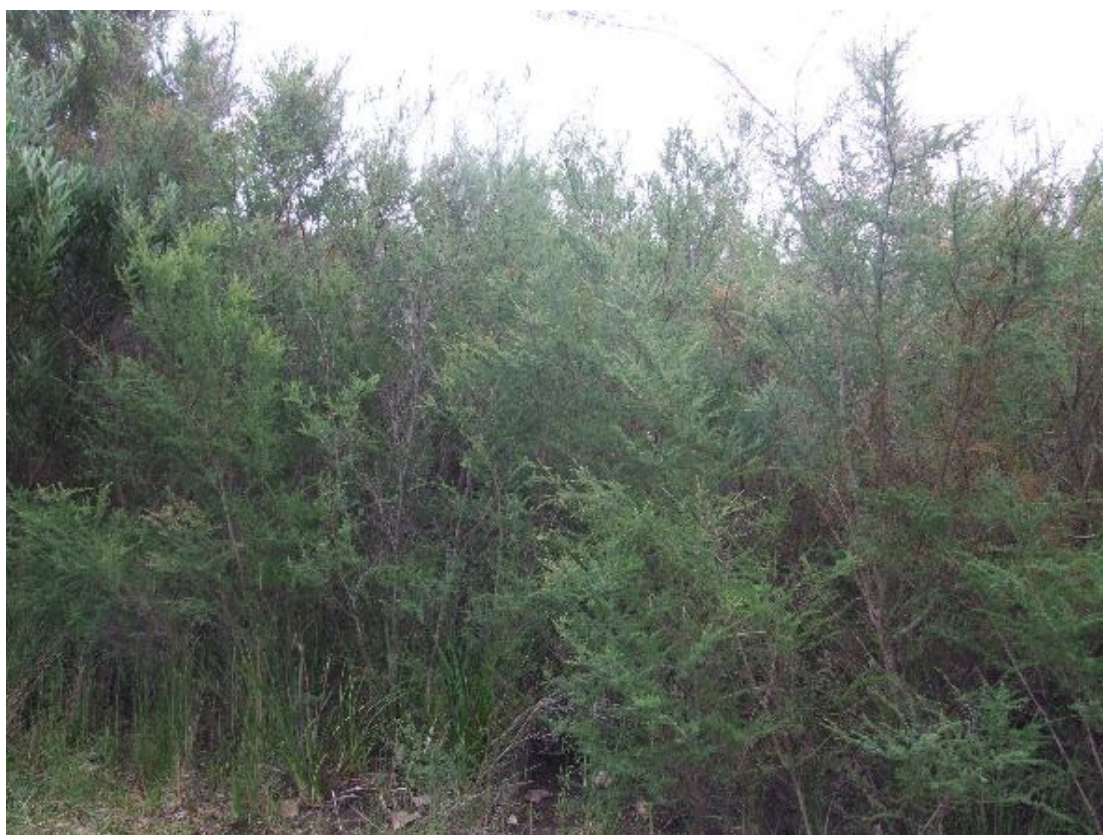
**Photo 6** – Tall Heath vegetation looking westerly on the eastern edge

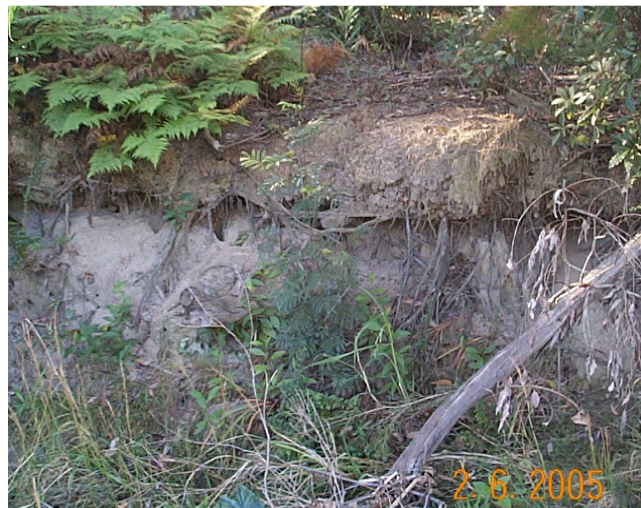
Deep-rooted natural vegetation lining stream banks reinforces the soil and is usually the most important safeguard against bank collapse. Recent experiments have shown that tree roots can substantially increase soil strength to a depth of at least 2 metres, and to a distance equivalent to the canopy drip line (*Land and Water Australia* 2005). Extensive clearing of this deep-rooted, natural vegetation from catchments for agricultural and urban development combined with the removal of native riparian vegetation from along stream banks has resulted in rainfall moving off the land surface at a much faster rate. This increased rate of water flow puts pressure on stream banks that can no longer support flood peaks.

**Photo 7** - Example of bank collapse of the Middle Creek Tributary

The rehabilitation and maintenance of riparian vegetation within the rehabilitation area (Figure 2) will increase the creek bank stability so that it may support flood peaks and provide increased bank and bed stability.

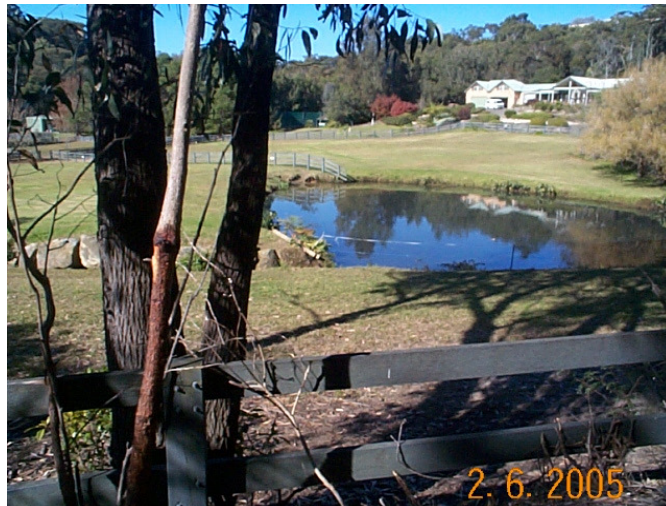
**Photo 8** - Drainage Line 2 and associated dam within Lot 1336 to the nearby south

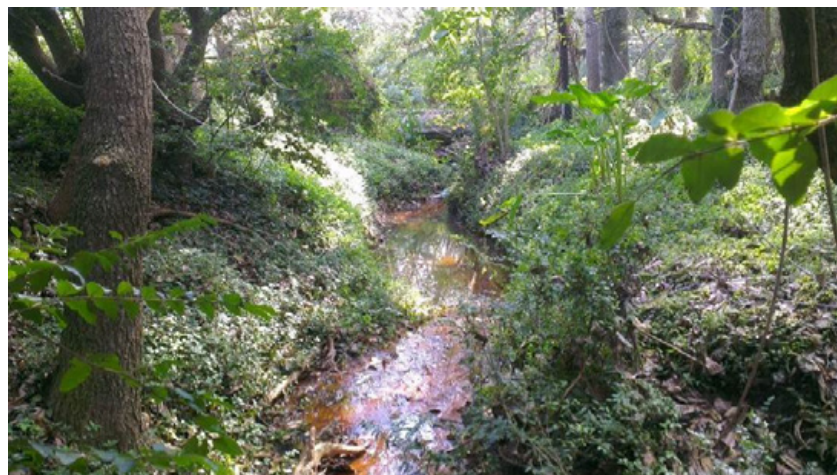
**Photo 9** - Example of siltation and weed incursion within the Middle Creek Tributary (2014)

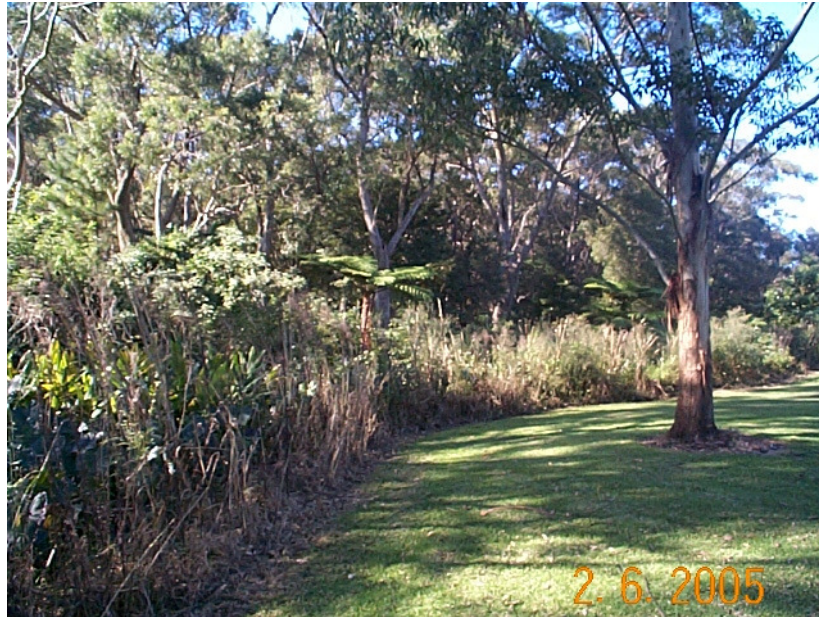
The existing riparian vegetation lining the drainage lines and in particular the Middle Creek Tributary are currently highly impacted by weed incursions (Photo 10). It is expected that portions of the Middle Creek Tributary within the site will be subject to weed management and restoration as part of the proposal. Weed management techniques for use in areas of native vegetation retention are outlined in Appendix 3. This will lead to an increase in habitat quality for native flora and fauna as well as an increase in the aesthetic appeal of the development and surrounding area.

**Photo 10** - Example of the density of weed incursions lining the Middle Creek Tributary within the neighbouring Lot 1111

Weeds within the core riparian zone and remaining areas of the site to the east of the Middle Creek Tributary are to be progressively removed in accordance with techniques recommended by the National Trust, NSW Office of Environment and Heritage and Conservation and the Australian Association of Bush Regenerators. Appendix 3 details specific low impact weed control techniques.
