RE: 2014SYE120 WARRINGAH DA2014/1062: RESIDENTIAL CARE FACILITY AND ASSOCIATED WORKS AT POR 1113 OXFORD FALLS ROAD, FRENCH FOREST

Bushland Regeneration and Biodiversity Management Plan

Barnes Road,
Frenchs Forest

Addendum Bushfire Protection Assessment

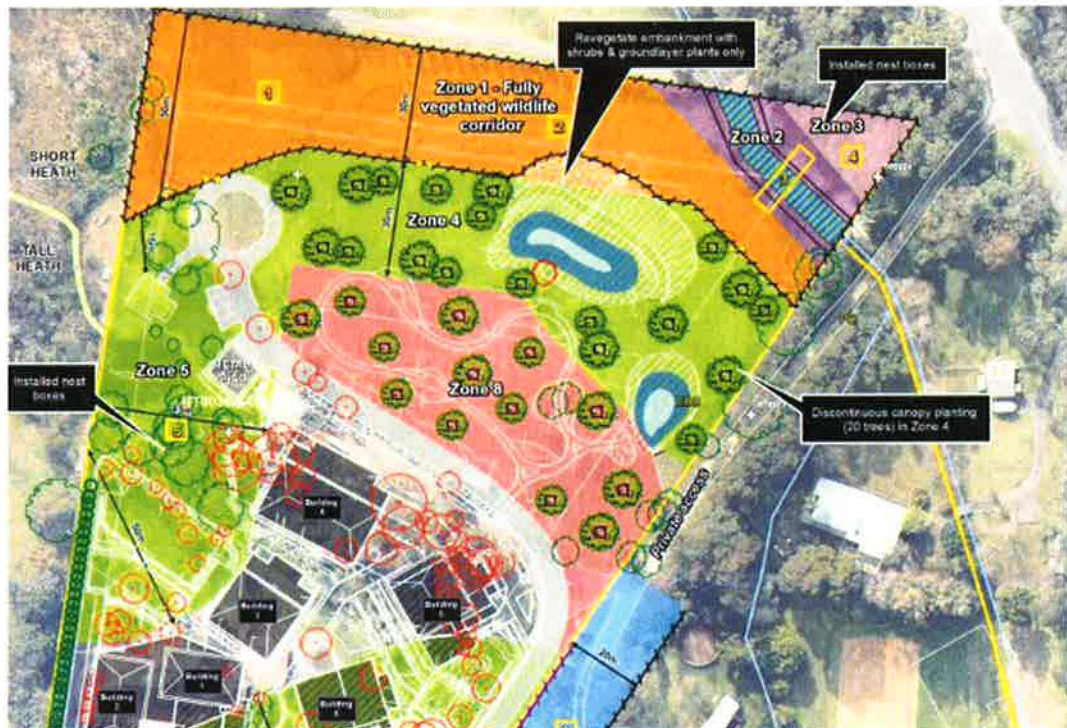
The following excerpt from the relevant Schedule in the BMP indicates the proposed regeneration of the northern part of the site and should be read in conjunction with the attached Landscaped Plans.

Except from Bushland Management Plan (Travers Bushland & Ecology)

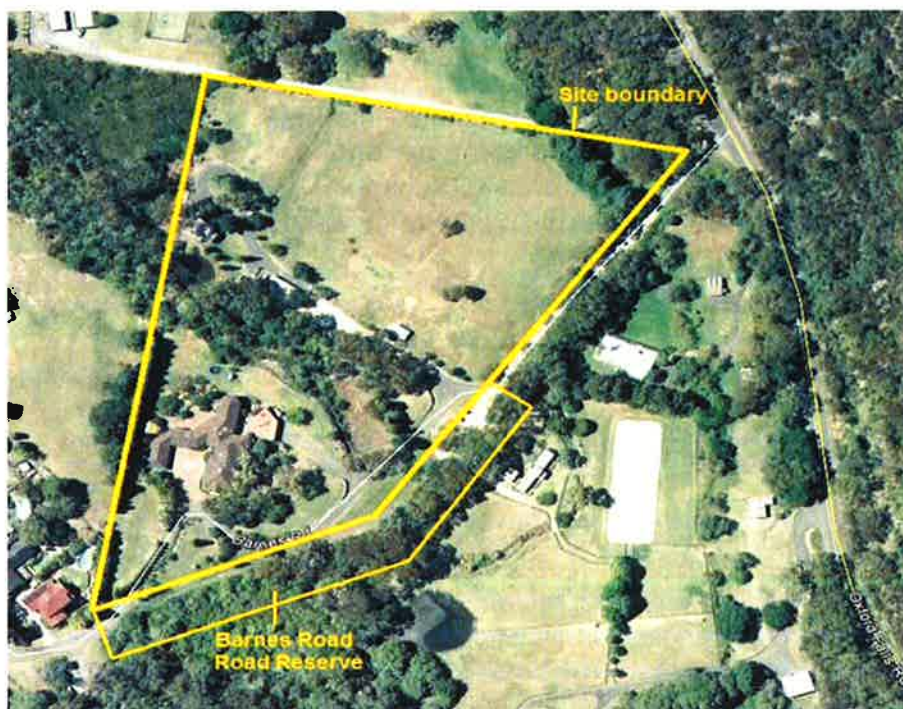
Figure 1 – Aerial appraisal

There is existing site condition is shown on Figure 1.

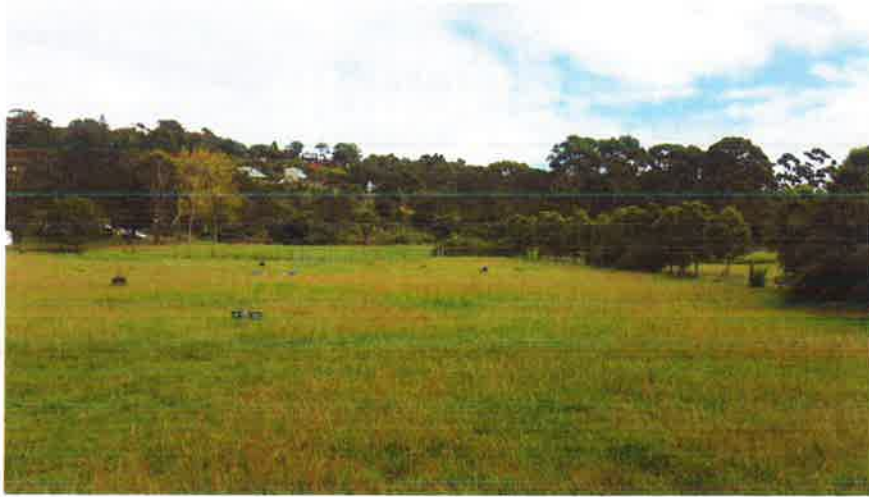
Photo 1 – Biodiversity corridor - existing cleared land adjoining the northern boundary

The zone is currently devoid of natural vegetation and there is a small amount of invasive weeds present (photo 1, photo 9). There is to be a high density of Banksia and other heath species planted within this corridor to encourage foraging for the Eastern Pygmy Possum which are known to occur in the local area.

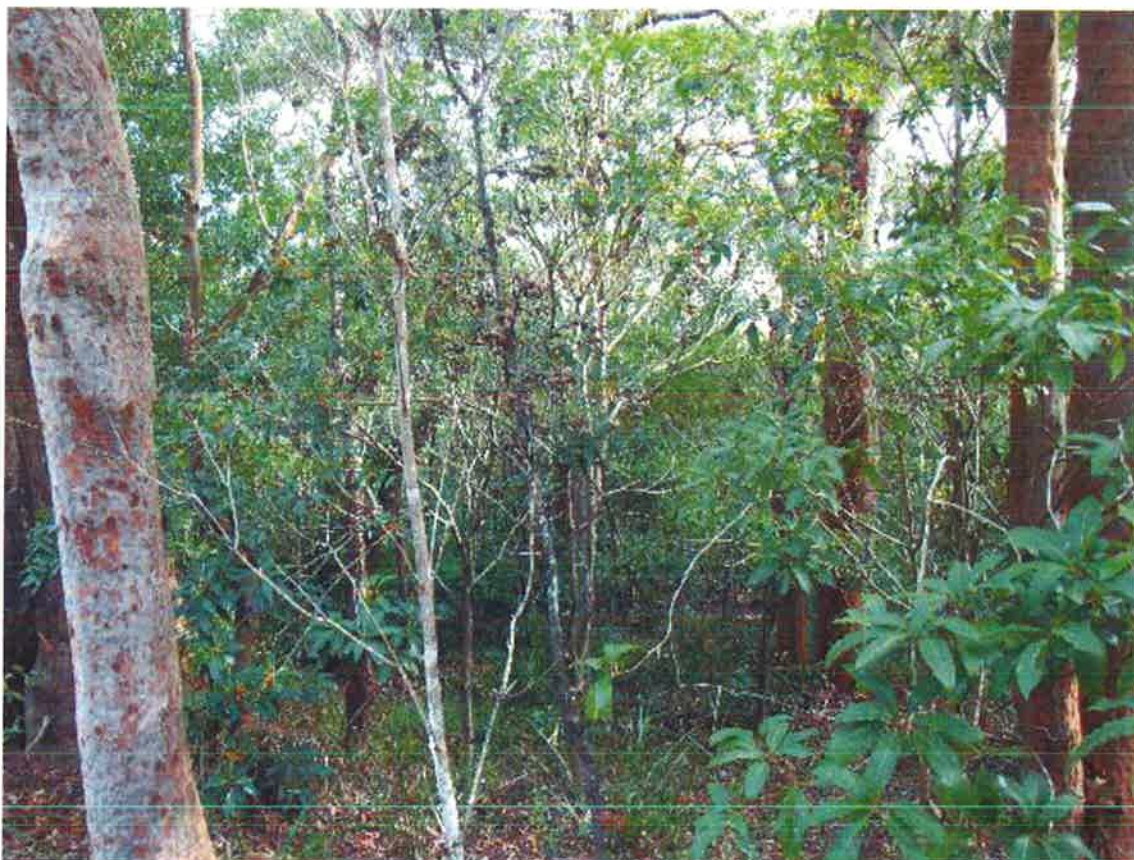
Photo 2 – Peppermint – Angophora Woodland / Open Forest vegetation adjacent to Oxford Falls Road, part of the better condition vegetation.

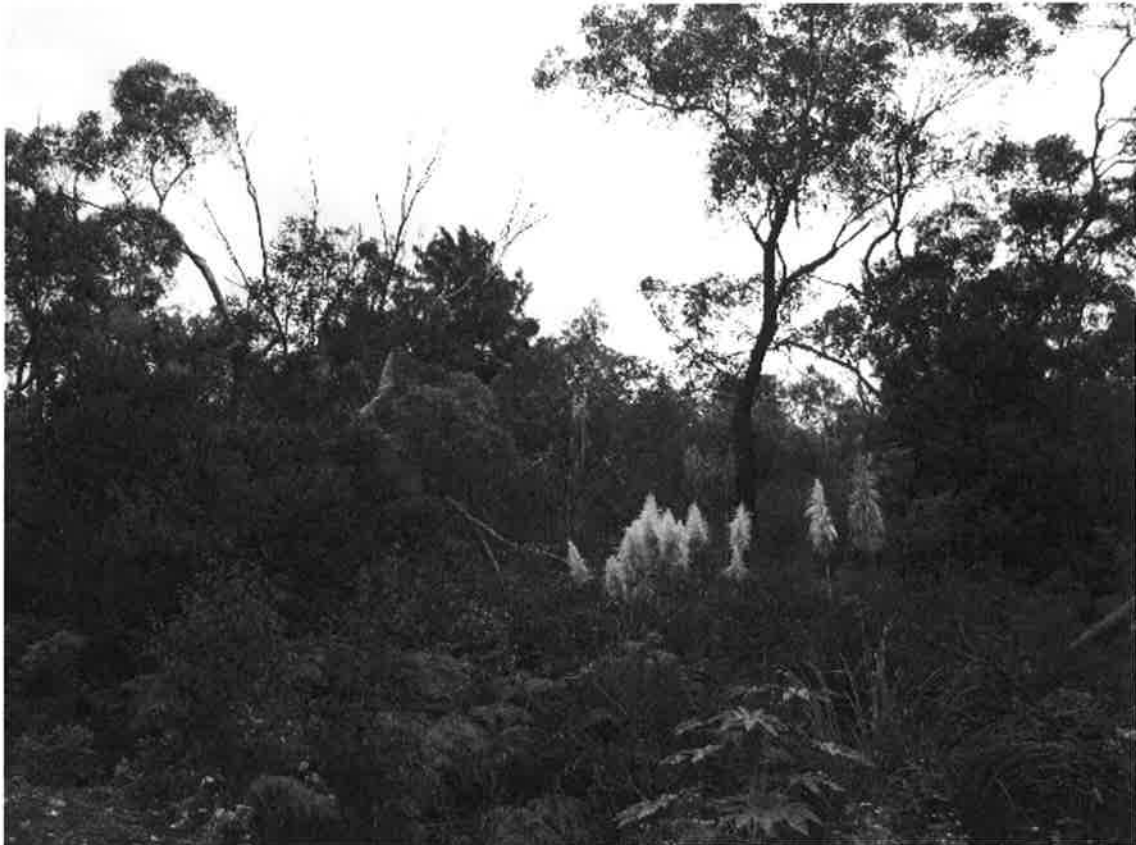
Photo 3 – Peppermint – Angophora Woodland / Open Forest vegetation in the central western portion of the subject site containing a high level of exotic plant disturbance.

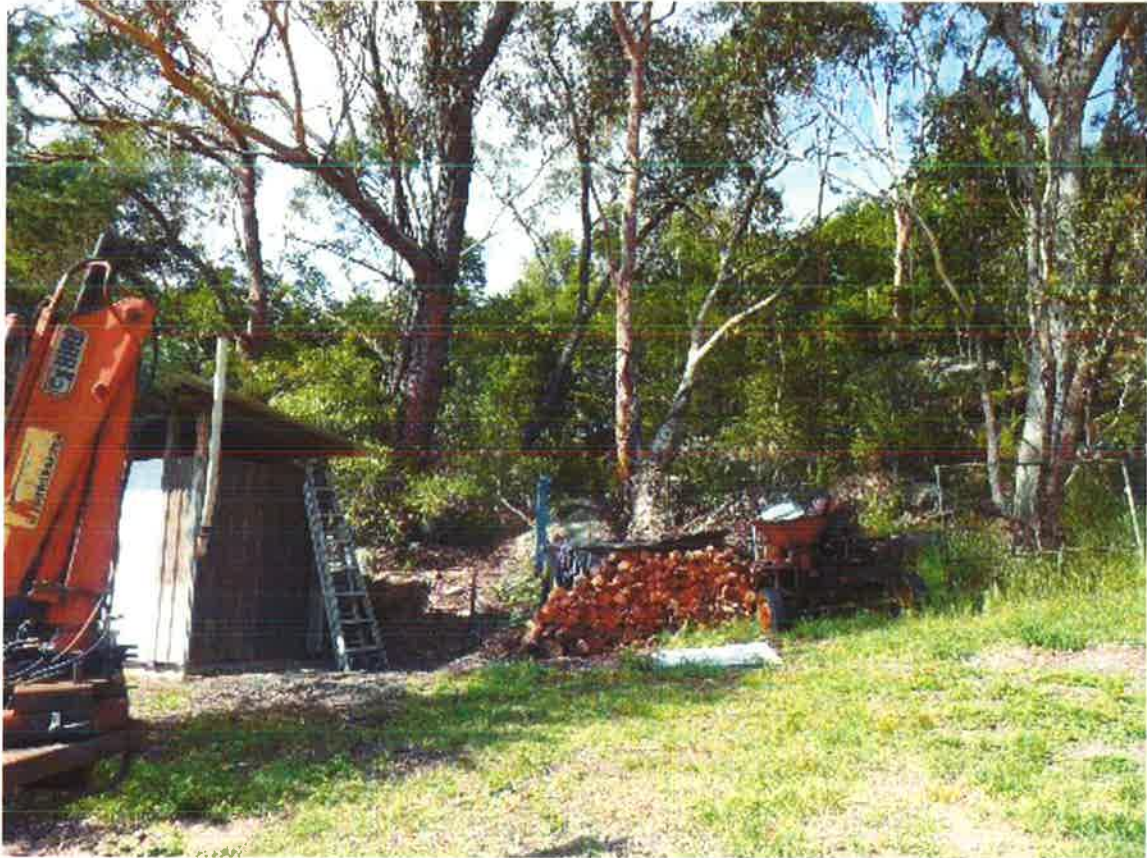
Photo 4 – Heavily impacted zone in the middle of the
Peppermint – Angophora Woodland / Open Forest

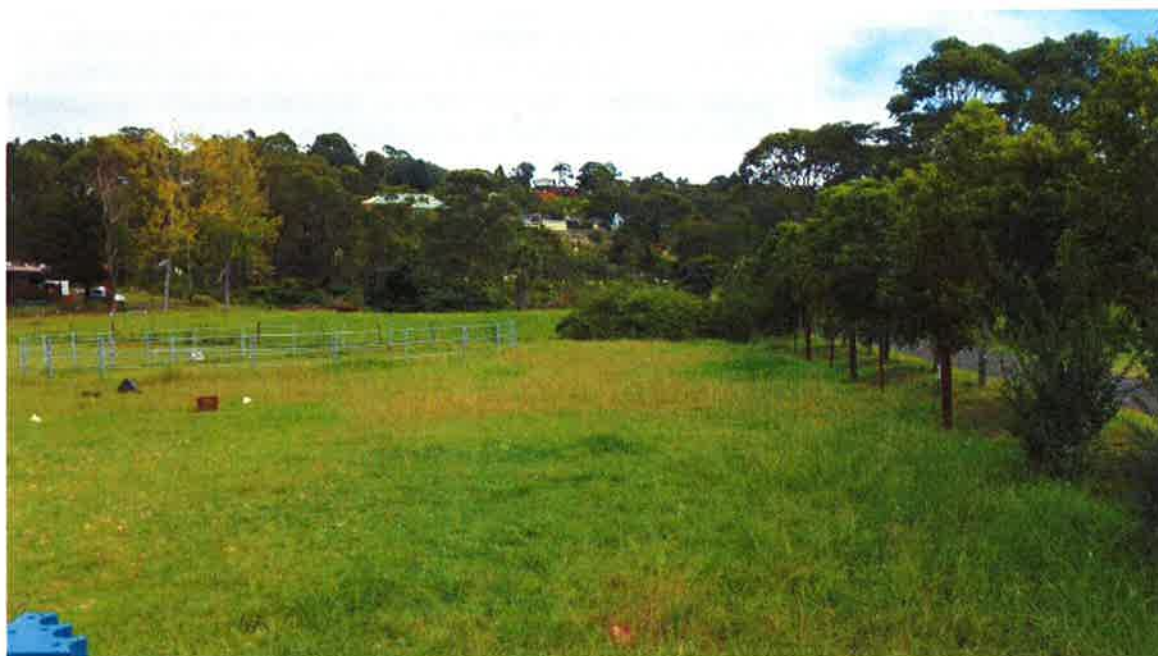
Photo 9 – Cleared vegetation in zone 1.

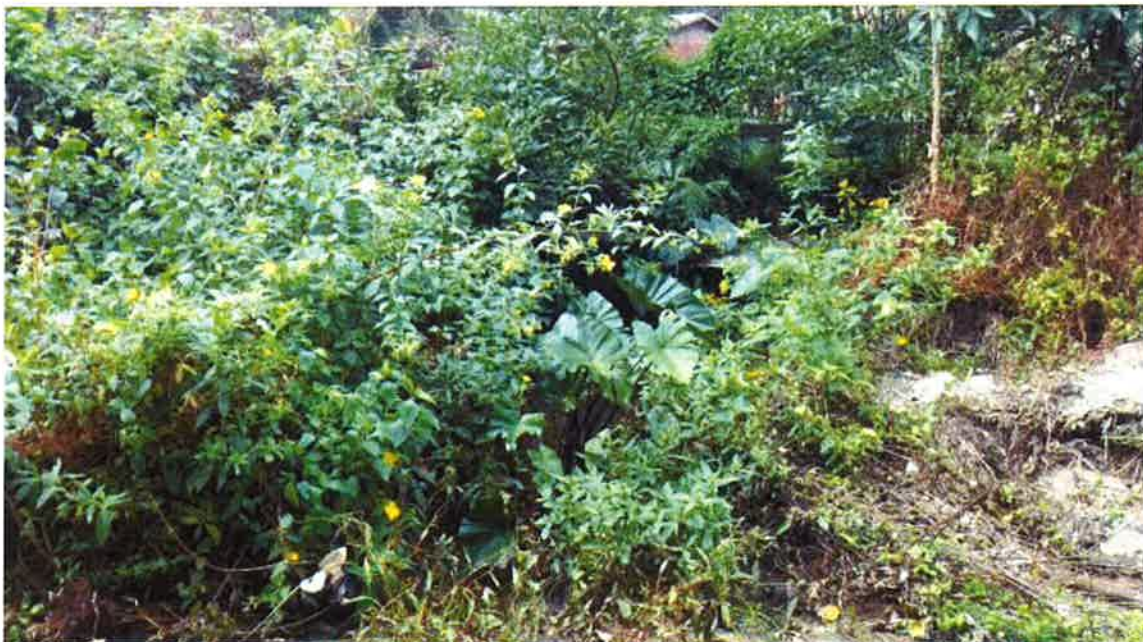
Photo 11 – Ludwigia peruviana on the other side of the Barnes Road corridor in the drainage line amongst a multitude of other weed species

The noxious aquatic weed *Ludwigia peruviana* occurs on the south-eastern side of Barnes Road in the riparian zone. It is a class 3 noxious weed and requires treatment such that it does not spread further along the drainage line. All parts of the plant need to be bagged and disposed of at an approved waste facility. Once established it is a difficult species to control, so therefore requiring targeted attention.

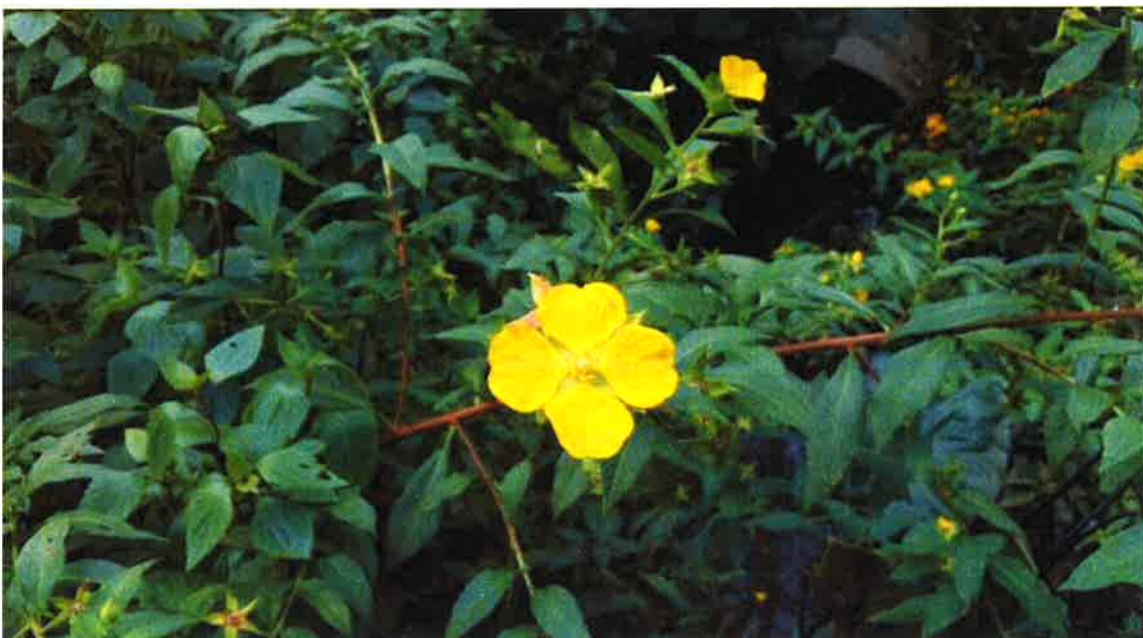
Photo 12 – Close up of Ludwigia peruviana in flower

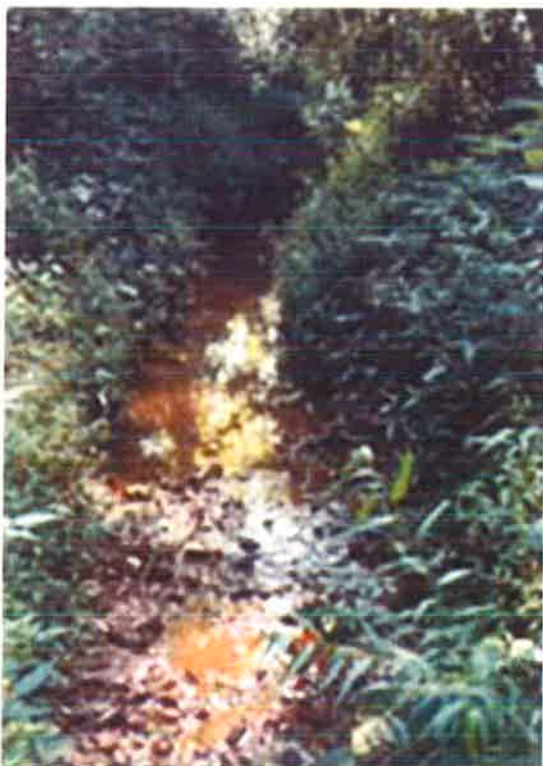
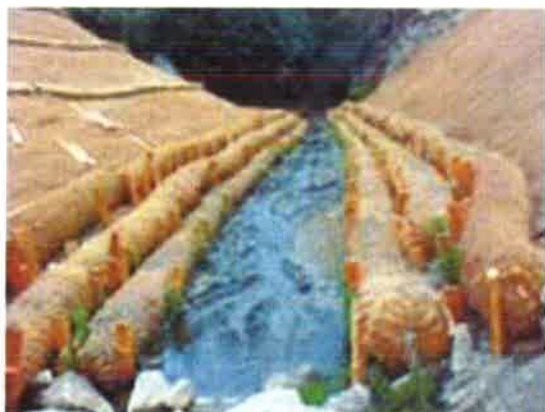
Photo 19 – Creek embankment stabilisation example.

Before creek line treatment

Coir logs along creek edge following removal of weeds, jute mat / jute mesh on embankment to be installed and planted with native plants.

Jute matting or jute mesh is to be laid over the embankment and then planted with tussock grasses, sedges and shrubs which can tolerate moister soils. Control of *Tradescantia* is variable through hand weeding, raking and application of herbicides. The use of Glyphosate products on this species has a limited success rate but Starane (another suitable herbicide) has a much higher kill rate. Starane is to be applied in accordance with the herbicide label and the Protection of Environment Operations Act (1997).

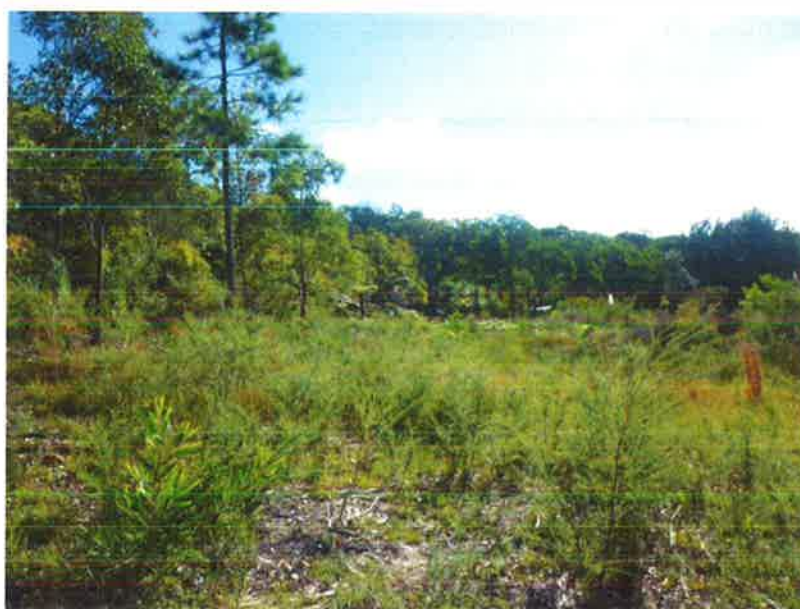
Photo 1 – Short heath to the north-west of the staff management cottage

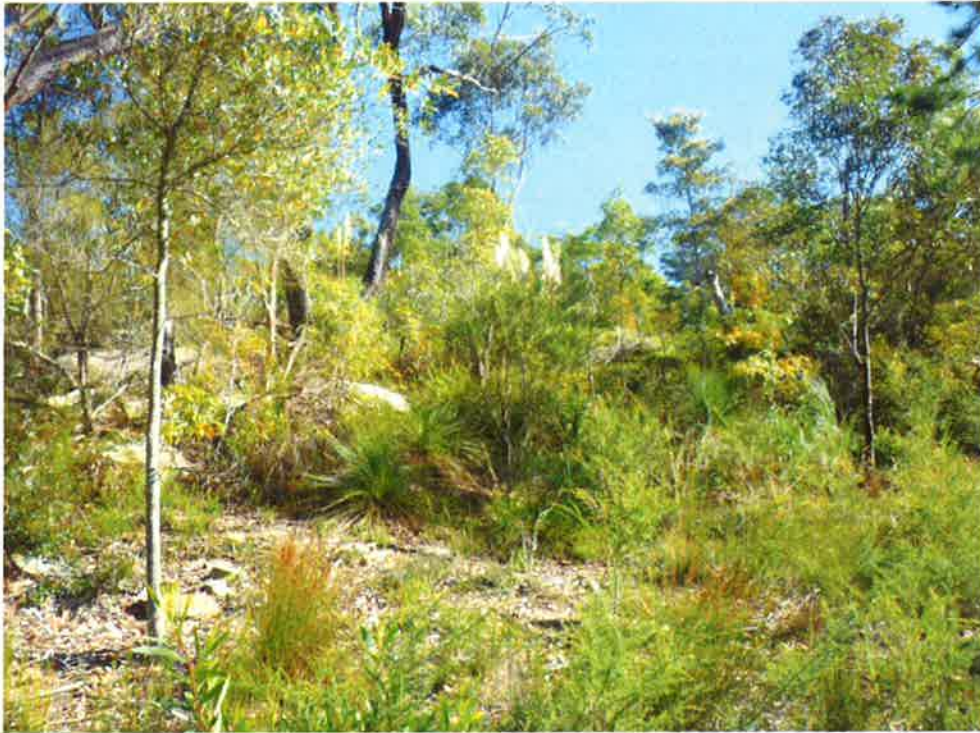
Photo 2 – Tall heath to the north-west

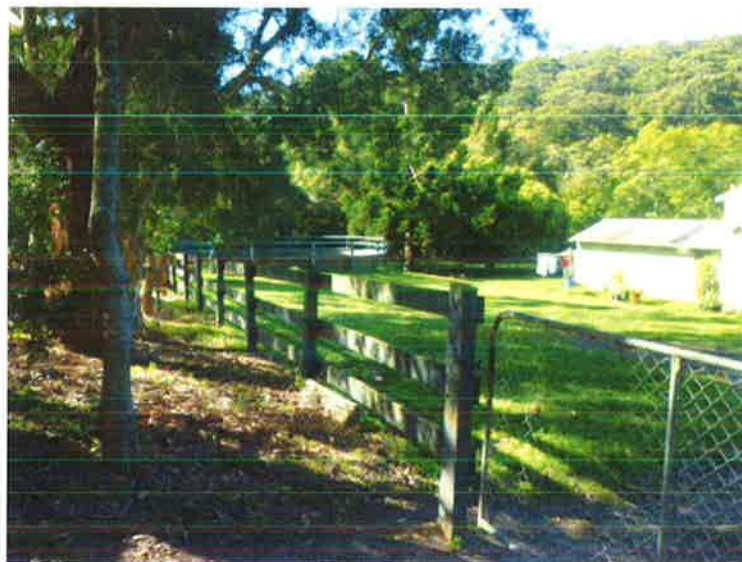
The remaining land, within 140m of the dwellings, is not considered a bushfire threat as it consists of a managed landscape with mown grass and scattered trees as depicted within the following photographs.

Photo 5 – Managed land to the east

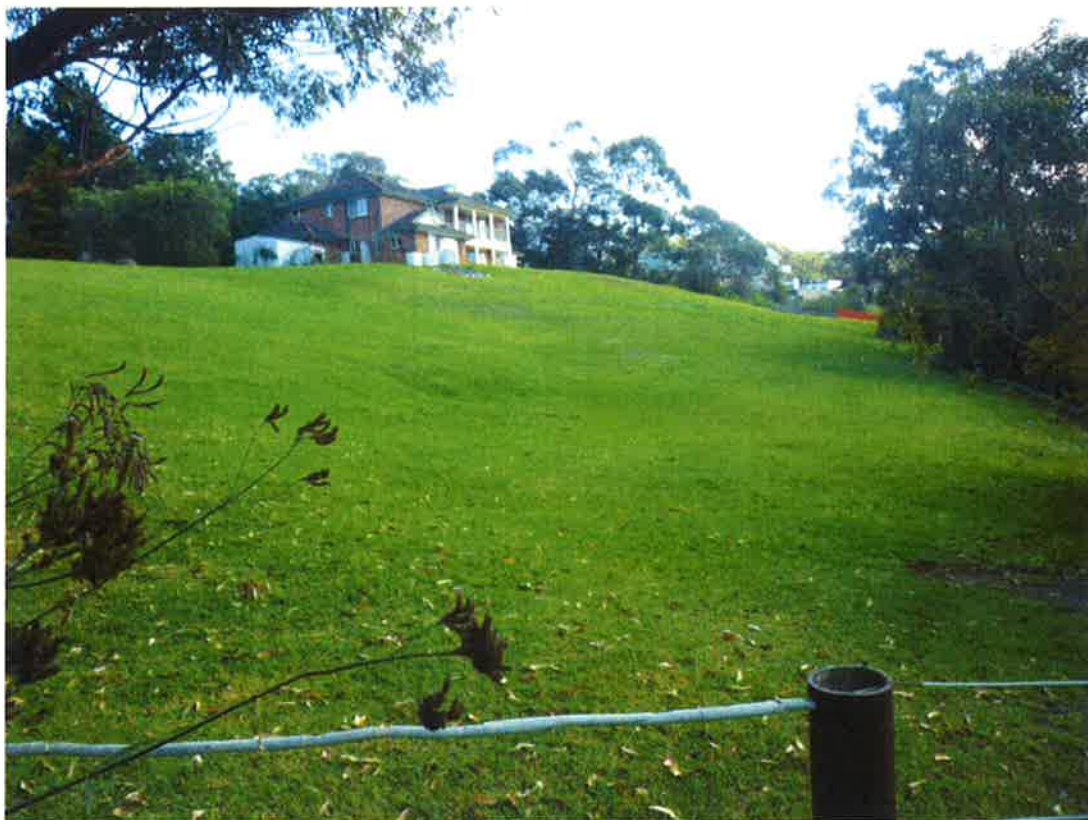
Photo 6 – Managed land to the west

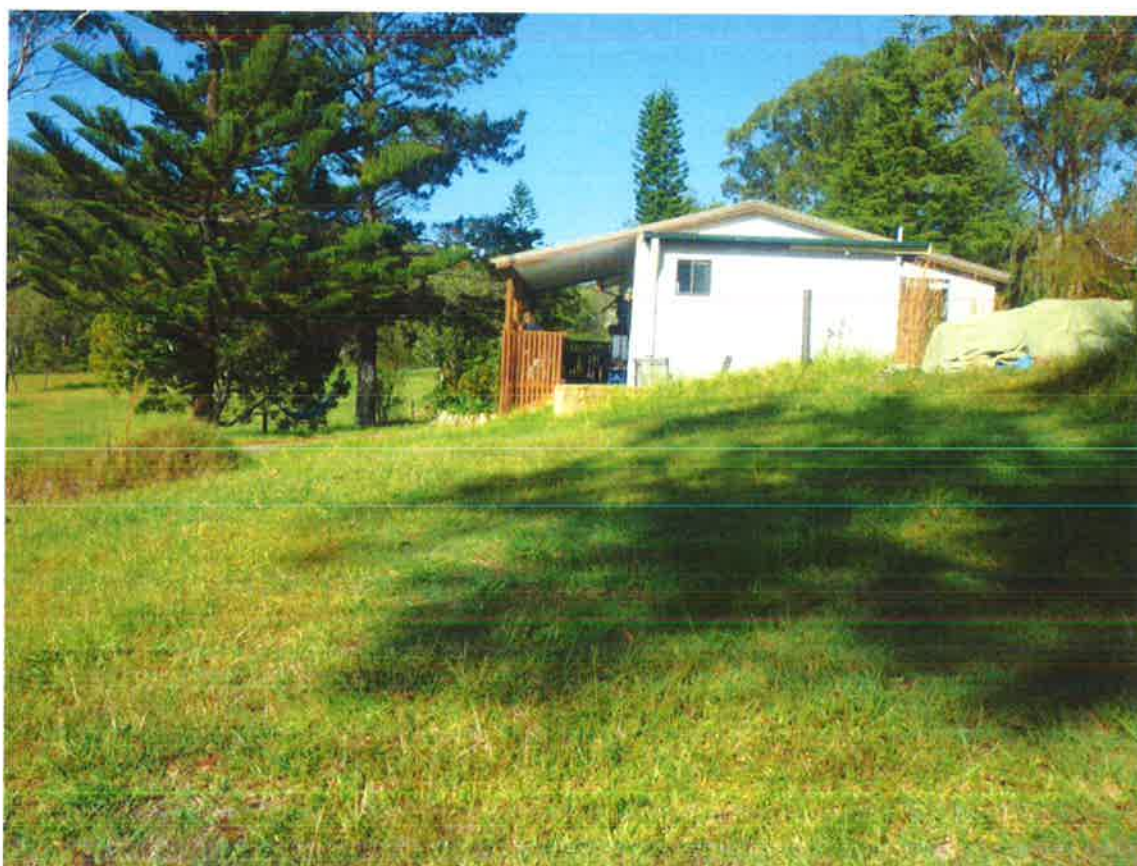
Photo 7 – Existing grassland vegetation providing separation between the dwelling and the tall heath / short heath vegetation.

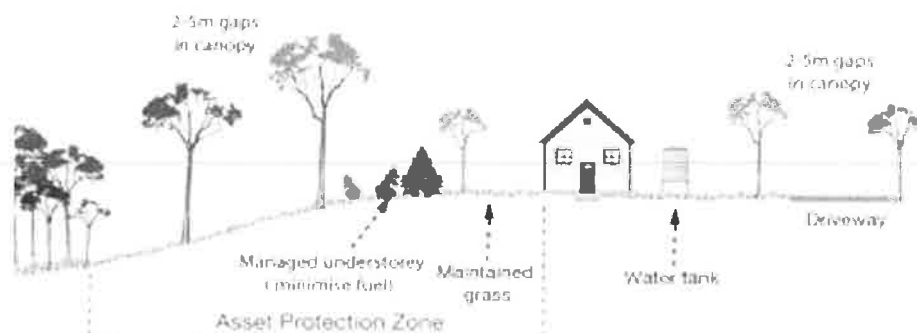
- The following RFS diagram depicts one version of an ideal situation. Divergence from this ideal should not be undertaken without expert advice.
