Geotechnical Investigation Report

**Proposed Development at
17-23 Merriwa Street, Gordon NSW**

Report No. G2013-026-Rev 0

June 2013

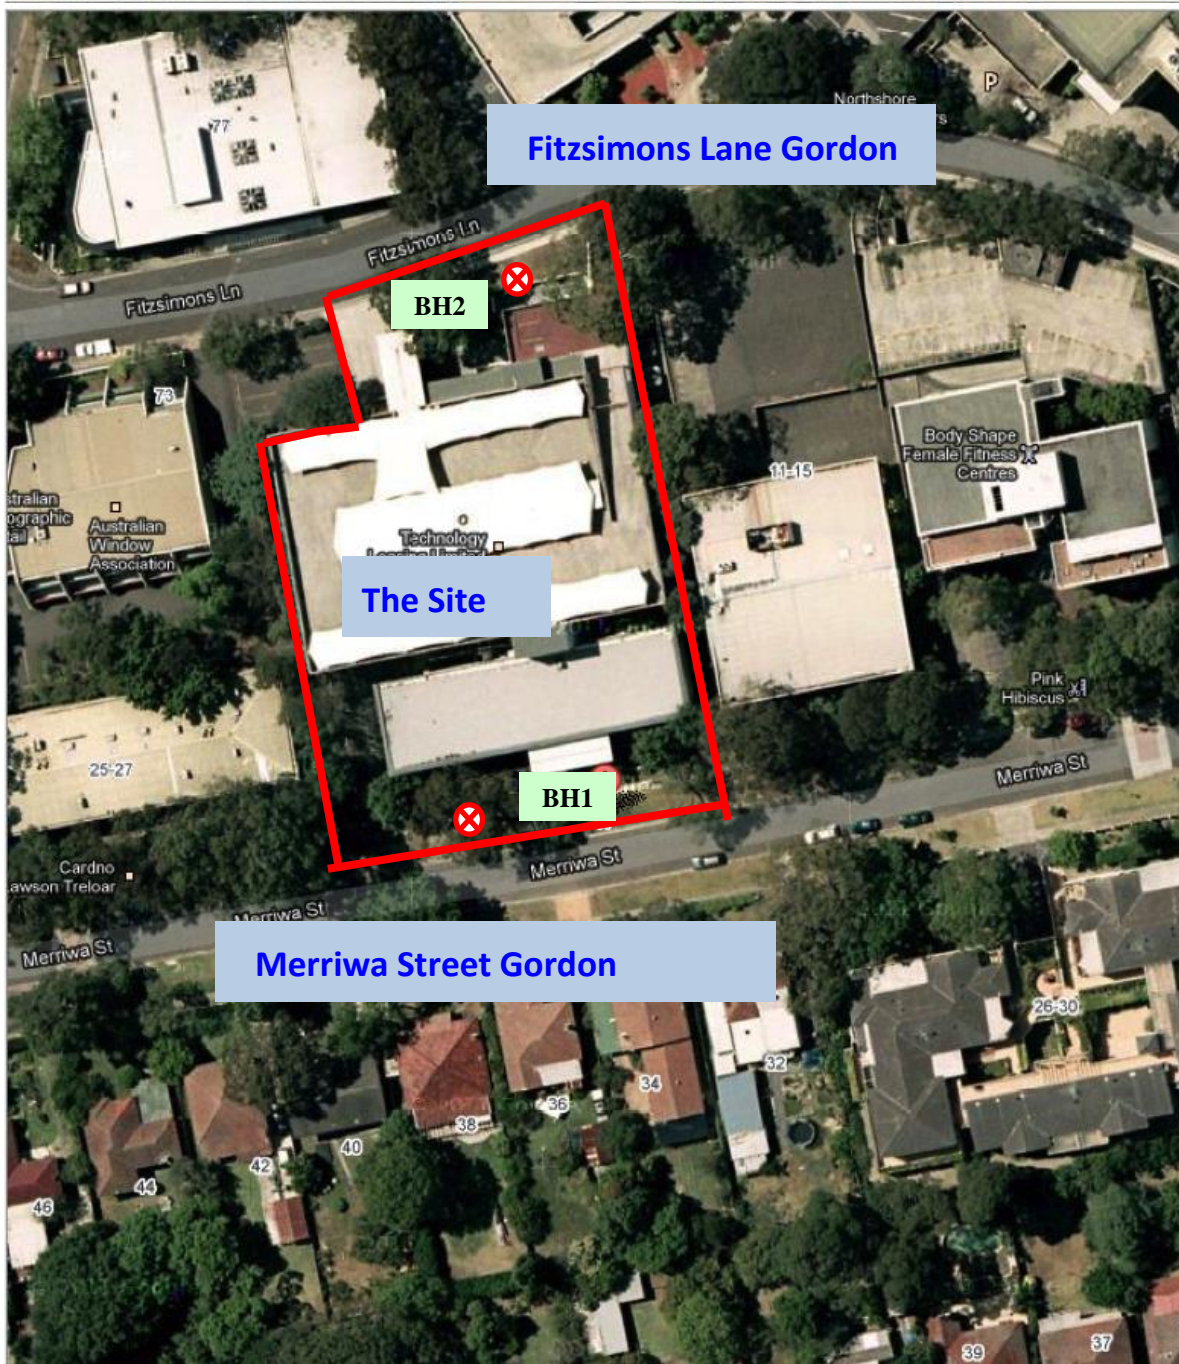
The site is in the suburb of Gordon, approximately 13 Km north northwest of the Sydney CBD (Figure 1). The site is bounded by Merriwa Street in the south and Fitzsimons Lane in the north as shown in the Site Plan (Figure 2). The site is sloping gently from north to south making a level difference of approximately 5 meters from Fitzsimons Lane to Merriwa Street. The proposed Basement 2 footprint, its setbacks from the respective site boundaries and the investigation holes are shown in Figure 3.

The approximate locations of the 2 boreholes are shown in Figure2 with respect to the current site conditions and Figure 3 with respect to the future proposed basement footprint. The Engineering Logs are presented in Appendix B.
