PHASE I ENVIRONMENTAL SITE ASSESSMENT REPORT

Lot 4 DP 1196266, Bridgman Road, Hunterview NSW

Woolworths Ltd – January 2015

Report reference: 1401107Rpt01FinalV01_23Jan15

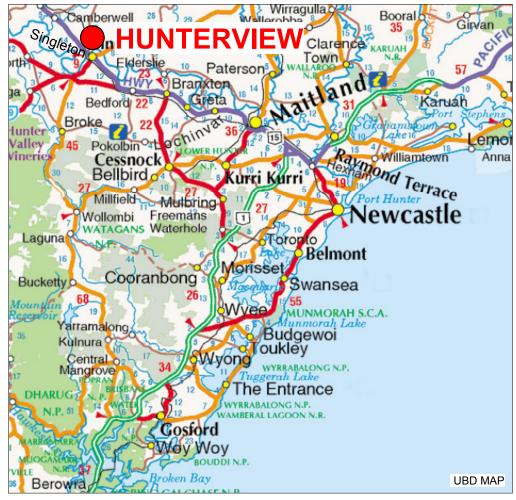
TE: 06/01/2015 SHEET A4 PROJECT No. 1401107 REV: 01 FIGURE 2

The site comprises the following property (Figure 2):

Site topography and observations suggest large volumes of fill have been applied to the site. Fill appears to be mounded approximately 1 to 2m higher than surrounding ground surface along the southern corner, western and northern boundaries of the site (Figure 2, Plates 1-3, 6). The majority of the site is largely flat with a slight slope to the east – southeast (Plates 4 and 5). The eastern portion of the site slopes steeply down towards the adjacent creek (Plates 7 and 8). Portions of these areas appear to have had fill applied, however the extent is unable to be determined based on visual observations.

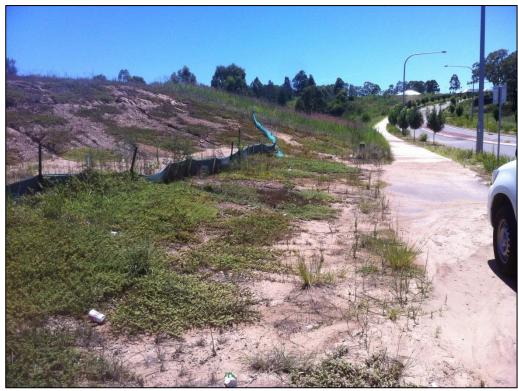
Plate 1 – The southern boundary of the site, looking towards the east.

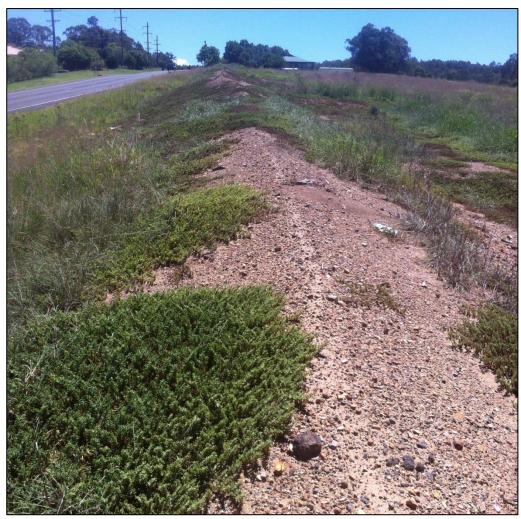
Site observations and comparisons with Google Street View suggest portions of the site have been filled sometime in the period 2010 to 2013. Conflicting anecdotal information in regards to earth works on the site have been obtained by Geo-Logix. The extent and volume of filling and origin of the fill material cannot be confirmed. Anthropogenic material including bricks, concrete, tile, metal and asphalt were observed on site suggesting the importation of filling material has occurred.

Plate 3 – Mounded material along the western portion of the site.

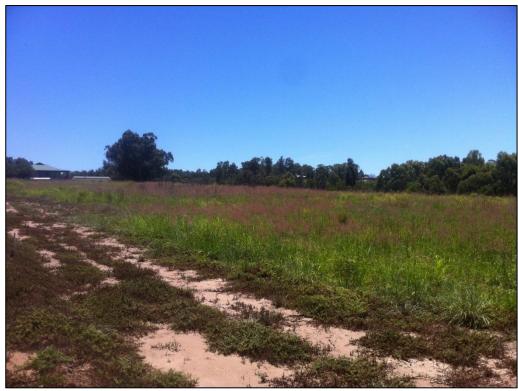
Plate 4 – The central portion of the site looking northeast.

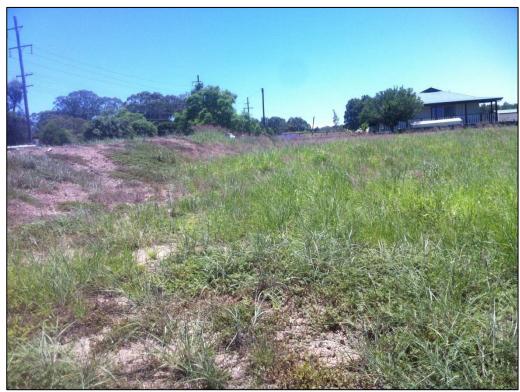
Plate 5 – The northwest corner of the site with mounded material along the boundary.

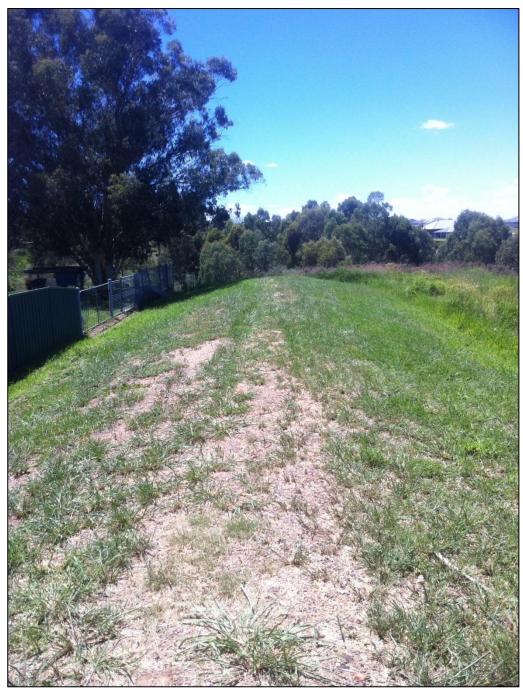
Plate 6 – Mounded material along the northern boundary of the site.

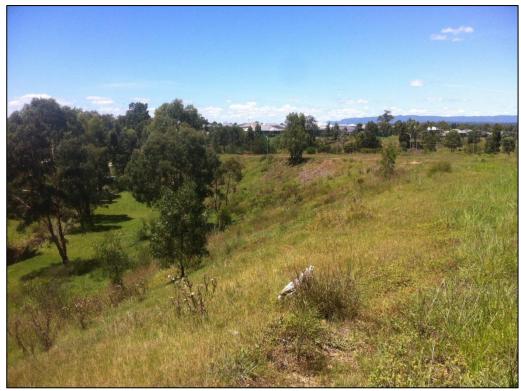
Plate 7 – The eastern boundary of the site, with the southern portion beyond.

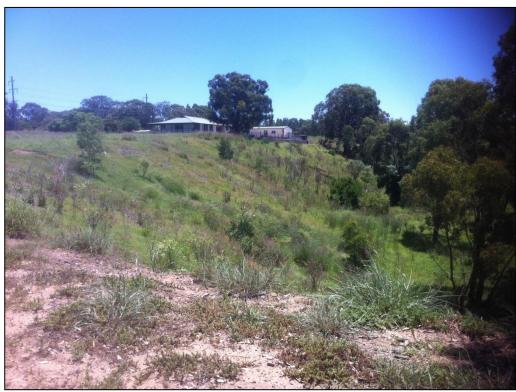
Plate 8 – The eastern boundary of the site with the northeast corner beyond.

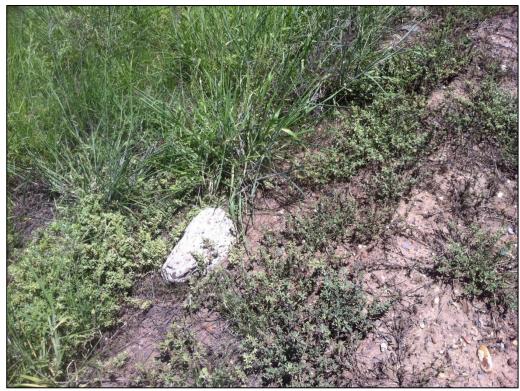
Plate 9 – Example of anthropogenic material (concrete) in surface material on site.

The results of preliminary sampling did not identify COPC at concentrations greater than assessment criteria however based on the above identified site history additional investigation is recommended to assess the presence/absence of land contamination.

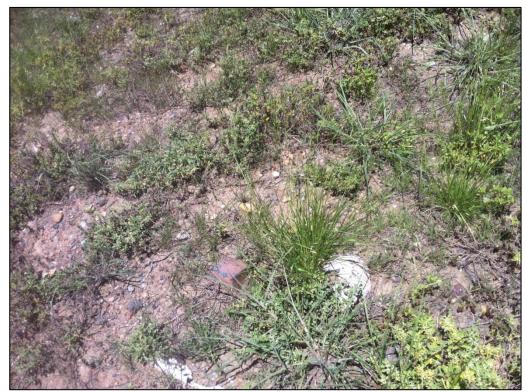
Plate 10 - Example of anthropogenic material (house brick and concrete) in surface material on site.

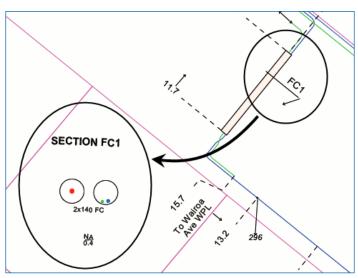
Figure 3

On some plans the "cross sections" may also be shown with a specific number (eg: FC1). This number will have an arrow pointing in the direction you will need to look for the cross-section detail. (refer to figures 3 and 4)

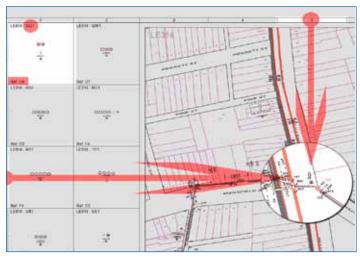
Figure 7

Ausgrid plans (refer to figure 7) are bordered by numeric identifiers along the *top and bottom borders* and alpha identifiers along the *side borders*.

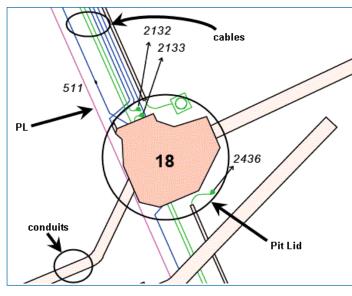
Figure 8

Underground "pits" are numbered on Ausgrid plans, positioned relative to the "property line" (PL), and can be found on either the footpath (nature strip) or the road (see figure 8).

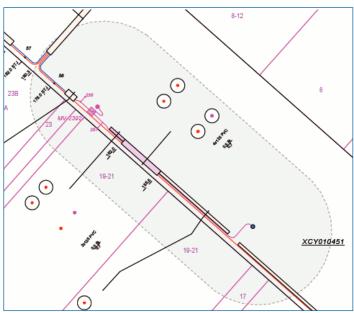
Figure 9

In some instances cables and other assets within the shaded "proposal area" will be shown in a bright magenta colour, indicating that the proposed new work displayed within the shaded area is based on initial planning documentation. (refer to figure 9)

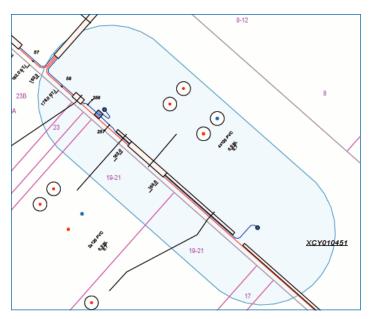
Figure 10

In other instances the shaded **"proposal area"** itself may be shown as a **blue** colour, indicating that the new work displayed within the shaded area on the Ausgrid plan is yet to include details regarding final depths and dimensioning. (refer to figure 10)

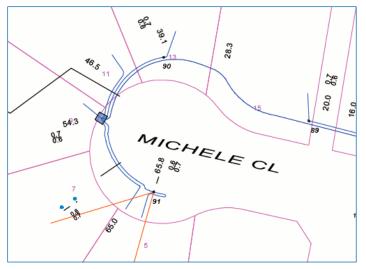
Figure 12

In some instances, the plans supplied may indicate road or property outlines that appear to have shifted in relation to the Ausgrid assets displayed. (refer to figure 12)

In such instances, always refer to the "property line" (in metres) and depth of "cover" (in metres) references displayed on the nearest relevant "cross sections" to obtain Ausgrid asset location information (see Reading Ausgrid Plans, clause 3, Cross Sections for more detail).
