REMEDIATION ACTION PLAN

4-12 MCGILL STREET, LEWISHAM NSW

Remediation Action Plan
4-12 McGill Street, Lewisham NSW

EI Report No.: E22830 AB_Rev0
Date: 6 May 2016

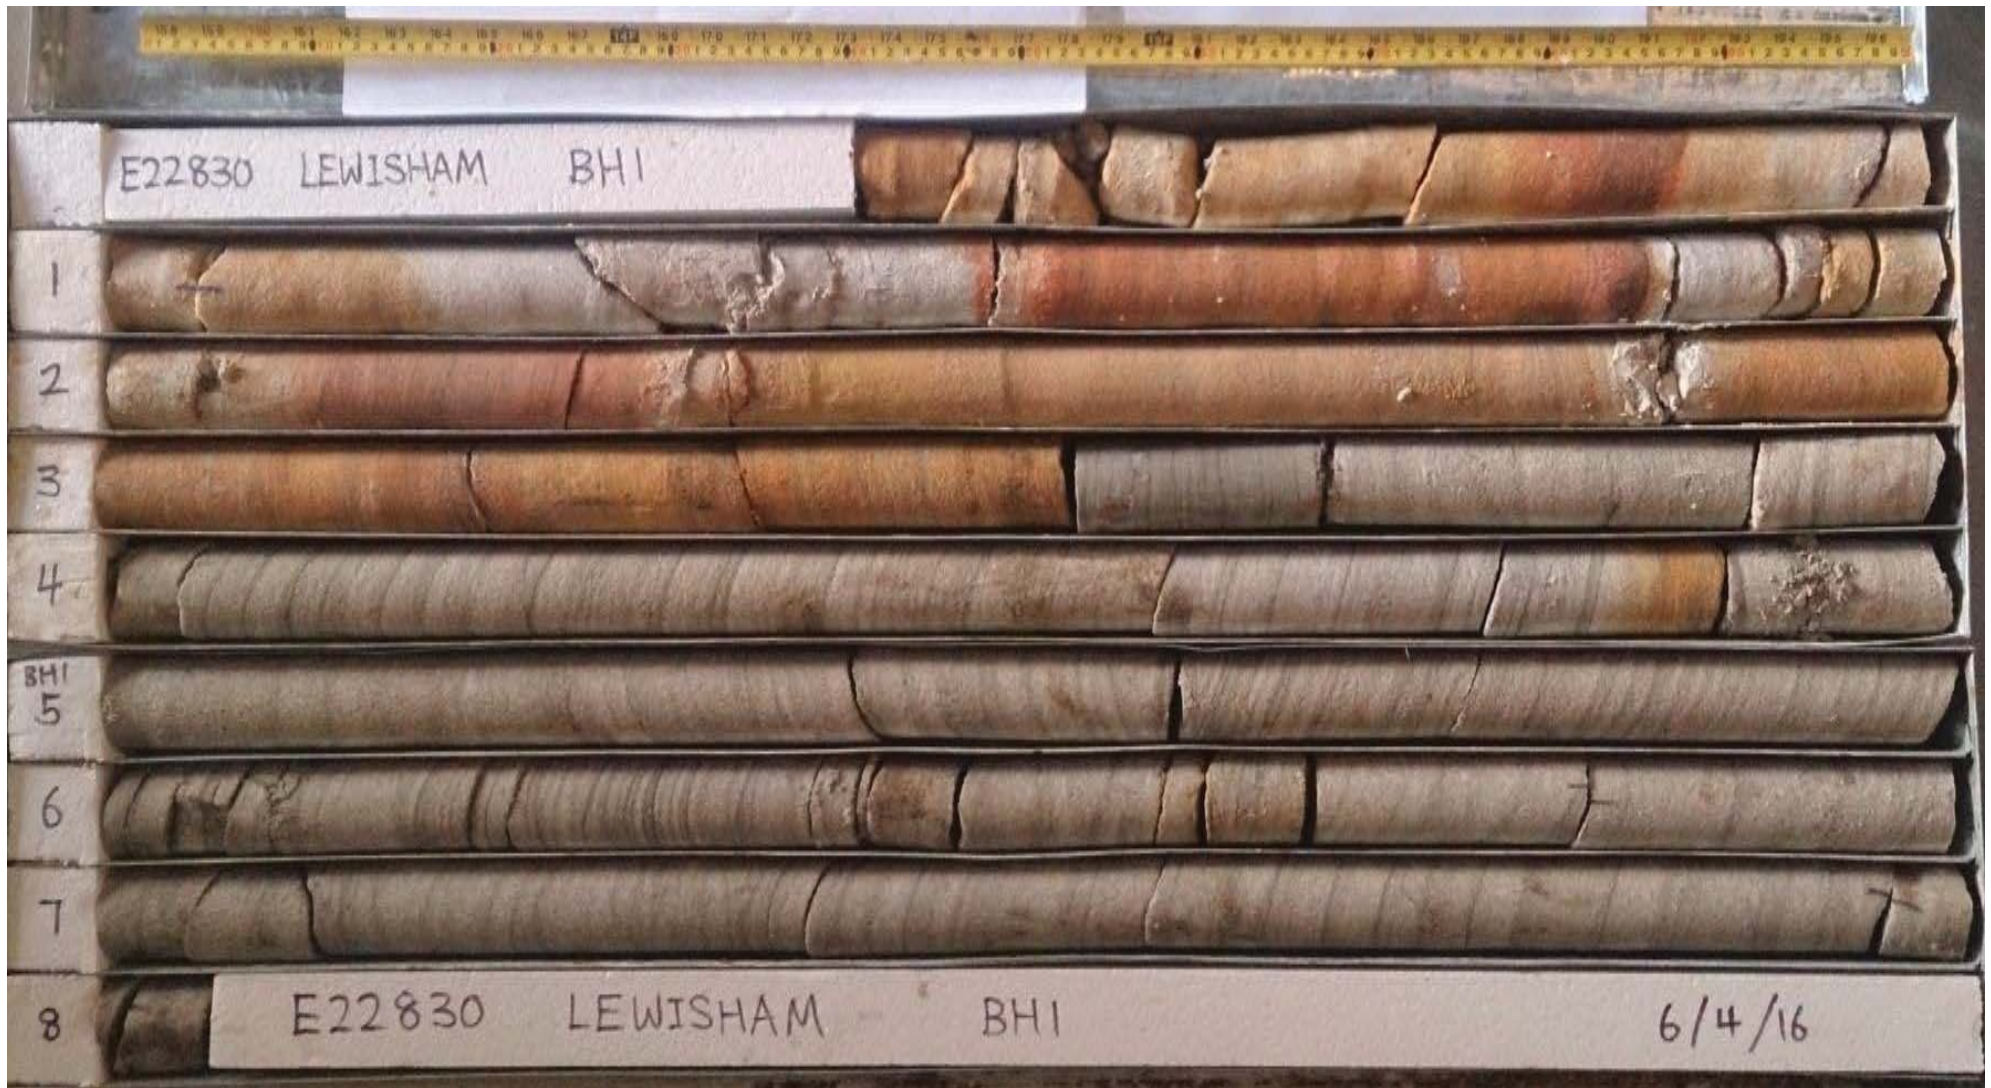
BH1

East: 328335.3m
North: 6247987.6 m MGA94 Zone 56
Surface RL: ≈12.50 m AHD
Inclination: -90°
Box: 1 of 1
Hole Depth: 8.05m

Depth Range: 0.4m to 8.05 m
Contractor: BG Drilling Pty Ltd
Drill Rig: Dando Dual Mast
LOGGED: JZ DATE: 6/4/16
CHECKED: JC DATE: 20/4/16

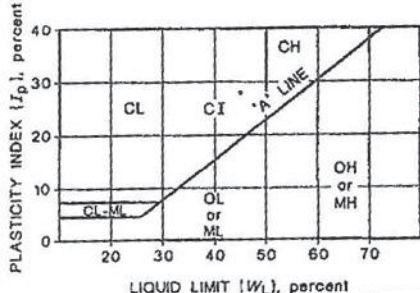
PLASTICITY PROPERTIES

The chart plots Plasticity Index (I_p) in percent on the y-axis (0 to 40) against Liquid Limit (W_L) in percent on the x-axis (20 to 70). A diagonal line labeled 'A' separates the clayey (above) from silty (below) regions. Regions are labeled: CL (Clayey Low Plasticity), CI (Clayey Intermediate Plasticity), CH (Clayey High Plasticity), OL (Organic Low Plasticity), OH or MH (Organic High Plasticity/Medium Plasticity), and CL-ML (Clayey Low Plasticity - Low Liquid Limit). The U-line is also indicated.
