**Phase 1 - Preliminary Contamination Assessment
Proposed Mixed Use Building Development
Lot 1 in DP 227083 and Lot 201 in DP 233376,
Nos 5-7 Northumberland Avenue
Auburn NSW**

Ref: JE14578A

December 2014

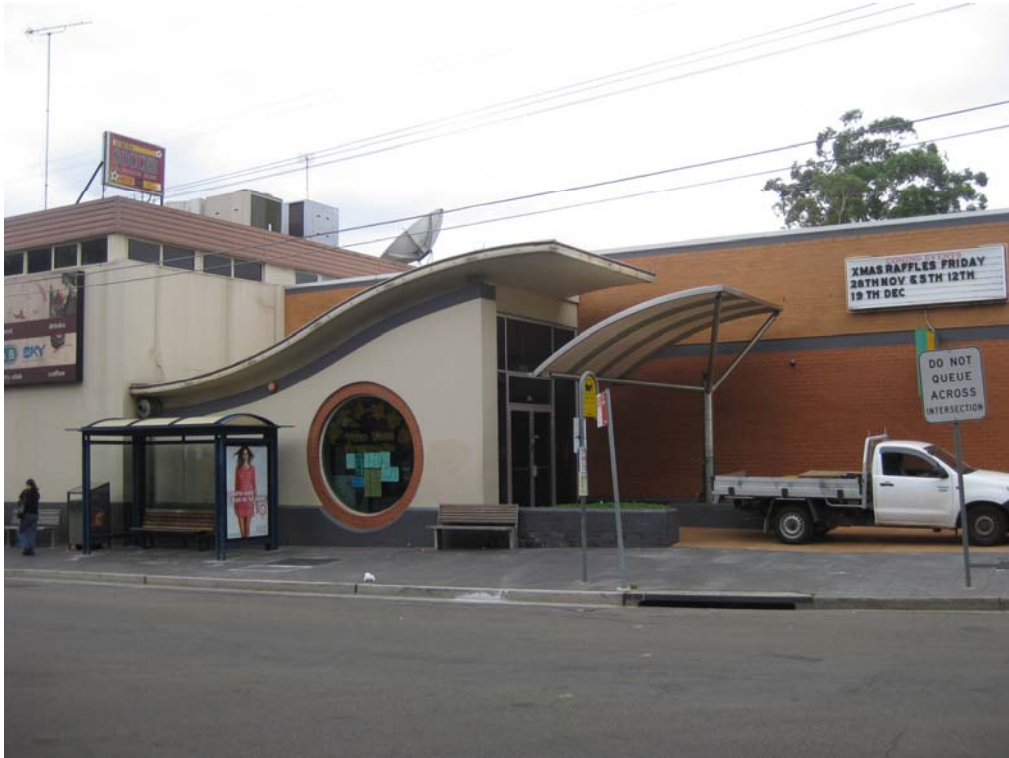
Photo 1: Auburn Soccer Sports Club Building

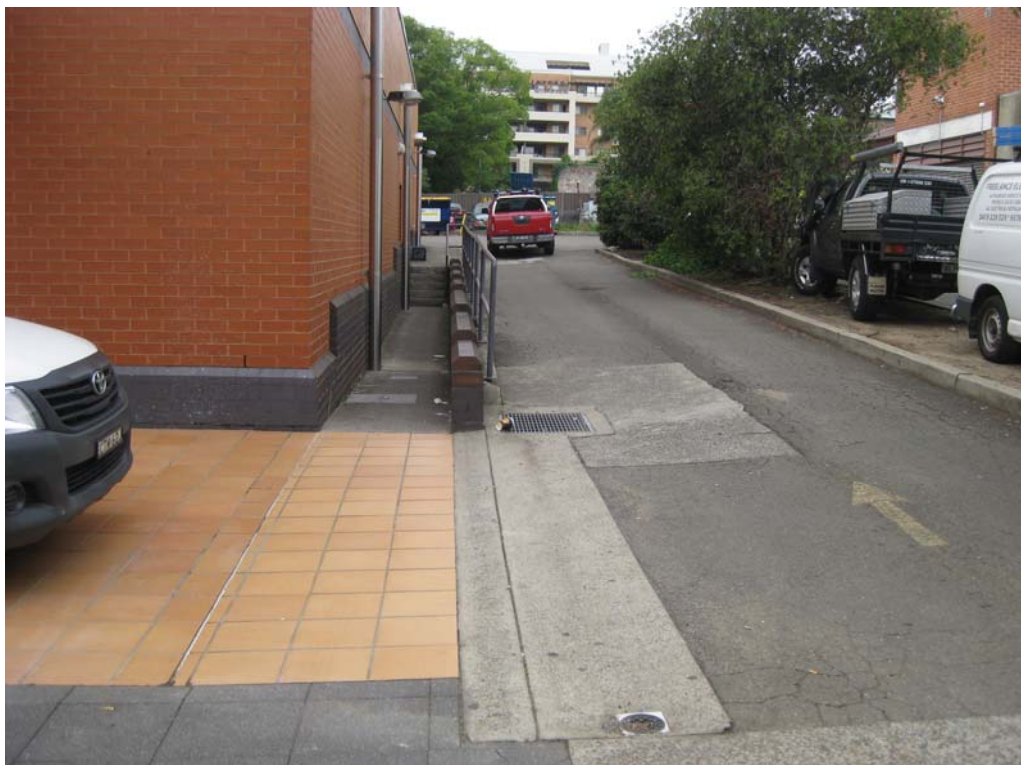
Photo 2: Southern Alley/Driveway

We note however that the rear and southern portions of the site are covered by bitumen pavements and it is common for old bitumen pavements to contain coal tar and hydrocarbon compounds (eg PAH). Should the old bitumen pavement contains these substances, there is a risk of these contaminants leaching into the underlying subbase and subgrade.

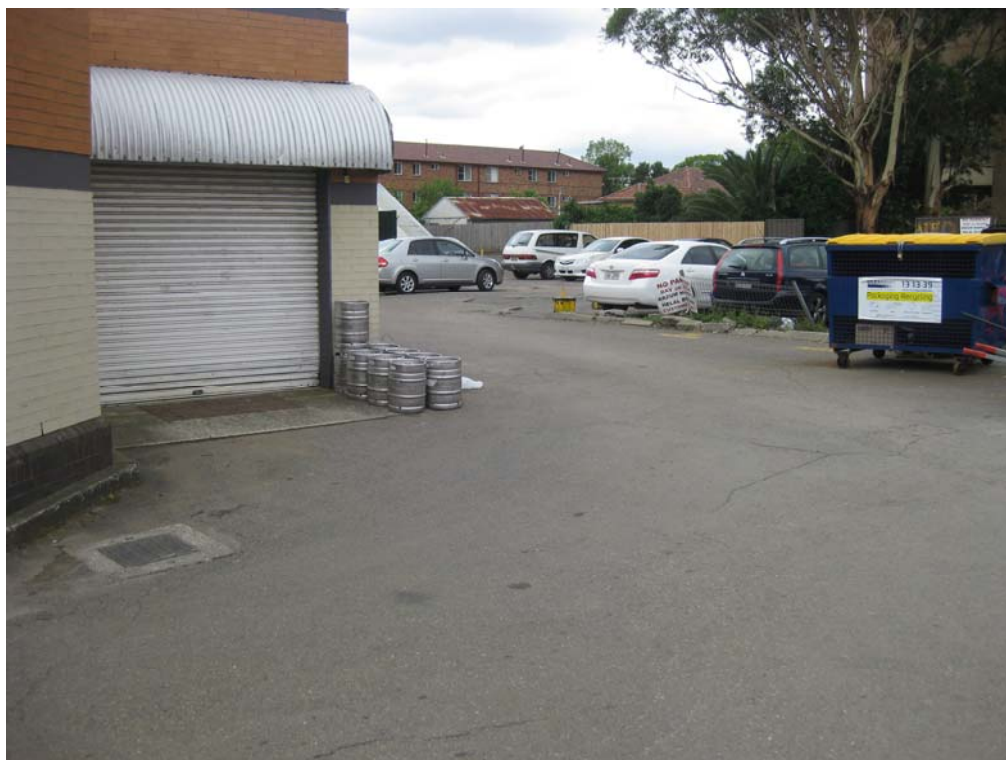
Photo 3: Rear Car Park and Loading Bay

The presence of buried rubbish fill was not fully investigated in this Phase 1 assessment however based on our review of aerial photographs, ground surface within the site appeared to be generally undisturbed except the rear portion where fill is possibly used to raise and level the carpark.

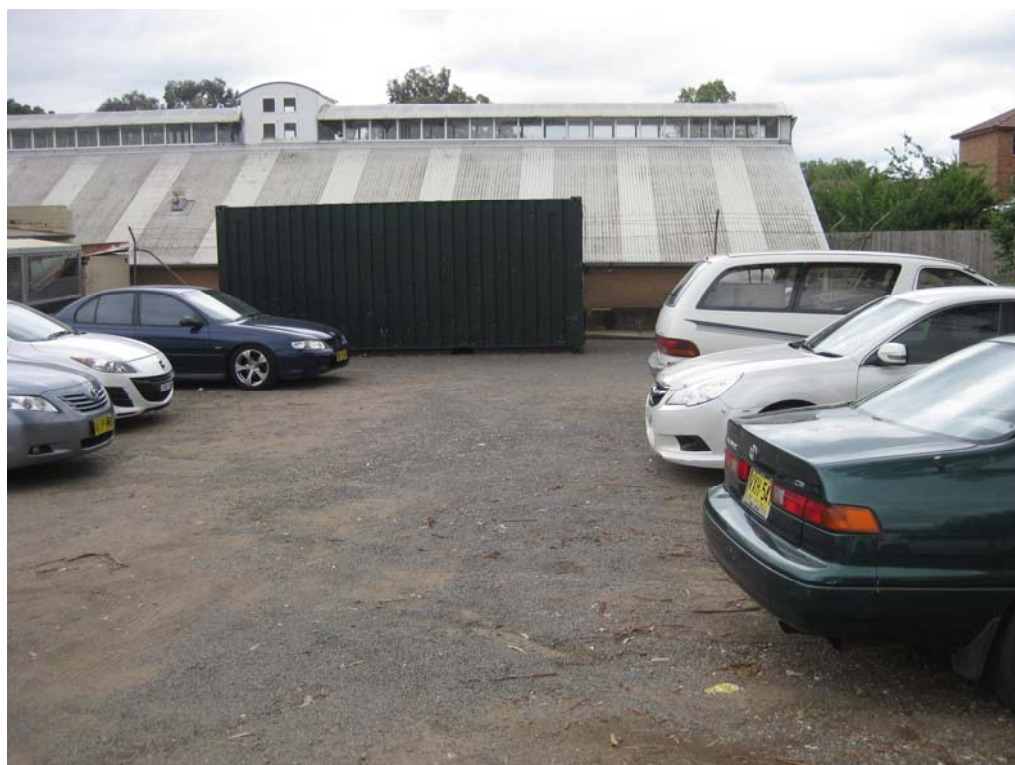
Photo 4: Rear Car Park

Fill contamination within the site if exist is likely to be confined to the rear portion of the site.
