Report on  
Geotechnical Investigation

Proposed Residential Development  
124 – 128 Killeaton Street  
St Ives

Prepared for  
Ausprospect Pty Ltd

Project 84348.00  
October 2014

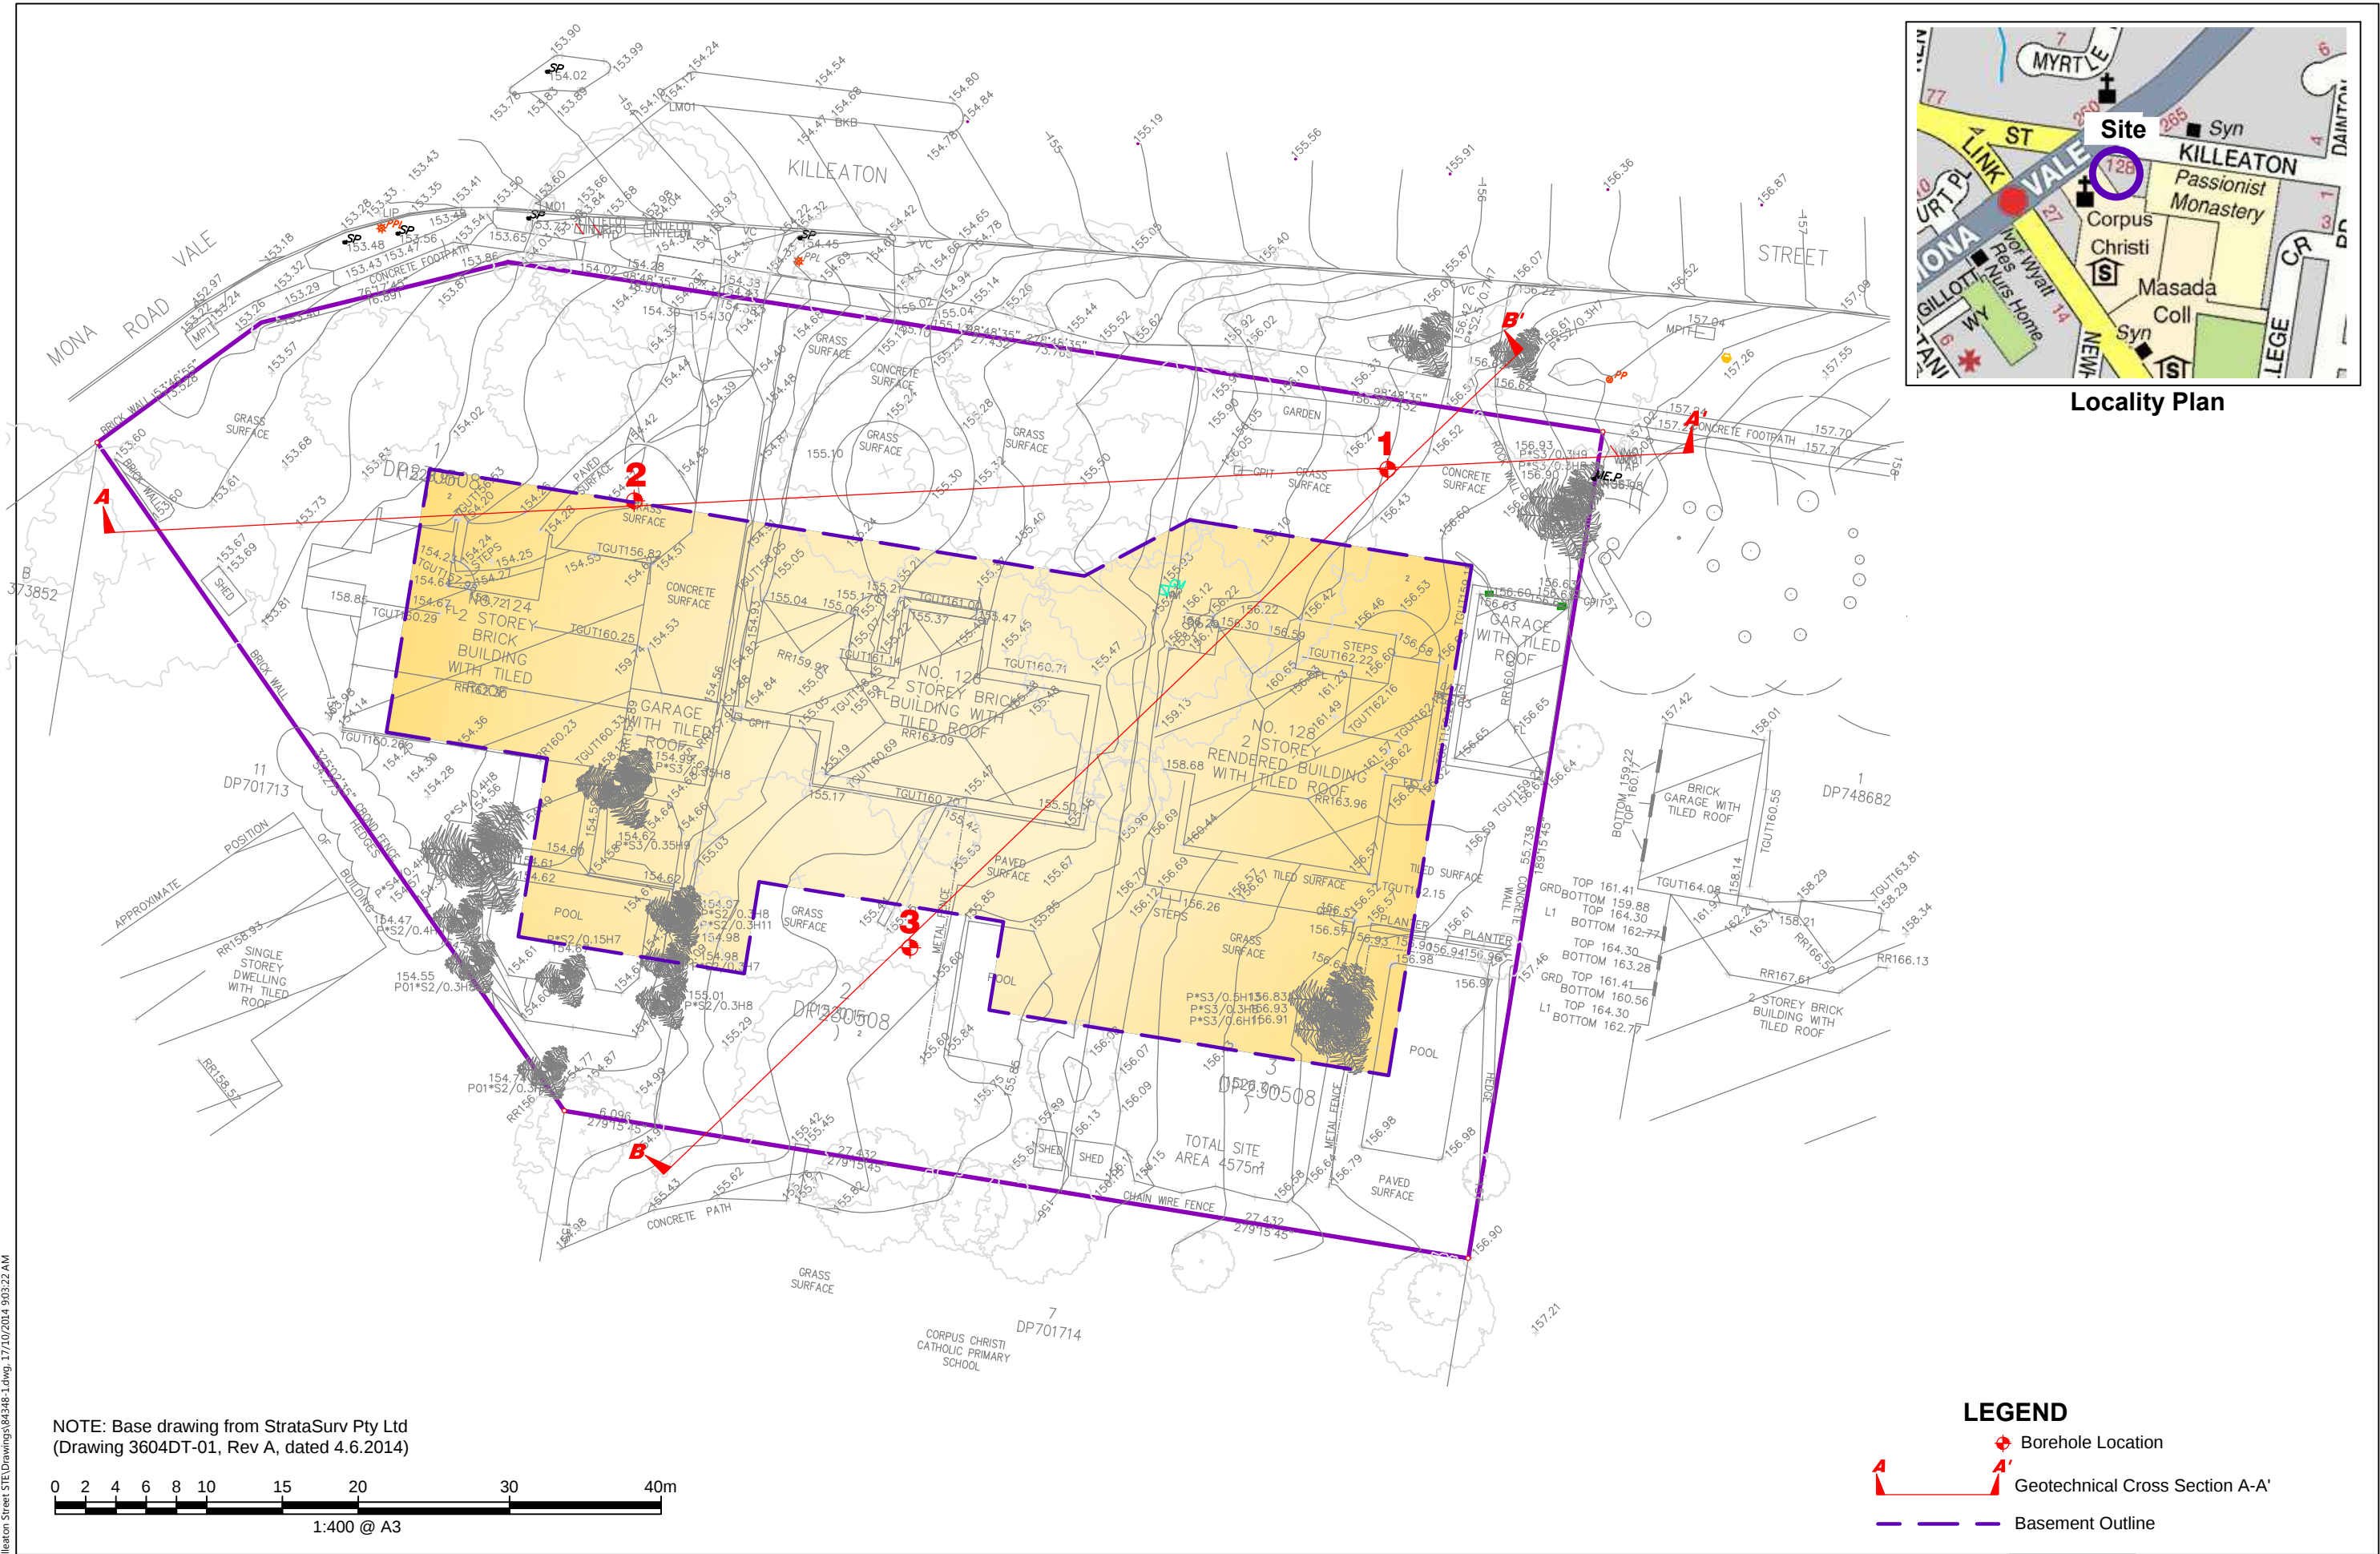
Locality Plan

NOTE: Base drawing from StrataSurv Pty Ltd  
(Drawing 3604DT-01, Rev A, dated 4.6.2014)

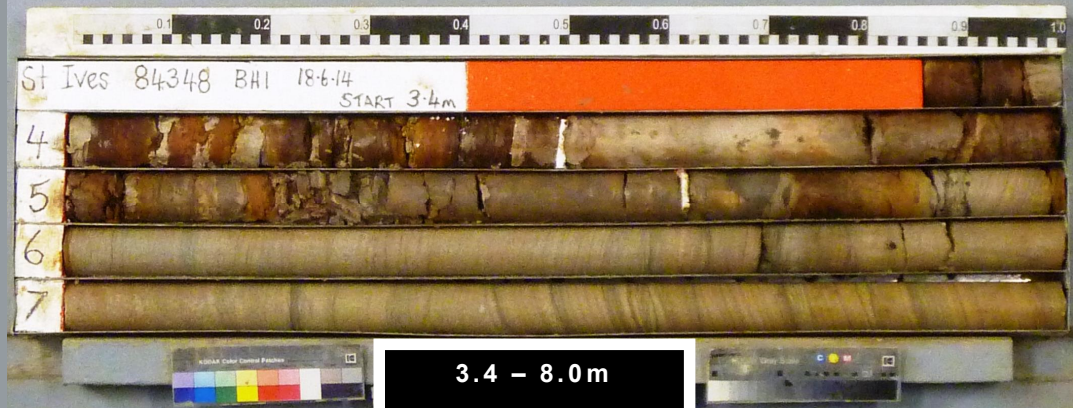
DOUGLAS PARTNERS PTY LTD  
PROPOSED RESIDENTIAL DEVELOPMENT – ST IVES  
BORE 1 PROJECT 84348 JUN 2014

Details of the subsurface conditions encountered in the investigation are given in the borehole logs in Appendix C, together with colour photographs of the rock core and notes defining classification methods and descriptive terms.
