Flora and fauna and bushfire assessment

**Corner of Bonnyrigg Avenue and Elizabeth Drive,
Bonnyrigg
Lots 1 & 2, DP 1071647**

Date: 28 January 2015

Document No: 1342-REP-149-ISS-1

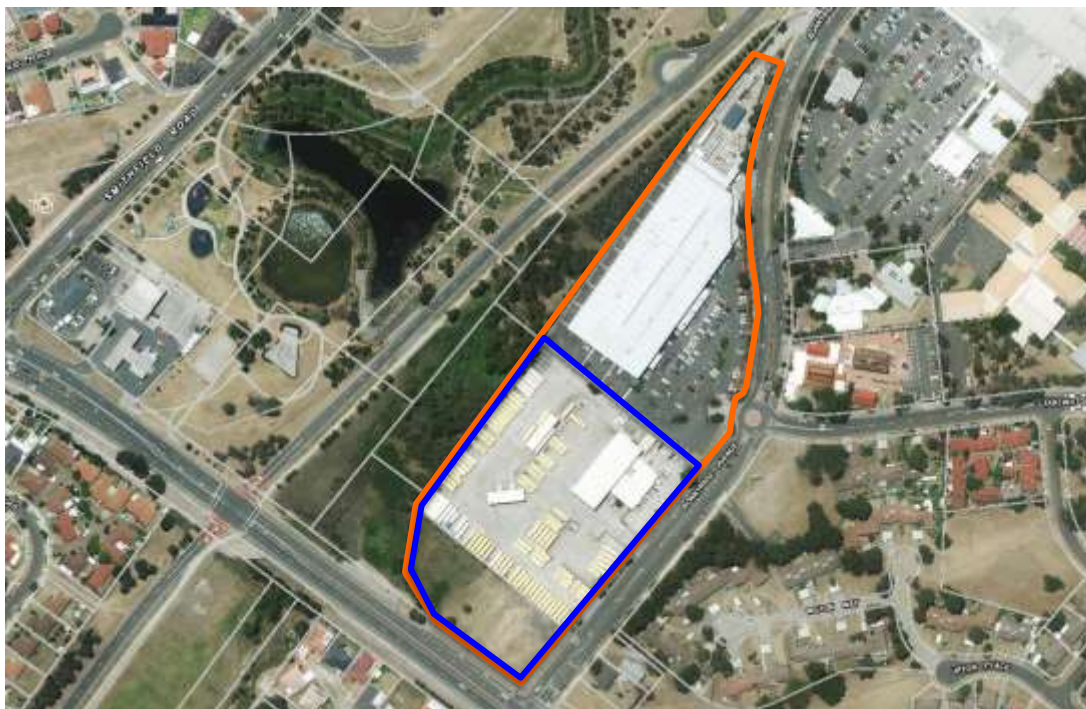
Figure 1. Air photo of the site and surrounding area

Area of proposed development

A bushfire and flora and fauna assessment of the proposed development site at corner of Bonnyrigg Avenue and Elizabeth Drive('the site' –Figure 1) was undertaken on 9 October 2014.

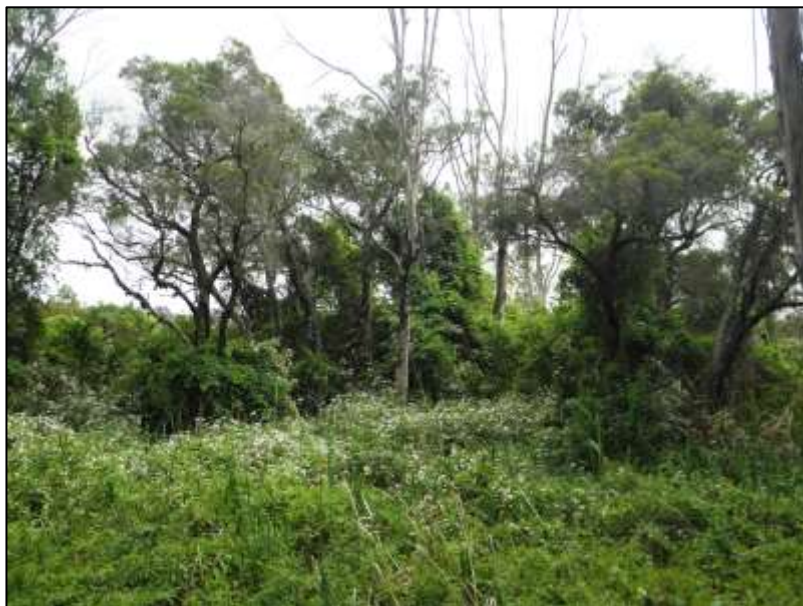
Figure 10. Remnant *Melaleuca linearifolia* on drainage line

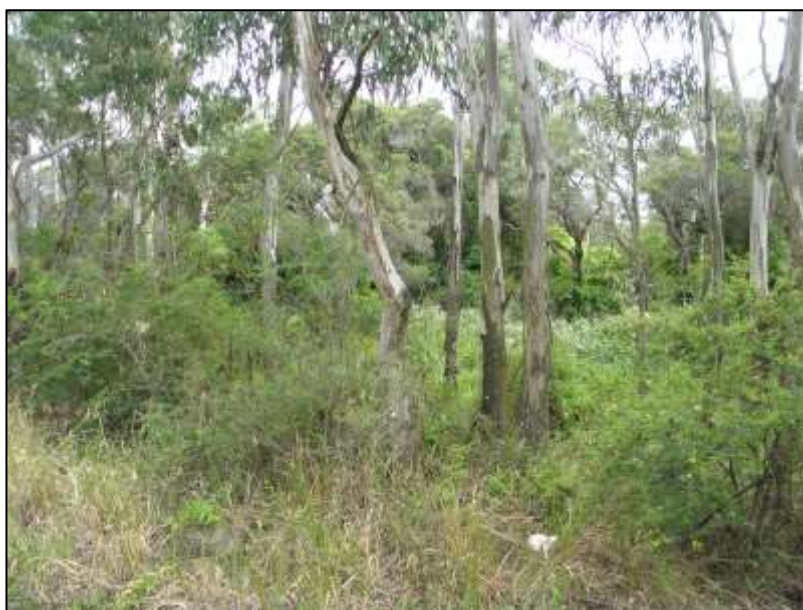
Figure 11. Regenerating CPW behind bus depot

An area of the EEC Cumberland Plain Woodland (Class 2 regenerating) exists behind the current Bunnings premises and the bus depot. Class 2 regenerating CPW occurs on the adjacent property and does not occur on the land to be developed. It currently receives water runoff from the existing developments. Several noxious weeds including *Ligustrum sinense*, *Lantana camara*, and *Asparagus asparagoides* all occur in or near to the patch of CPW.

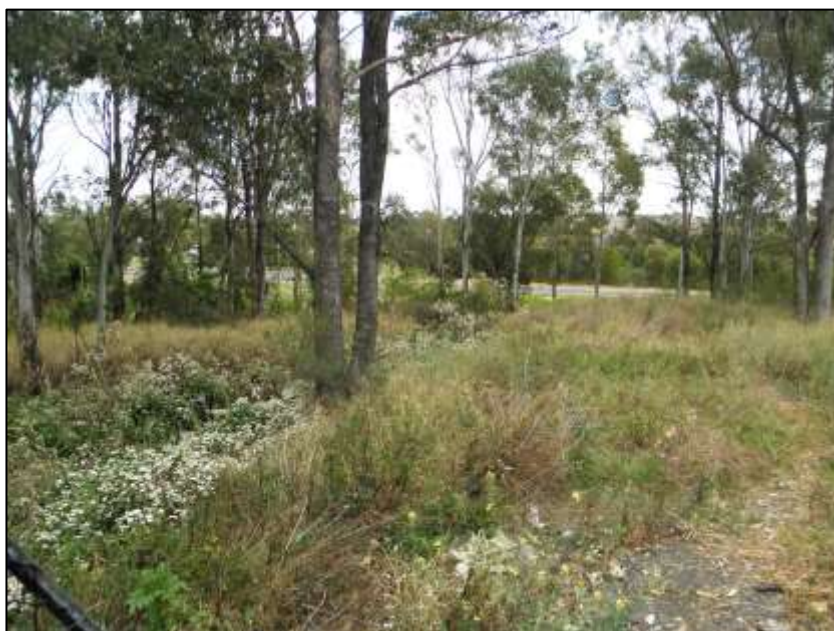
Figure 12. Drainage line behind Bunnings and Bus depot

The adjoining property to the northwest of the site features a stand of regenerating Cumberland Plain Woodland that provides habitat for some fauna species. Water runoff from Bunnings and the bus depot has created two drainage lines in the regenerating CPW. These drainage lines are dominated by dense *Lonicera japonica*, and *Ageratina adenophora*, which converge centrally in the patch of regenerating CPW. A stand of remnant *Melaleuca linearifolia* trees with an understory of *Ligustrum sinense* grows along the central watercourse. *Phragmites australis* also grows along part of the central watercourse indicating a possible past dam.

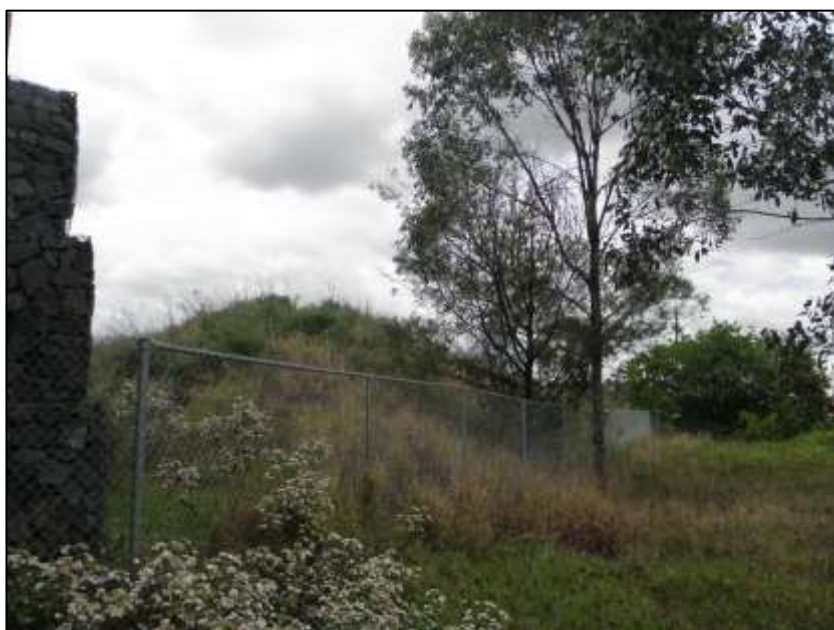
Figure 13. Soil dump on western side of grassy paddock

The grassy paddock has been cleared of all original vegetation and the original soil profile has been disturbed. A soil dump occurring in the northwestern half of the grassy paddock has been overtaken by weeds and some native vegetation. Grass on the level area of the grassy paddock is mown and maintained. All significant natural features appear to have been removed or altered. No habitat trees were observed in the grassy paddock.

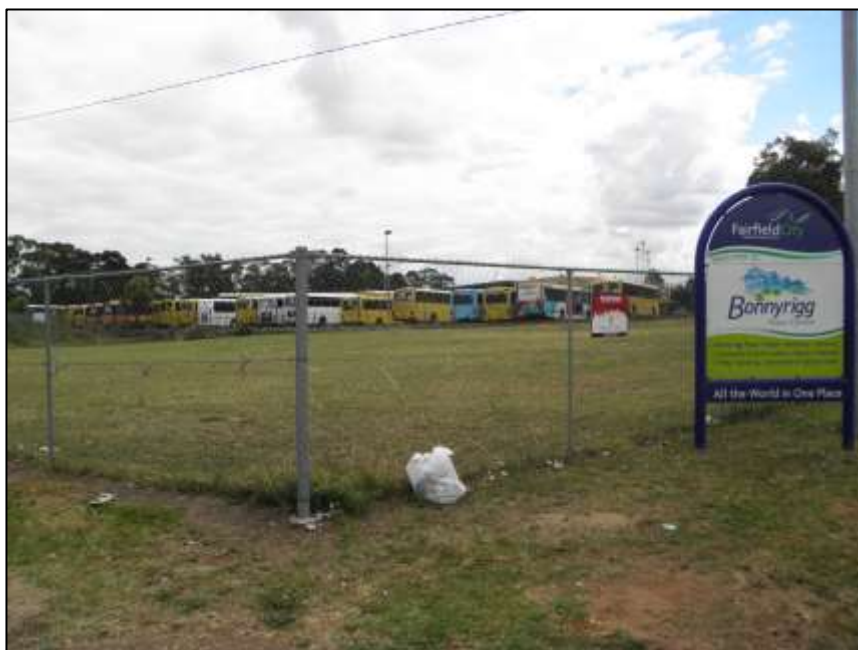
Figure 15. View of grassy paddock from south

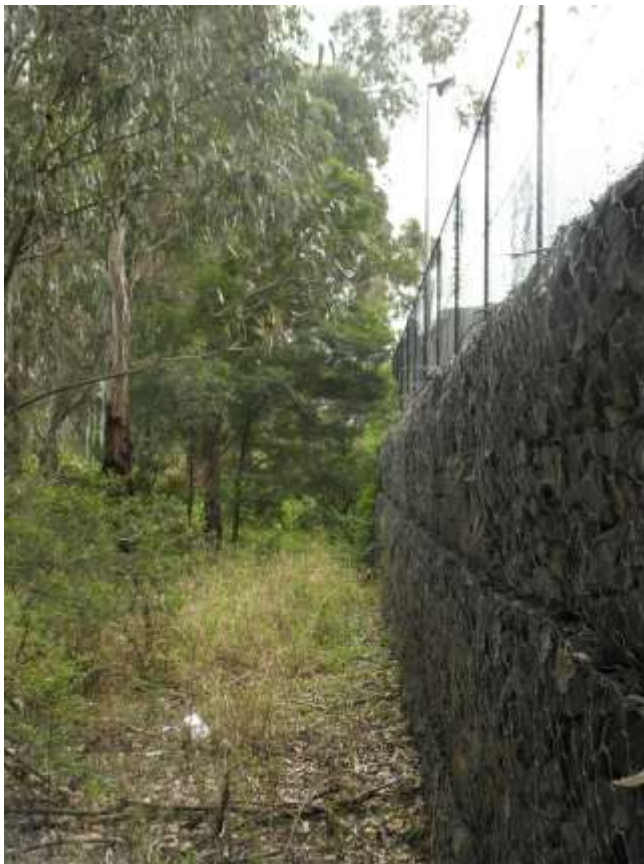
Figure 16. Bus depot built on raised surface

The bus depot has been cleared of all original vegetation and the original soil profile has been disturbed or substantially destroyed throughout. No natural habitat exists on the site. The natural topography of the bus depot has been altered in the process of excavation and filling and development. Both the bus depot and the adjoining Bunnings premises are built on a raised platform (see Figure 16) which provides protection from significant flood events.

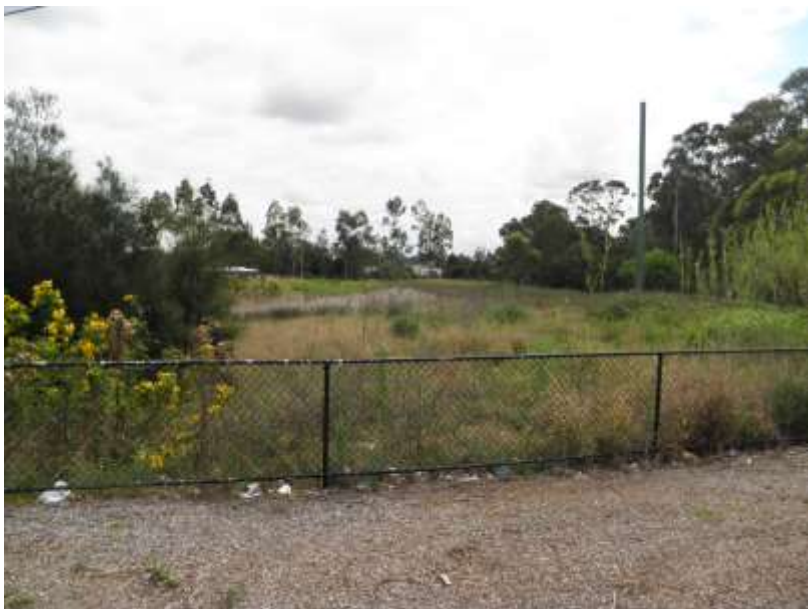
Figure 17. Stream behind bus depot

The site for the proposed development is within 40 metres of a riparian corridor that is a second order stream. The stream flows through a culvert beneath Elizabeth Drive and then northeast across part of the adjoining land. (see Figure 17)

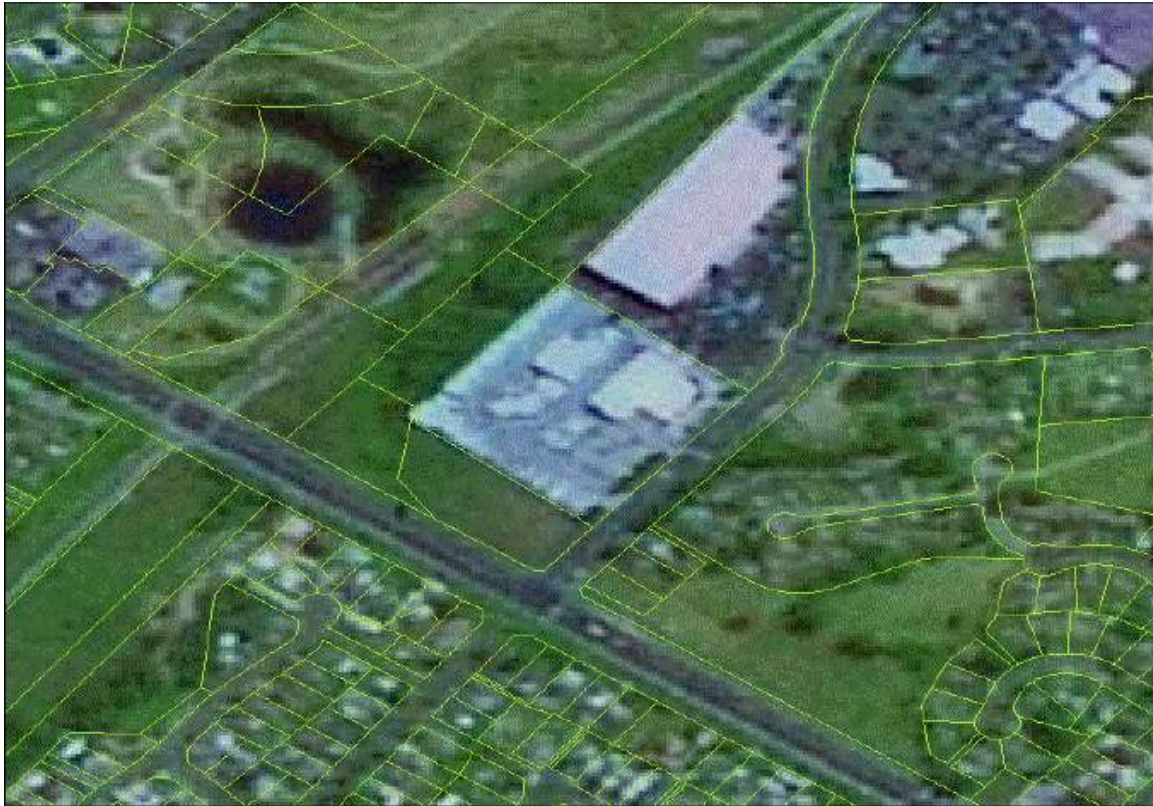
Figure 18. AHIMS search results

- 2
- 4 A search of the office of Environment and Heritage AHIMS Web Service (Aboriginal Heritage
- 6 Information Management System) has shown that two aboriginal sites are recorded near the
- site, but do not occur on the site itself. No aboriginal places have been declared in or near
- the site.

There are no items of heritage or Aboriginal significance on the land. The AHIMS on-line basic search results can be seen in Appendix 1.
