Mulgoa Excavations Pty Ltd C/-  
Precise Planning

Remedial Action Plan:  
25 Martin Road,  
Badgerys Creek, NSW.

P1404242JR04V01  
April 2016

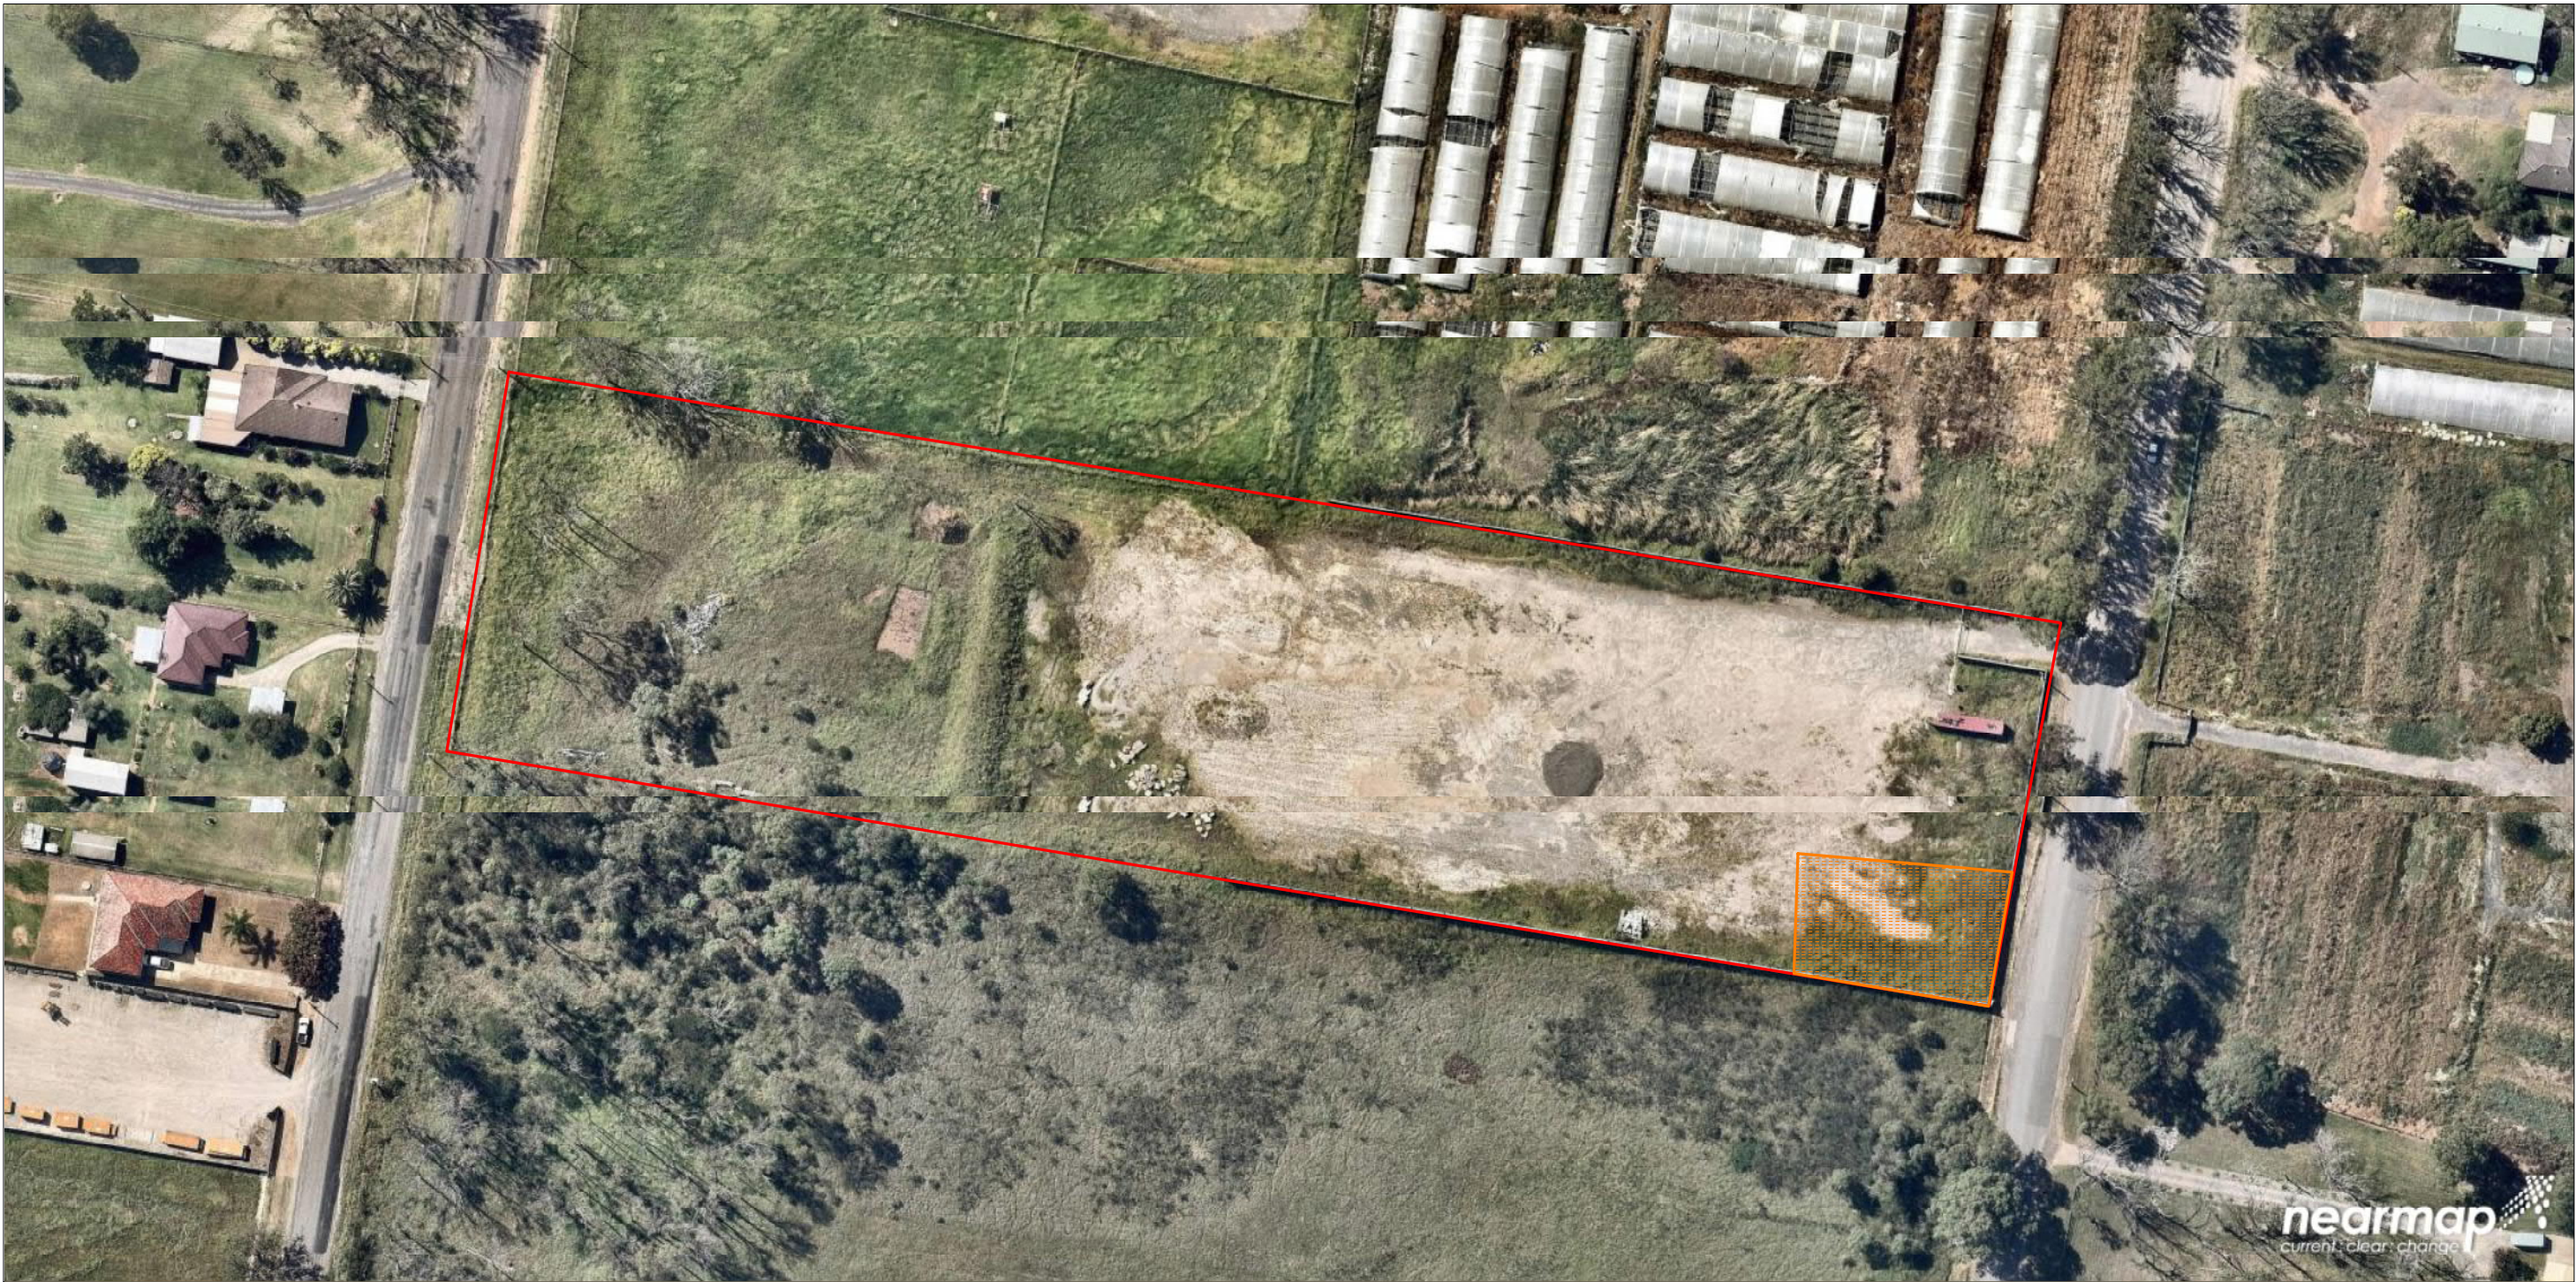
## 12      **Attachment A – Remediation Plan**

Site plan is provided in Attachment A (Figure 1).

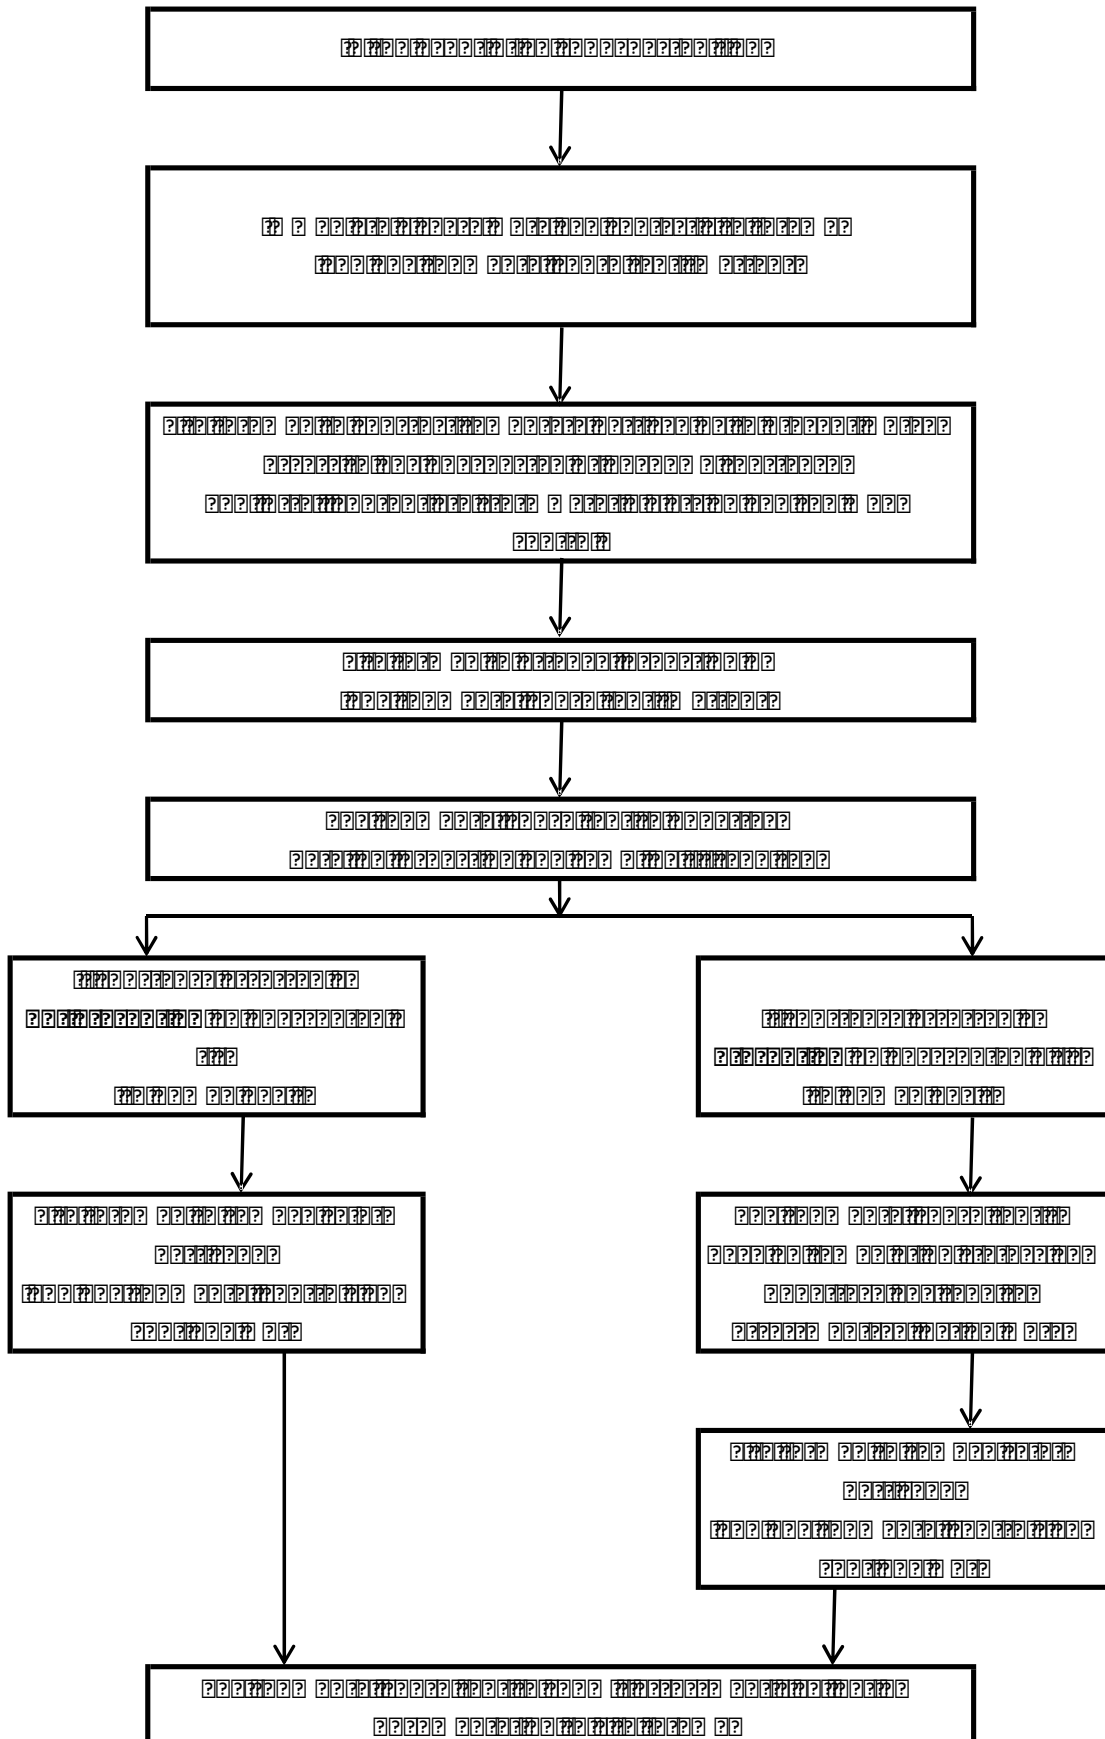
## Unexpected Finds Protocol

A flow chart outlining unexpected finds protocol is found in Attachment B

1. Suspicious material/soil which has been excavated should be stockpiled on bunded, strong, impermeable plastic sheeting, protected from erosion, with seepage retained.
2. Excavation works at that part of the site where the suspicious material (soil, fill or other) was encountered should cease until observed by an experience environmental consultant.
