Report on
Contamination Investigation

Part Coopers Paddock
Governor Macquarie Drive
Warwick Farm

Prepared for
Stockland Development Pty Ltd

Project 84377.00
October 2014

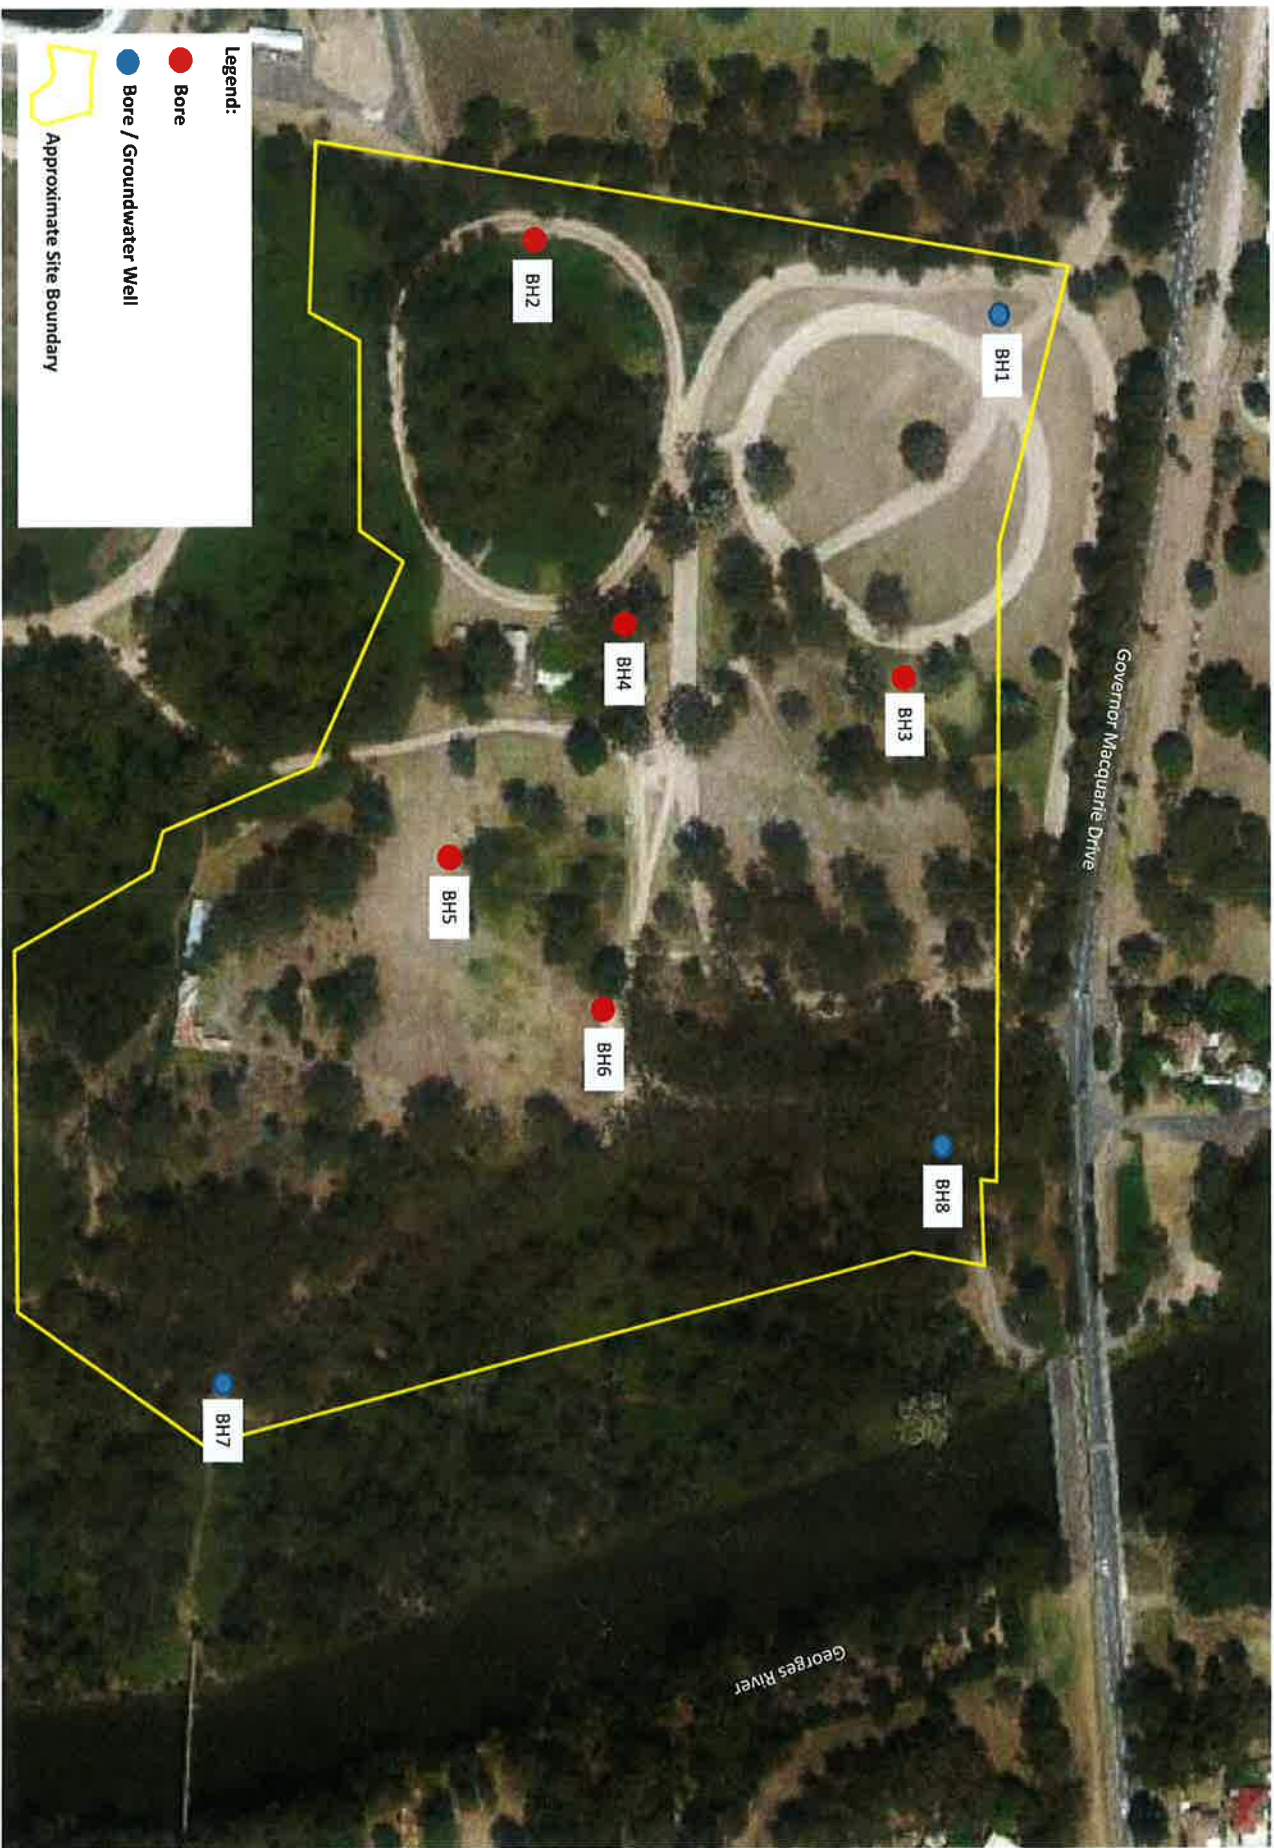
- Positioning of 8 test bores (BH1 to BH8) across accessible areas of the site to provide a general coverage. The bores were positioned primarily to assess ground conditions at proposed warehouse building locations;
