# Rowland Hassall School Relocation 49 Woodville Road, Chester Hill

# **Contamination Investigation**

Report number: 15-GS91B

Prepared for NSW Department of Education

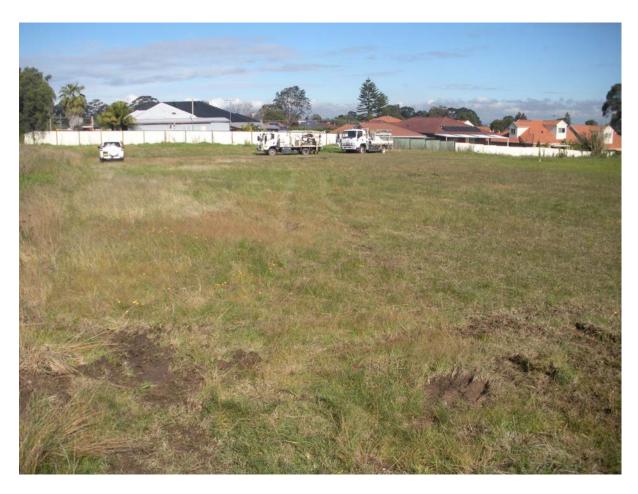
**PLATE 1:** General view of the eastern terrace, looking towards the south-west.

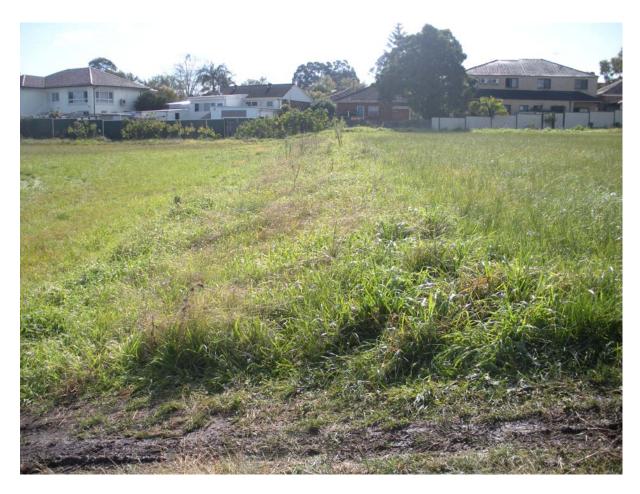
**PLATE 3:** View looking north along the grass-covered fill batter between the eastern and western terraces.

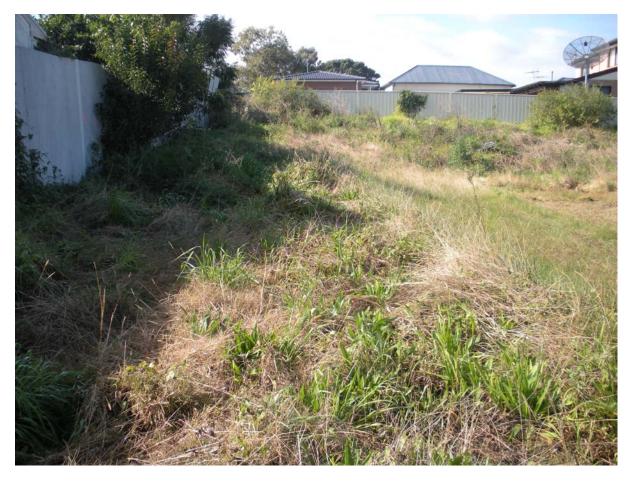
**PLATE 4:** View looking east near the northern boundary fence. Rubbish and debris are located near the fenceline; however it's partially obscured by vegetation in this photograph.

- The observed debris/ rubbish on the ground surface in the north-eastern and south-western parts of the Site should be removed and be properly disposed offsite to a licensed landfill. Any fibre-cement fragments found, unless proved otherwise, should be assumed to contain asbestos and be designated as asbestos waste. The Site should then be secured (if possible) to prevent any further illegal dumping of waste.

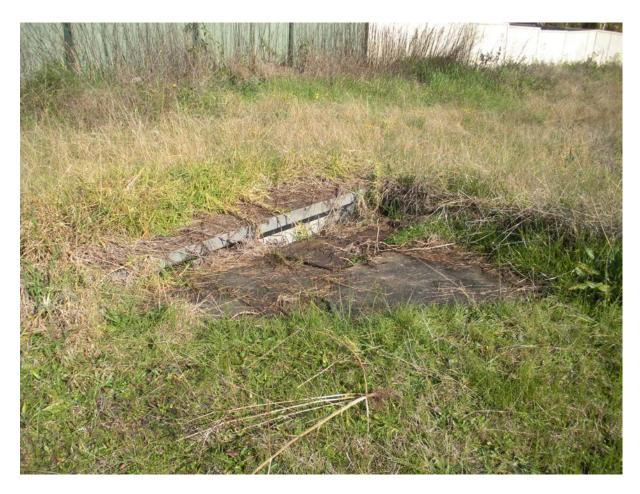
**PLATE 5:** Concrete kerb and stormwater pit in the south-western corner of the eastern terrace.

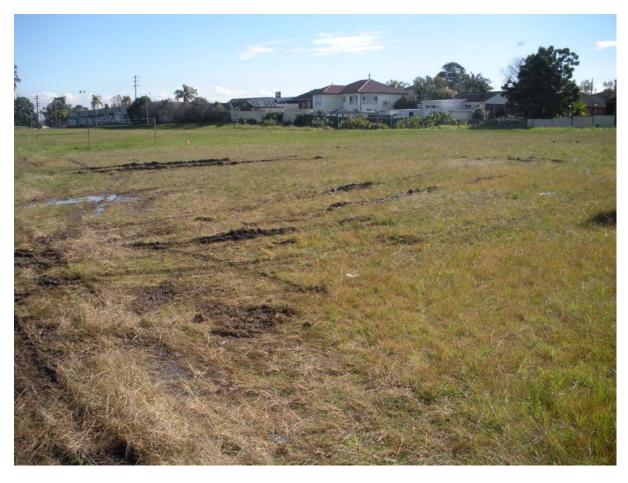
**PLATE 6:** At the time of fieldwork, the middle and southern parts of the eastern terrace were very soft, water logged and boggy.

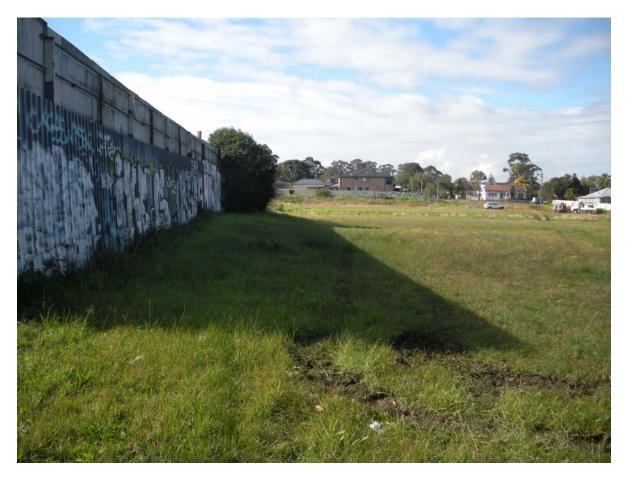
**PLATE 7:** View looking east showing the low cut embankment along the northern boundary of the western terrace.

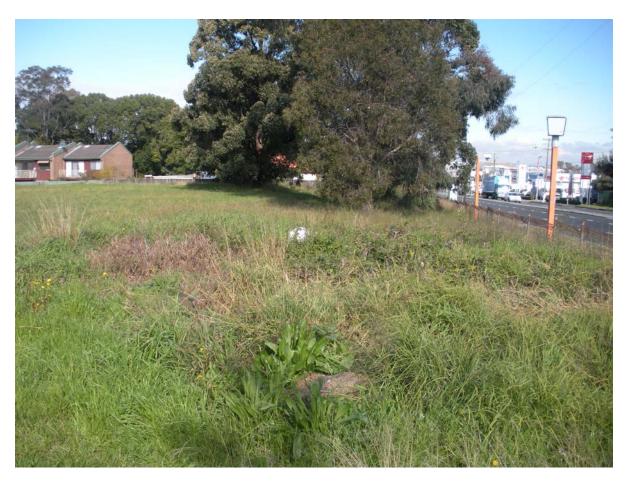
**PLATE 8:** View looking south showing the fill embankment along the western boundary of the western terrace, near Woodville Road.

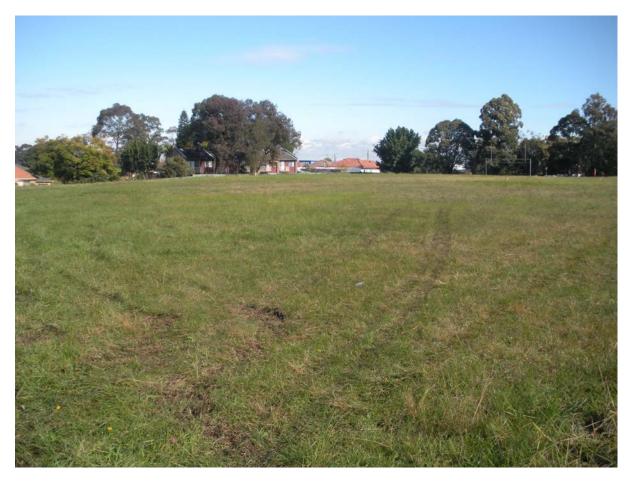
**PLATE 9:** View looking south-west showing the western terrace.

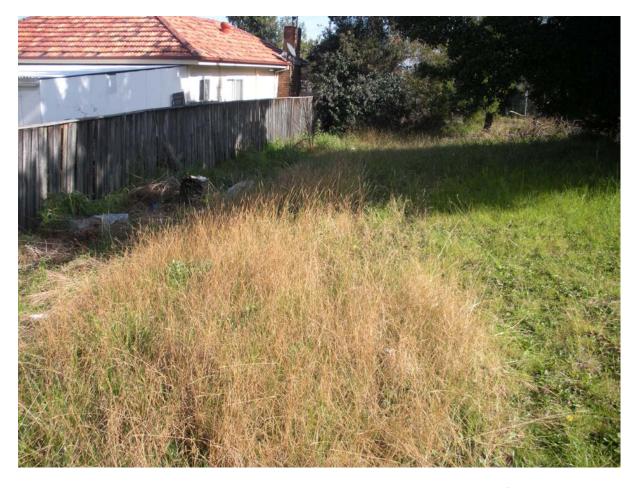
There were no other fibre-cement fragments observed on the ground surface within the Site. However the possibility of encountering some ACM debris within the dumped debris/ rubbish in the north-eastern corner and south-western corner of the Site should not be discounted. This debris/ rubbish should be removed from the Site and properly disposed offsite to a licenced landfill.

**PLATE 10:** Rubbish and debris dumped near the south-western corner of the Site.

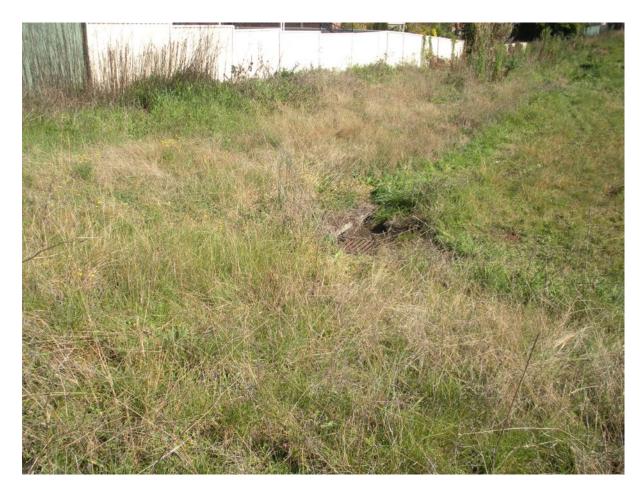
**PLATE 11:** Concrete kerb and stormwater pit located in the south-eastern corner of the western terrace.

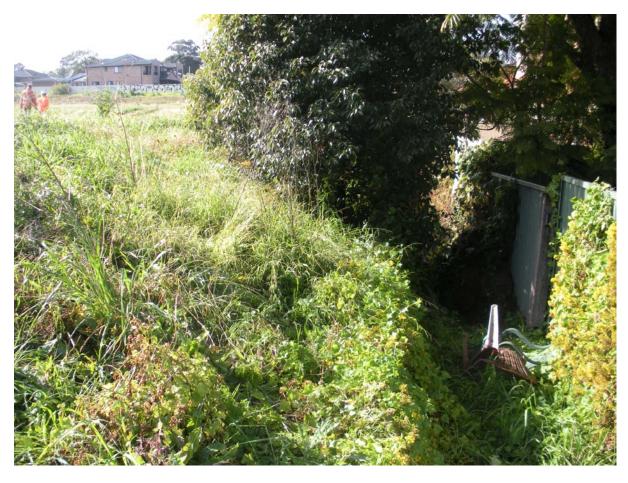
**PLATE 12:** View looking east showing the fill batter along the southern boundary. The low retaining wall is obscured by vegetation.
