JOINT REGIONAL PLANNING PANEL Western

2015WES004
2015/0085
Bathurst Regional Council
Additions and Alterations to Existing Buildings and Use as an Education Facility (Engineering School)
353 Panorama Avenue, Mitchell
Charles Sturt University Reserve Trust
0
Approval with Conditions
Scott Hoy, Development Control Planner & Richard Denyer, Manager Development Assessment

Assessment Report and Recommendation

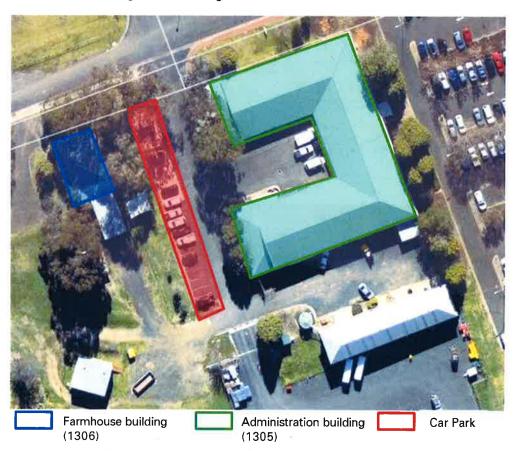
Figure 3 - Existing development

Car spaces for 22 vehicles exist between the two buildings and a truck turning/delivery area is located near the entrance of the administration building. Vehicles gain access to the buildings via Village Drive which connects to Panorama Ave at the main entrance of the campus.

Vegetation exists along the eastern and western walls of the administration building and surrounds the farmhouse building as shown in **Figure 3**.

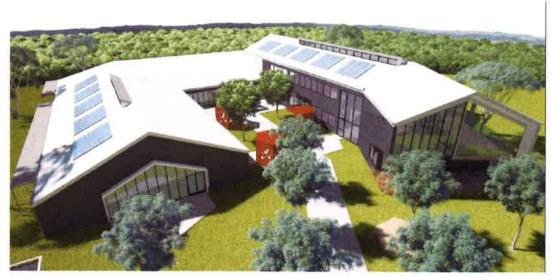
Figure 4 – 3D model of proposed refurbishment Source: Thomson Adsett Architects

Architectural drawings prepared by Thomson Adsett Architects are provided at **Attachment A** and a 3D perspective of the development is shown at **Figure 4**.

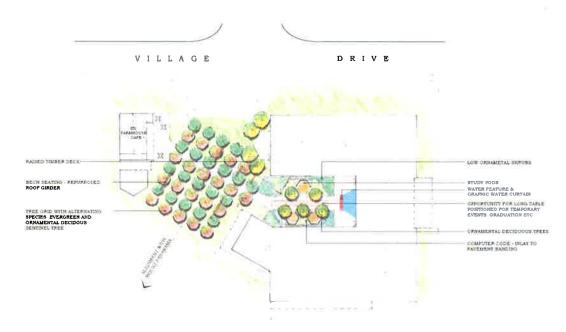
Figure 5 - Landscape Plan Source: Thomson Adsett Architects

A landscape plan is included at **Attachment B**. The plan incorporates an orchard of alternating deciduous and evergreen trees as shown in **Figure 5**. A large courtyard is proposed at the current entrance of the building which will include three 'study pods' and outdoor seating. A walkway will lead from the entrance of the School of Engineering to the converted farmhouse.

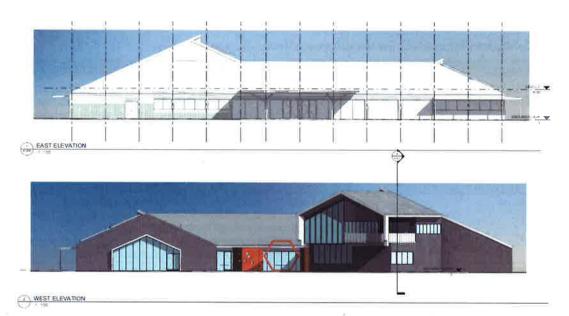
Figure 7 - Elevations
Source: Thomson Adsett Architects

The proposed refurbishment will result in a largely new building that is mostly contained within the existing building footprint. The primary alteration will be to the southern wing which will be extended and an additional storey added. The maximum height of the building will be 9.55m which is in keeping with the surrounding context of the campus and will not cause any undue impacts in terms of views on the surrounding rural landscape.

The selection of materials and finishes for this project is acknowledged as highly important in the context of achieving a high quality design outcome that both respects and complements the rural character of the site and its surrounds.

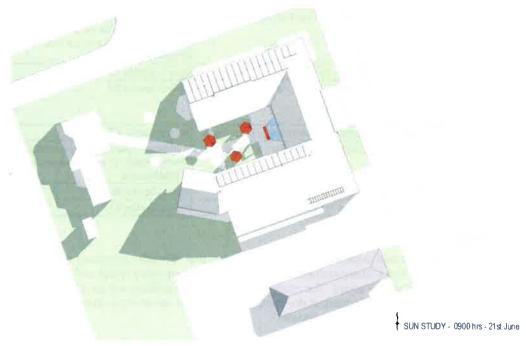
Figure 8 – Shadow diagram Source: Thomson Adsett Architects

Shadow diagrams have been prepared by Thomson Adsett Architects and are included at **Attachment A.** The proposal will not cause any adverse shadowing impacts on neighbouring buildings, including the farmhouse building as illustrated in **Figure 8** below.

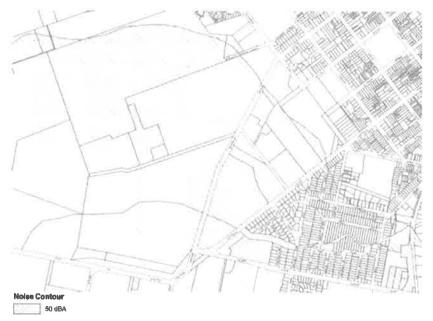
Figure 10 – Mount Panorama Environs Map Source: Bathurst Regional Council

The design of the building is oriented to the north, away from the Mount Panorama race track, with minimal open areas facing south. The addition to the south western end of the building will also act as a sound barrier to the open courtyard and northern section of the building.

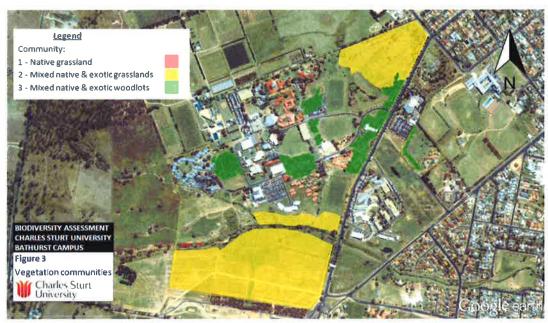
Figure 11 - Vegetation Map

The proposed development will require the removal of some trees adjacent to the building to enable the extension to the current building footprint (these works will be undertaken as exempt development as part of the enabling works package, separate to this DA). This vegetated area has been developed since the area was used as a services precinct. Accordingly, the development will not cause any undue impacts on surrounding natural flora and fauna.

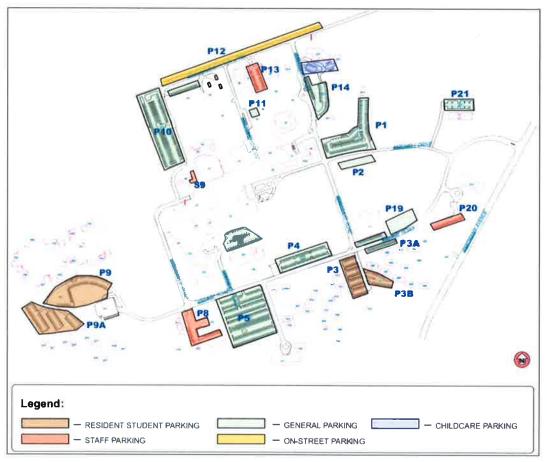
Figure 12 - CSU existing parking

CSU is currently seeking observed parking demand data and an assessment of the traffic provisions for the proposal by TEF Consulting, who undertook a traffic and parking study in 2011. This is to be issued to Council as an addendum in the next week and is expected to support the position that additional car parking will not be required as a result of the proposal.

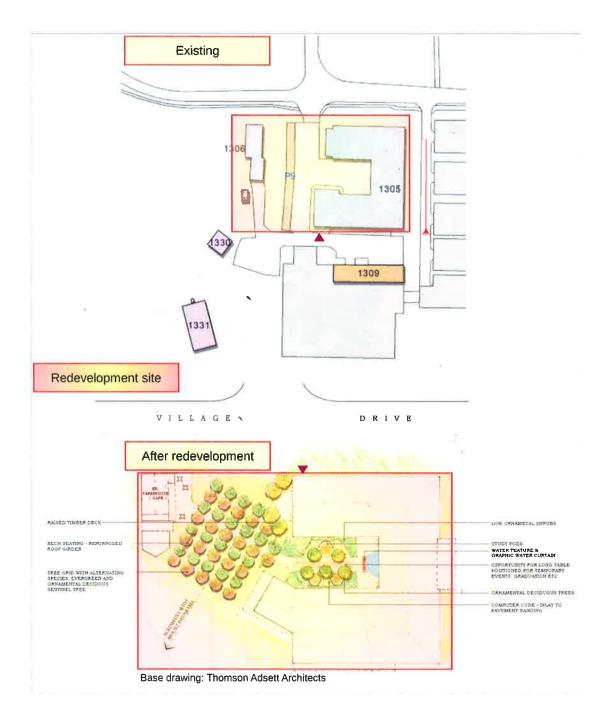
Figure 2. Proposed redevelopment.

- Refurbishment of the existing administration and farmhouse buildings to facilitate a new School of Engineering faculty
 - Refurbishment of the existing ground floor to include student study space, meeting rooms and labs;
 - Additional 107 m² of GFA at the tip of southern wing of the ground floor for a new lab;
 - Addition of a mezzanine Level 1 to facilitate staff open plan office and meeting rooms;
 - o Associated landscaping works;
 - Minor additions and amendments to existing access and road infrastructure;
 - o Installation of solar panels; and
 - Refurbishment of the existing farmhouse and addition of meeting room.
- Total increase of GFA from 1,960 to 2,467 m², by 507 m².

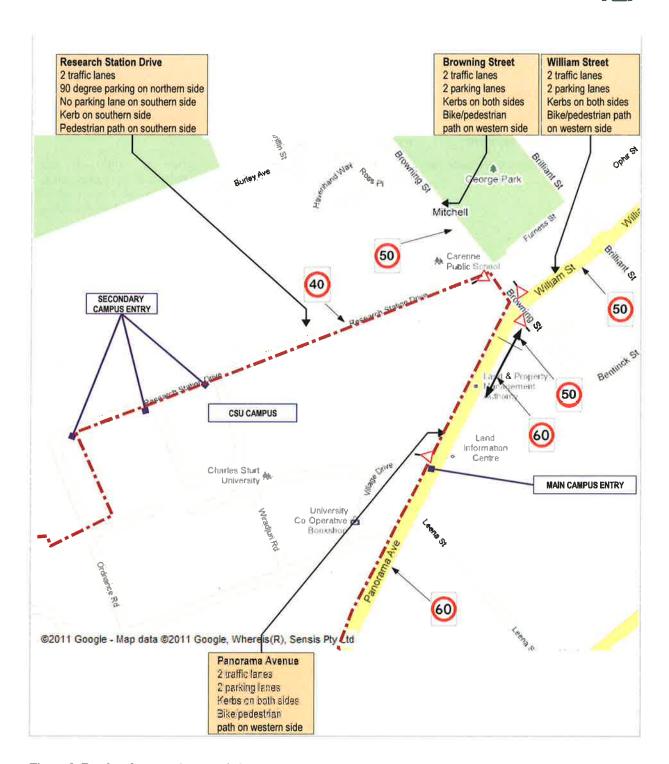
Figure 3. Road and access characteristics.

- Street characteristics
 - External streets and access Refer to Figure 3.
 - Internal streets low to moderate traffic volumes, no capacity issues.
