Report on  
Preliminary Site Assessment (Contamination)

Proposed Upgrading of Facilities  
Medowie Christian School  
Waropara Road, Medowie

Project 81808.00  
December 2015

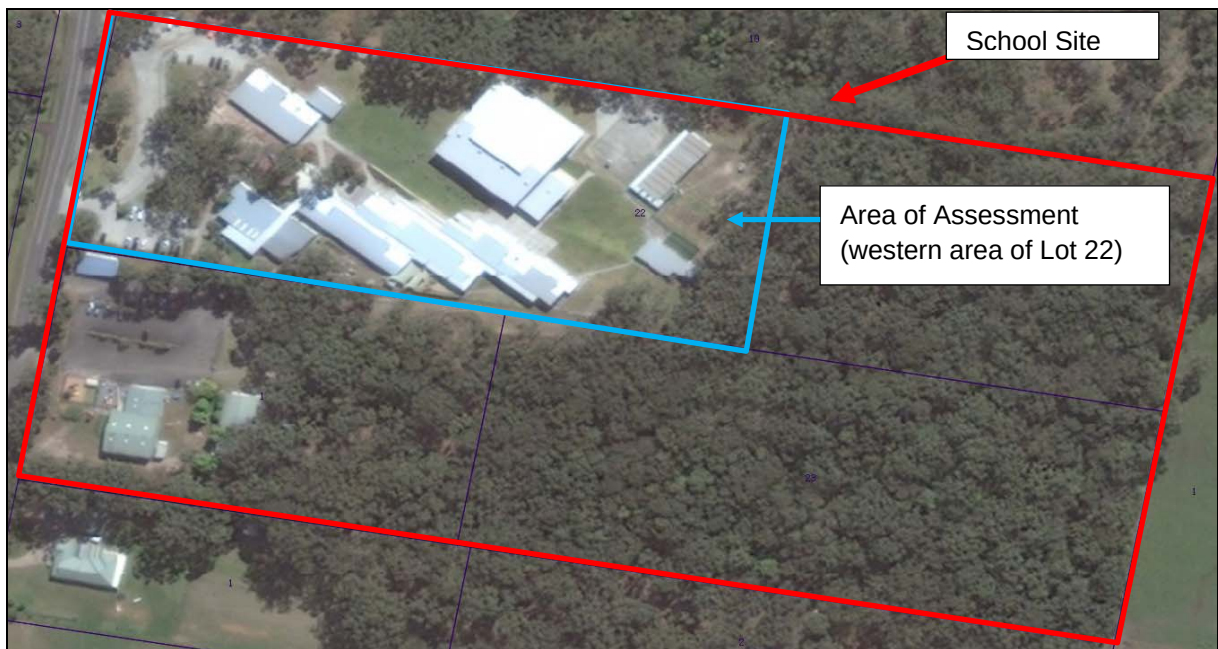
**Figure 1: Aerial image of school site**

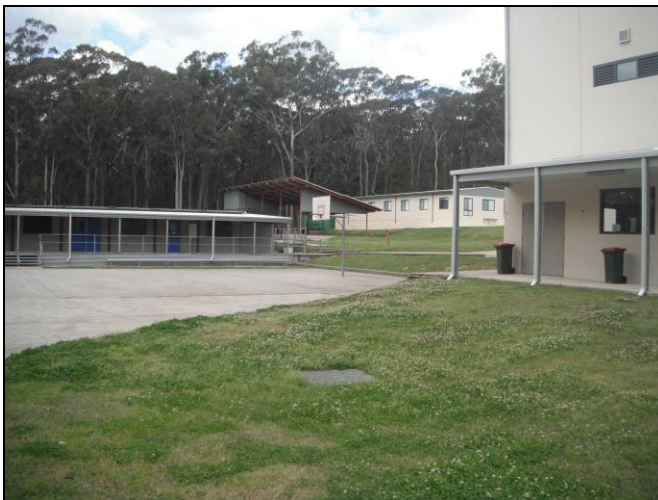
**Figure 2: View of existing building, looking south-west**

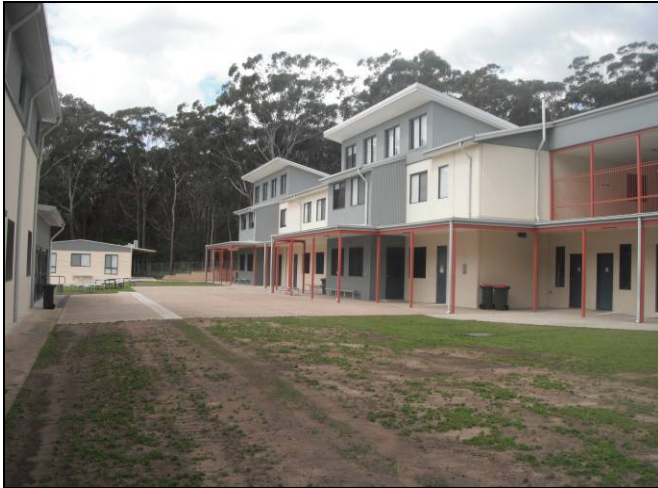
**Figure 3: Existing buildings in south-eastern area of school grounds**

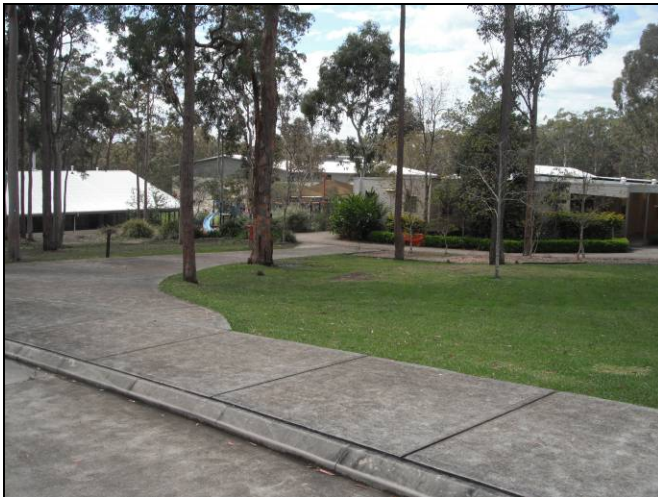
- Numerous concrete paved areas are located within the school ground (refer Figures 4 and 5);

**Figure 4: Concrete access pavement and footpath, looking north-east**

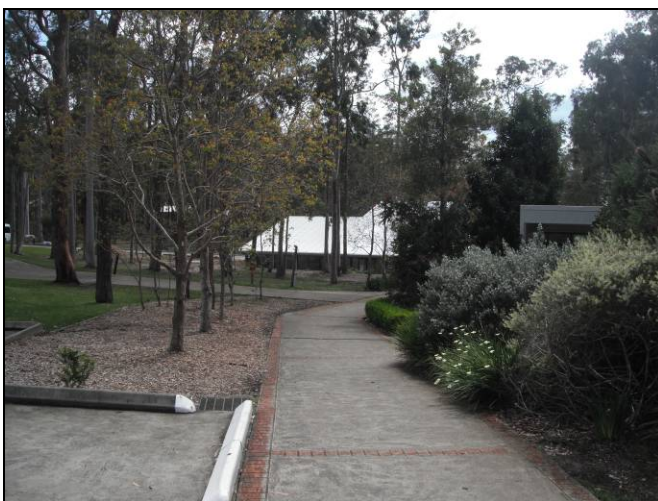
**Figure 5: Footpath running to the north near administration building**

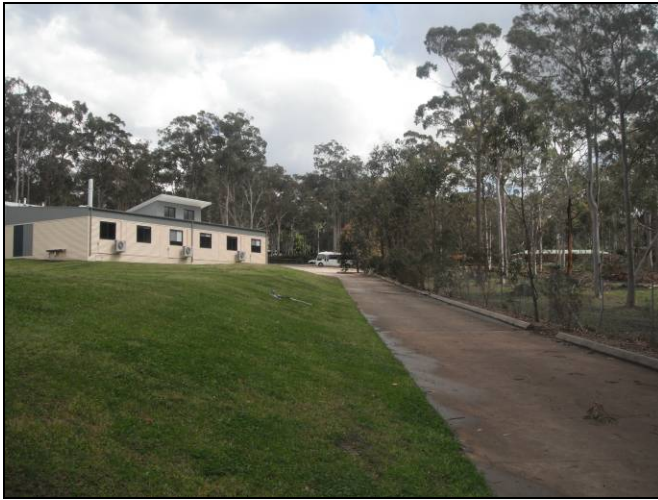
- Several near level grassed areas are present within the school grounds, including an area of approximately 1,000 m<sup>2</sup> to the west of the multi-purpose hall (refer Figure 6);

**Figure 6: View looking along northern edge of near level grassed area**

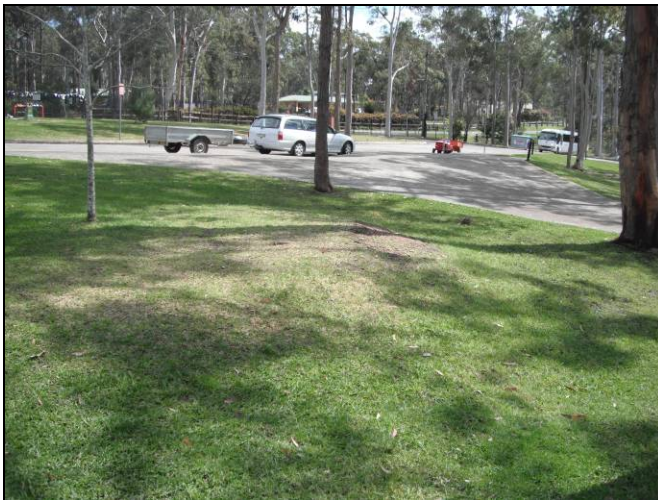
- This area seems to have been created by cut and fill operations. The depth of filling is not known, however, 0.7 m depth of filling was encountered on the batter during investigations for the concurrent geotechnical investigation;
- A smaller areas of possible filling was present to the west of the existing administration building (refer Figure 7);

**Figure 7: Possible mound of surficial filling in south-western area of site**

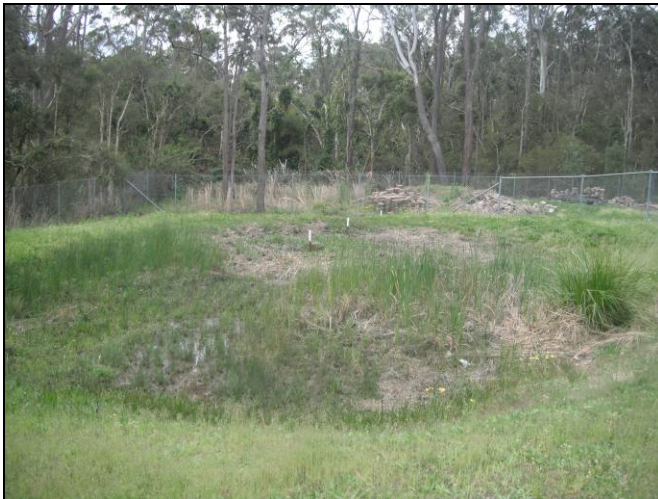
- A detention pond was located in the north-eastern corner of the school grounds and was approximately 15 m in diameter and about 1.5 m deep. Some filling appears to have been placed during the construction of this pond (refer Figure 8);

**Figure 8: Detention pond in north-east corner of school grounds**

- Importation of filling to the site, or excavation and placement of material won from site to form the level areas and the detention pond embankments. Fill materials which may have been imported to site may contain a range of contaminants included TRH, BTEX, PAH, OCP, OPP, PCB and asbestos depending on the source; and
- Possible application of herbicides and pesticides during weed control around the school grounds. Potential contaminants would include TRH, PAH, BTEX, PCB, OCP, OPP, Metals and Herbicides.
