Report on  
Geotechnical Investigation

Proposed  
Administration Building and Carpark  
Medowie Christian School  
Waropara Road, Medowie

Project 81808  
December 2015

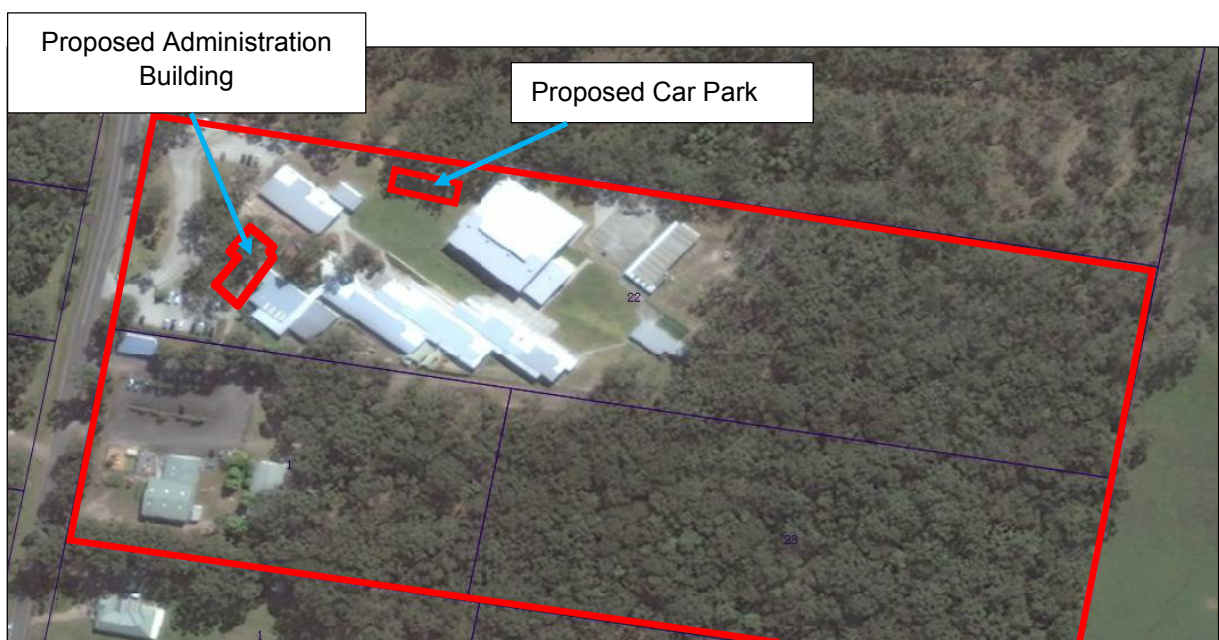
Figure 1, below, shows an aerial view of the school with the approximate proposed development areas.

**Figure 1: Aerial image of school showing proposed administration and car parking areas**

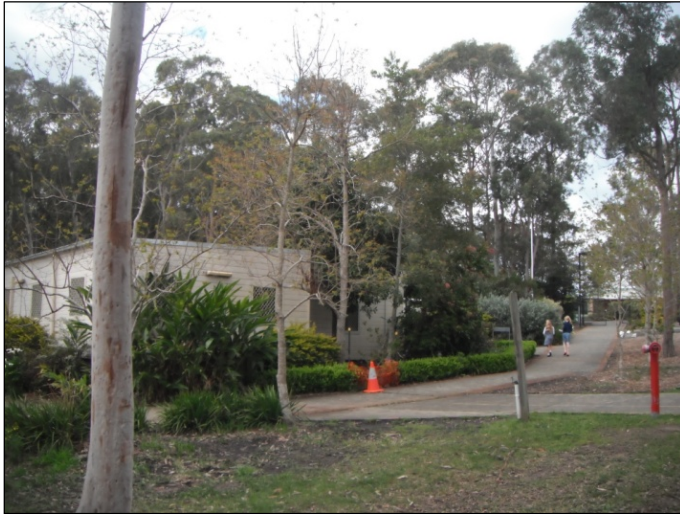
The proposed administration building footprint lies within a partially developed area of the site. An existing administration block is located within the eastern part of the development footprint (refer Figure 2).

**Figure 2: View of proposed administration building footprint, looking south**

The ground surface generally falls to the south at slopes in the order of 5 to 10°.

An existing footpath is present within the development footprint, together with in-ground services (fire ring main, electricity cabling and irrigation lines).

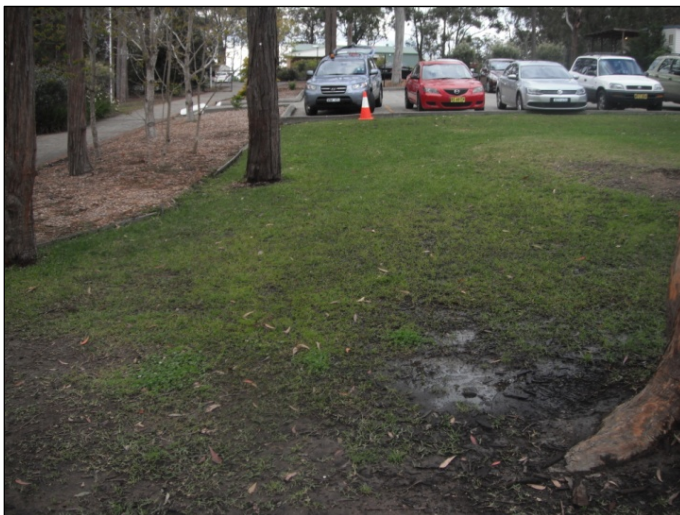
The ground surface within the south-western area of the proposed building footprint was damp at the time of investigation (refer Figure 3).

**Figure 3: Area of damp ground in south-western corner of proposed administration building footprint, looking south**

During the investigation it was noted that the ground surface was damp within the footprint of the proposed building. Based on discussion with school staff, it is understood that seepage regularly occurs within the area immediately upslope of, and within, the proposed administration building footprint.

To minimise the effects of fluctuations of moisture content within the reactive soils present at the site, it is recommended that a cut-off drain is constructed upslope of the proposed building to intersect surface and near surface water flows. The drain should be constructed to at least 0.6 m depth and include dual ag-line encapsulated in geofabric and surrounded by free draining gravel, with the upper 0.3 m of the trench excavation backfilled with low permeability clay soils, such as present at the site. The drains should convey the collected water into the formal stormwater collection system downslope of the proposed building development.

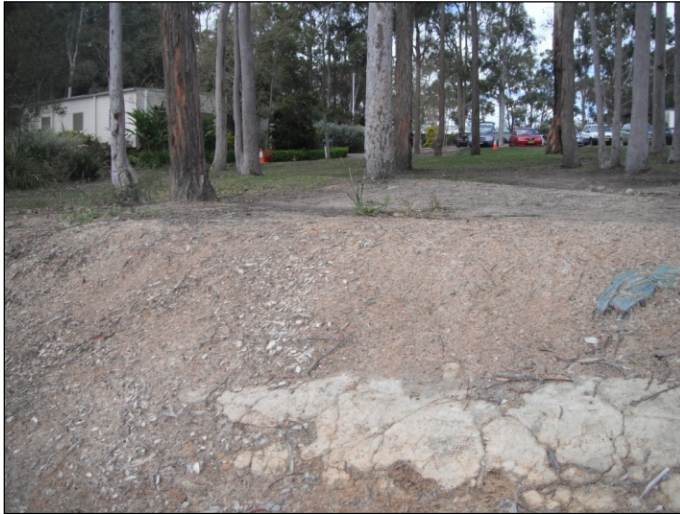
An existing cutting of approximately 2 m in height was located to the north of the proposed building footprint. Conditions exposed within this cutting included grey mottled orange residual clay (refer Figure 4).

**Figure 4: Existing cutting to the north of proposed administration building**

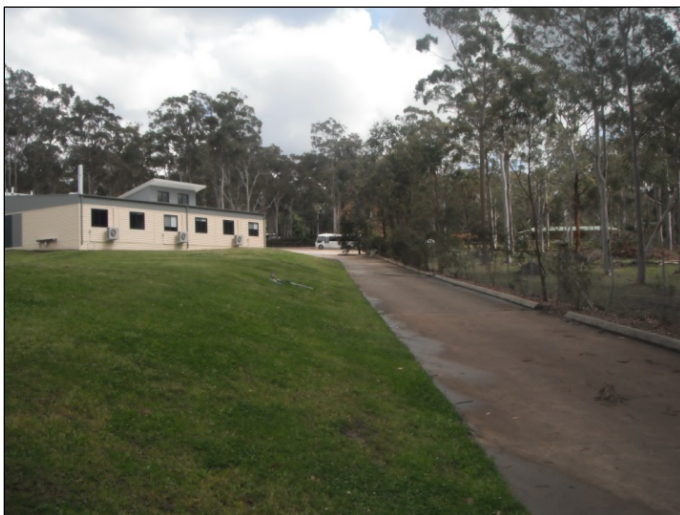
The proposed car parking area is located within the northern area of the school grounds. It lies within an embankment batter between an existing pavement and a flat, grassed area (refer Figure 5).

**Figure 5: Area of proposed car park**

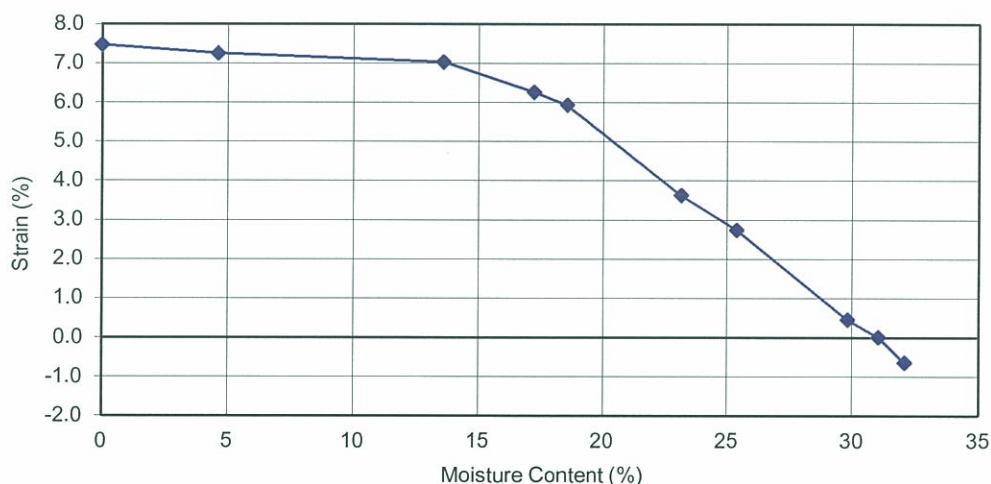
### SWELL TEST

Pocket penetrometer reading at initial moisture content	400 kPa
Pocket penetrometer reading at final moisture content	220 kPa
Initial Moisture Content	30.1 %
Final Moisture Content	32.1 %
Swell under 25kPa	0.7 %

### SHRINK-SWELL INDEX $I_{ss}$ 4.3% per $\Delta pF$

<b>Description:</b>	Silty CLAY - Grey brown mottled red
<b>Test Method(s):</b>	AS 1289.7.1.1, AS 1289.2.1.1
<b>Sampling Method(s):</b>	Sampled by Newcastle Engineering Department
<b>Extent of Cracking:</b>	<div>UC - Uncracked</div> <div>SC - Slightly cracked</div> <div>MC - Moderately cracked</div> <div>HC - Highly cracked</div> <div>FR - Fractured</div>

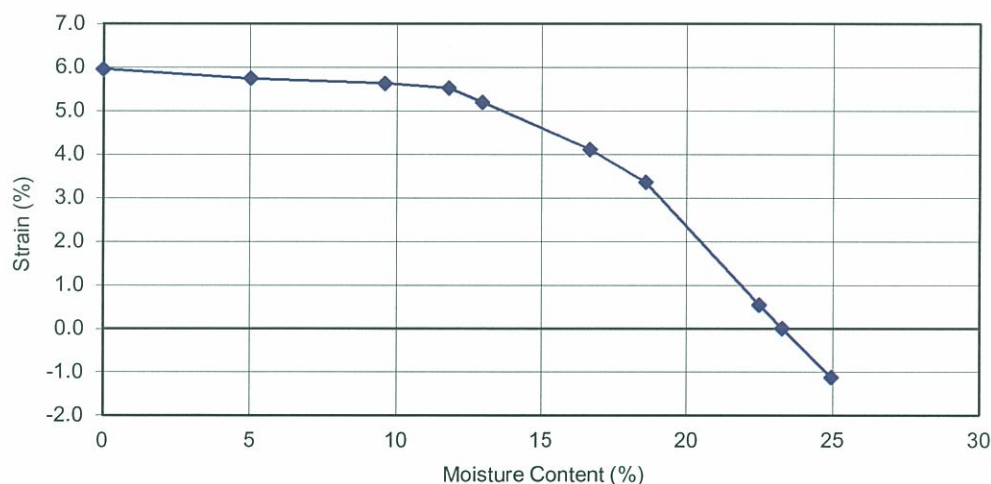
### SWELL TEST

Pocket penetrometer reading at initial moisture content	300 kPa
Pocket penetrometer reading at final moisture content	200 kPa
Initial Moisture Content	22.8 %
Final Moisture Content	24.9 %
Swell under 25kPa	1.1 %

### SHRINK-SWELL INDEX $I_{ss}$ 3.6% per $\Delta pF$

<b>Description:</b>	Silty CLAY - Grey brown
<b>Test Method(s):</b>	AS 1289.7.1.1, AS 1289.2.1.1
<b>Sampling Method(s):</b>	Sampled by Newcastle Engineering Department
<b>Extent of Cracking:</b>	<div>UC - Uncracked</div> <div>SC - Slightly cracked</div> <div>MC - Moderately cracked</div> <div>HC - Highly cracked</div> <div>FR - Fractured</div>

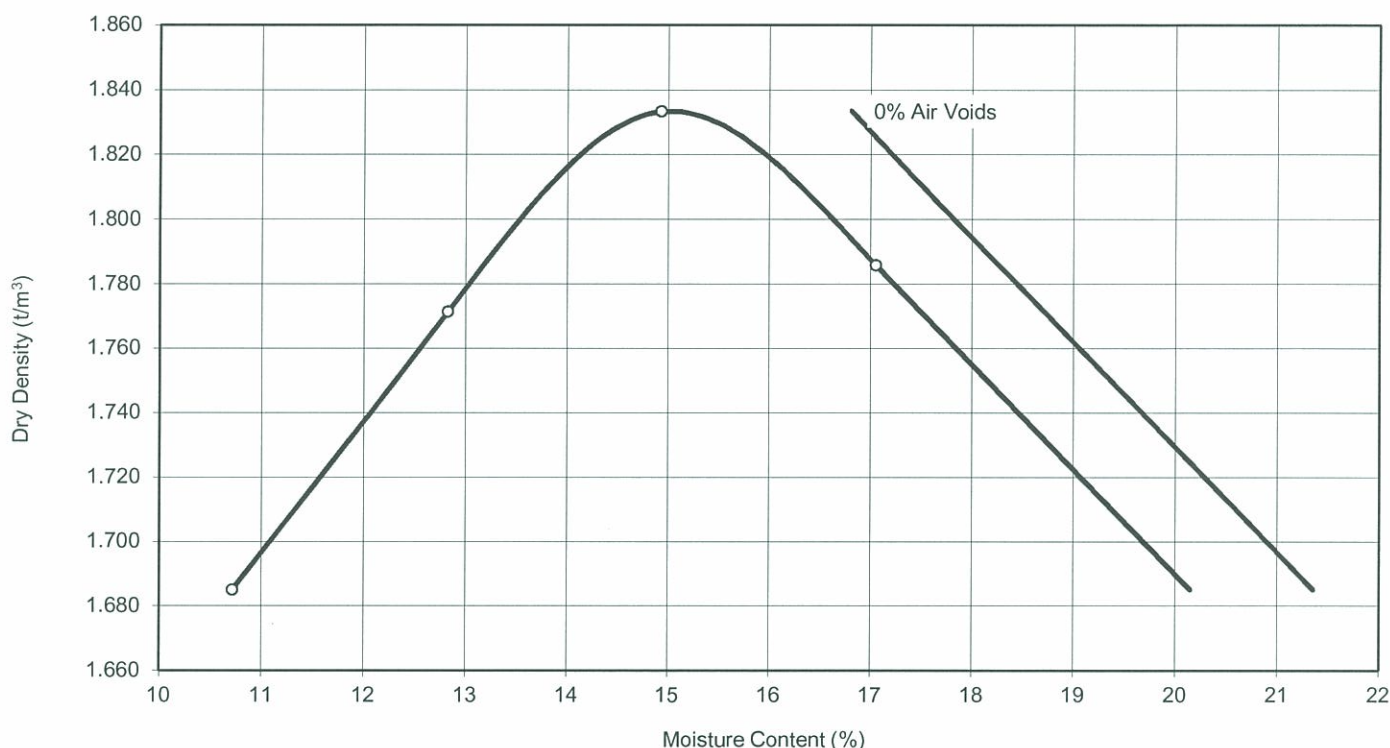
## Results of Compaction Test

**Sample Details:** Location: Bore 5  
Depth: 1.1 - 1.3m

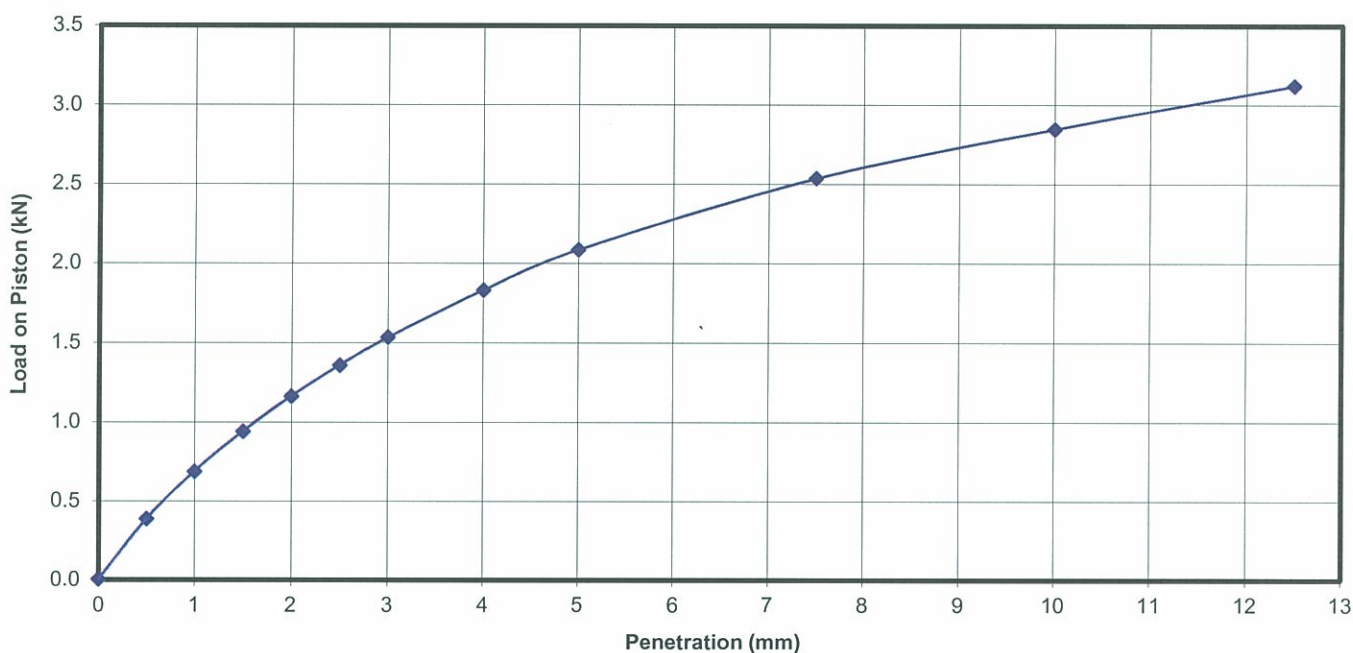
## Result of California Bearing Ratio Test

**Description:** Sandy Silty CLAY - Brown grey
