Report on
Geotechnical Investigation

Westfield Kotara, Stage 4 Redevelopment
Northcott Drive, Kotara

Prepared for
Scentre Group Ltd

Project 71995.07
July 2016

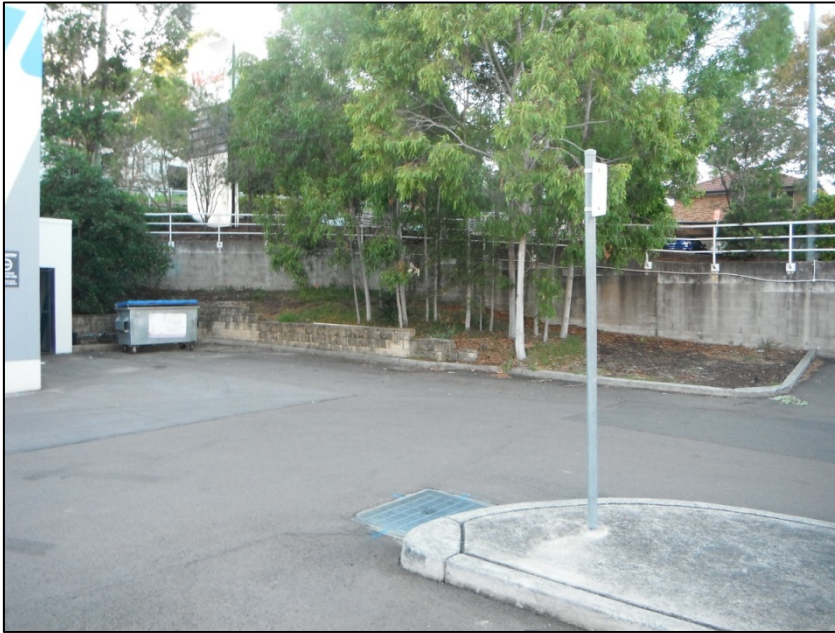
An existing concrete block retaining wall is visible within this area and is about 2 m in height with a further block wall of about 1.2 m in height located below and to the north (refer Figure 2).

Figure 2: Looking towards south east retaining wall

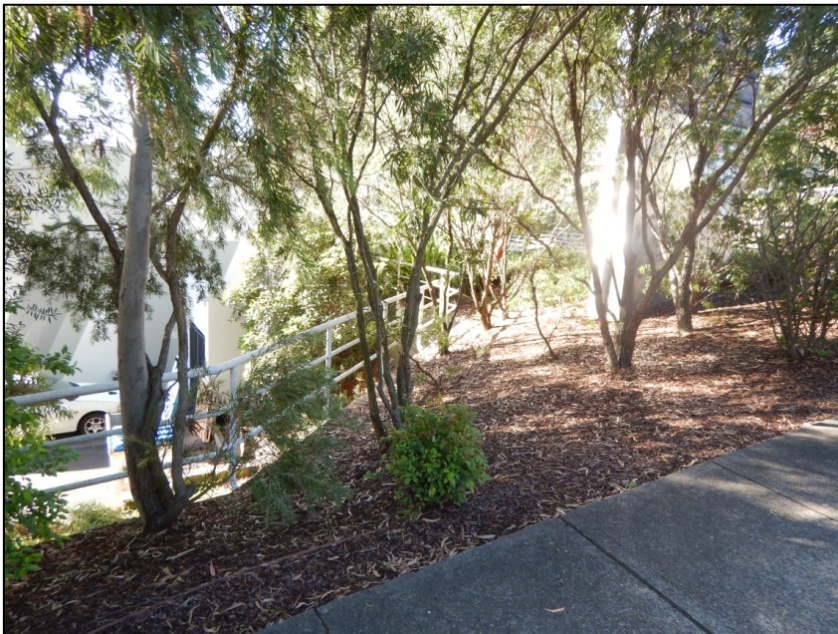
The area behind the retaining wall is generally covered with shrubs and several mature trees (landscaped garden) as shown in Figure 3 below.

Figure 3: Area behind existing retaining wall

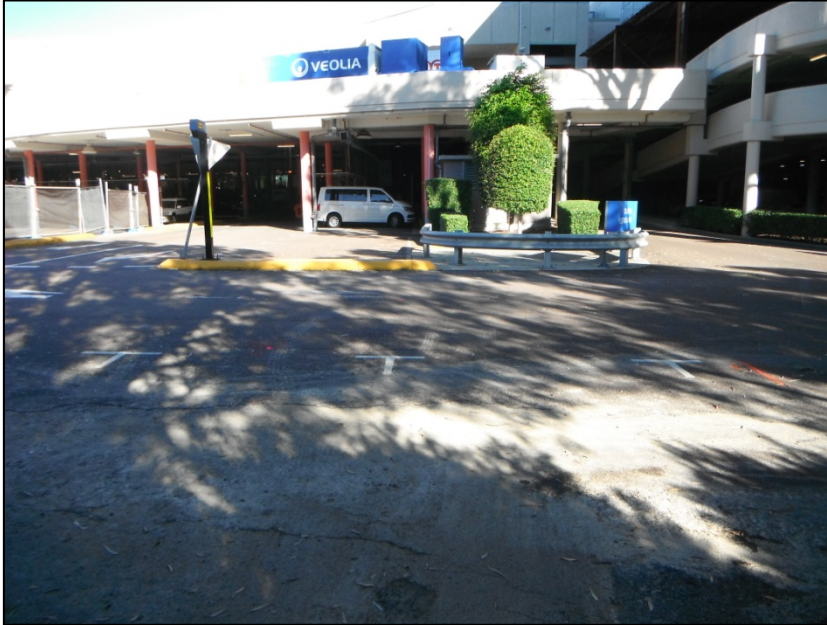
At the time of investigation the “Red Zone” comprised an uncovered, ground level car park, which was surfaced with asphalt (refer Figure 4). Site slopes generally fall to the west at approximately 1° to 3°. Surrounding slopes are generally to the north and west towards Park Avenue.

Figure 4: Looking south-west from Bore 108 in “Red Zone”

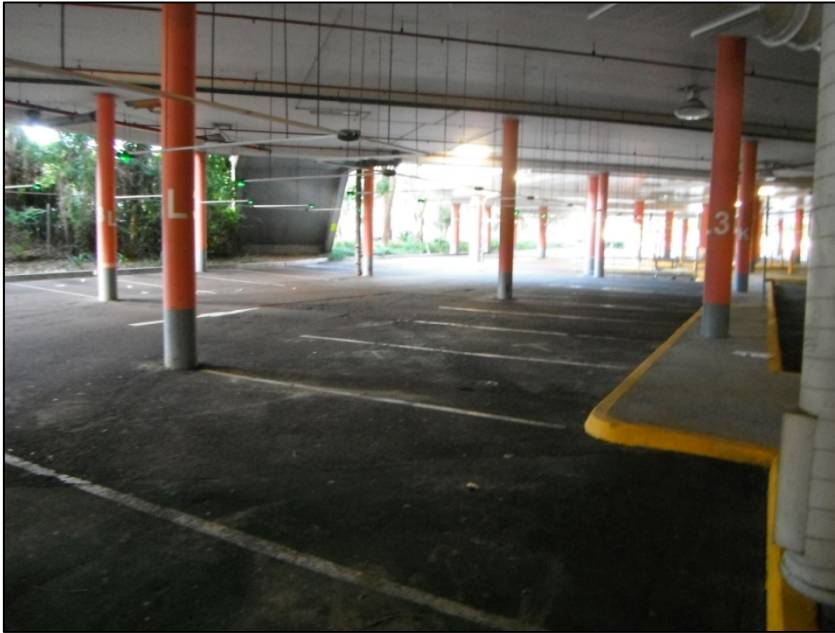
The “Green Zone” comprises a covered car parking area. The area is characterised by traffic isles or lanes around several strips of double car parking spaces. Concrete columns are present throughout the area at regular spacing. The ground surface generally falls to the west at slopes of less than 5°. The head height to the overlying first floor slab ranges from about 3.7 m to greater than 6 m (refer Figure 5 and Figure 6).

Figure 5: Looking south at test location 104

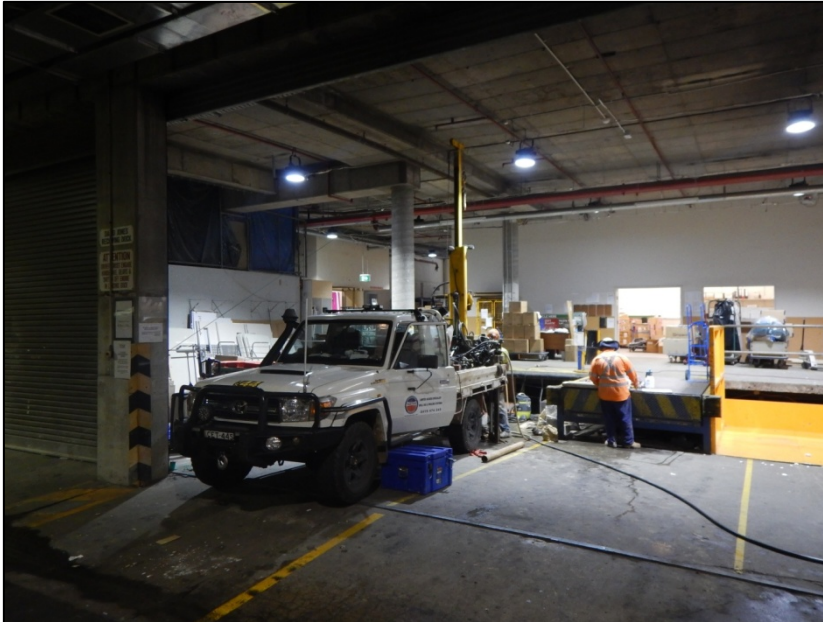
The proposed shear walls will be located within the area currently being occupied by the David Jones loading dock (refer Figure 7).

Figure 7: General area of David Jones loading dock (Drilling rig at Bore 302 location). New shear wall will be located to the rear of the raised area

The head room within the area of proposed development is understood to vary from about 4 m to 5.2 m. A number of existing services (ducting, electrical and water) are located immediately below the concrete floor slab of the overlying floor level (refer Figure 7).

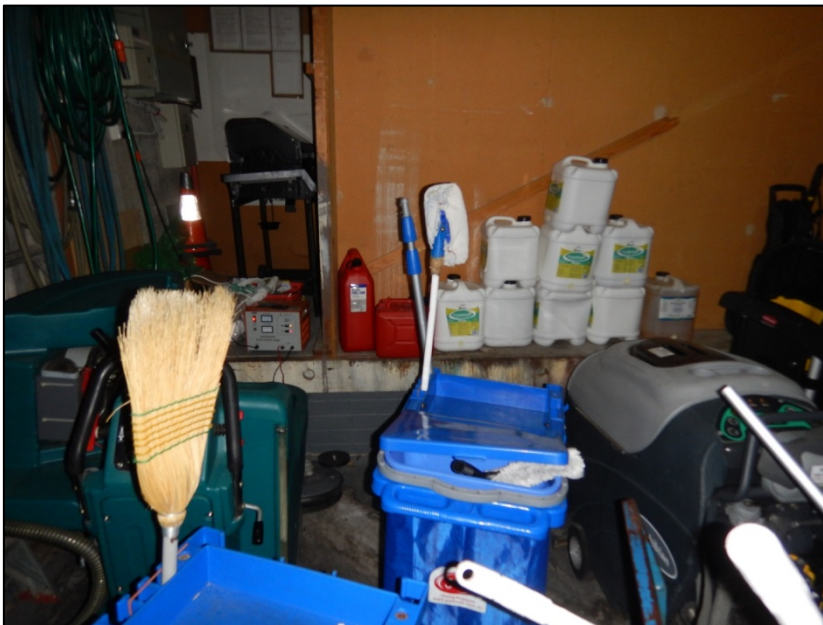
The new hoist will be located in an area currently being used as a cleaners store room (refer Figure 8).

Figure 8: General view of cleaners storeroom where new hoist will be located

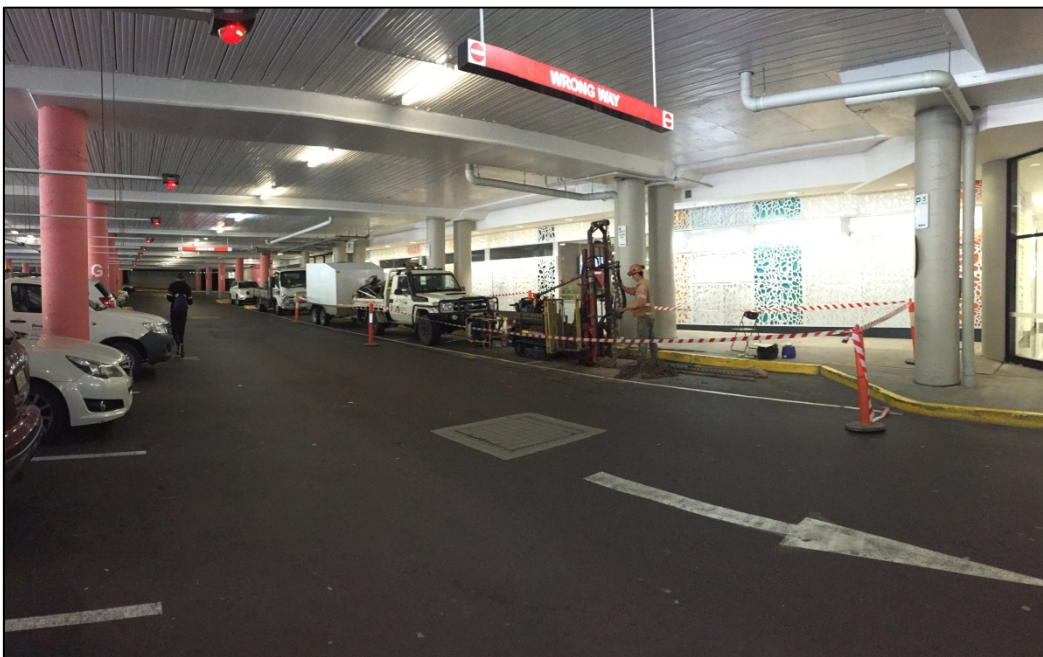
The new Block 15 lift pit will be located in the southern area of the shopping centre site (refer Figure 1). It is within the undercover car parking area and positioned within a lay-by area off the main vehicle accessway (refer Figure 9). The head room in this area is in the order of 3.5 m.

Figure 9: Looking south west towards bore location 201

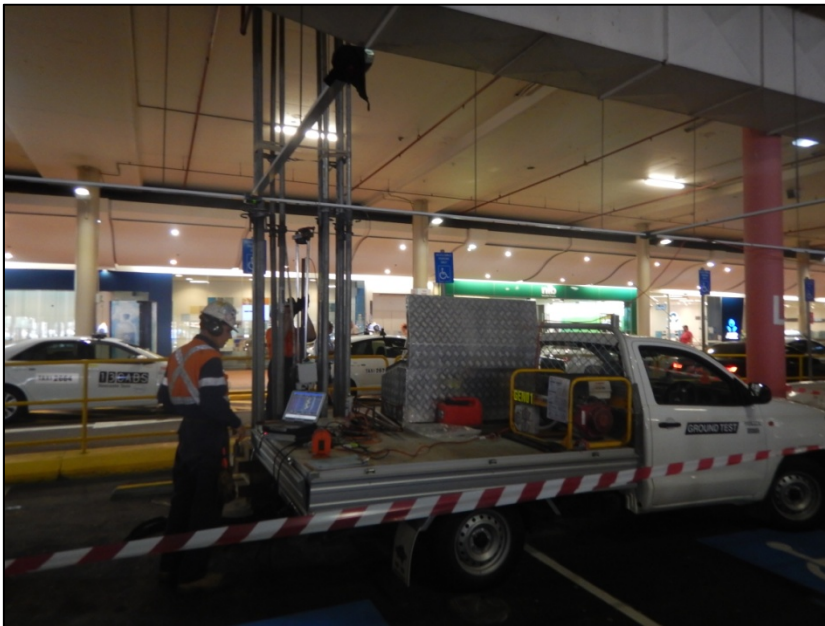
The CPTs were conducted using a portable purpose built CPT rig. A 35 mm diameter instrumented cone and friction sleeve assembly was hydraulically thrust into the soil at a rate of 2 cm / sec using the overlying floor slab for resistance (refer Figure 10).

Figure 10: Typical set up of portable CPT equipment

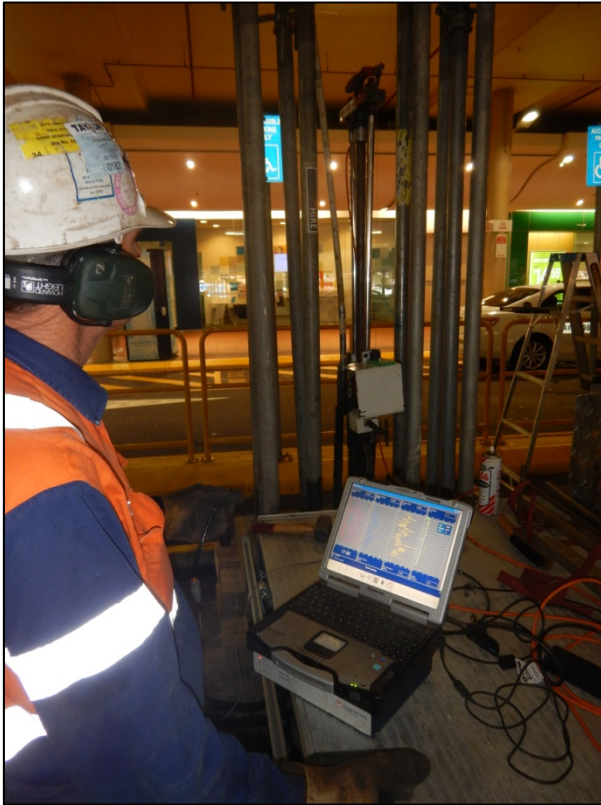
Cone tip resistance and sleeve friction were recorded by a computer data acquisition system for subsequent plotting and analysis (refer Figure 11). The remnant CPT holes were dipped to measure the depth to water or hole collapse.

Figure 11: Capture of CPT investigation data

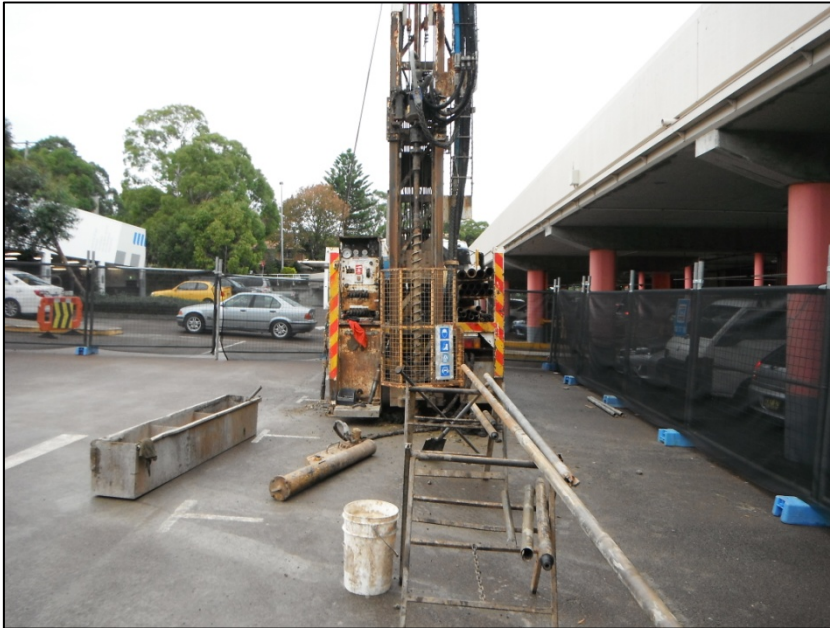
Bores were drilled at CPT locations 101, 102 and 104 within the “Green Zone” and Bores 106 to 108, located within the “Red Zone”. The bores were drilled to depths ranging from 16.71 m to 24.1 using either a small 4WD mounted drilling rig (“Green Zone”) or truck mounted drilling rig (“Red Zone”) [refer Figure 12].

Figure 12: Truck mounted drilling rig at Bore 107

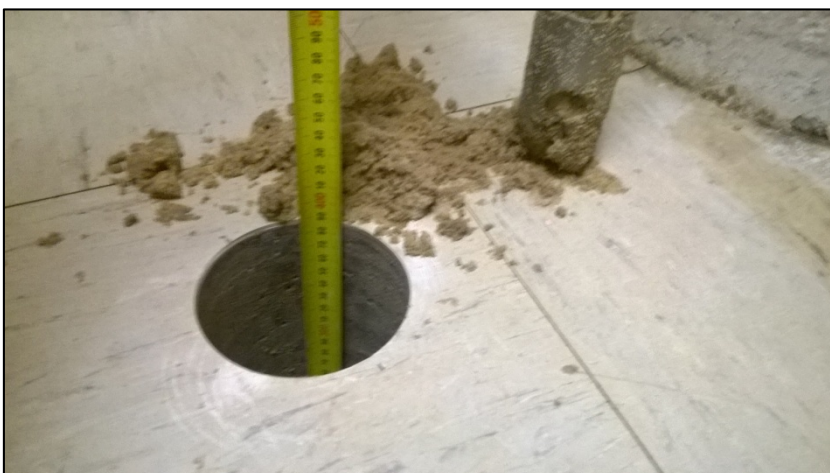
Figure 14: Location of Core 601 (Darrell Lea Storeroom). Note column EE/34-35 in top right hand corner

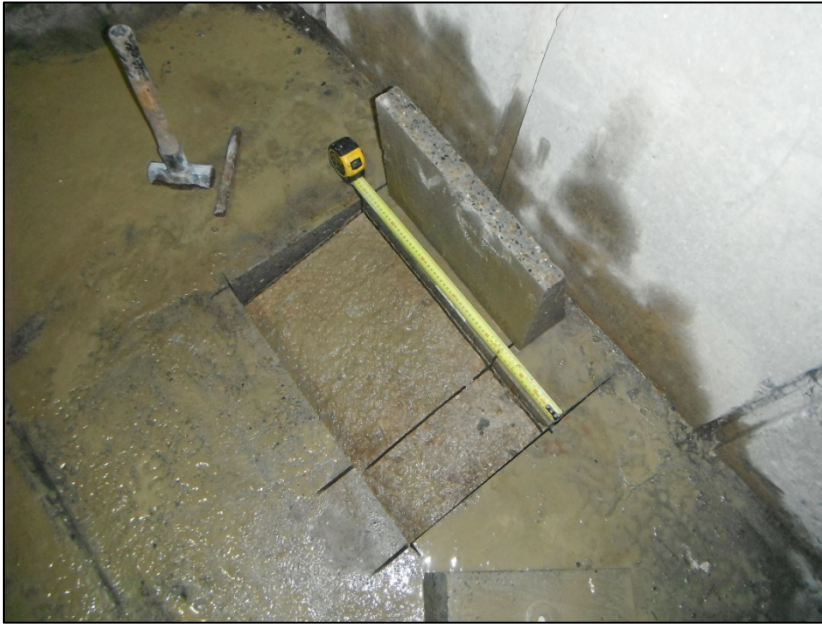
Figure 15: Location of Core/Saw 603. Note apparent footing below initial thin slab

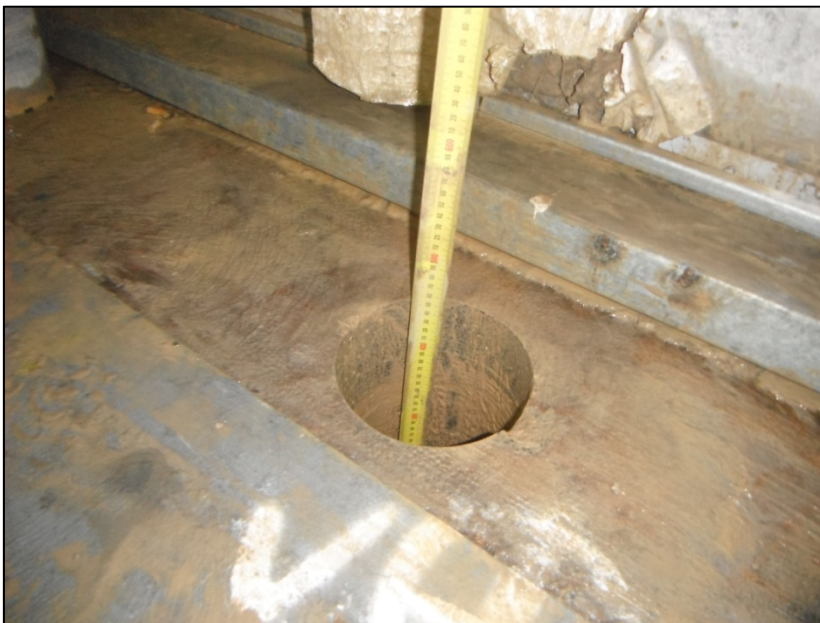
Figure 16: Location of Core 604

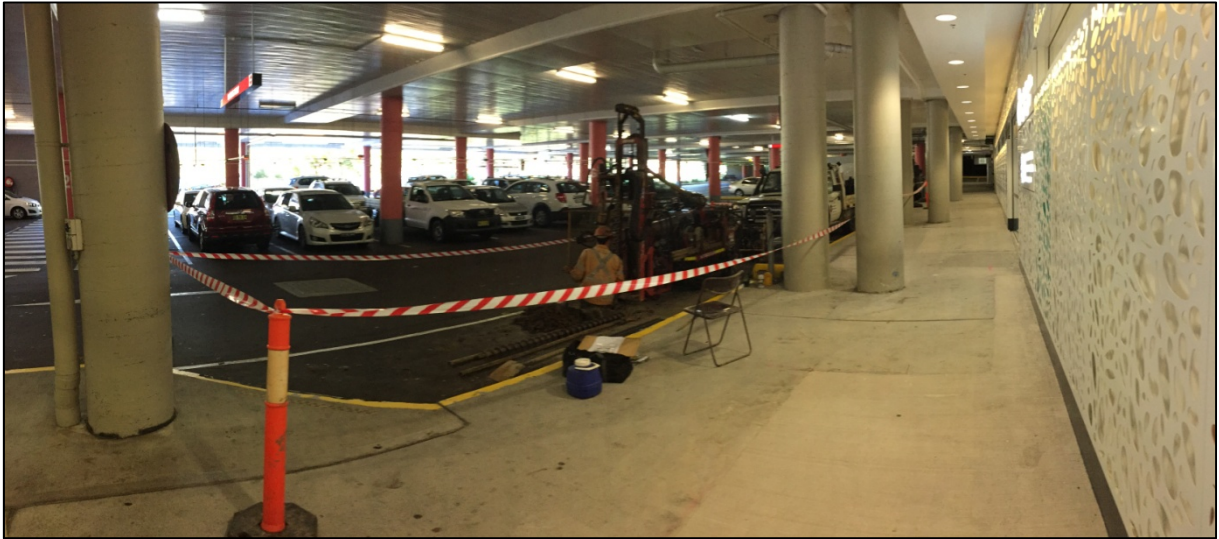
A single bore (Bore 201) was drilled to a depth of 7.95 m using a buggy mounted low head height investigation rig fitted with solid flight augers (refer Figure 17).

Figure 17: Location of Bore 201

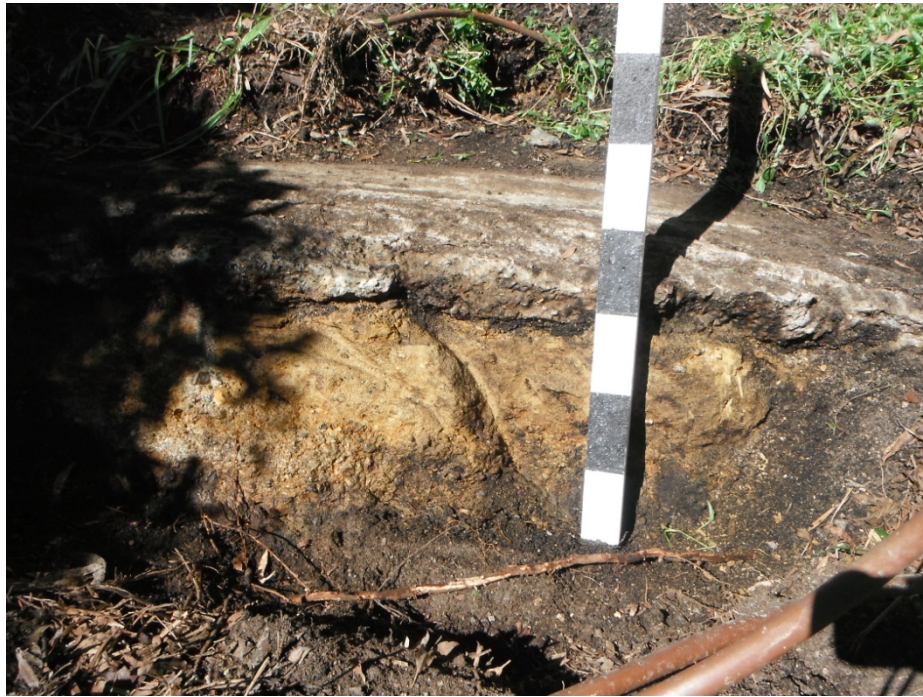
Photo 1: Pit 402/1

Pits 402/1 to 402/3 were excavated using hand tools and exposed bedrock to the rear of the lower retaining wall. The exposed conditions were logged by a geotechnical engineer. Photos of the test pits are attached on Plates 7 and 8 in Appendix B.

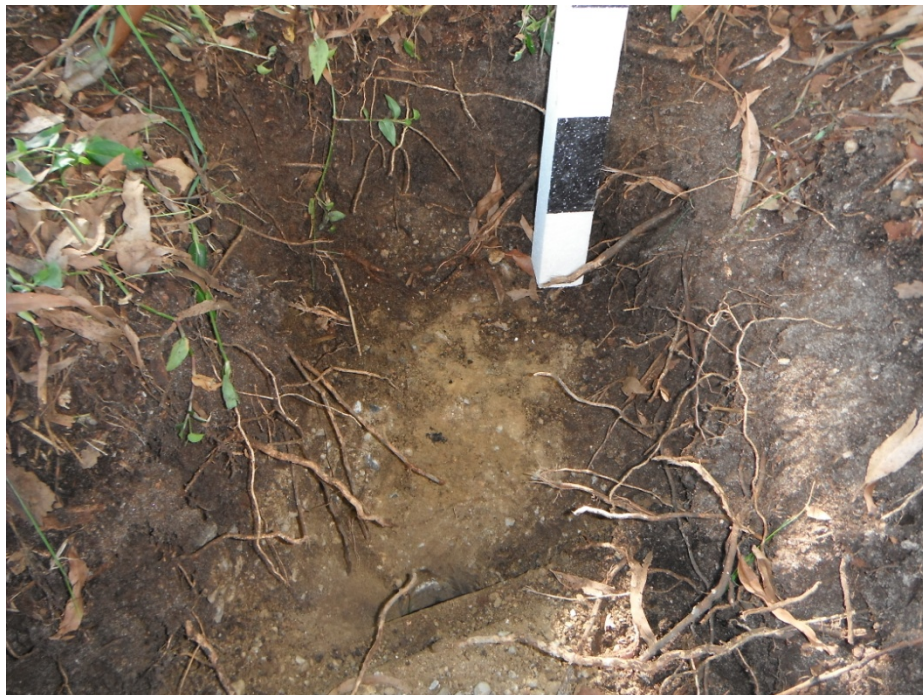
Photo 2: Pit 402/2

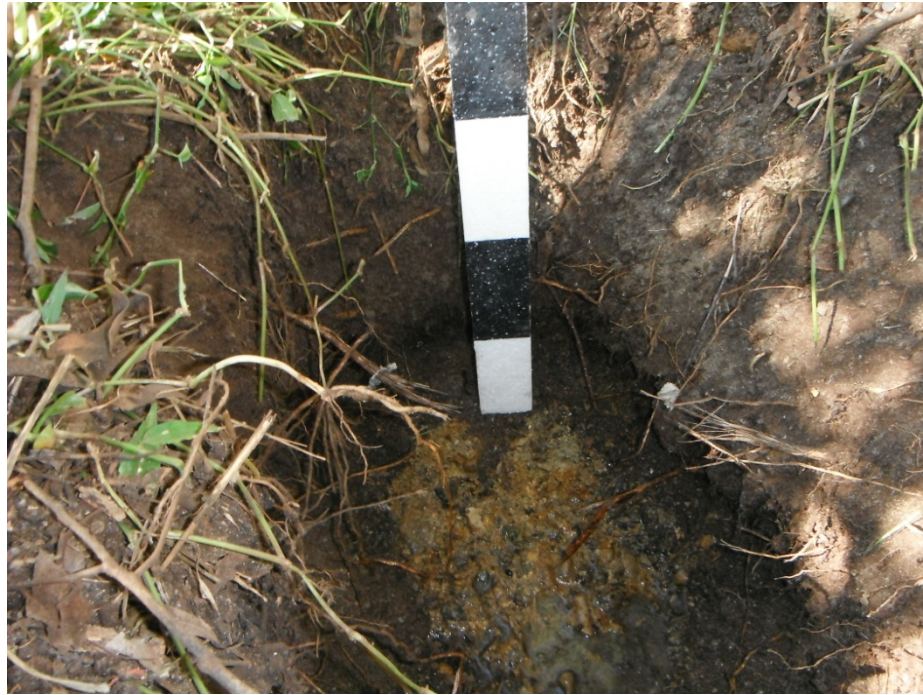
Photo 3: Pit 402/3

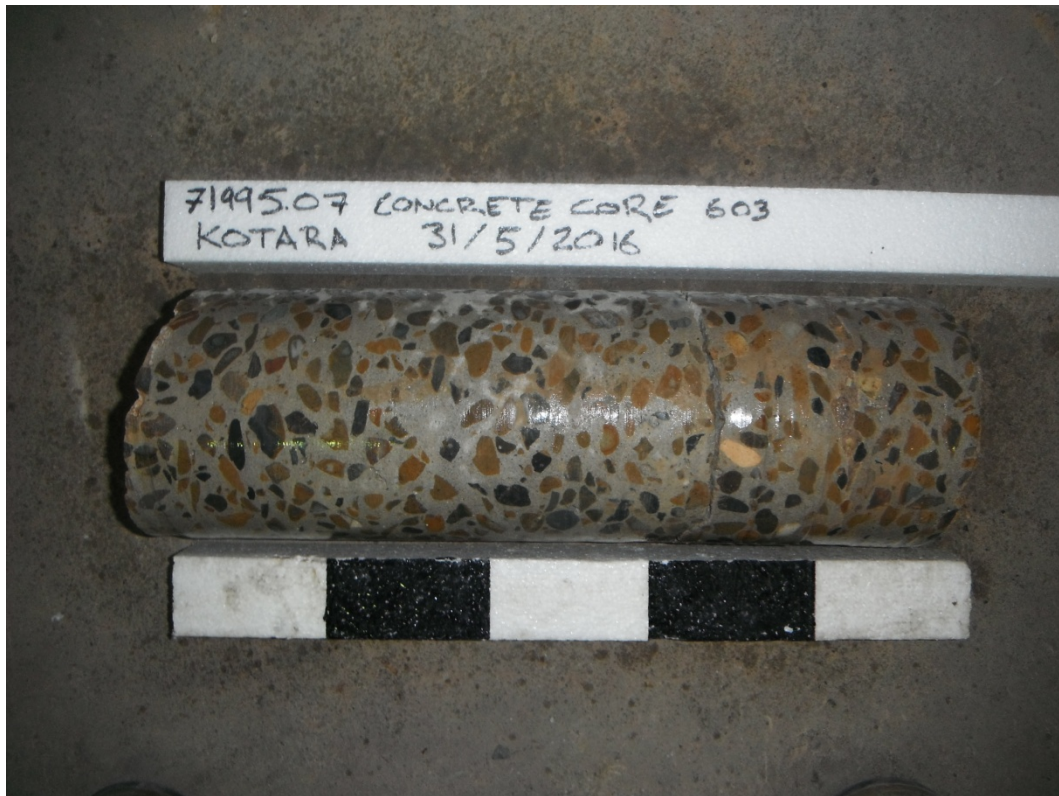
Photo 1: Concrete core from Bore 603

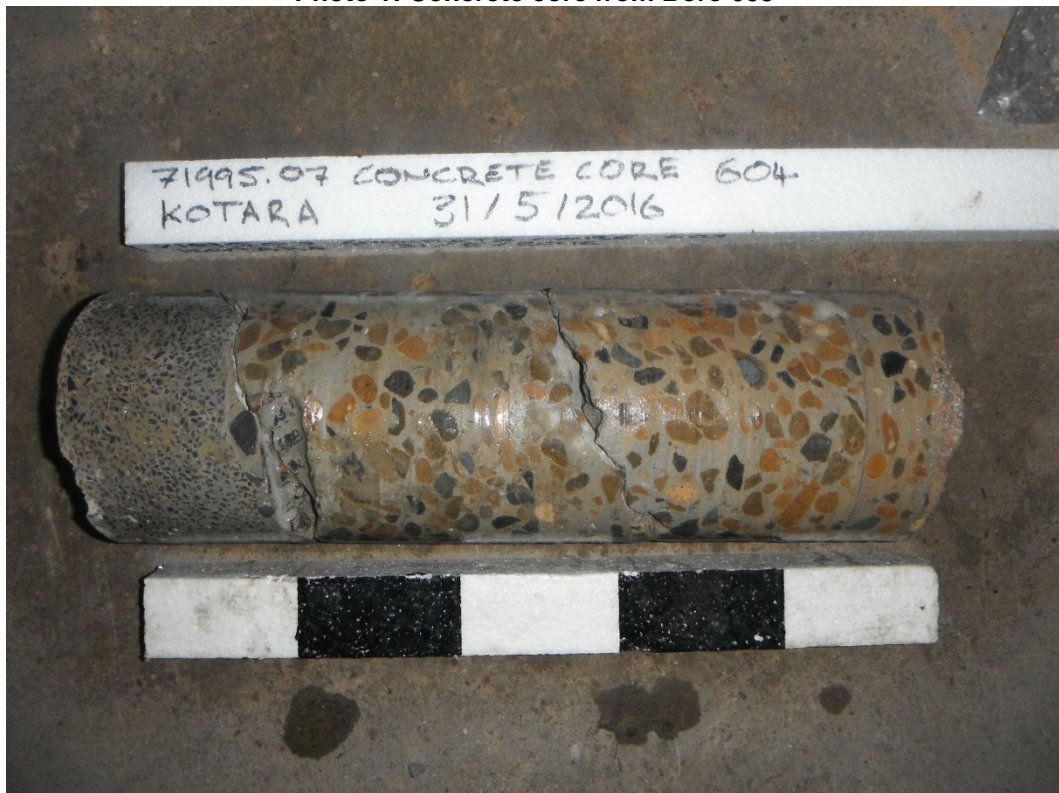
Photo 2: Concrete core from Bore 604
