Rothbury Country Resort Development Preliminary Archaeological Survey

Visual Impact Assessment

STORMWATER MANAGEMENT PLAN

At
**Lots 2 - 4 DP 869651 and Lot 11 DP 1187663
Wine Country Drive, Rothbury**

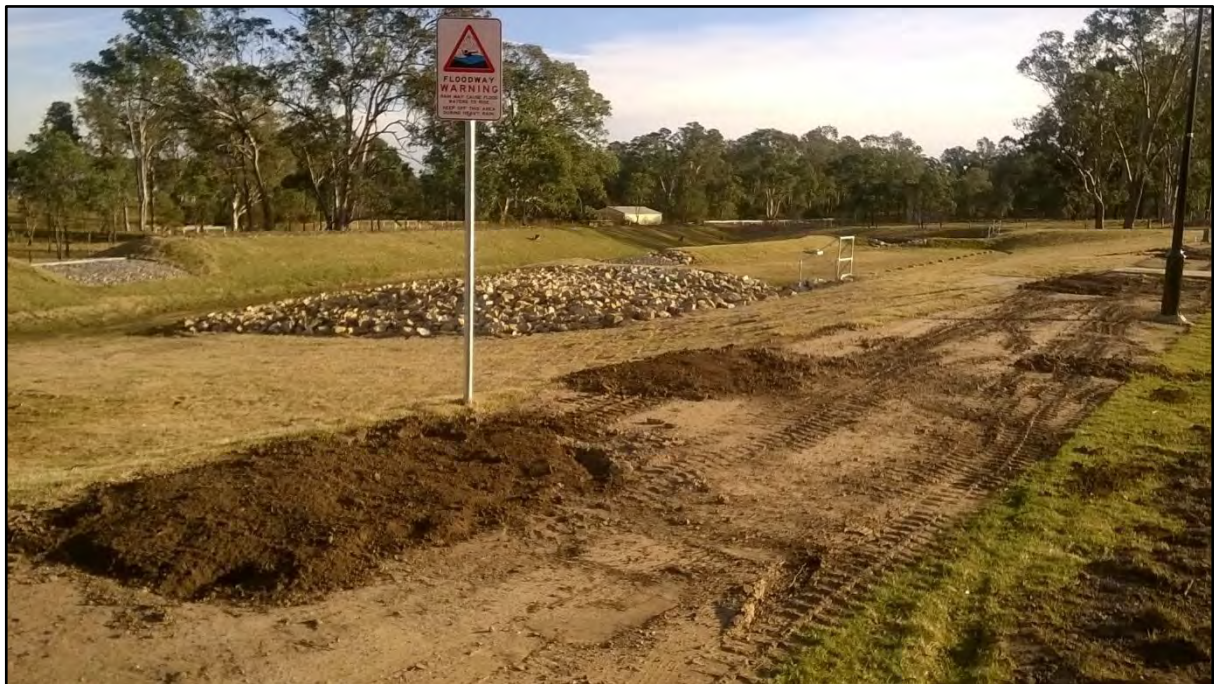
Figure 4: Typical bio-retention/detention basin
Source: HDB Town Planning & Design - June 2016

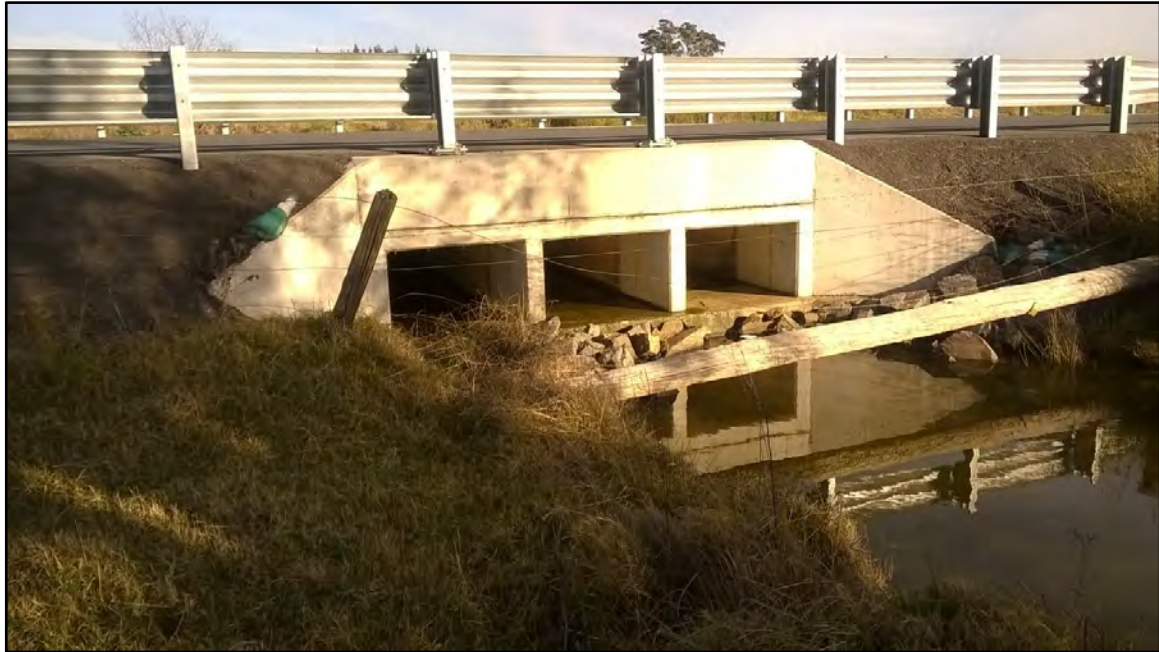
Figure 5: Existing culvert under Wine Country Drive

The existing catchment that contributes to the watercourse that traverses the site in the north (Watercourse "A"), was modelled using a single catchment with a base flow determined from the Martens Flood Assessment for the 'Vintage'. The study identified several sub-catchments which ultimately arrive at the triple culvert that conveys the water under Wine Country Drive and onto the subject land.

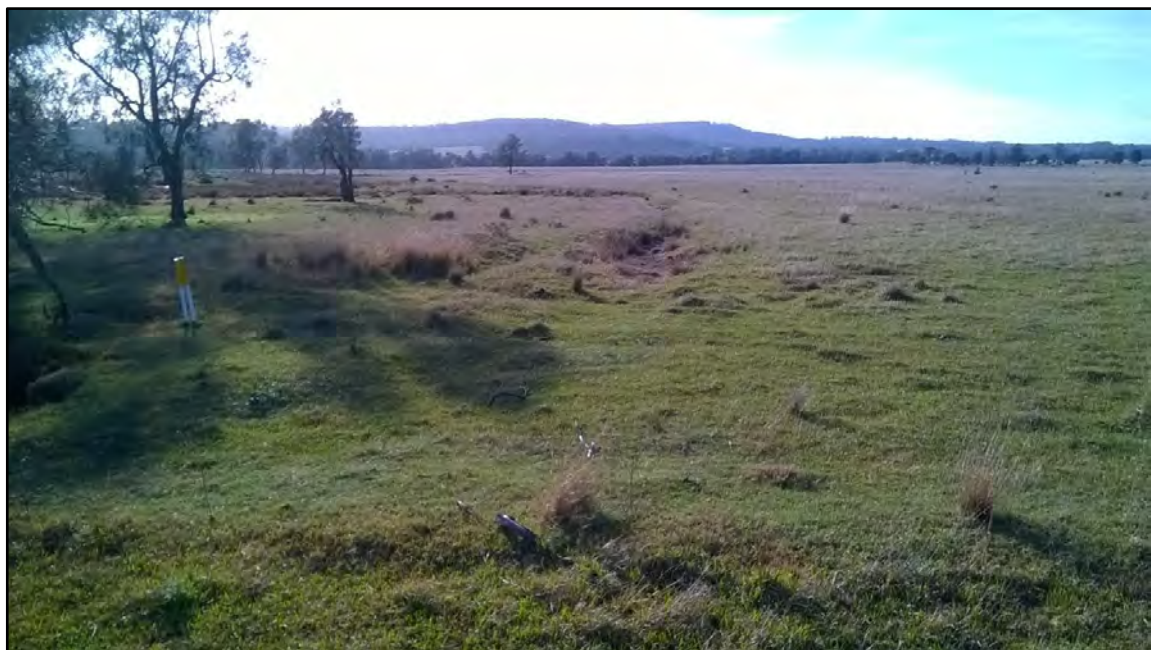
Figure 6: View of watercourse "A" looking down-stream

The purpose of the model was to confirm visual inspection and assessment that the existing watercourse is inadequate for the anticipated flows from the road culvert and to estimate a formalised channel that will form part of later Development Applications. Flat grades, and only a small defined channel at the outlet, will cause overtopping and disperse most of the flow, resulting in sheet flow over a broad area.

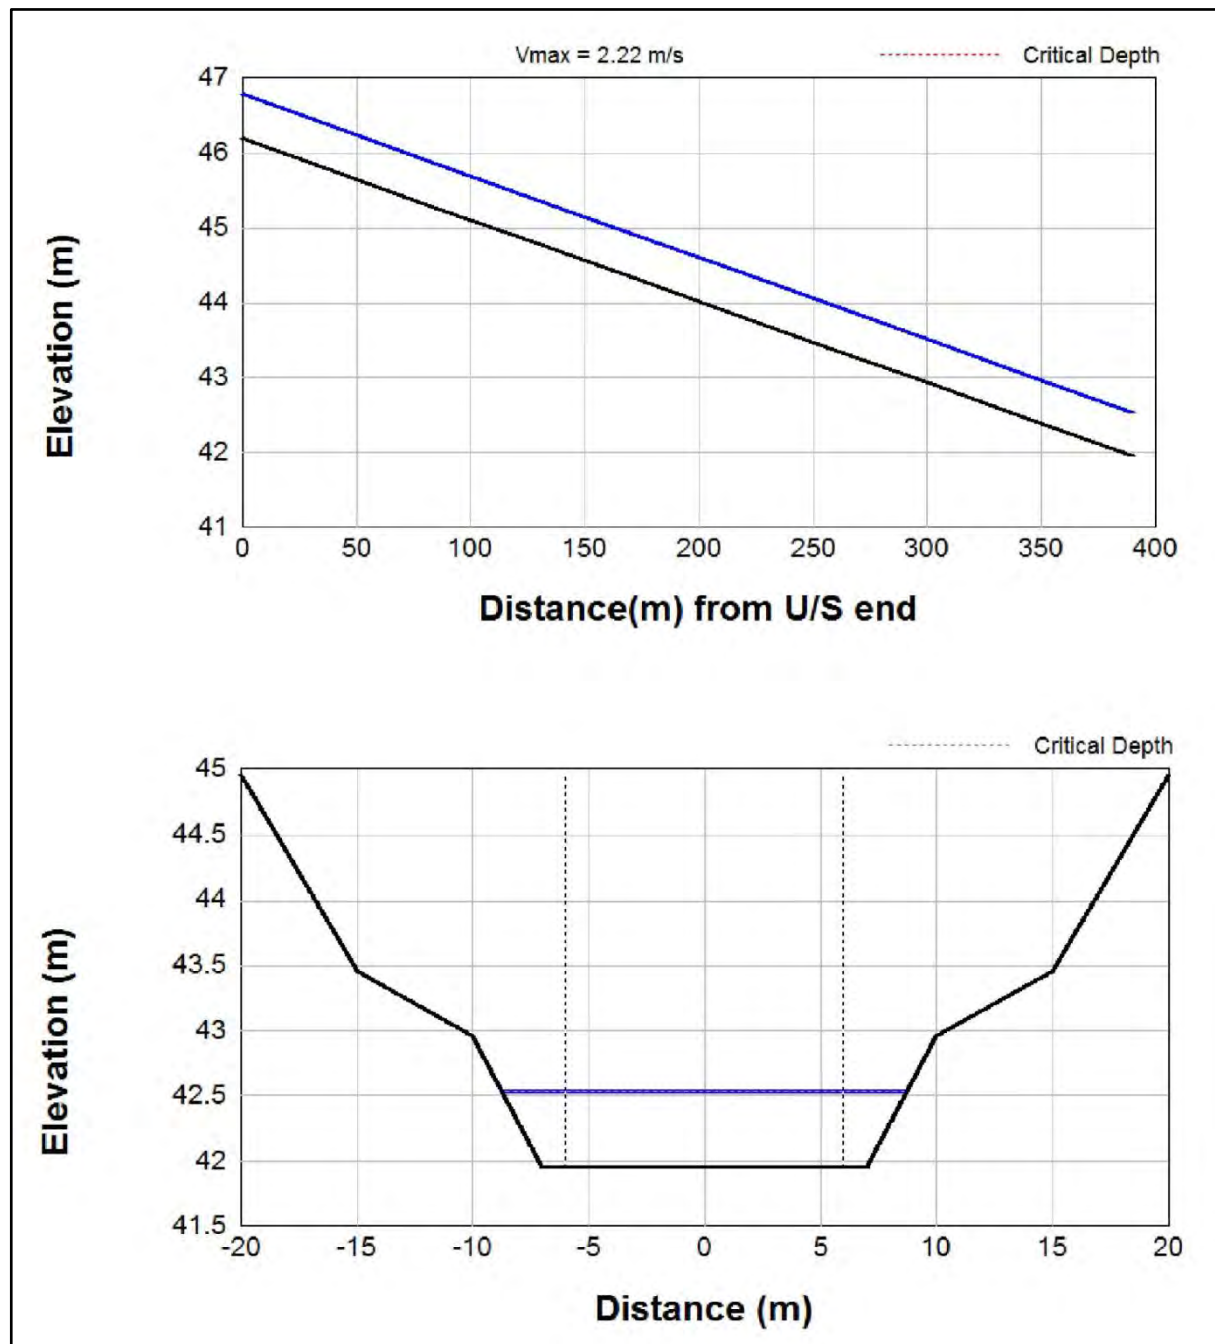
Figure 7: DRAINS model output of proposed watercourse "A" upgrade

It is however intended, at the design stage, to reshape, consolidate and formalise a 'natural' man made stream that can adequately cater for the anticipated flows through the site. This will not only form an aesthetically pleasing and challenging feature to the Golf Course, it will facilitate the safe flow of water during storms and flood events. Bridges made from reinforced concrete culverts will allow safe and flood-free access to the residential community.

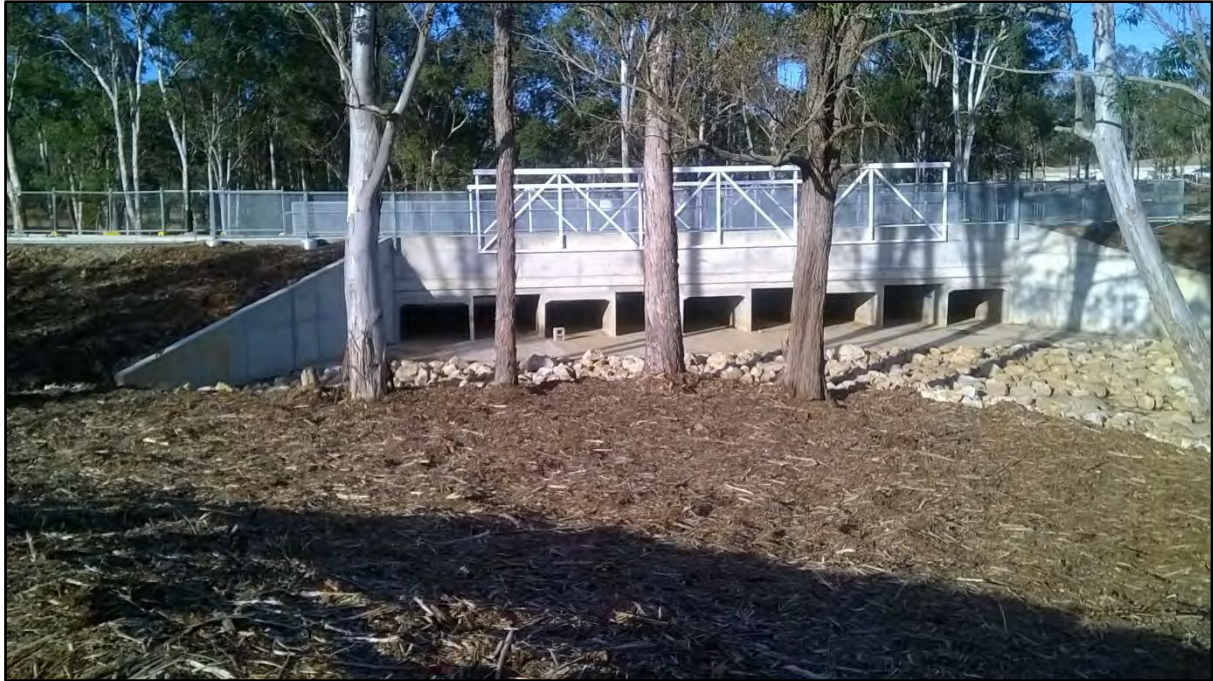
Figure 8: Typical road-bridge over watercourse
Source: HDB Town Planning & Design - June 2016
