2016SYE074 – 36A Gerrale Street and 6R The Esplanade,
Cronulla

DA16/0834

ASSESSMENT REPORT APPENDICES

CRONULLA SURF LIFE SAVING CLUB

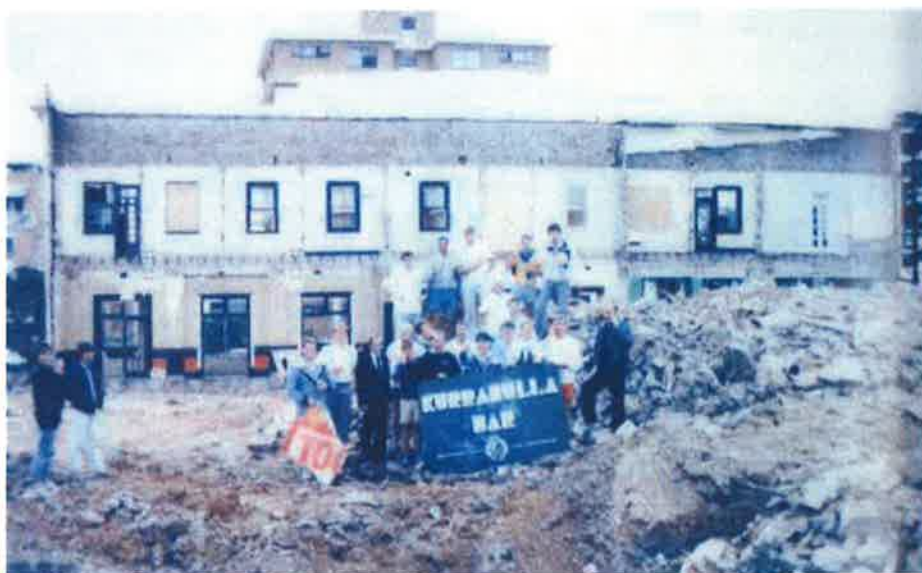
Figure 2.19 | 1988

Cronulla North Surf Lifesaving Club demolition
during extensions

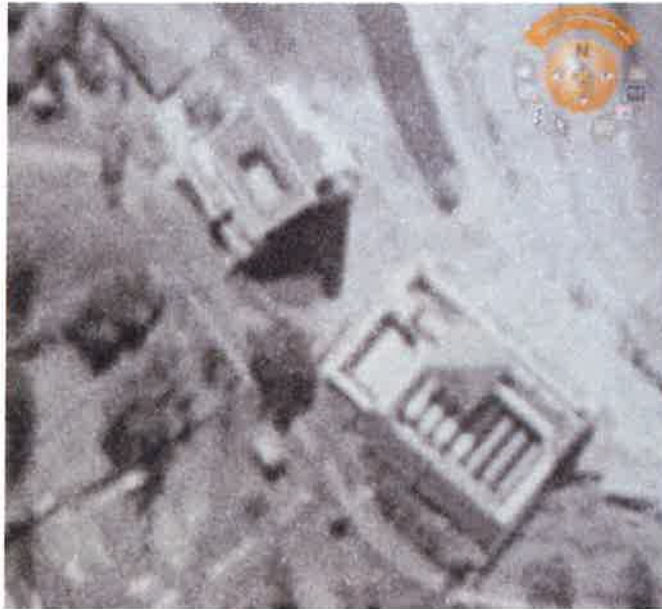
Figure 2.20

Aerial Photo indicating original Cronulla Beach South clubhouse footprint

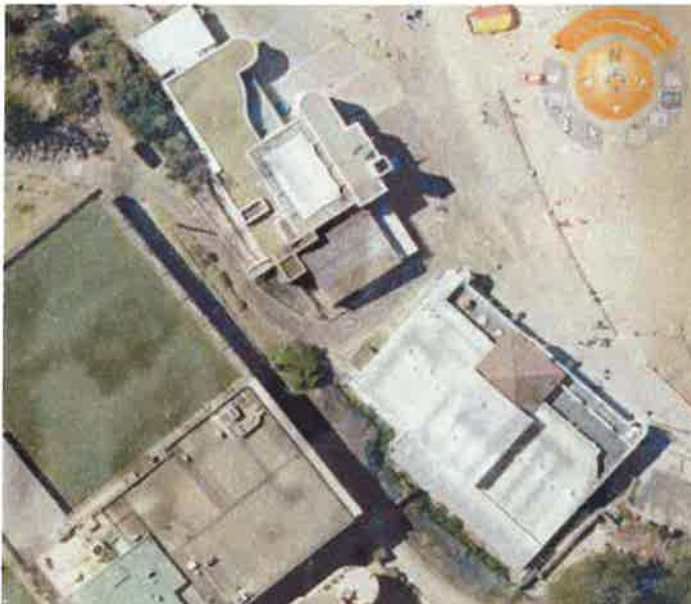
Figure 2.21

Aerial Photo of Cronulla Beach South clubhouse current footprint which has doubled in size

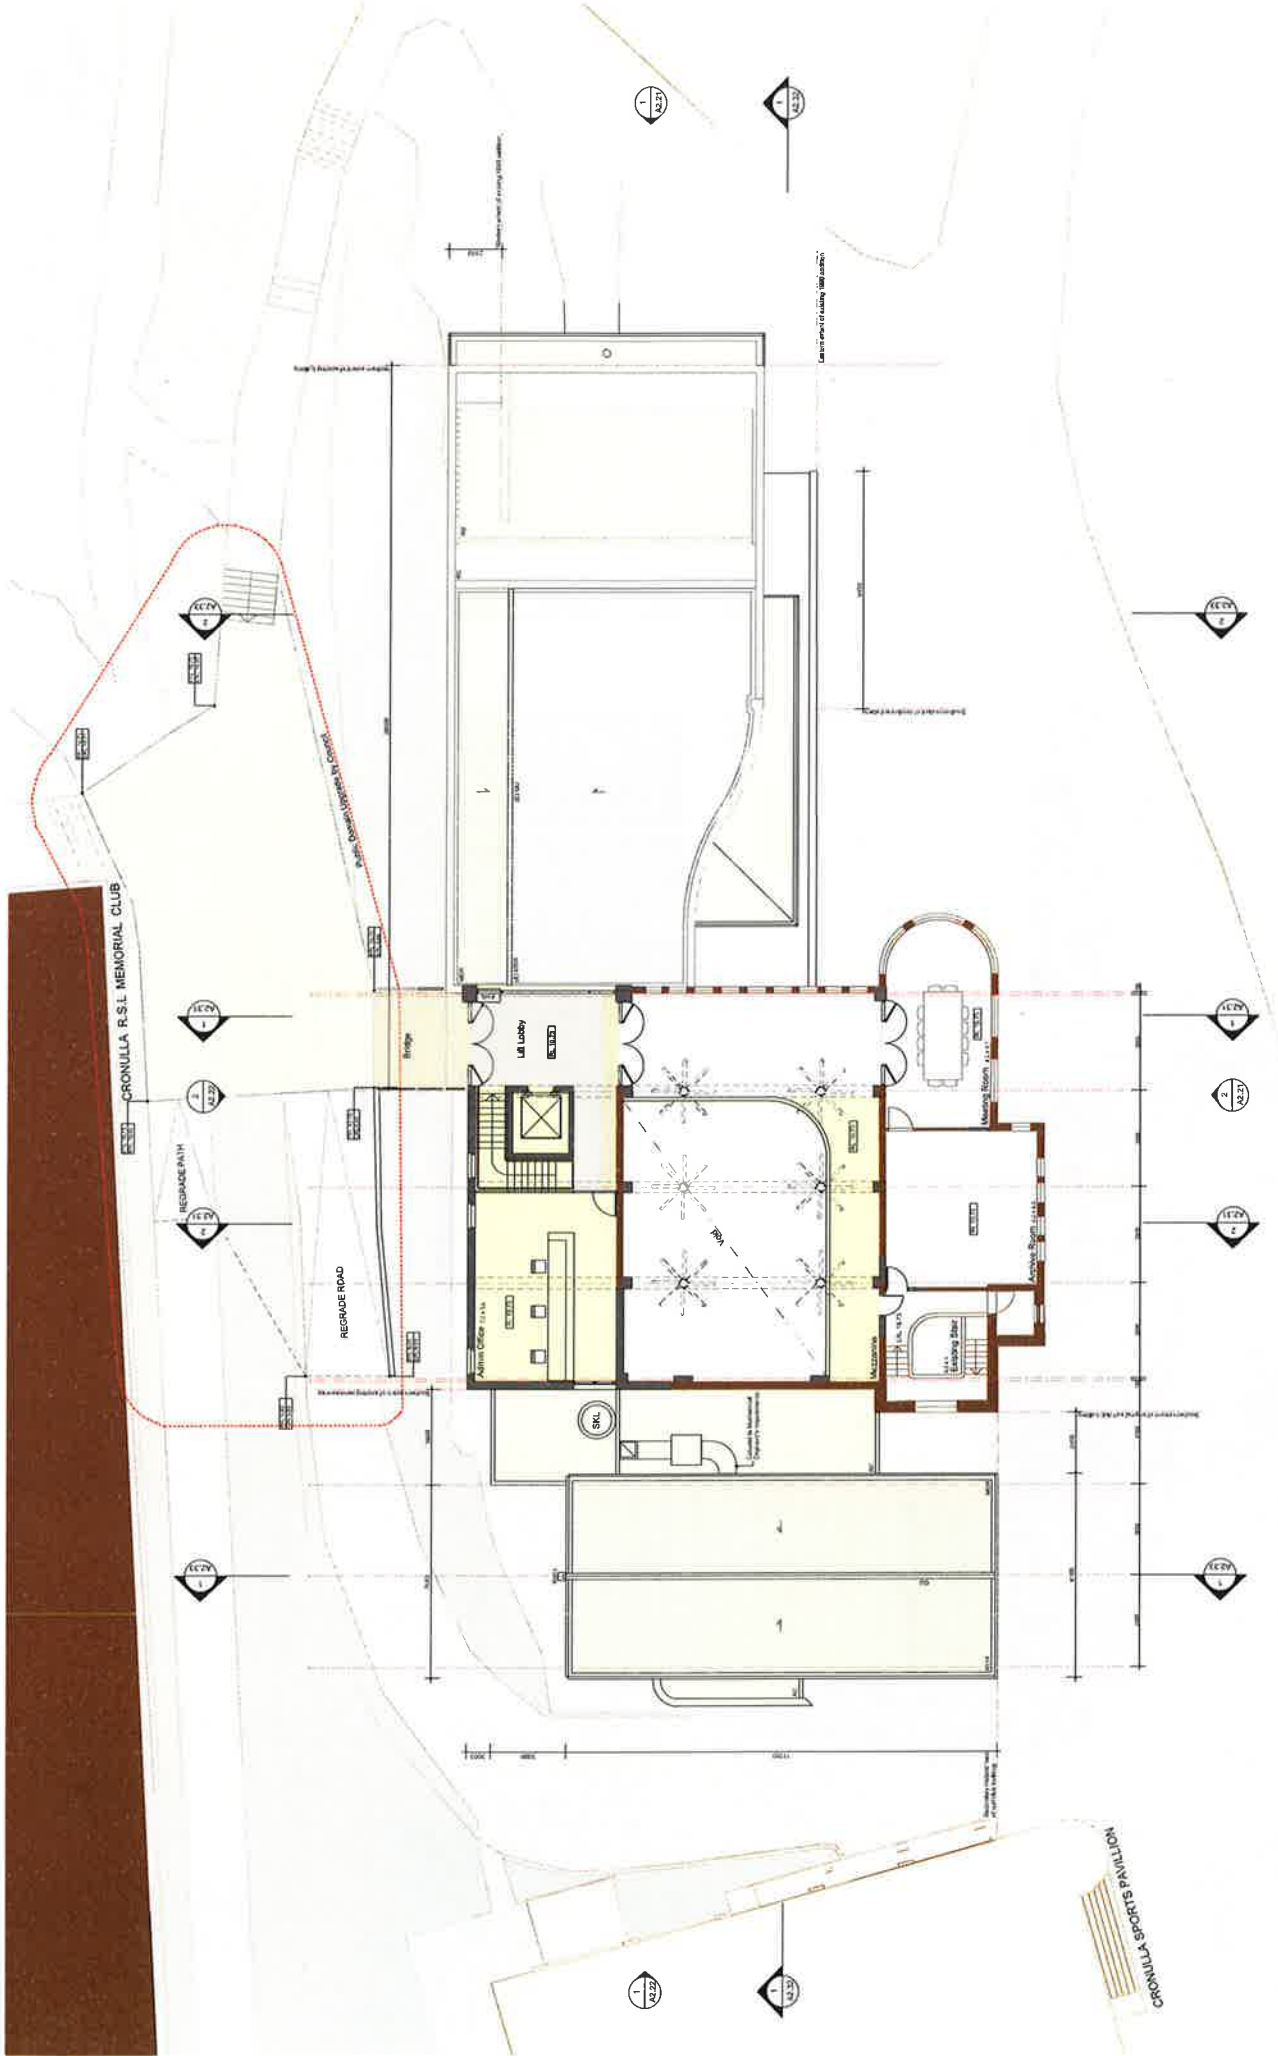
1 Second Floor Plan
1:100 @ A1

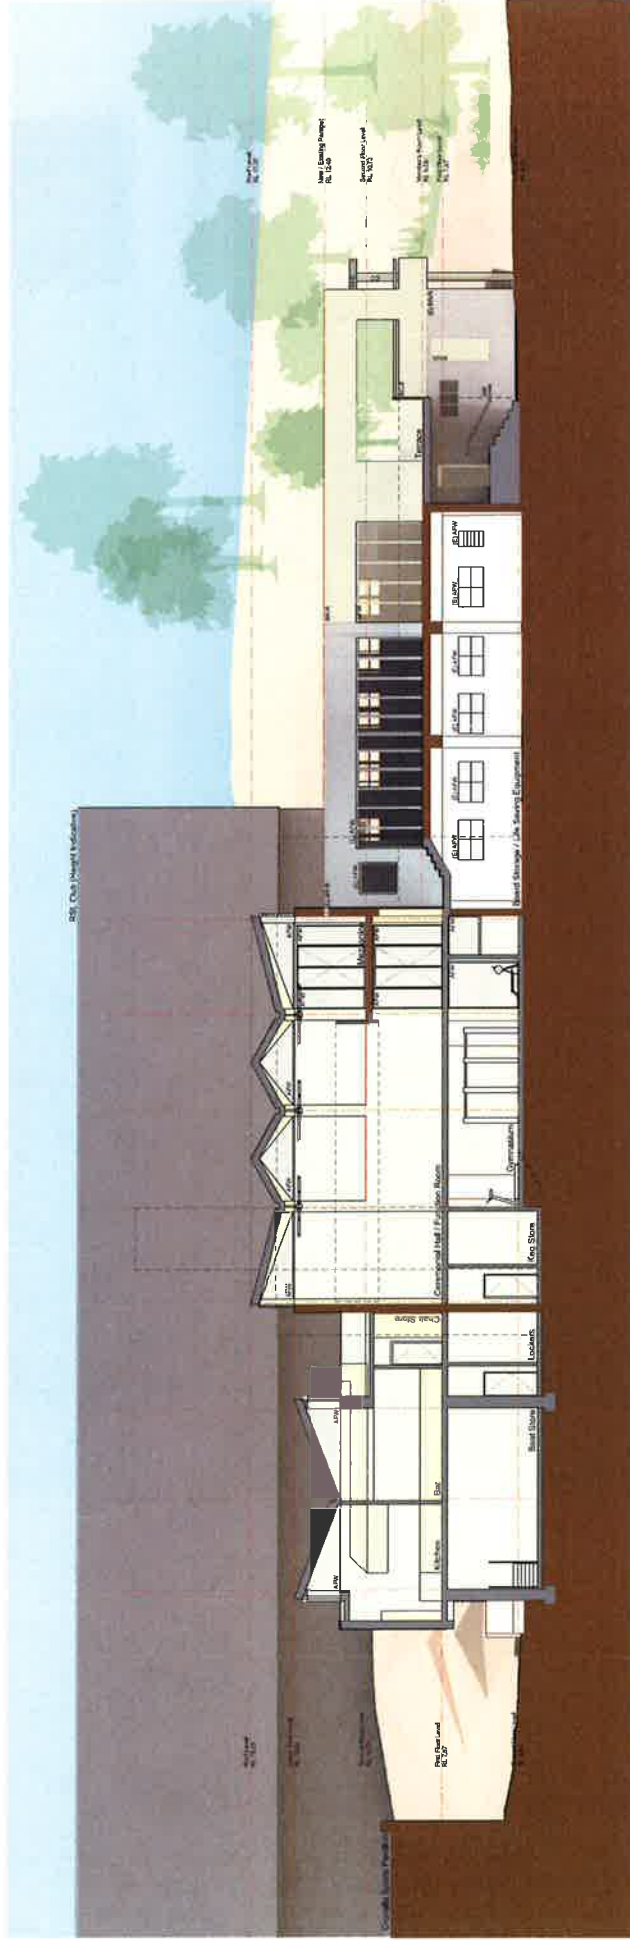
1 Section Through Hall
1:100 @ A1

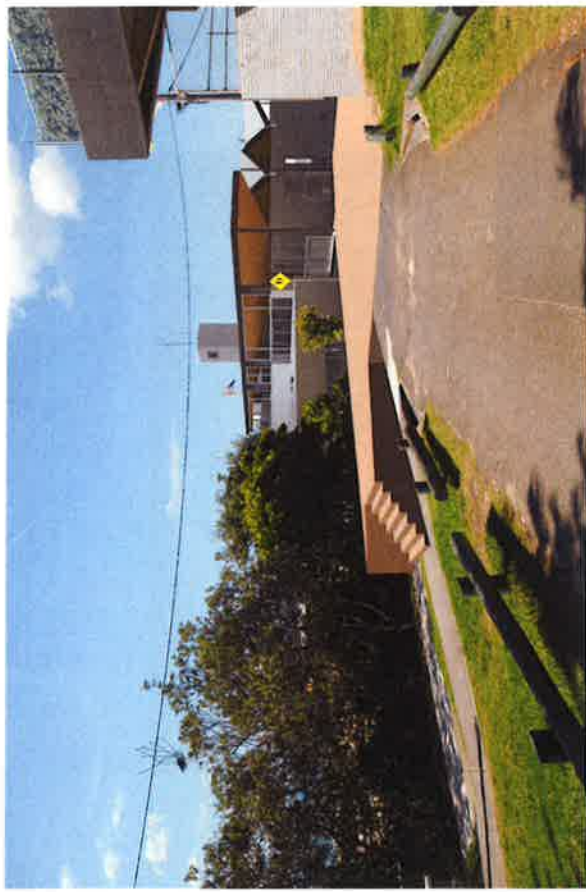
View of proposed scheme from Cronulla Park

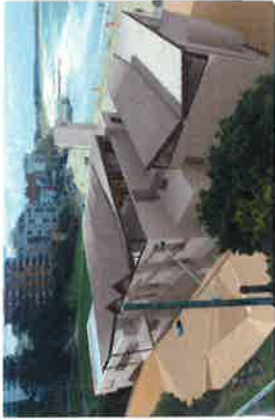
View of proposed scheme from RSL Club

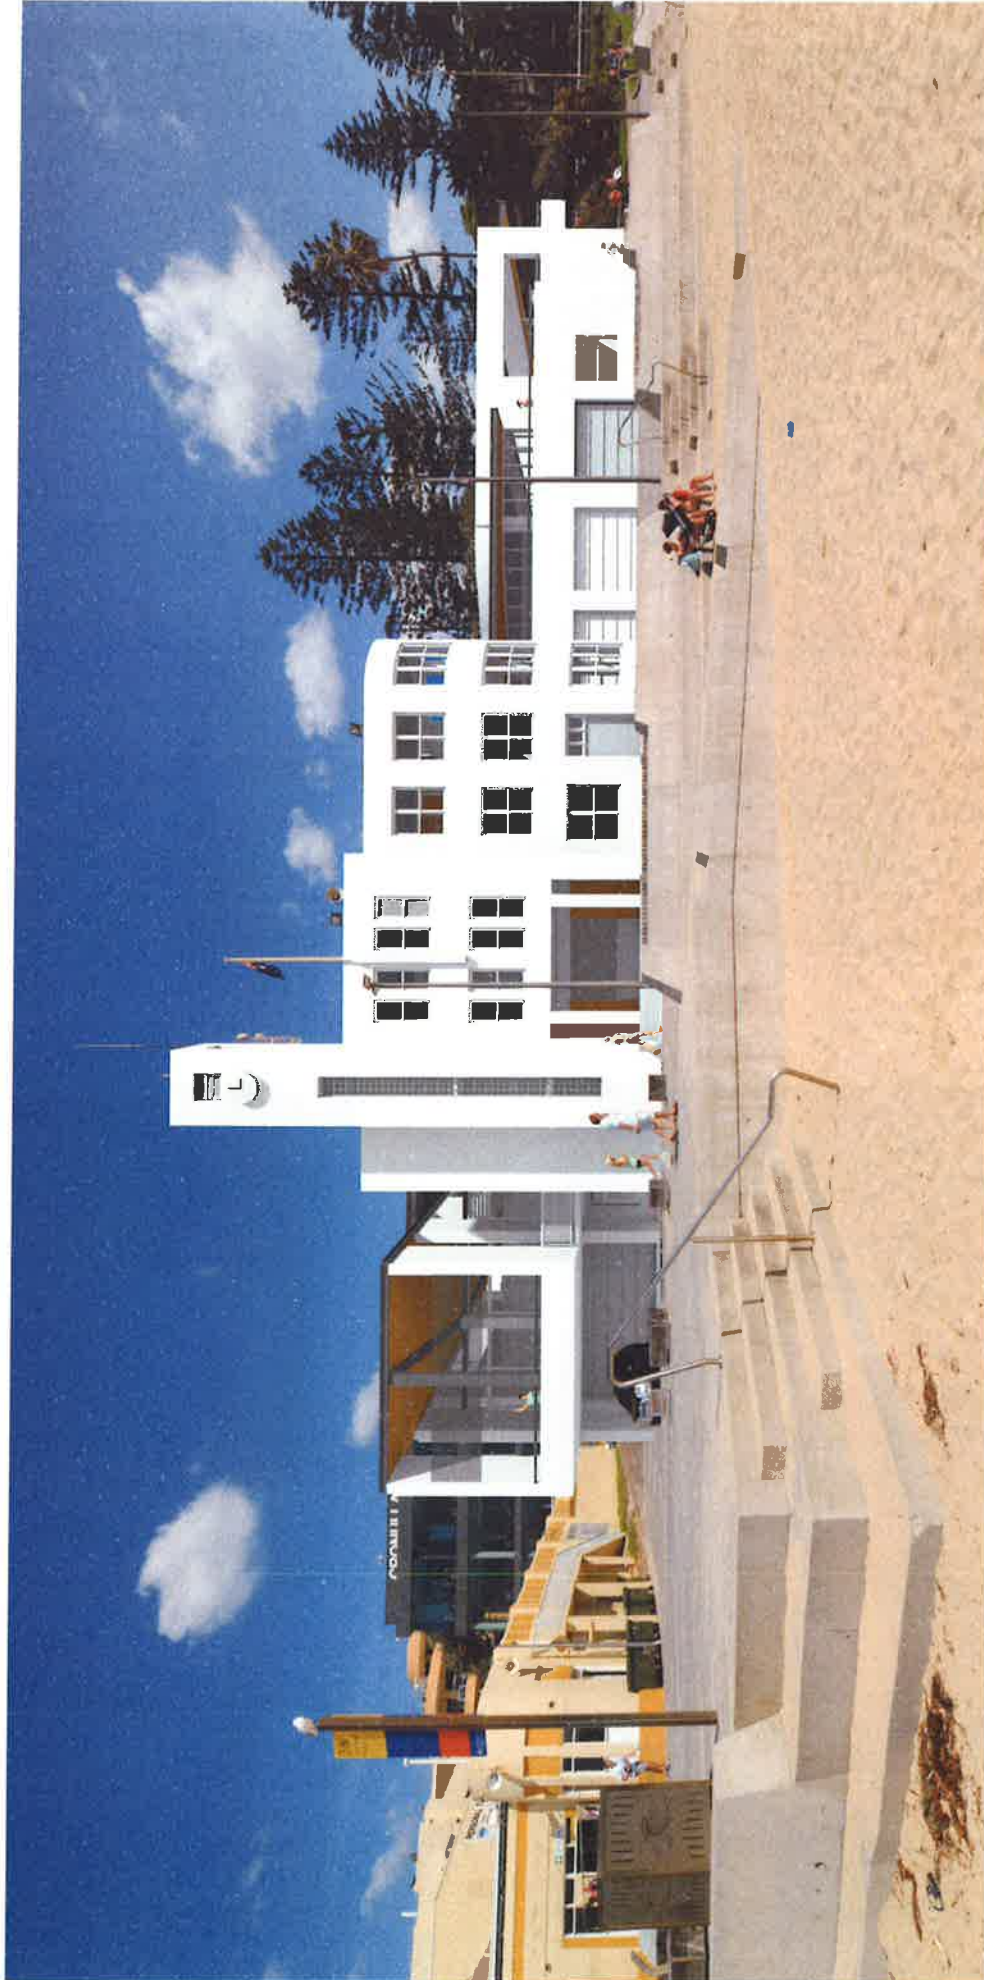
1 Beach View of Completed Proposal
NTS

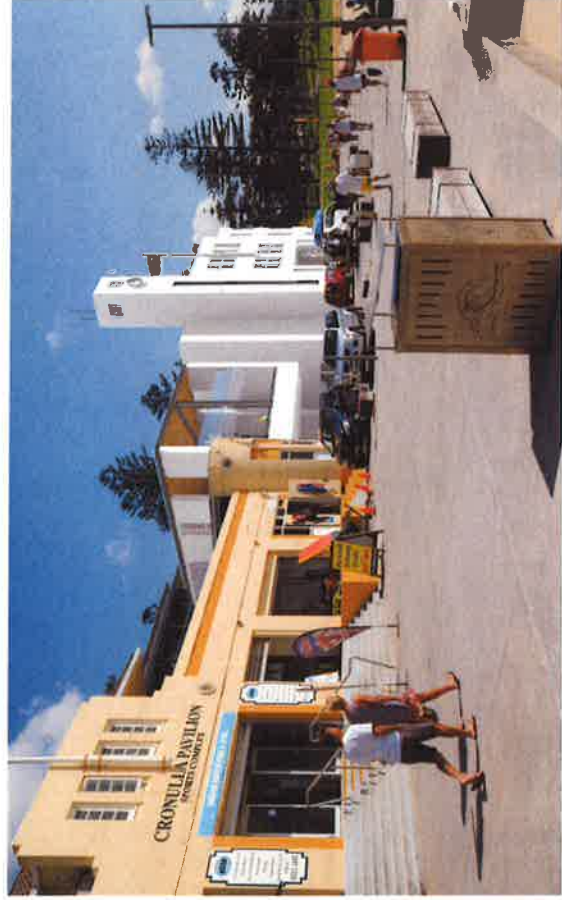
View of proposed scheme from promenade - South side

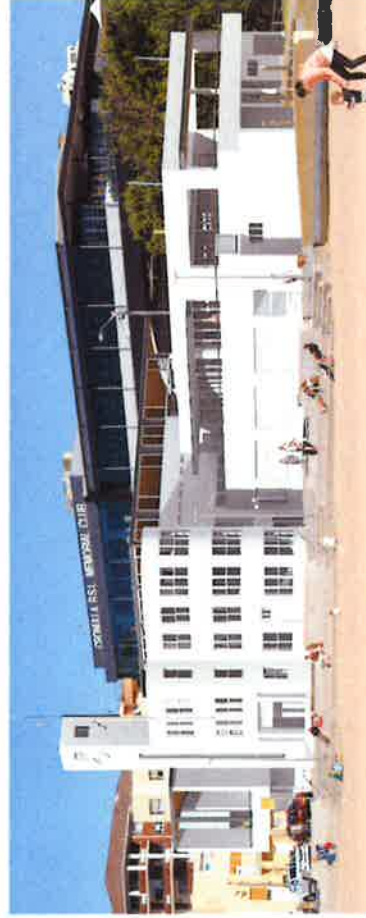
View of proposed scheme from promenade - North side
