# PHASE 1 (PRELIMINARY) ENVIRONMENTAL SITE ASSESSMENT

548-552 Pacific Highway, St. Leonards

PREPARED FOR: Magnificent Investments P/L

<u>DATE:</u> 17th June 2016

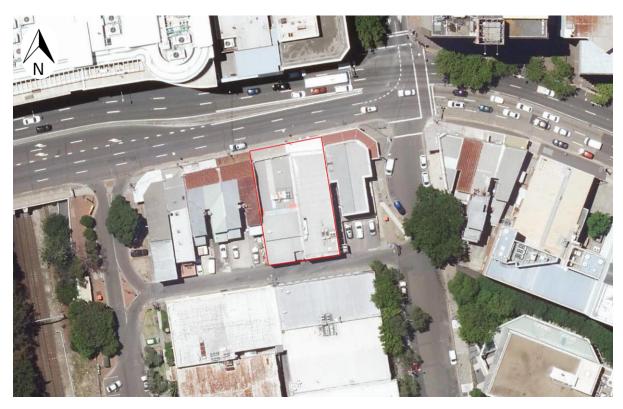
Figure 2 Aerial Image of the site and immediate surroundings (NSW Spatial Information Exchange 7/06/2016)

**Figure 1** shows the location of the site in relation to the surrounding area, while **Figure 2** provides an aerial photograph.

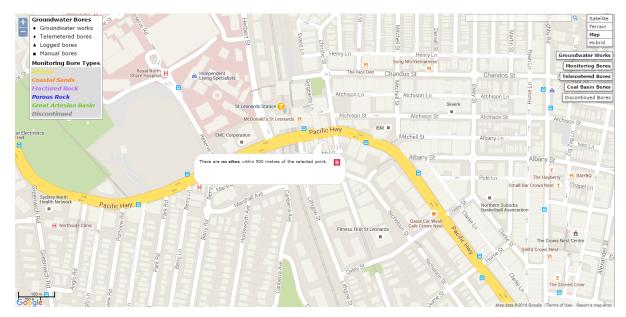
Figure 3 Department of Primary Industries Office of water 'All Groundwater Map' search

A search of the Department of Primary Industries, Office of water 'All Groundwater Map' revealed no groundwater bores within a 500 m radius of the site (Figure 3). Increasing the search radius to 1 km revealed one (1) groundwater bore (GW108224) approximately 1 km north-east. It is licensed for 'Domestic' purposes and has a drilled depth of 132 m and standing water level of 35 m. Groundwater is expected to flow south-west towards Lane Cover River.

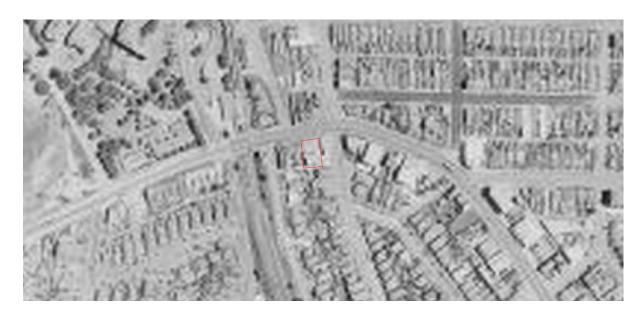
Year	Description
1930	Poor resolution black and white photo. Site occupied by a commercial building.
	Surrounding area highly urbanized.
1951	High resolution black and white photo. The commercial building visible in 1930
	has either been replaced with a larger building or extended to the south.
	Surrounding area remains highly urbanized.
1956	Very poor resolution black and white photo. No visible change from 1951.
1965	Poor resolution black and white photo. No visible change from 1956.
	Surrounding area remains highly urbanized with some larger higher rise
	buildings becoming evident.
1976	Very poor resolution black and white photo. No visible change from 1965.
1986	Poor resolution colour photo. No visible change from 1976. Surrounding area
	remains highly urbanized with larger higher rise buildings becoming prominent.
1994	Poor resolution colour photo. No visible change from 1986.
2004	Moderate resolution colour photo. No visible change from 1994. St. Leonards

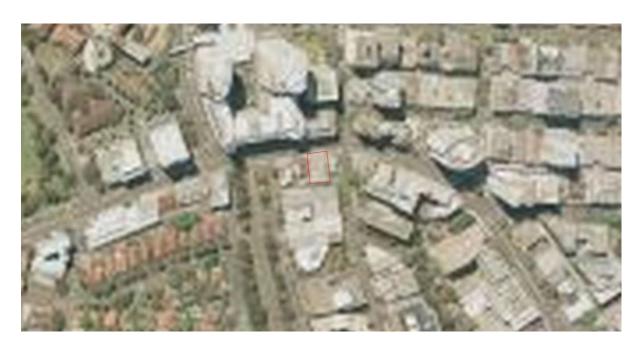
2004

Railway Station has been re-developed.
2015	High resolution colour photo. Roof configuration on the commercial building
	present differs from that visible in 1951 indicating either the building (or at least
	the roof) has been re-developed sometime between then and now.
