SES
AUSTRALIA
Environment & Soil Sciences

Tier 1 Detailed Site Investigation

Manly Civic Club JV

2 West Promenade

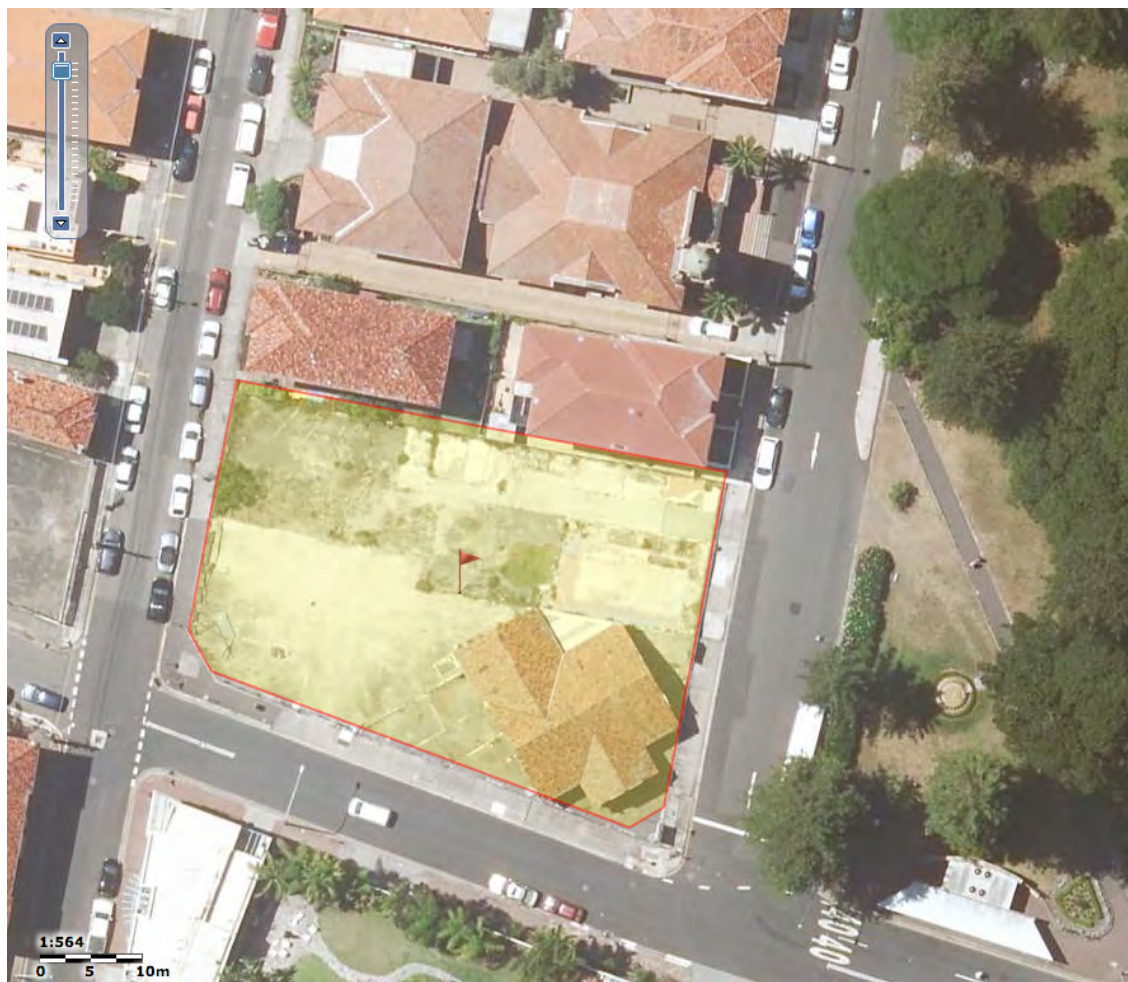
Figure 2 – Site Layout: 2 West Promenade, Manly NSW 2095

The site layout can be viewed in Figure 2 and Appendix A. The site is predominately vacant with hardstand coverings. The south eastern corner of the site has a single building. The buildings interior is concrete hardstand with gyprock walls dividing internal rooms. The buildings exterior is in poor condition. The building layout has been included in Appendix A. The client has advised this building is heritage listed as a former service station and workshop and will be incorporated into the new development.

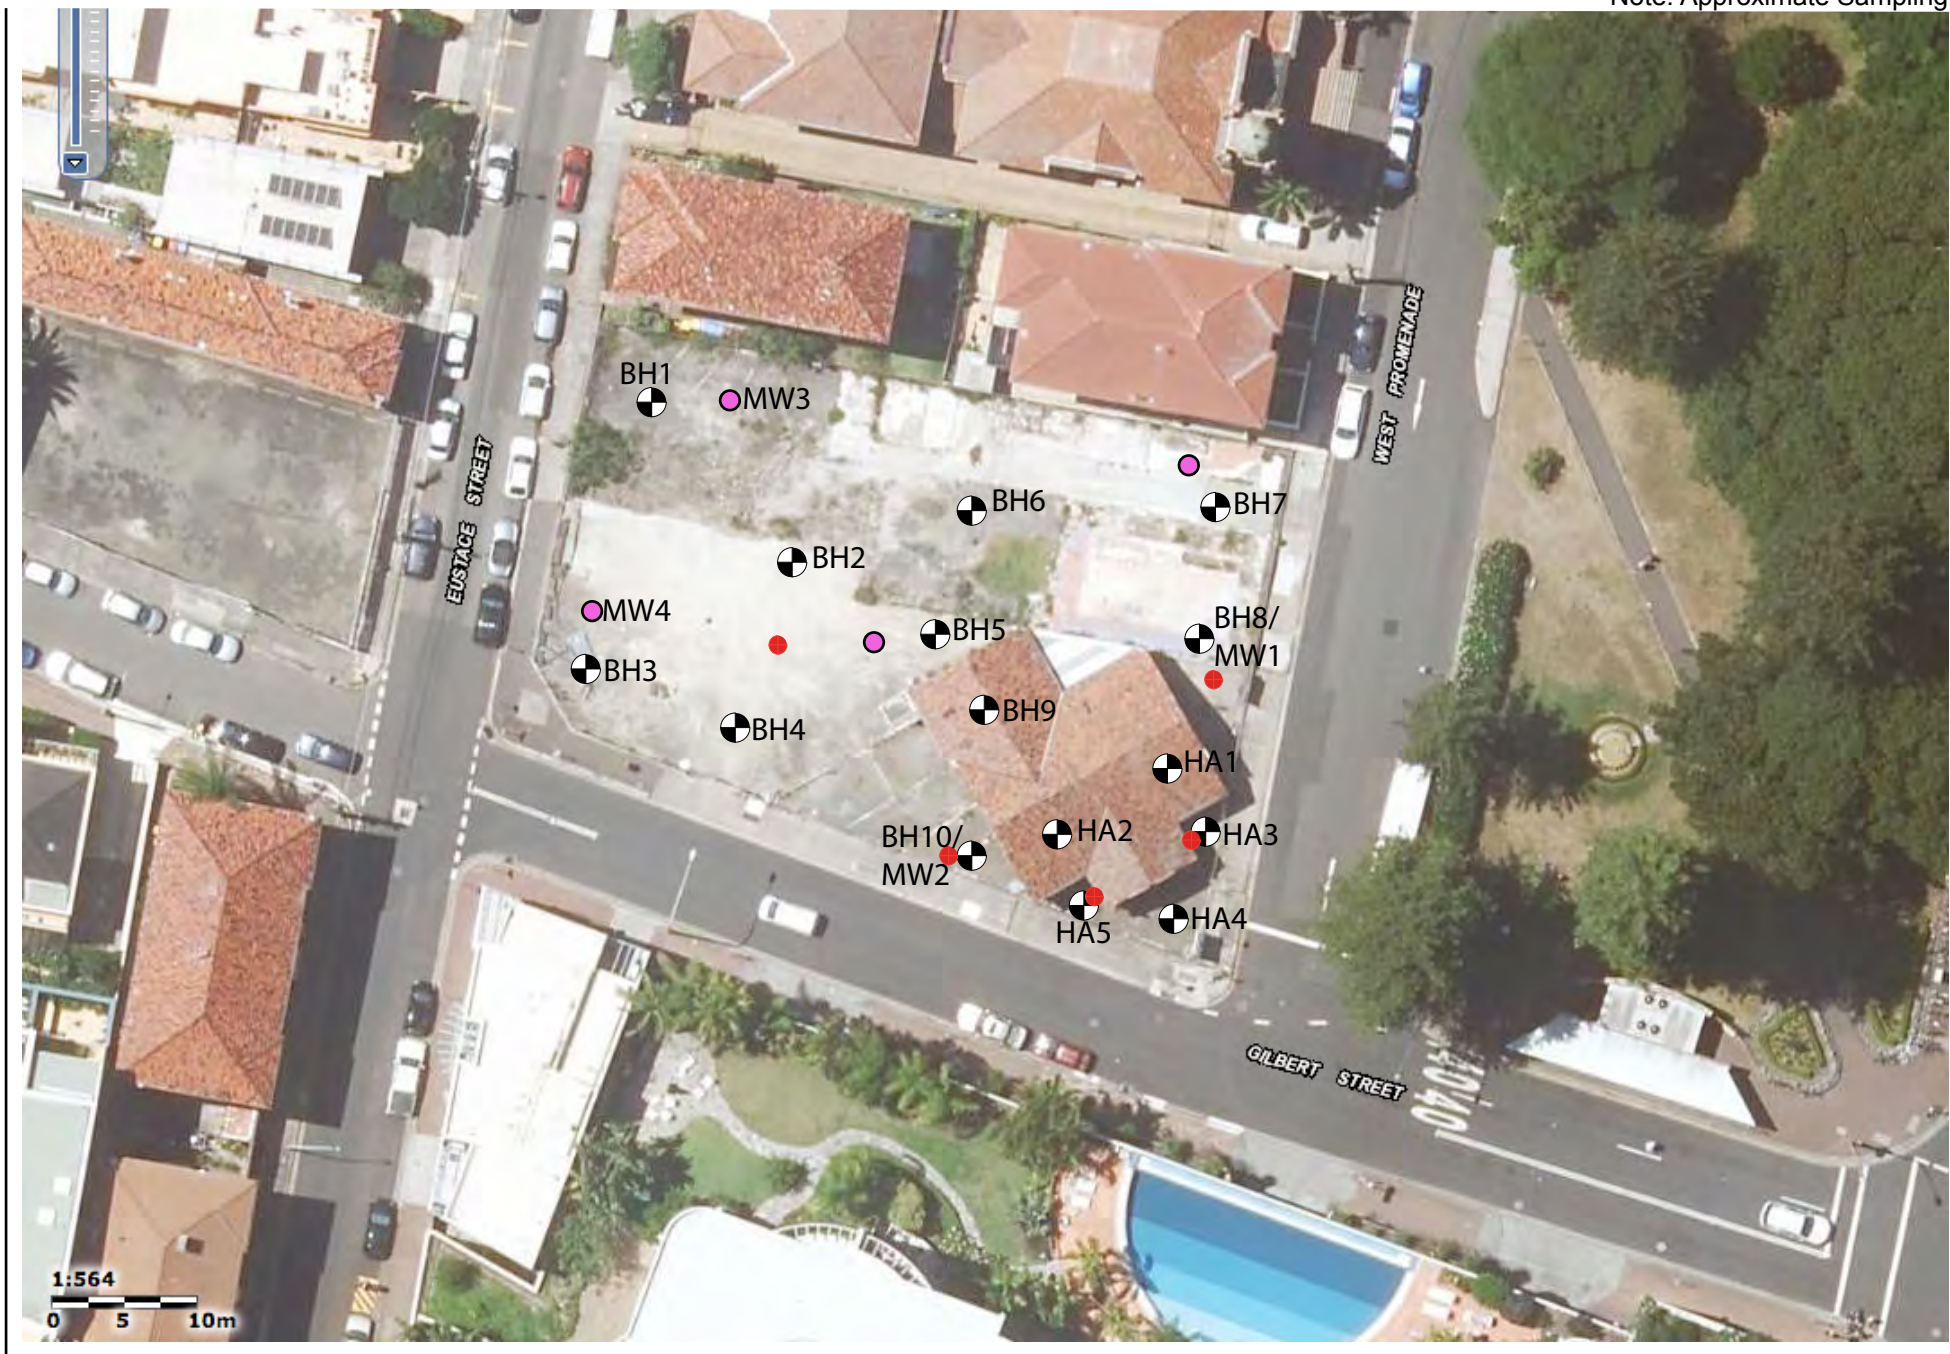
- Borehole/Hand Auger/Groundwater Sampling Locations
- Former Sampling Sites (UEC Report 2002)
- Existing Monitoring Wells

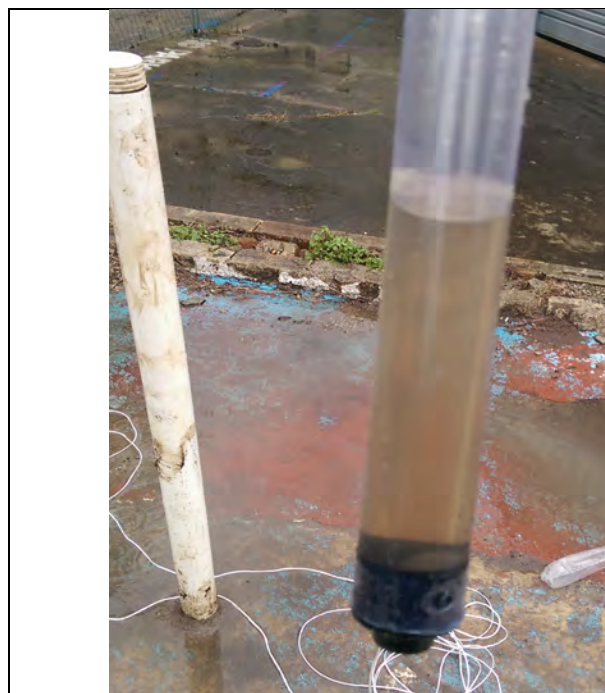
Photo 5. Groundwater grab sample

Site observations made during this investigation identified natural sands with groundwater at approximately 3m. During purging and establishment of monitoring wells, it was noted that the aquifer was fast flowing.

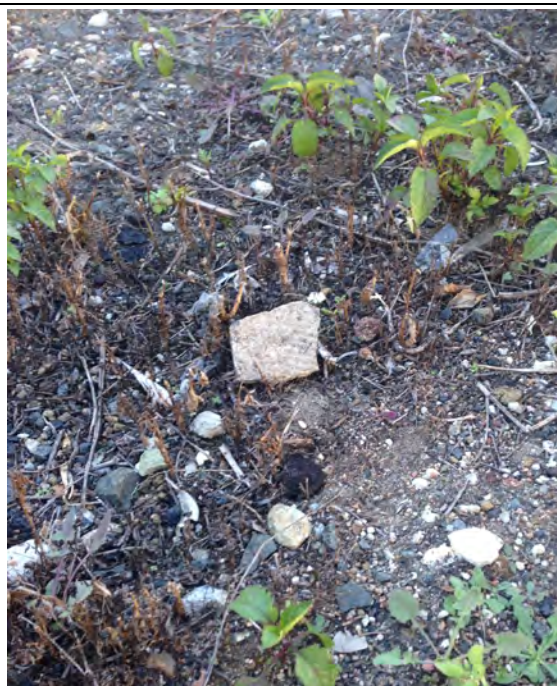
A limited number of asbestos fragments were observed within the foot print of the former Civic Club. These fragments are likely associated with the demolition of the club. Bonded fragments were also observed within the fill of a raised slab behind the former workshop.

Photo 6. Asbestos fragment on surface

Due to the age of the heritage maintenance workshop, no asbestos containing materials were observed in the former service station, however a hazardous materials assessment is recommended prior to any refurbishment works, which will also include the risk of PCB and Lead paint.
