Campion College

Phase 2: Detailed Site Investigation

119 Rausch Street,
Old Toongabbe, NSW 2146

4 April 2016

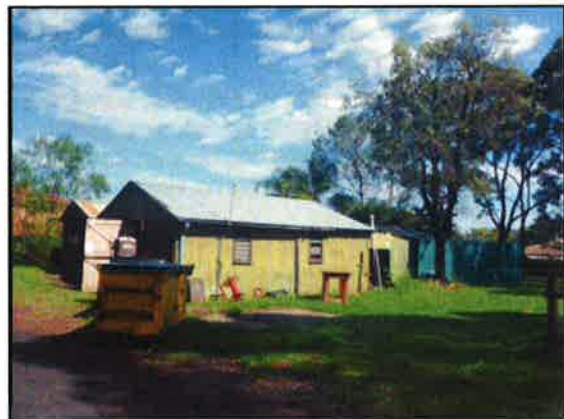
- A cluster of three small structures are present within this part of the site. The largest, western-most structure is used as a workshop and storage area. Materials stored within this structure included old wooden furniture, paints, soil, pesticides/herbicides/fertiliser and landscaping equipment. The small rectangular structure situated immediately east of the workshop/storage building is used as a gymnasium where weight-lifting equipment, stationary bikes and rowing machines are stored. A shipping container situated to the north of these structures is used to store documents and office materials.

Photo 1: View of gymnasium and storage sheds located within northwestern portion of the site.

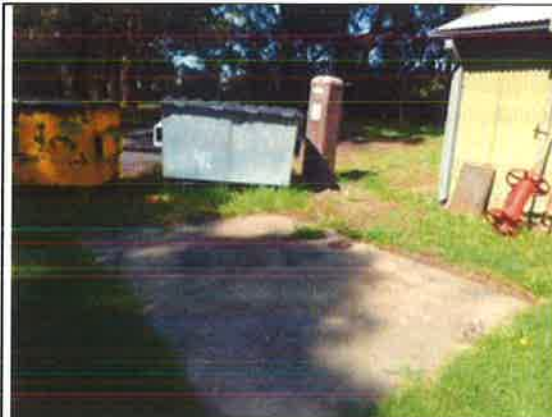
- An old 'Mobil Distillate' fuel bowser is present in this area adjacent to gymnasium. A rectangular concrete slab lies adjacent to the bowser measuring an area of approximately 4m by 4m. Two small caps are present on the slab indicate that an underground storage tank (UST) is present beneath the slab. The small caps were removed as part of the field investigation conducted as part of this study, to assess their purpose. One of the caps revealed a graduated dipstick, which provided a strong indication that a UST remains in-situ. The Coffey field engineer supervising the investigation works confirmed the base of the tank was 1.88mbgs and there was a small volume of water in the base of the tank. The water did not contain visible sheens or odours, suggesting the UST does not contain clearly perceptible petroleum residues.

Photo 2: concrete slab situated over UST. Disused fuel bowser located adjacent to waste skip bin.

- Given the presence of volatile petroleum hydrocarbons, and the absence of chemical indicators typically associated with diesel fuels, it is assessed that the UST is likely to have stored petroleum historically. Recovery of the tank dipstick and gauging of the tank indicates that the tank no longer contains petroleum, although some water is present within the UST which is likely to have derived from infiltration.
- Soil samples did not report concentrations exceed the ecological assessment criteria with the exception of TRH F3 (C16-C34) in sample HA02 (0.0-0.15m).
- Analysis of soil samples reported concentrations of petroleum hydrocarbons below the adopted Management Limits presented in Table 6.5. Similarly, the reported concentration of petroleum hydrocarbons did not exceed the vapour inhalation HSL presented in Table 6.6.

- Demolition of existing structures. Prior to demolition works commencing, it is recommended that a pre-demolition survey of these structures is undertaken to accurately identify hazardous building materials. Hazardous building materials should be removed prior to demolition.
- Removal of the UST, fuel bowser, and associated fuel distribution and ventilation lines. Removal of soil impacted with petroleum hydrocarbons to a level which mitigates the identified health risks.
- Removal of fill materials surrounding the structures that have been impacted with ACM, Lead and hydrocarbons
- Removal of stockpiled wastes that have the potential to pose aesthetic issues.

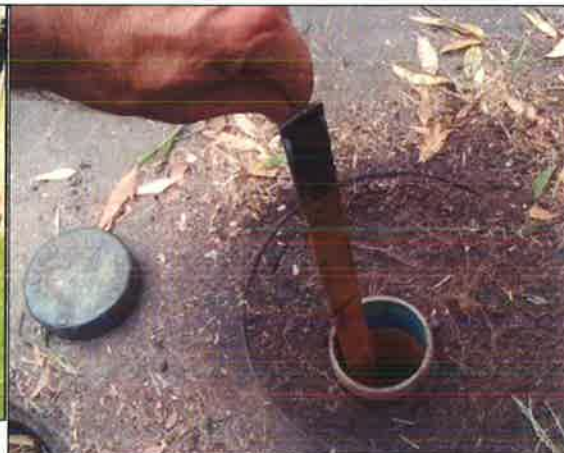
Photo 3: UST dipstick located beneath cap on concrete slab.
