## **Proposed Mixed-Use Development 20 Shepherd Street, Liverpool, NSW**

Report on  
Geotechnical Investigation, Salinity & Acid Sulfate Management  
Plan

2606-R2 Rev2  
10 November 2015

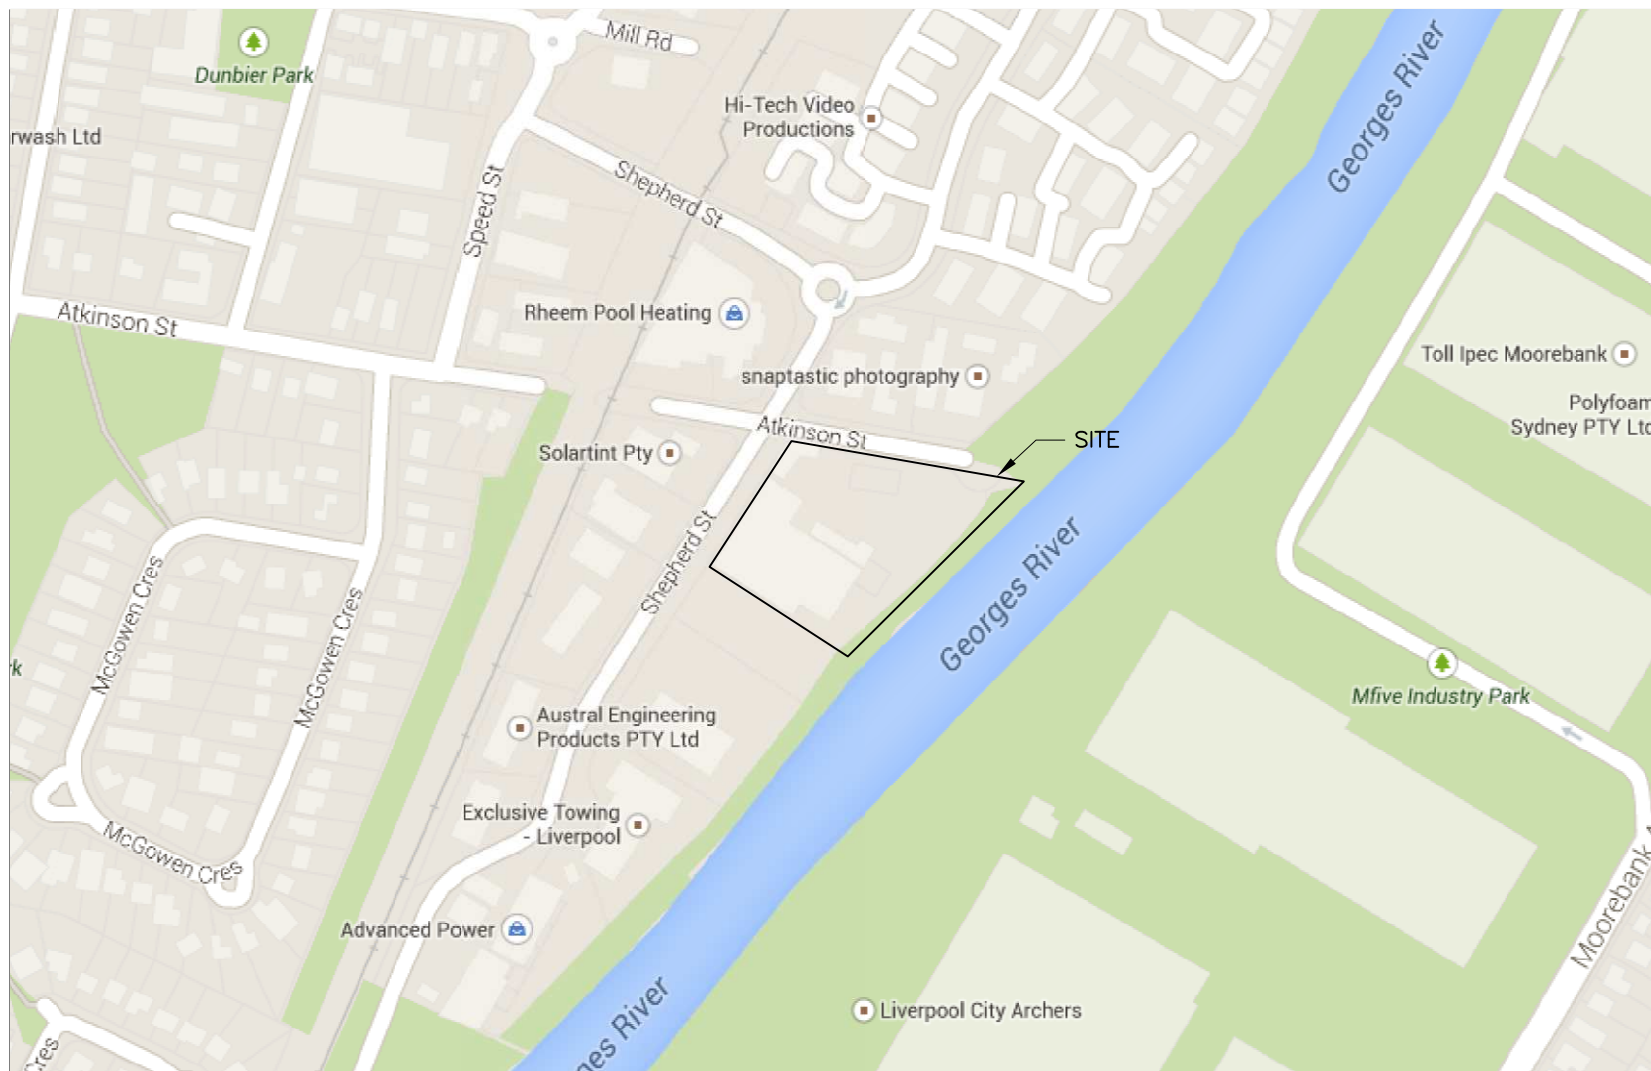
Figure 1 – Site Locality  
Figure 2 – Test Locations

APPROXIMATE ONLY –  
SUBJECT TO DETAIL SURVEY.

SOURCE: "Google Maps"

The site is located along the eastern side of Shepherd Street and southern side of Atkinson Street in the suburb of Liverpool, as shown in Figure 1. It has a frontage to Atkinson Street of about 110m wide and is about 80m to 125m deep. The site is bounded to the northeast, east, and south by the Georges River. The entire site comprises a total area of approximately 9873m<sup>2</sup> with a building area of 3560m<sup>2</sup>.
