7. RESULTS AND DISCUSSION

8. CONCLUSION AND RECOMMENDATIONS

Client: Bethel Mar Thoma Church Job Number: 171144
Project: Contamination Report Addendum Contractor: N/A
Location: 1650 The Horsley Drive, Horsley Park Logged by: JR

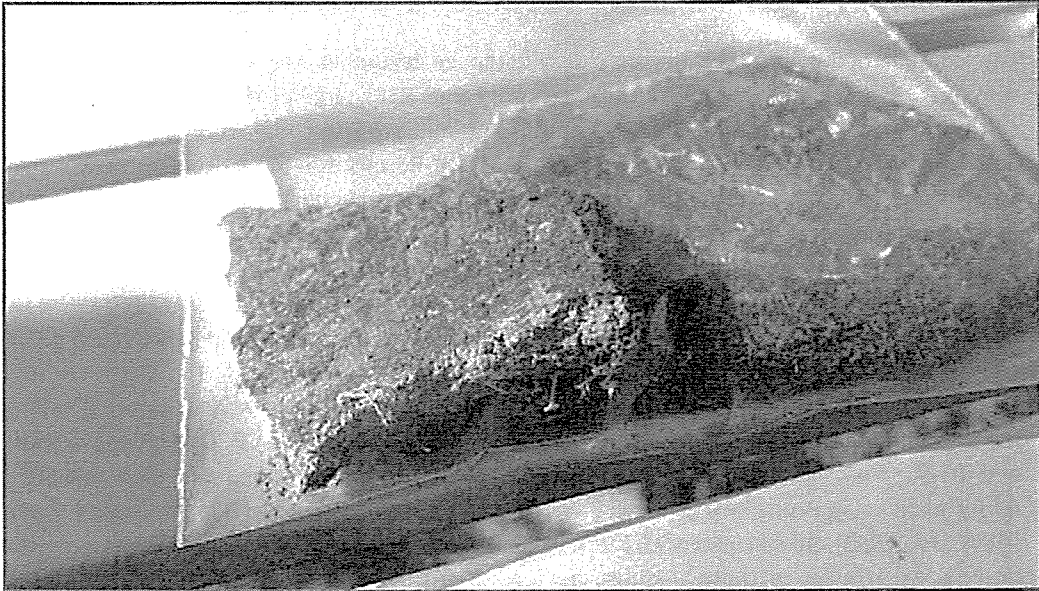
Figure 7-1: Bonded Asbestos Found on the Soil Surface at Pit STOCK 2 on the Stockpile in Area 4

However, asbestos concentrations in exceedance of the NEPM HIL A SAC was detected by the laboratory in two of the three soil samples from the fill stockpile, in the proposed residential area, Area 4 (Table 7-3).

Two pieces of suspected bonded asbestos (ACM) of approximately 10 cm x 5 cm were found in the immediate sub-surface of the stockpile material at sampling point STOCK 2, (Figure 7-1), which was confirmed to be bonded ACM by lab testing. No asbestos was visible in pit STOCK 3, however, lab results indicated the presence of fibrous asbestos (ACM in a degraded condition).

A remediation action plan must be prepared to guide the removal of asbestos contamination. Benbow Environmental recommends that the whole stockpile is sent for disposal to an appropriate waste facility. Following the remediation works (i.e. removal of asbestos contaminated stockpiles), a validation programme would be undertaken to ensure that surface soil in the affected portion of the site (Area 4) is free from any form of asbestos potentially released during the removal of stockpile material. Soils in Areas 1, 2, 3, 5 and 6 do not require remediation/validation for presence of any chemicals of concern.

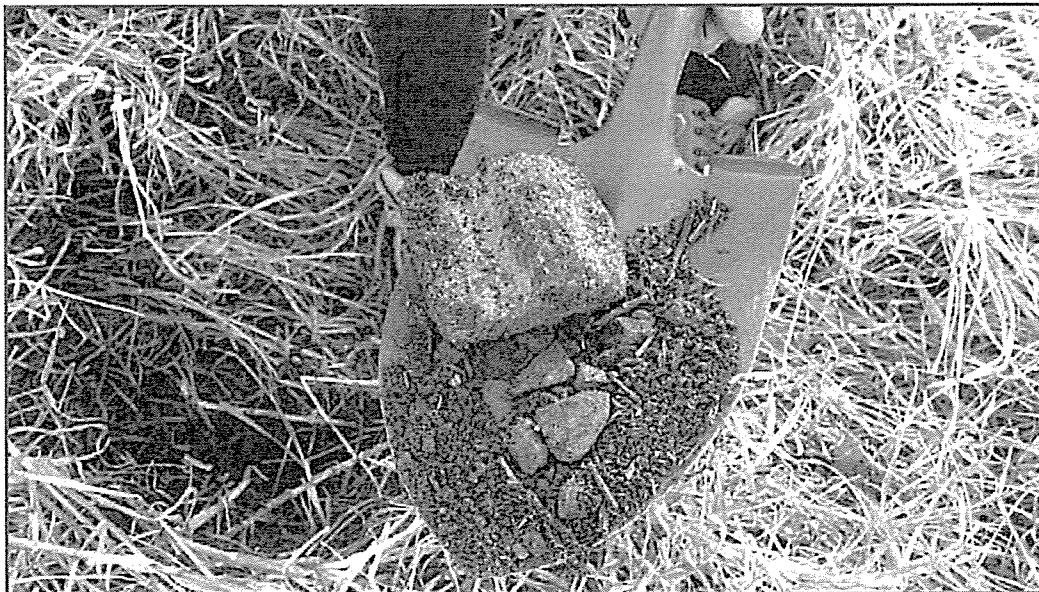
Figure 7-2: Building Waste Found in sampling point STOCK 3 on the Stockpile in Area 4

This indicates that the asbestos is most likely from building waste that has been either brought in with the fill or dumped in the soil stockpile at a later stage. Fragments of building waste, including brick and concrete ranging from 1 cm to 10 cm in diameter, were throughout sampling point STOCK 3 as shown in Figure 7-2, which supports this conclusion. No building waste was visible in pit STOCK 1 and no asbestos was detected by the lab in this sample, so asbestos contamination may be localised in hotspots throughout the stockpile. No other form of contamination was detected in the stockpile during previous sample testing by ESP.
