## GEOTECHNICAL ASSESSMENT REPORT

21 ATKINSON STREET, LIVERPOOL, NSW

El Report No. E23001 GA

Date: 17 June 2016

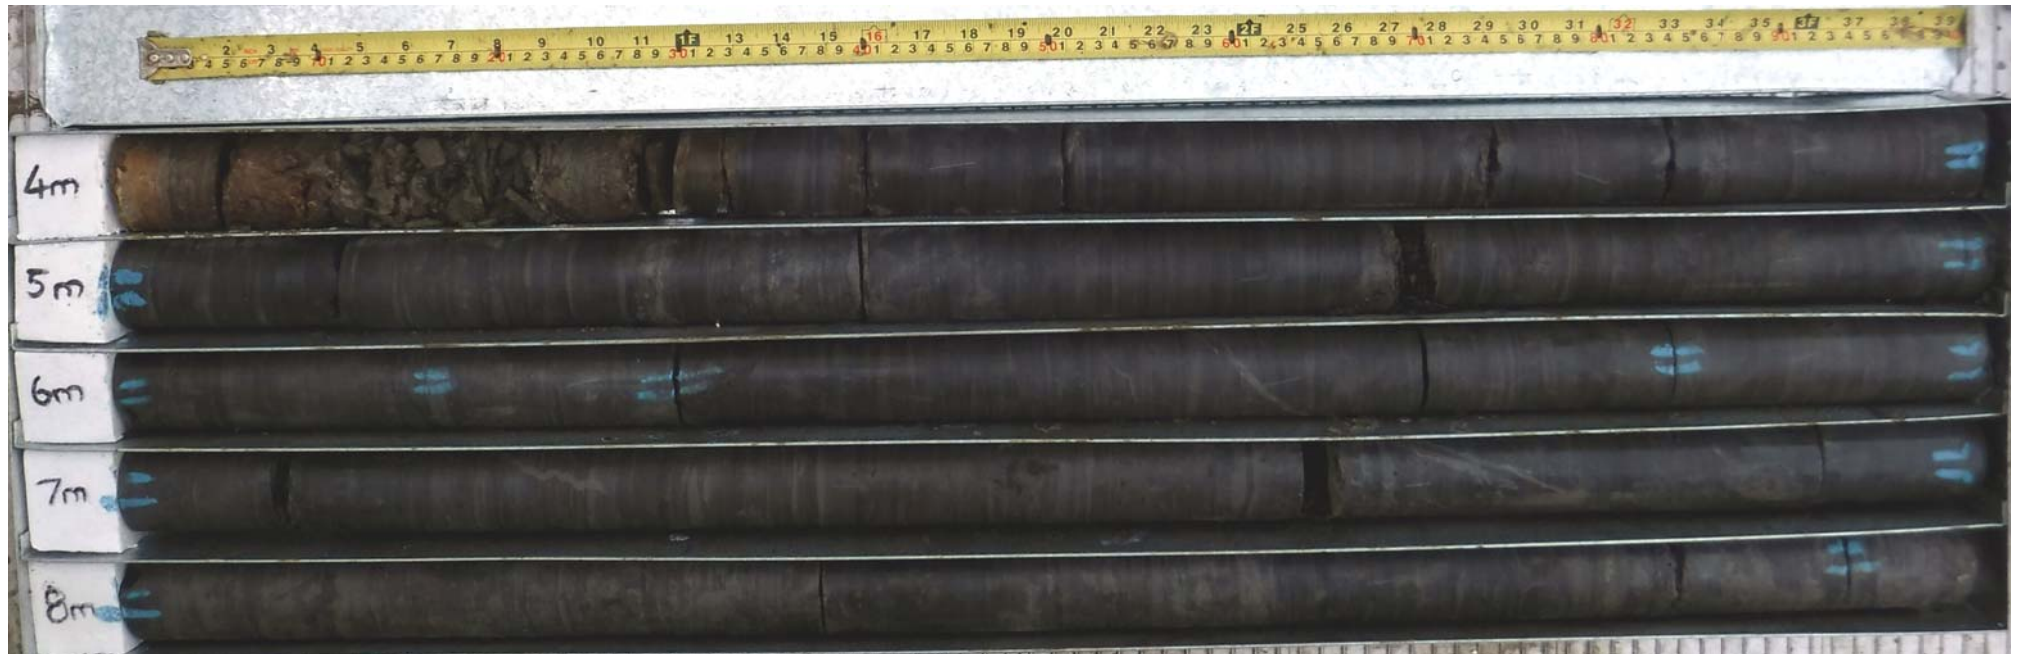
East: 307979.3 m  
North: 6243520.9 m MGA94 Zone 56  
Surface RL: 9.70 m AHD  
Inclination: -90°  
Box: 1 of 1  
Hole Depth: 9.00 m

Depth Range: 4.00 m to 9.00 m  
Contractor: Rockwell Drilling Pty Ltd  
Drill Rig: Hanjin DB8  
LOGGED BY: DATE: 16/05/16  
CHECKED: SK - DATE: 17/06/16

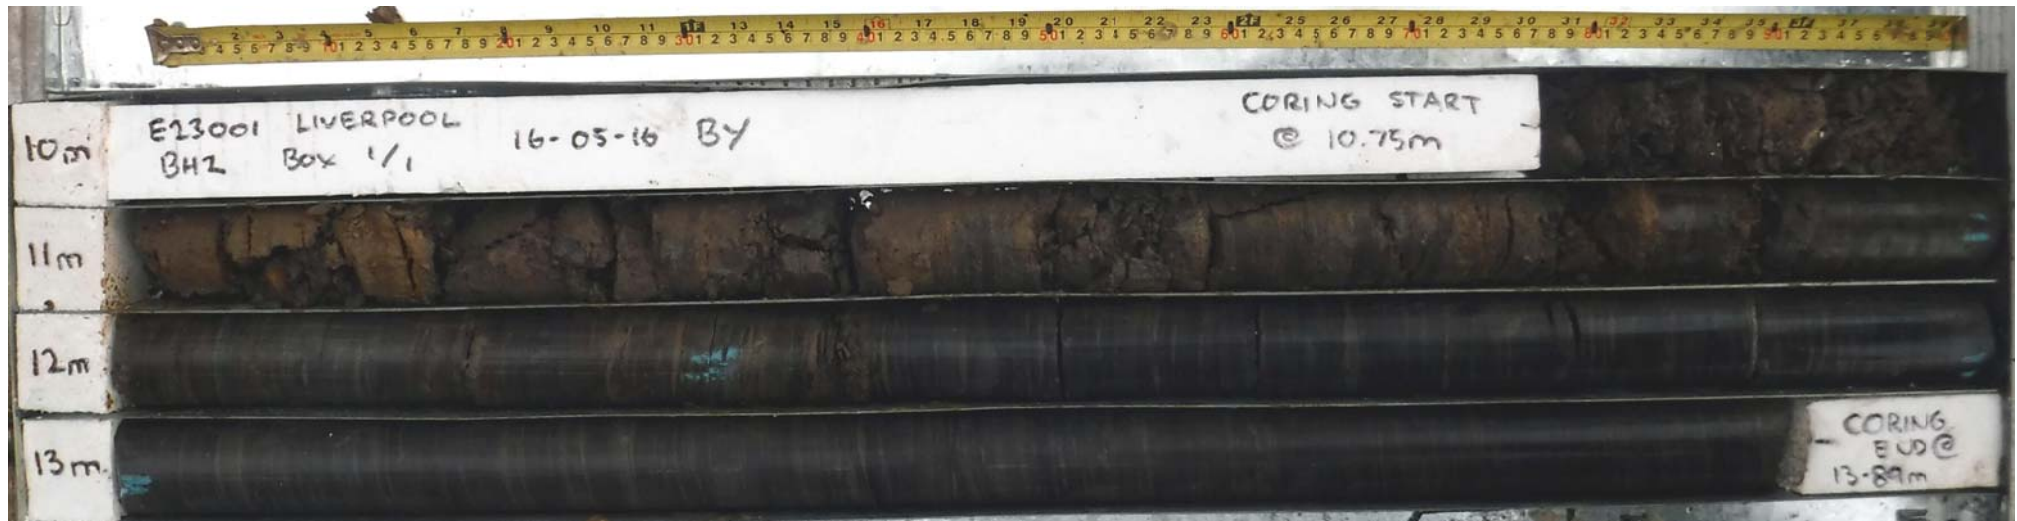
East: 308046.9 m  
North: 6243571.1 m MGA94 Zone 56  
Surface RL: 9.80 m AHD  
Inclination: -90°  
Box: 1 of 1  
Hole Depth: 13.89 m

Depth Range: 10.75 m to 13.89 m  
Contractor: Rockwell Drilling Pty Ltd  
Drill Rig: Hanjin DB8  
LOGGED BY: DATE: 16/05/16  
CHECKED: SK - DATE: 17/06/16
