GTE795 – Contamination Report
7 April 2016

Ostar Developments

RE: STAGE 1 CONTAMINATION ASSESSMENT at Nos.116-124 Restwell Street, Bankstown

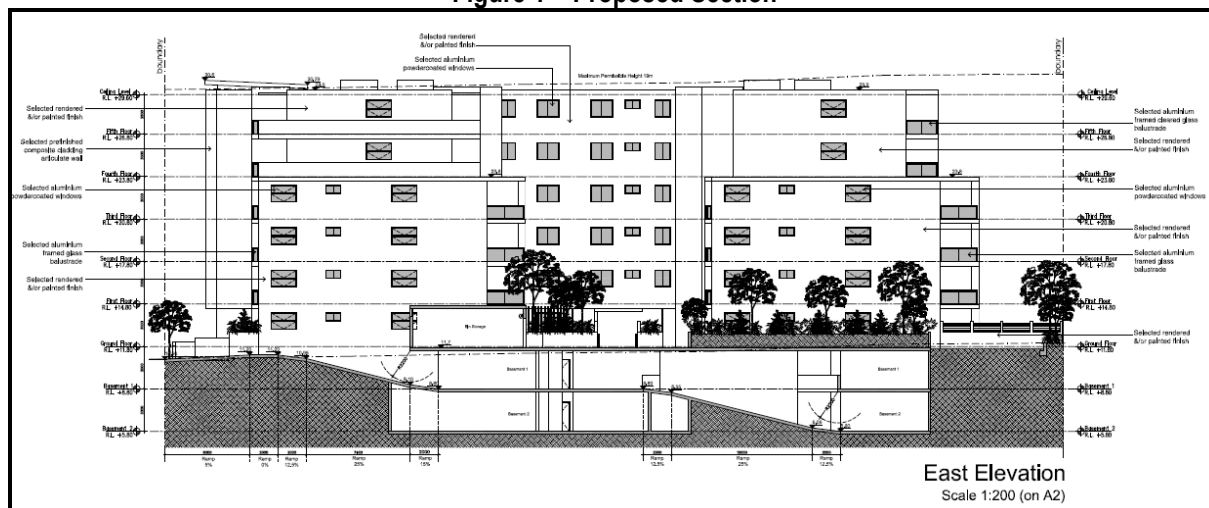
Figure 1 – Proposed Section

Ground Technologies Pty Ltd have undertaken a Stage 1 Contamination Report as requested by Ostar Developments on No.116-124 Restwell Street, Bankstown. It is understood that the proposed works will comprise the demolition of five existing houses allowing the construction of a six storey apartment building with two levels of basement level car parking. The basement level car park will extend across the entire building envelope to a depth of approximately 6.0m below existing ground surface levels.

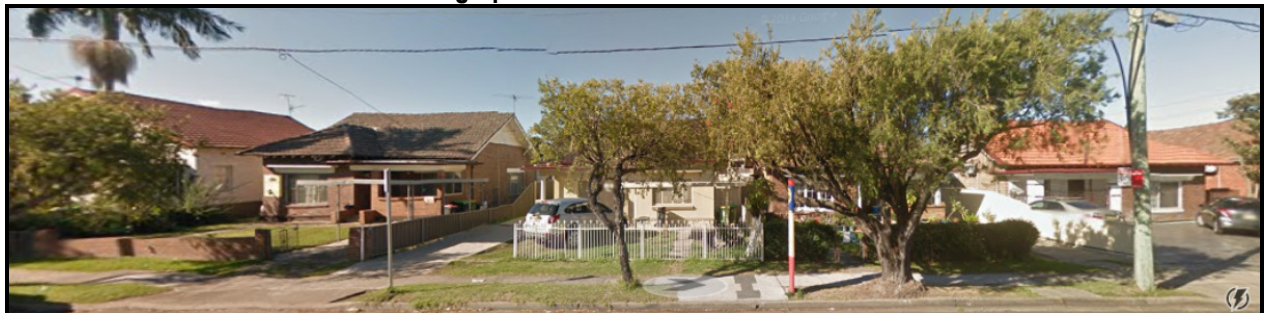
Photograph 1 – No.116-120 Restwell Street

The subject site is a combination of five residential lots measuring approximately 65m wide along the Restwell Street Frontage and up to 50m in length. The site covers an area of approximately 3250m² and is relatively flat.. No's 116, 120 & 122 Restwell Street contain single storey brick houses. No 118 Restwell Street contains a single storey weatherboard house and No. 124 Restwell Street contains a double storey brick house. Based upon architecture and material inputs it is estimated that the houses in No.116-122 were constructed prior to 1980 whilst the house on No.124 was build post 1980.

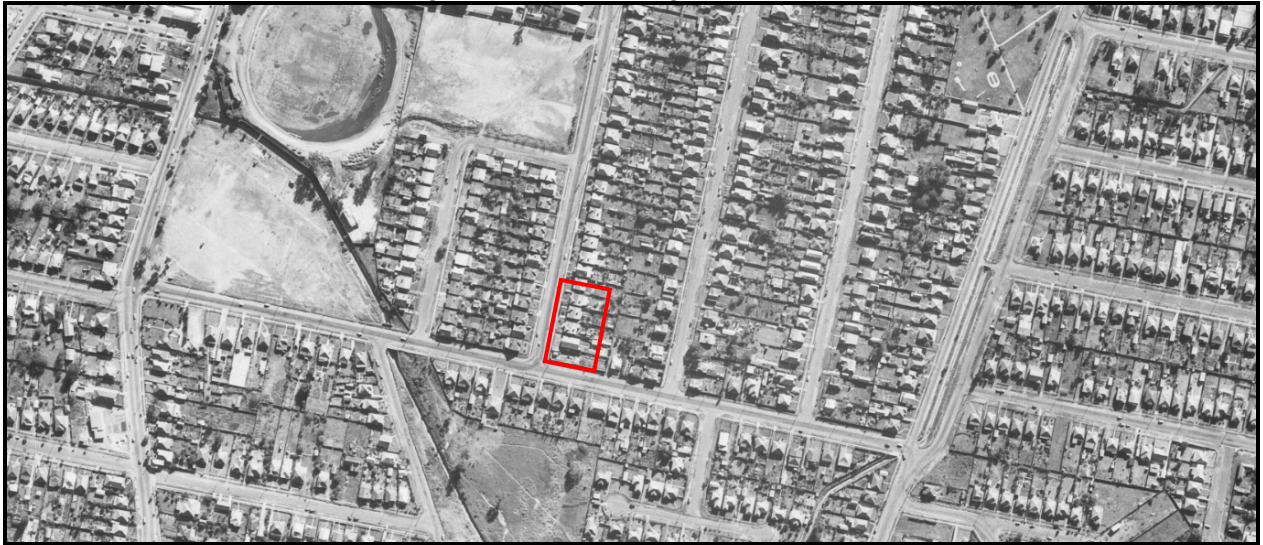
Figure 3 – Aerial Photograph from 1961

1961 – In 1961 the site appears to be in use for residential purposes. The surrounding properties appear to be residential. The subject site is highlighted in figure 3.

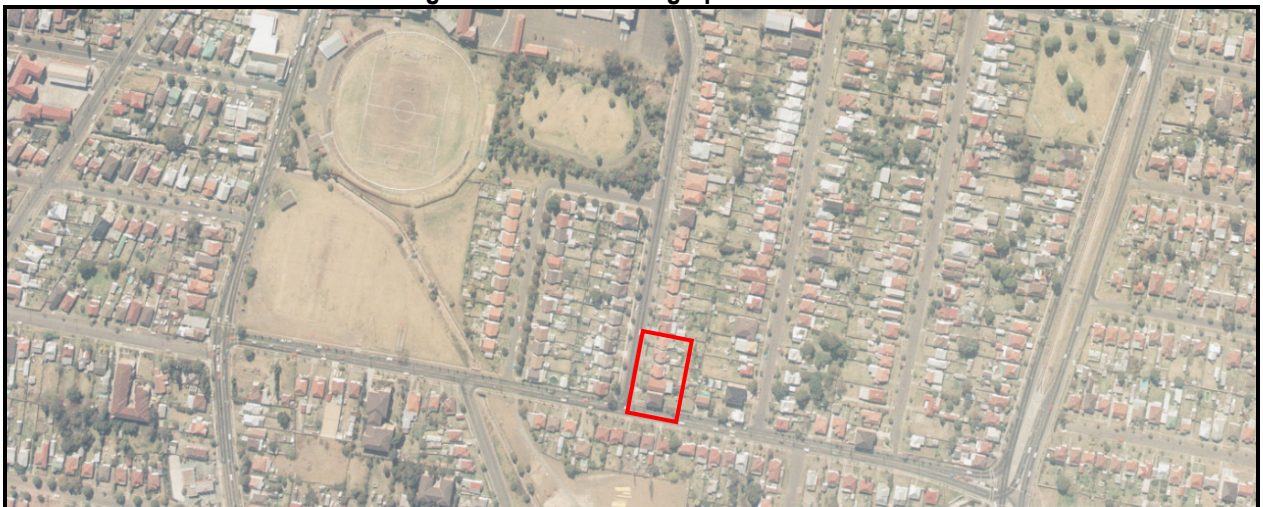
Figure 4 – Aerial Photograph from 1986

1986 – In 1986 the site appears to be in use for residential purposes. The surrounding properties appear to be residential. No significant changes to the surrounding region could be observed, however the house at No.124 has been constructed. The subject site is highlighted in figure 4.

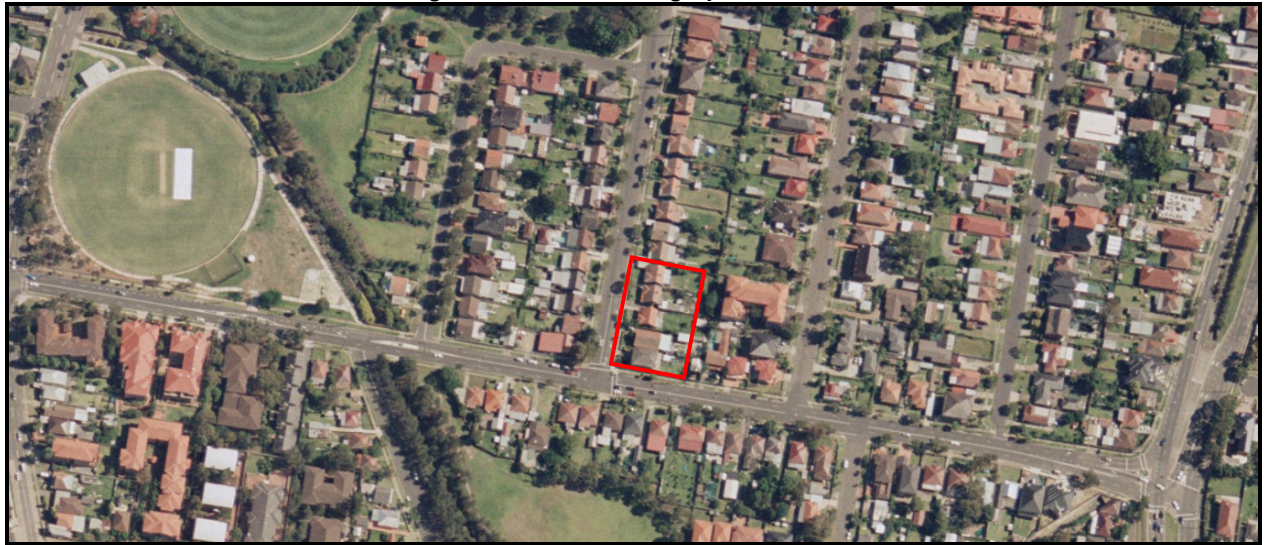
Figure 5 – Aerial Photograph from 2005

2005 – No significant changes to the surrounding region since 1986 could be observed and the site is appears to be in use for residential purposes. The surrounding properties appear to be residential. The subject site is highlighted in figure 5.

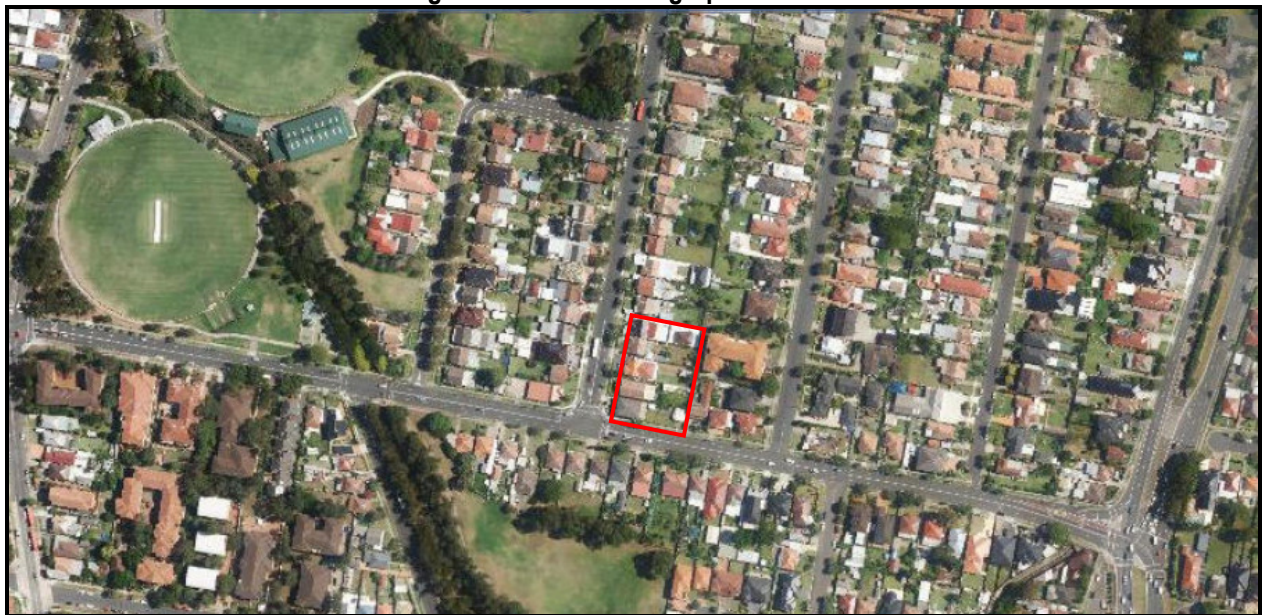
Figure 6 – Aerial Photograph from 2016

2016 – No significant changes to the surrounding region since 1986 could be observed and the site is appears to be in use for residential purposes. The surrounding properties appear to be residential. The subject site is highlighted in figure 6.
